Green Infrastructure in the Great Lakes—Assessment of Performance, Barriers, and Unintended Consequences

Circular 1496

U.S. Department of the Interior
U.S. Geological Survey

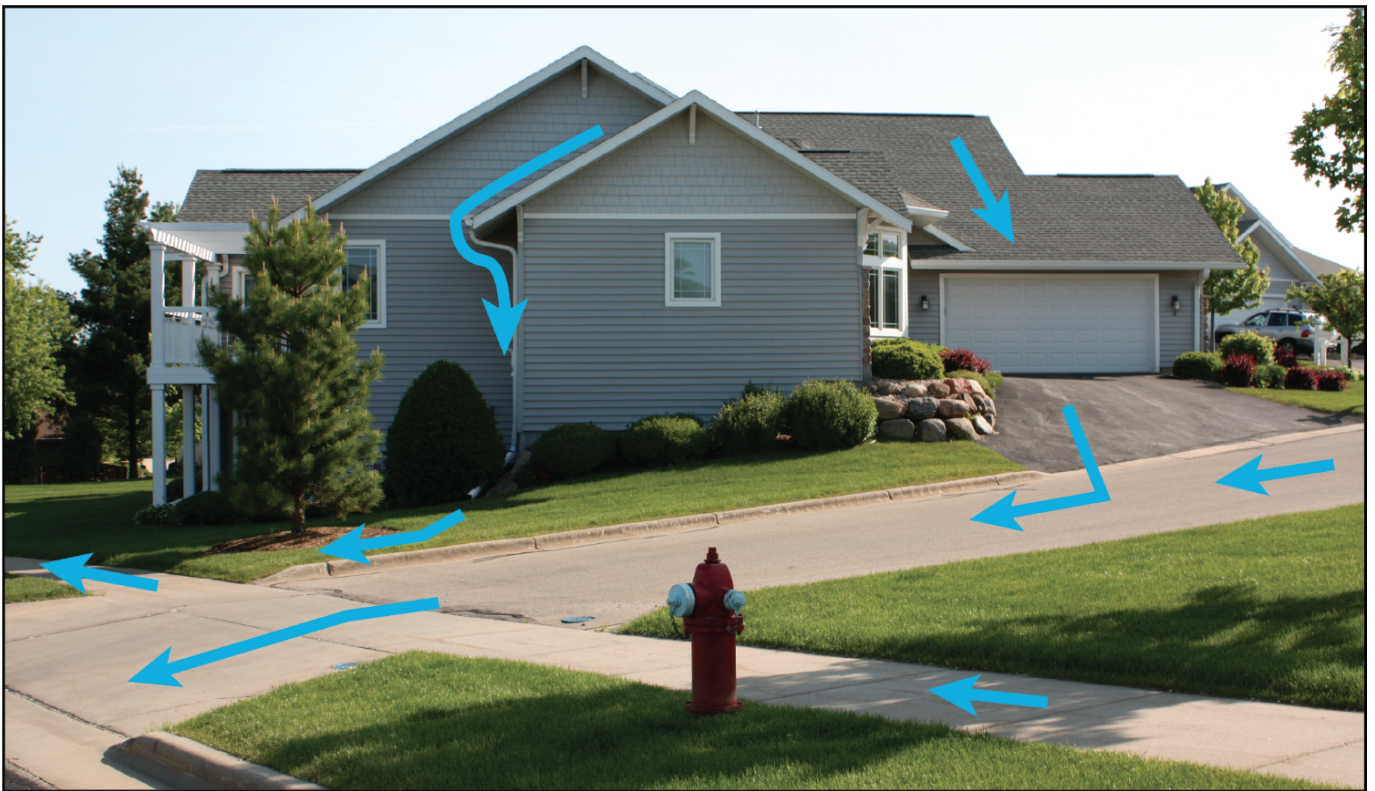
Figure 3. Flow routes of precipitation runoff from impervious surfaces. The blue lines represent the path stormwater would take as it flows off residential impervious surfaces (roofs, driveways, sidewalks, and roads). (Source: Courtesy of U.S. Geological Survey.)

Urban stormwater is rainfall or snowmelt that is not infiltrated into the subsurface, but rather flows off impervious surfaces such as roads, roofs, and parking lots (fig. 3) into stormwater conveyance systems that drain to a receiving water body like the Great Lakes. Stormwater runoff from urban areas is one of the largest contributors of flooding and point and nonpoint source pollution in the Great Lakes Basin (Great Lakes Law, 2010; Hand, 2010).

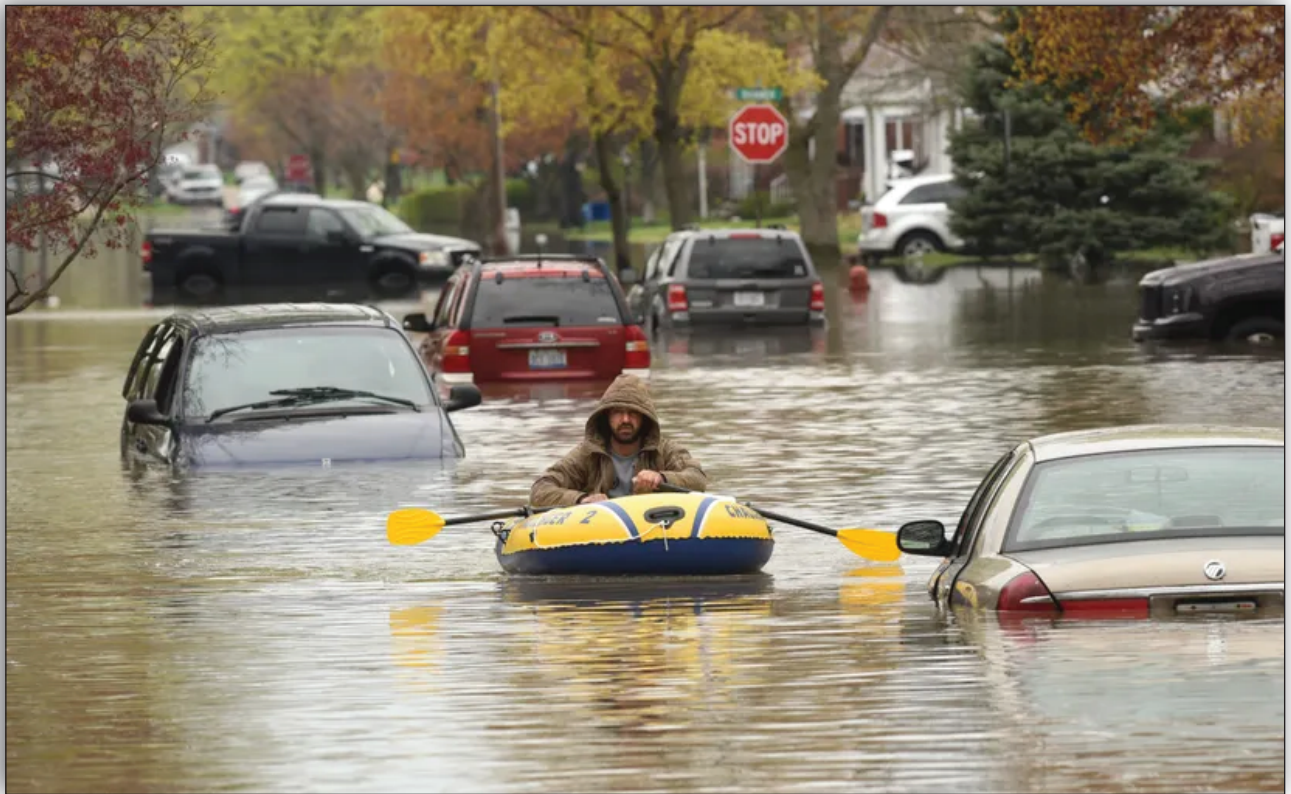
Figure 6. Flooding along a Detroit-area street in 2019. (Source: The Detroit News; Ramirez and others, 2019.)

The overall effect of urban infrastructure is that the natural water cycle is disrupted, with large areas of impermeable surfaces that short circuit paths of runoff, infiltration, and evapotranspiration (fig. 4). During heavy rainfall, excess stormwater runoff can cause localized flooding and changes in streamflow. Urban flooding is prevalent in many Great Lakes cities, and although not unique to this region, communities near the Lakes may be at a greater risk of flooding, than in the past, because of climate change. The communities in the region are typically older with inadequate infrastructure and are not designed to minimize the effects on the receiving waters of the Lakes. A study of Cook County, Illinois, identified 177,000 property damage insurance claims during a 5-year period from 2007 to 2011 (Center For Neighborhood Technology, 2014). This is the equivalent of one in six properties in the county making a claim with total claims amounting to \$660 million during the 5 years examined. Figure 5 shows where properties are at risk from flooding in the Great Lakes region and the predicted percent increase in the number of properties at risk in 30 years. Many areas adjacent to the lakes, like the greater Chicago, Ill., and Gary, Indiana areas, are particularly vulnerable, in part because of large expanses of impervious surfaces in these densely populated areas combined with predicted intensification of storms as a result of climate change (First Street Foundation, 2020; figs. 5 and 6).

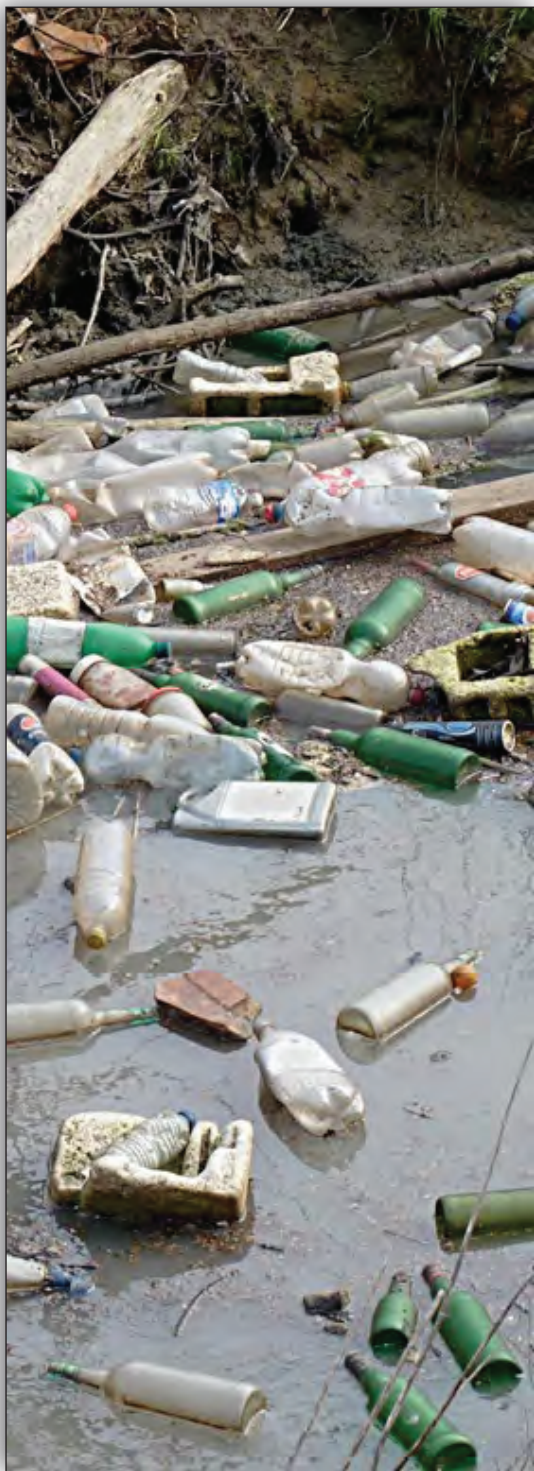
Figure 9. Plastic debris in stream. (Source: Capital Region Water, 2017.)

Runoff from impervious areas contributes accumulated plastics (like bottles, bags, synthetic clothing, and diapers) that are washed off streets into stormwater drains. In a study where water samples were collected from 29 tributaries to the Great Lakes, litter-related plastics (fragments, foams, and films) were found at higher concentrations in stream samples from drainage basins having a higher percentage of urban land use (Baldwin and others, 2016). Plastic litter is not only more prevalent in urban drainage basins than in areas with other land covers, but it also is more mobile because impervious surfaces and storm sewers facilitate conveyance of plastics to receiving water bodies during runoff-event conditions (figs. 8 and 9).

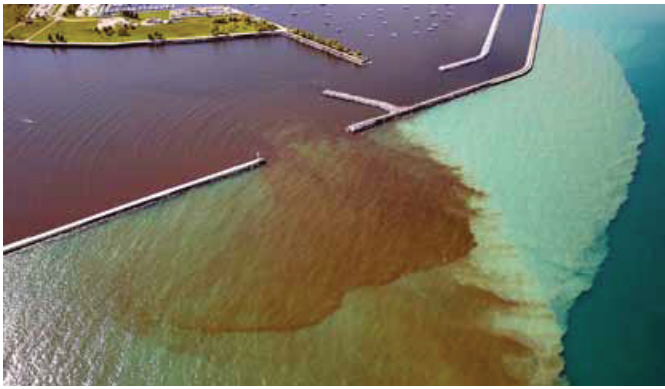
Figure 13. Combined sewer overflow event. (Source: Lyandres and Welch, 2012.)

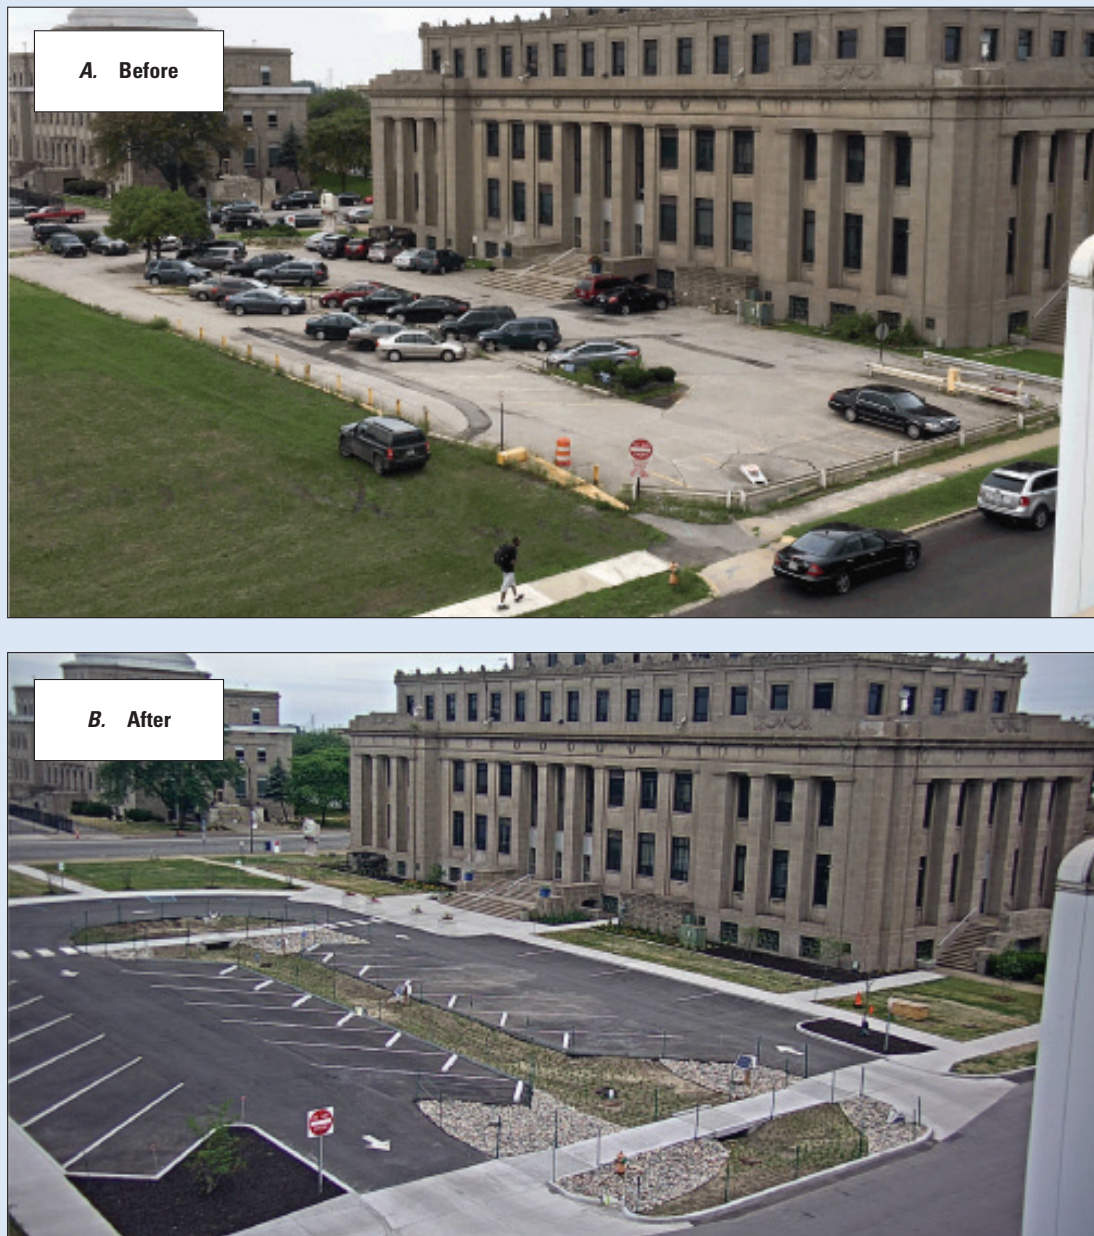
Figure S1.1. City Hall, Gary, Indiana, before and after installation of central rain garden and peripheral grassed areas.

The city of Gary, Indiana, is on the southern-most shore of Lake Michigan and is representative of the Great Lakes' coastal sandy soils and subsurface deposits that are conducive to infiltration. During 2016–17, the city of Gary redeveloped a parking lot south of city hall using Green Infrastructure (GI), a project supported by the Great Lakes Restoration Initiative. The redevelopment included the removal of impervious cover, installation of structures to redirect runoff from the storm-sewer system to a central rain garden, and the addition of peripheral grassed areas (fig. S1.1; U.S. Geological Survey, 2021a).

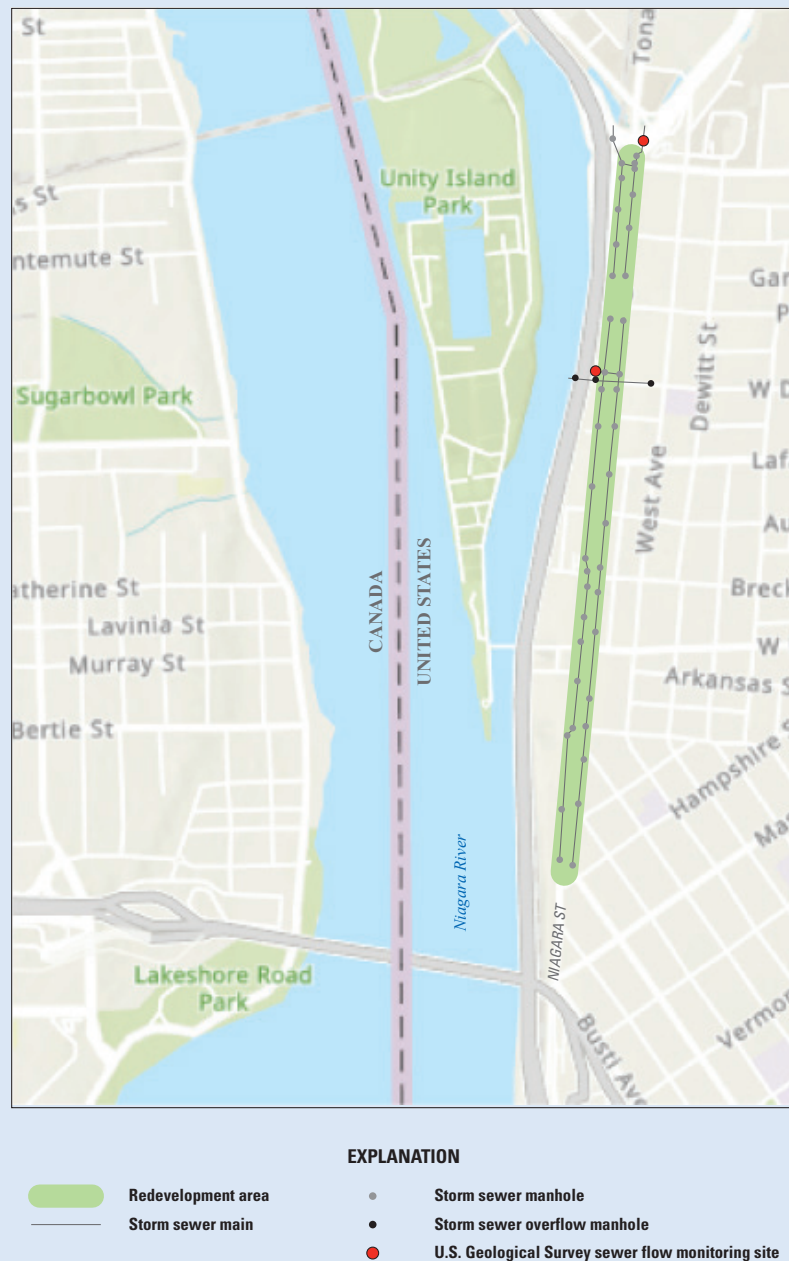
Figure S2.1. Locations of monitoring stations along the Niagara Street redevelopment area in Buffalo, New York.

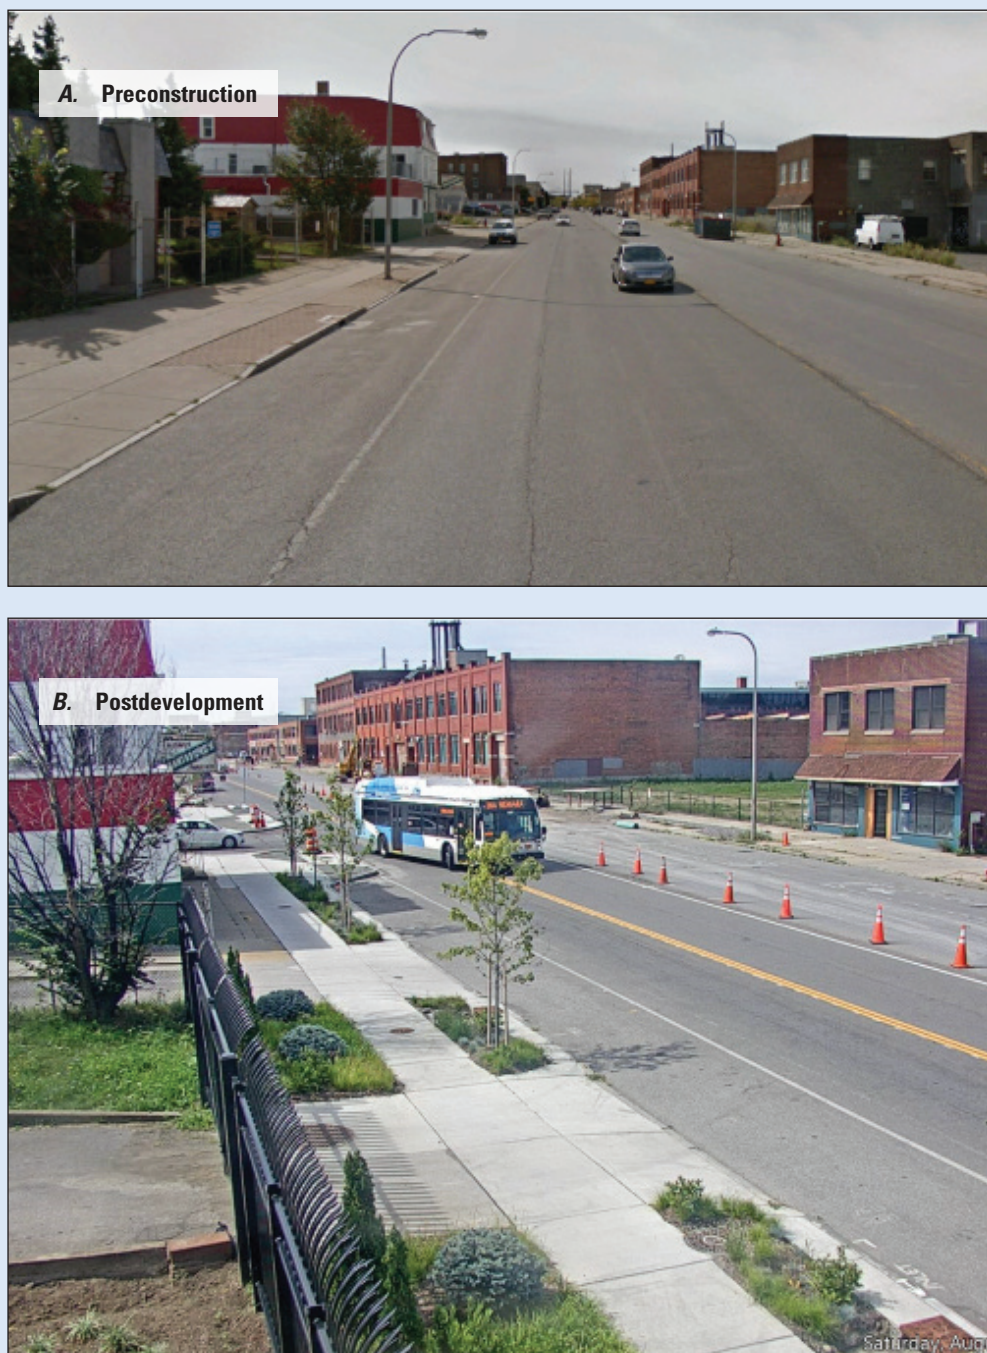
Figure S2.2. Preconstruction and postdevelopment segment of Niagara Street. (Courtesy of U.S. Geological Survey).

In Buffalo, New York, the U.S. Geological Survey (USGS) is partnering with the city of Buffalo and the Niagara River Greenway Project to assess the volume reduction of stormwater runoff and limit the risk of combined sewer overflows in the Niagara River Area of Concern after installation of green infrastructure (GI) practices. An area of 16 city blocks along Niagara Street is undergoing redevelopment to reconnect residential land use to the waterfront and implement a safer corridor for pedestrians and bicyclists (fig. S2.1). Instead of traditional development, GI replaced aging infrastructure and impervious surfaces in this 50-acre area. GI practices such as sand filters, planter boxes, and rain gardens installed in the Niagara Street redevelopment area have the potential to reduce the volume of stormwater runoff by 16 million gallons per year (fig. S2.2; U.S. Geological Survey, 2021b).

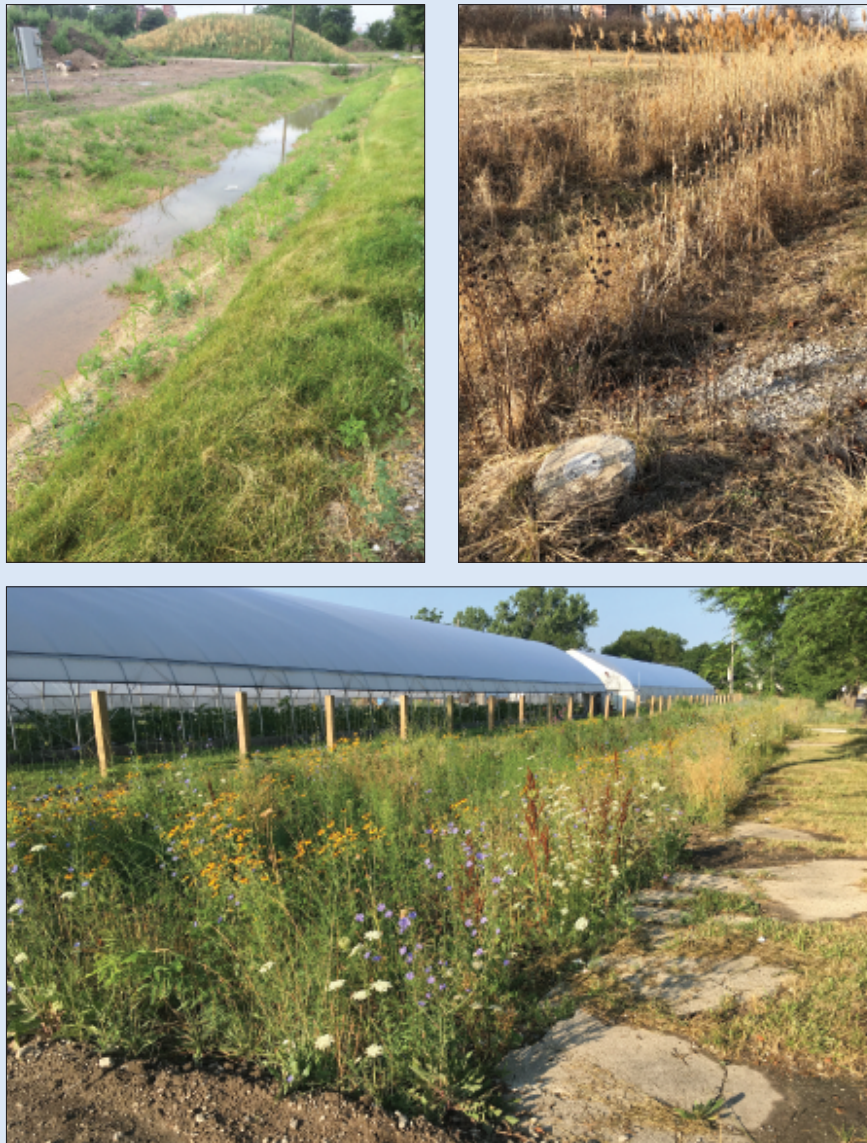
Figure S3.2. Vegetated swales and stormwater capture system installed in RecoveryPark, Detroit, Michigan. (Courtesy of U.S. Geological Survey).

2. Testing includes a feasibility assessment through measurement of soil moisture content around RecoveryPark and stage (water level) within the grass swales.

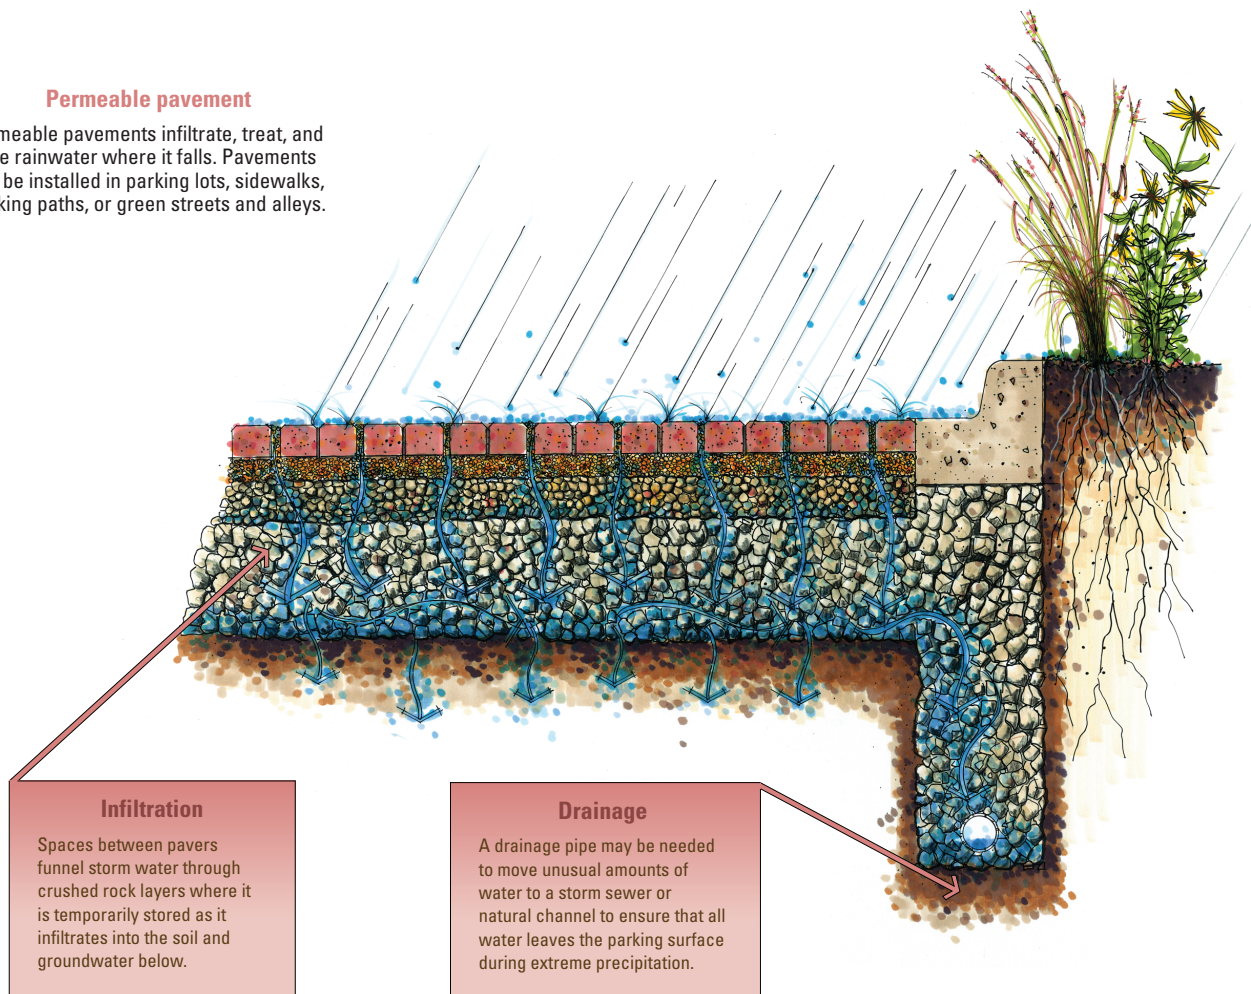
Figure 19. Permeable pavement design.

may be at the periphery of less costly traditional paving so that the permeable part allows for infiltration of small, frequent rains and the first flush of larger storms which wash off most pollutants. Stormwater may leave the permeable pavement system through one or more of the following four hydrologic pathways: evaporation, exfiltration (infiltration into the underlying soil), underdrain discharge (if an underdrain is present), or surface runoff (fig. 19).

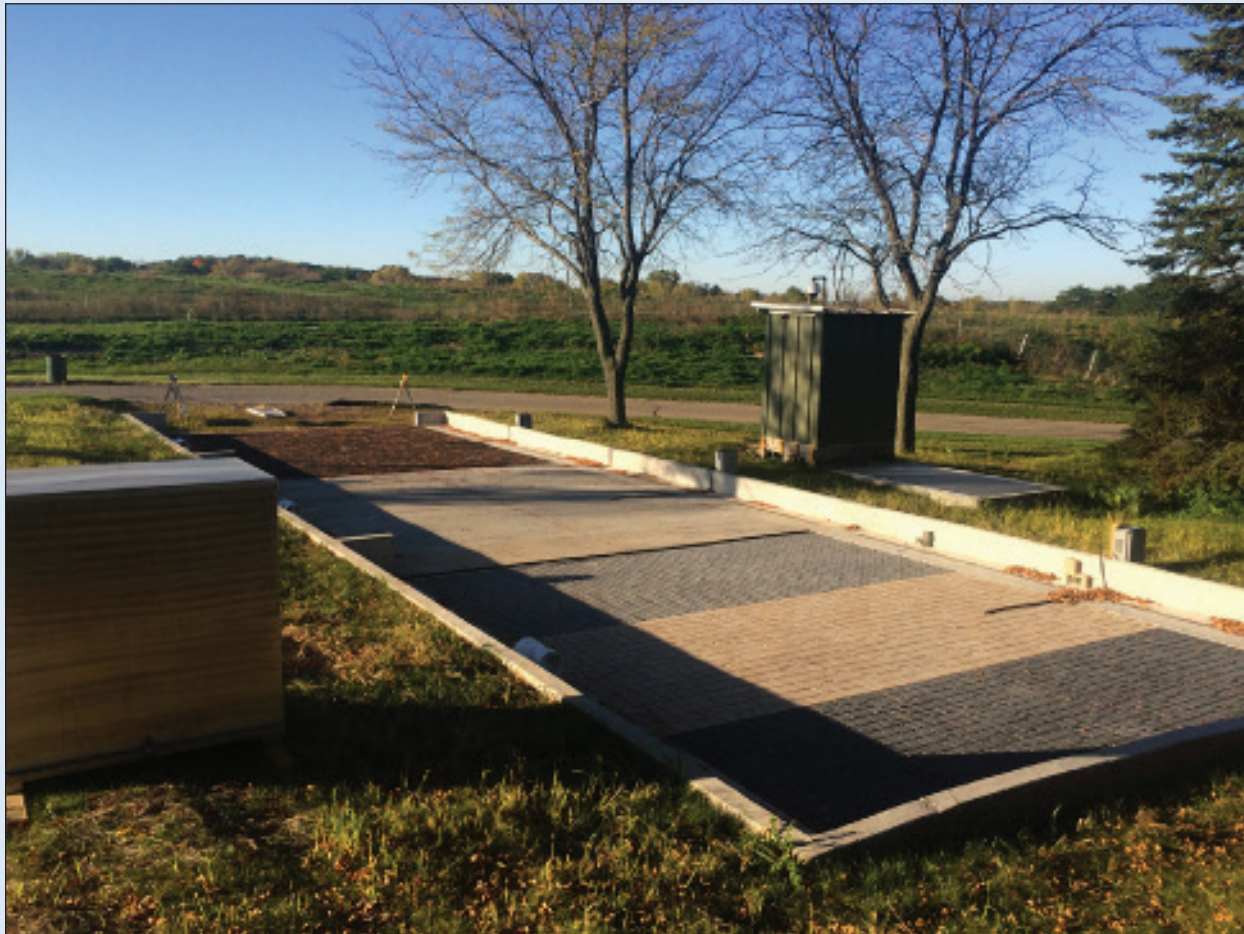
Figure S4.2. Permeable pavement testing facility in Madison, Wisconsin. (Source: Selbig and Buer, 2018.)

The test site was built with three sections of permeable pavement—permeable interlocking concrete pavers (PICP), pervious concrete (PC), and porous asphalt (PA; [fig. S4.2](#)). The surfaces were selected based on how commonly they are used and industry interest in learning more about the performance of each. Each type of pavement was a 500-square foot plot with 21 inches of base material over an impermeable membrane with a slope of 2 degrees ([fig. S4.3](#)). Undrains constructed of 6-inch diameter PVC pipe routed stormwater to a monitoring vault. Concrete walls separated each plot to prevent exfiltration between test plots.

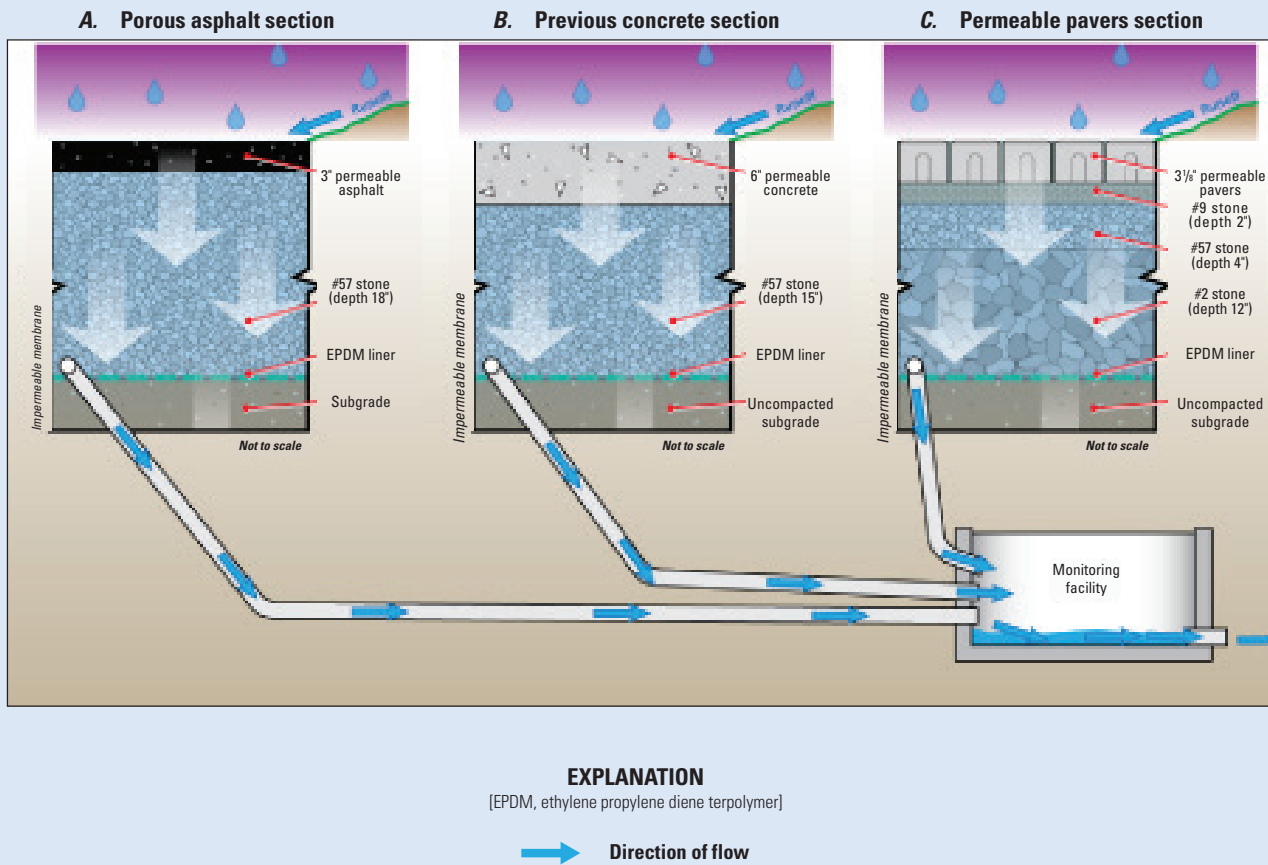
Figure S4.3. Cross-sectional profile of porous asphalt, pervious concrete, and permeable interlocking pavers test surfaces and aggregate base. Blue arrows indicate flow of infiltrated runoff from the underdrain towards the monitoring chamber. (Courtesy of County Materials Corporation.)

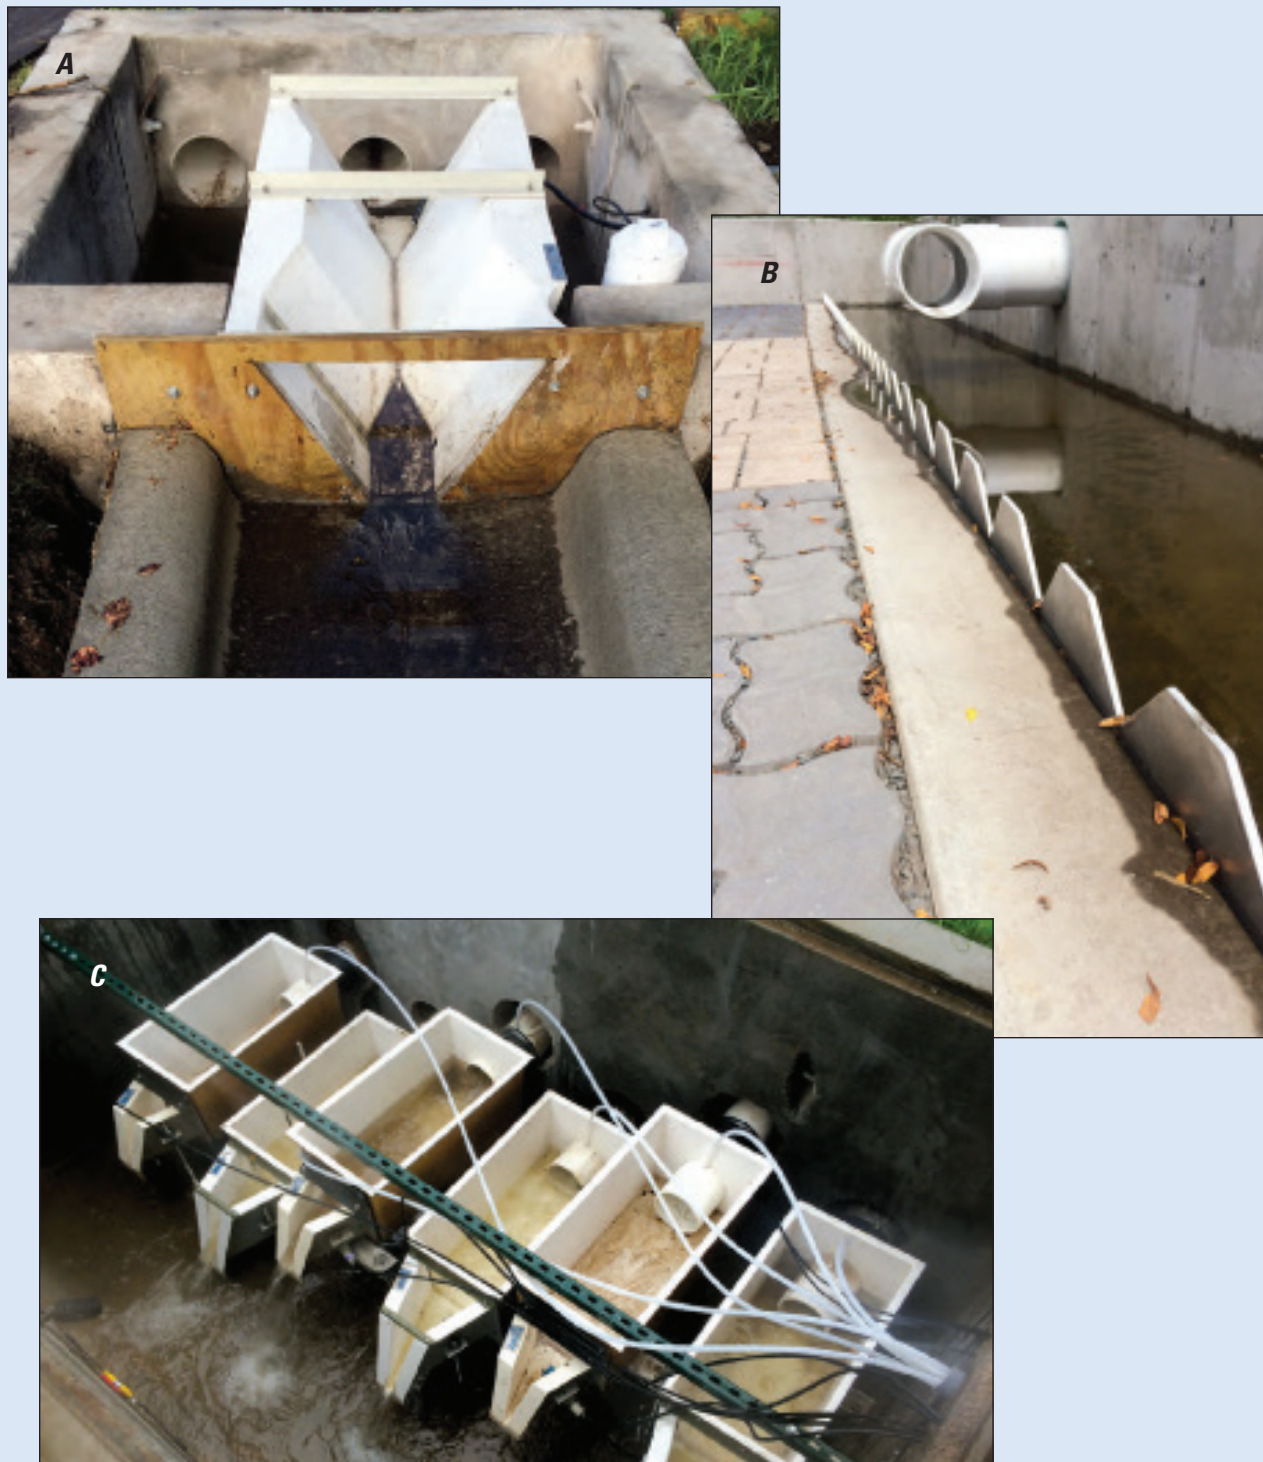
Figure S4.4. Hydraulic structures used to, *A*, measure and distribute the flow of runoff from the parking lot; *B*, uniformly spread runoff across the test surface; and, *C*, measure runoff that either passes through the underdrain of each permeable surface or bypasses as overflow. (Source: Selbig and Buer, 2018.)

Runoff from the parking lot drained into a concrete structure designed to equally split runoff to each test plot (fig. S4.4). This configuration is unique in that it allows for measurement of the quantity and quality of runoff directly before it enters each permeable surface and again immediately after passing through each treatment section. Once delivered to the test plot, runoff was spread across a serrated weir plate for even distribution of water across the permeable surface. Stormwater then either filtered through the permeable surface or bypassed as overflow that was collected and conveyed separately to a concrete monitoring vault. Flow in and out of each treatment section was measured. Samples were taken and analyzed for selected contaminants and nutrients.

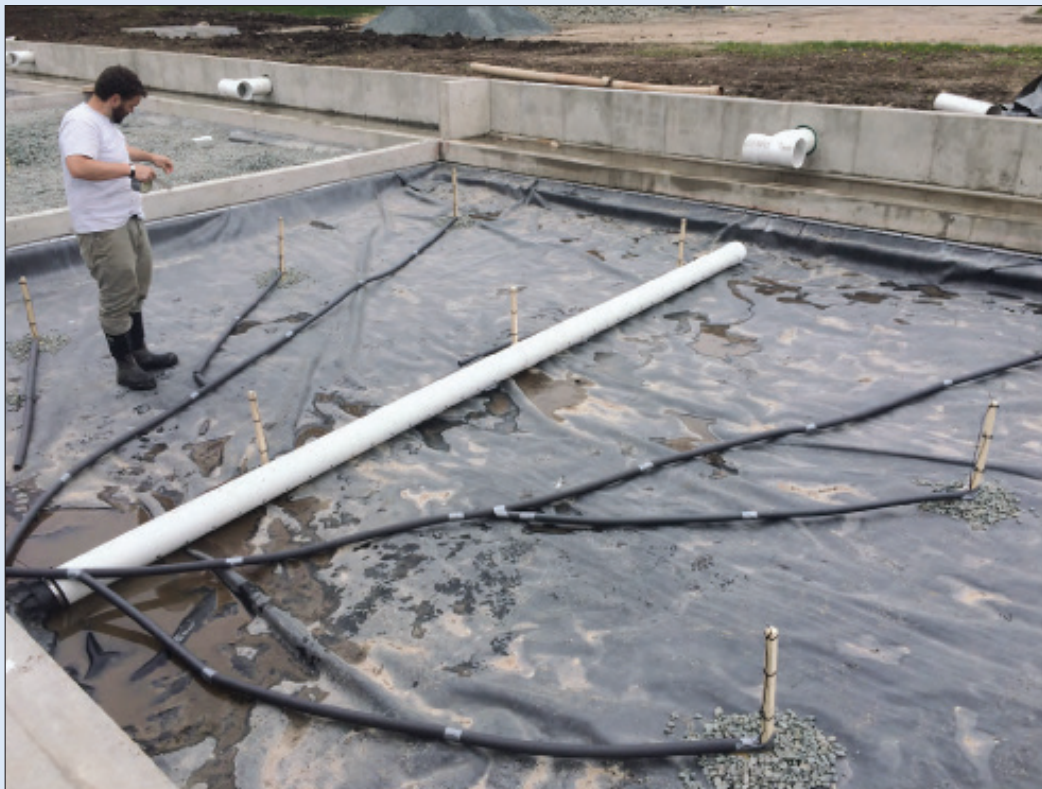
Figure S4.5. A network of temperature sensors placed in the porous asphalt test plot before installation of the aggregate base and asphalt surface. Attached to each wooden dowel placed in the three-by-three matrix were sensors spaced at about 0 (top), 6 (middle), and 12 (bottom) inches below the permeable surface. The pervious concrete and permeable interlocking pavers test plots had a similar configuration. (Source: Selbig and Buer, 2018.)

Temperatures below each permeable surface generally followed changes in air temperature with a more gradual response observed in deeper layers (fig. S4.5). Therefore, permeable pavement may do little to mitigate heated runoff during summer. During winter, deeper layers remained above freezing even when air temperature was below freezing. Although temperatures were not high enough to melt snow or ice accumulated on the surface, temperatures below each permeable pavement did allow void spaces to remain open, which promoted infiltration of melted ice and snow as air temperatures rose above freezing. These open void spaces could potentially reduce the need for application of deicing agents in winter because melted snow and ice would infiltrate, thereby preventing refreezing of pooled water in what is known as the “black ice” effect. The environmental benefits and potential unintended consequences of stormwater practices like permeable pavement that use infiltration as a form of treatment warrant consideration in management of urban runoff.

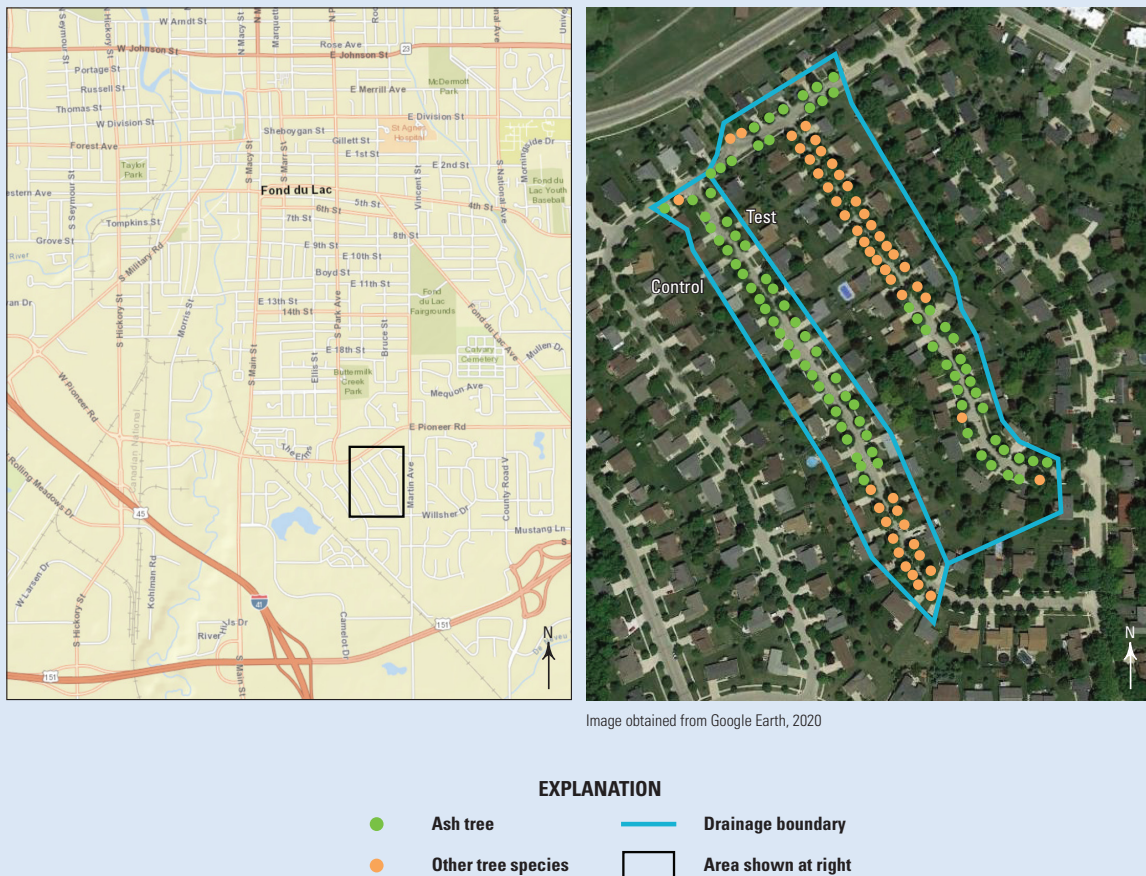
Figure S5.1. Urban-tree stormwater-reduction study location and catchments in Fond du Lac, Wisconsin.

This study characterized the effect of street tree removal on stormwater runoff characteristics from two medium-density residential catchments in Fond du Lac, Wisconsin (figs. S5.1 and S5.2). Catchments were comparable in size and consist of single-family housing with approximately 0.25-acre parcels with trees interspersed along the right-of-way that flanks each street. Stormwater runoff was conveyed via curb and gutter to stormwater inlets as the entry point to the centralized storm sewer collection system.

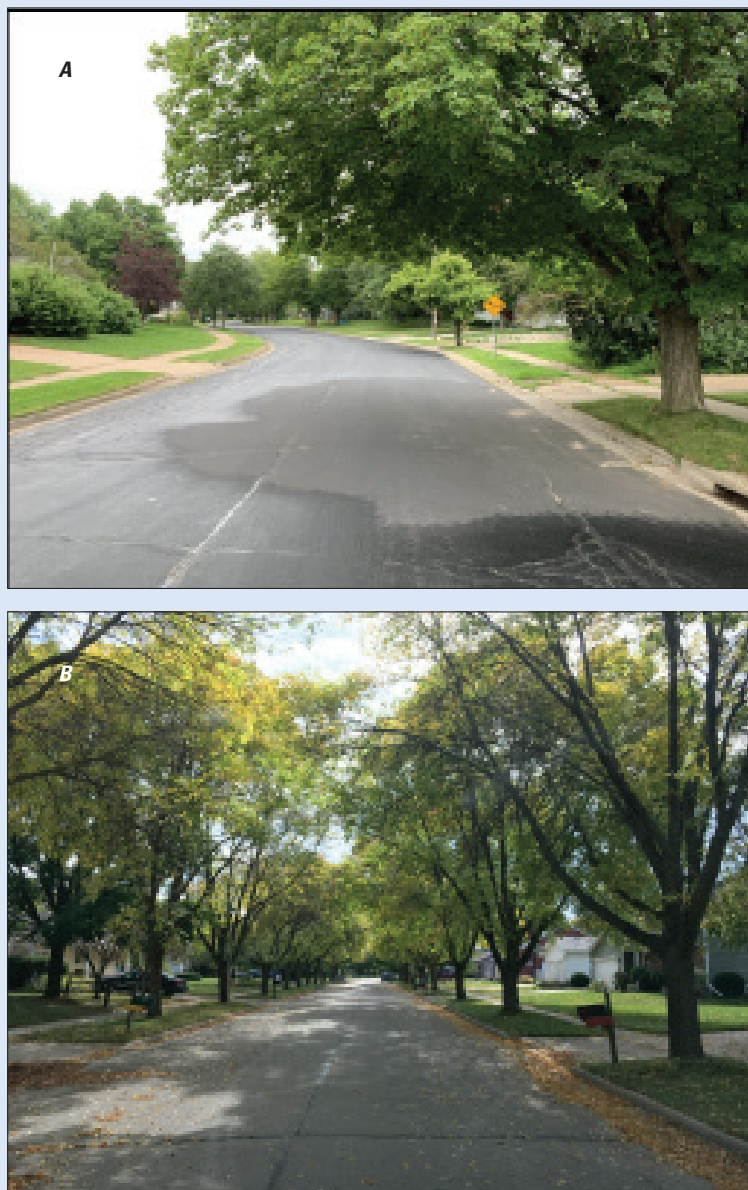
Figure S5.2. Photos showing, *A*, the effects of rainfall interception indicated by dry area underneath the canopy and, *B*, a tree lined street in Fond du Lac, Wisconsin. Trees intercept and store runoff and transfer water back to the atmosphere through evapotranspiration, reducing the volume of runoff. (Courtesy of U.S. Geological Survey.)

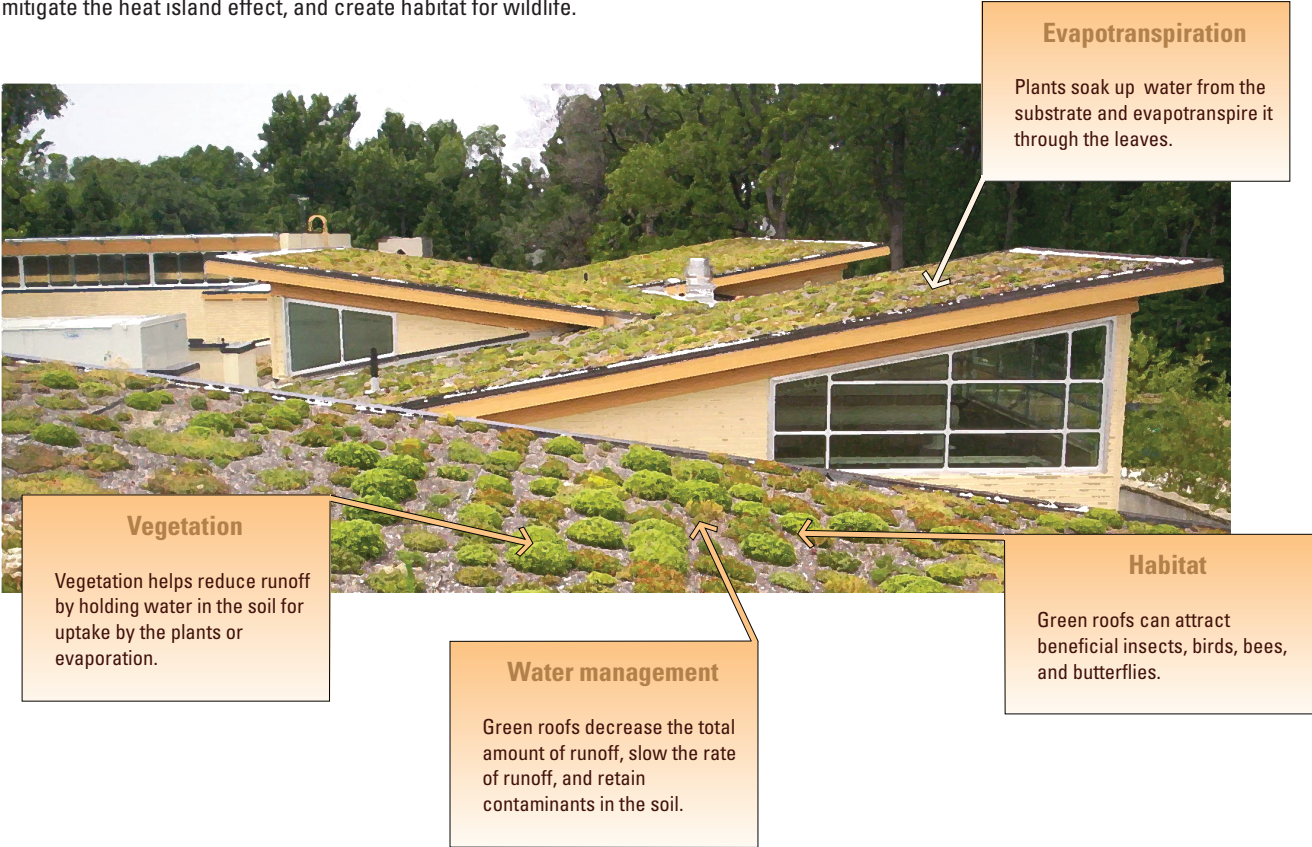
Figure 23. Example of green roof construction on an office building.

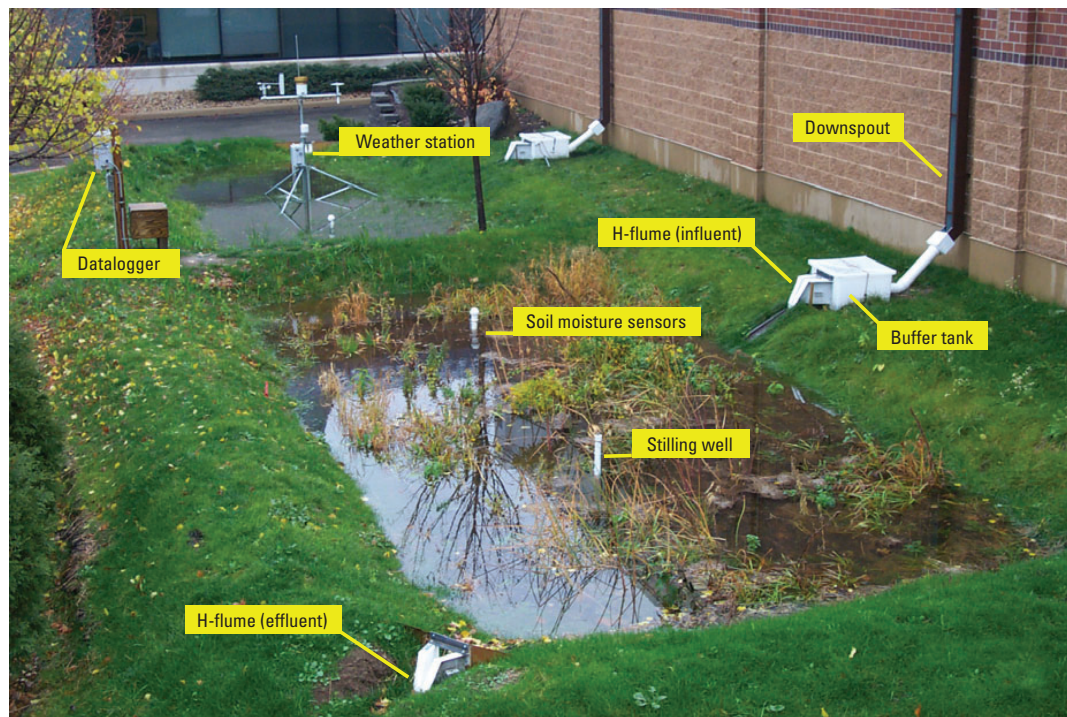
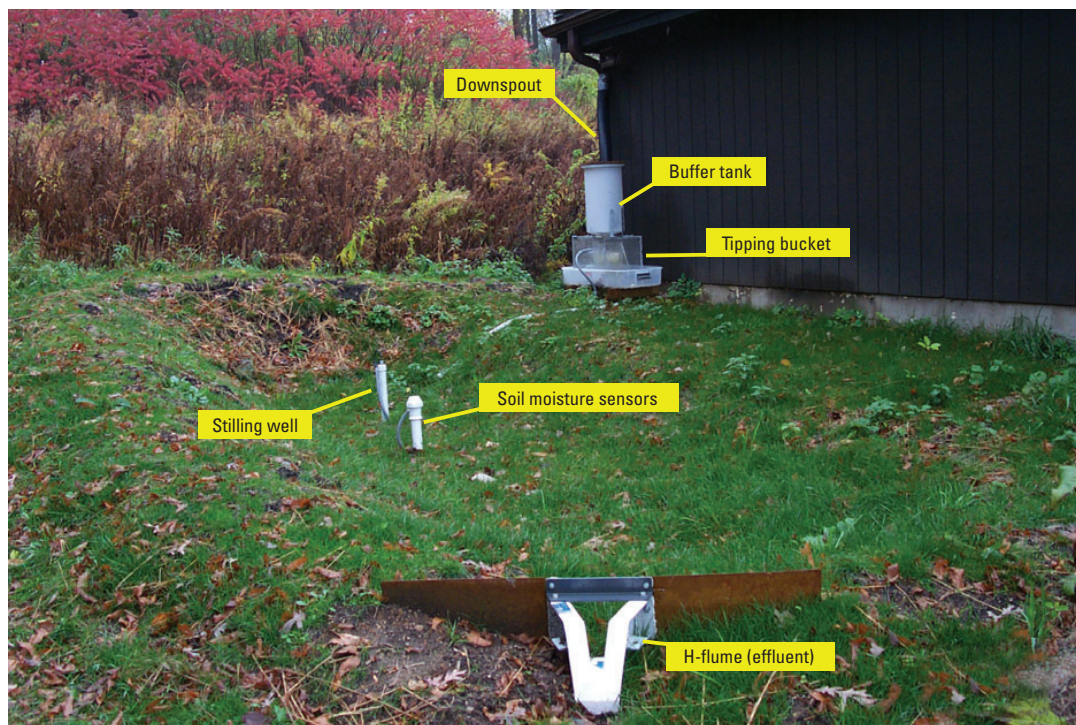
Figure 26. Rain gardens with monitoring equipment installed in *A*, clay and *B*, sand in Madison, Wisconsin. (Courtesy of U.S. Geological Survey.)

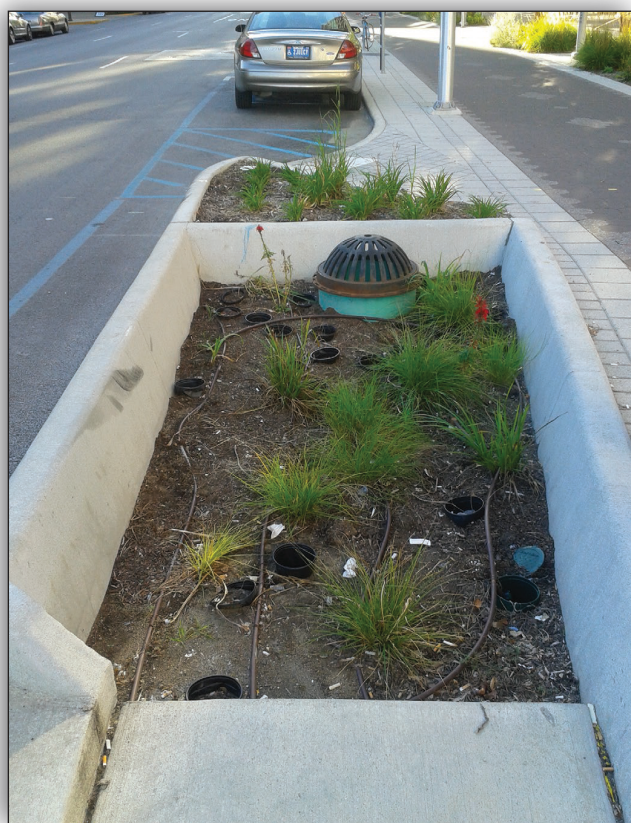
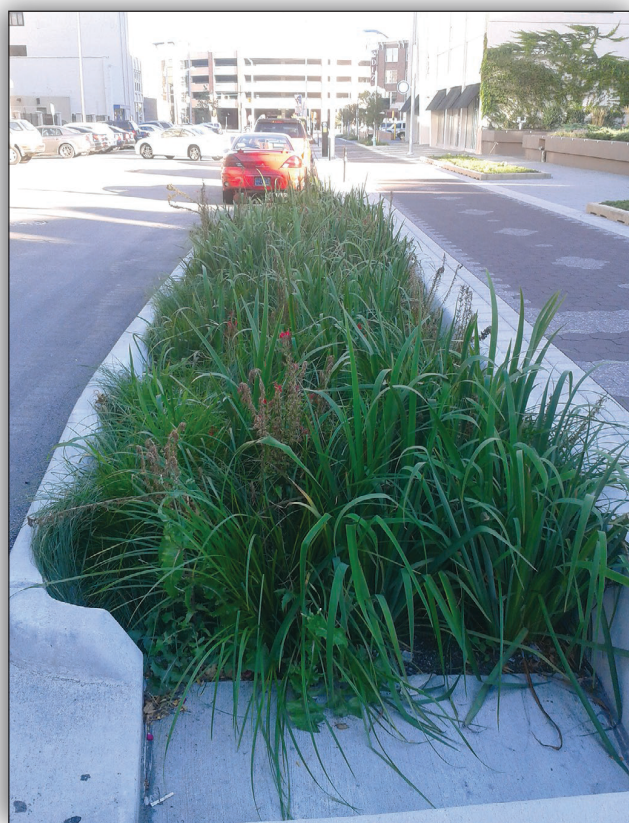
Figure 27. Examples of bioswales in downtown Indianapolis, Indiana. Left bioswale needs maintenance and revegetation; right bioswale is well vegetated and appears to be working properly. (Source: U.S. Environmental Protection Agency, 2016b.)
