Green Infrastructure in the Great Lakes—Assessment of Performance, Barriers, and Unintended Consequences

Circular 1496

U.S. Department of the Interior
U.S. Geological Survey

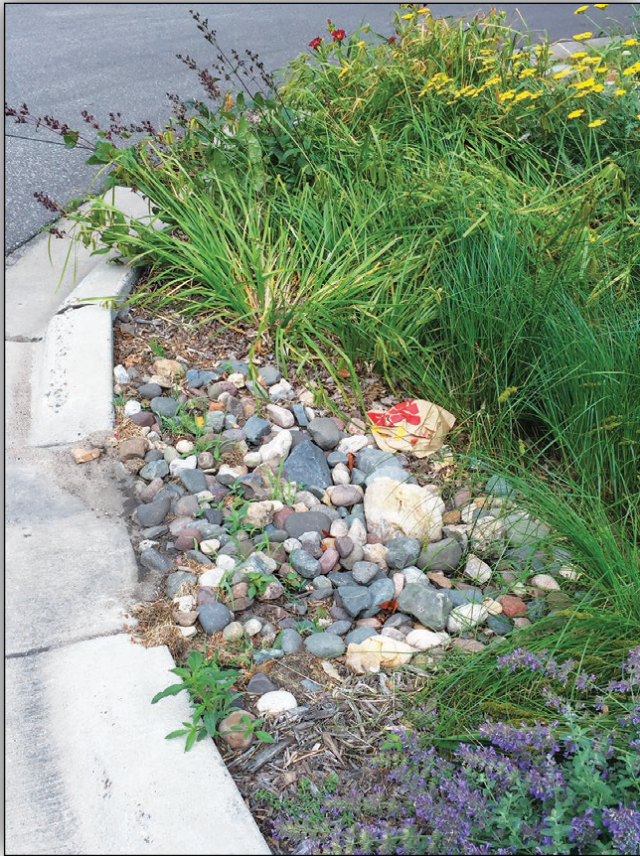
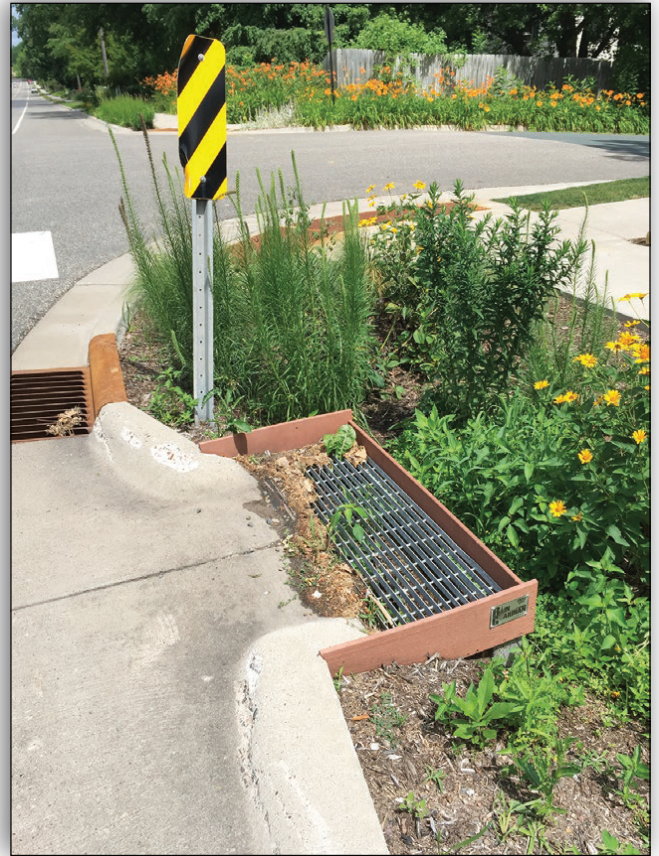
Figure 28. Two types of street rain garden inlets: *A*, rock inlet and, *B*, pretreatment inlet designed to aid in collection of gross solids (sediment, leaves, and trash). In some communities, rock inlets are no longer allowed because of difficulty maintaining the effectiveness of the inlet for pretreatment. (Source: U.S. Environmental Protection Agency, 2016b.)

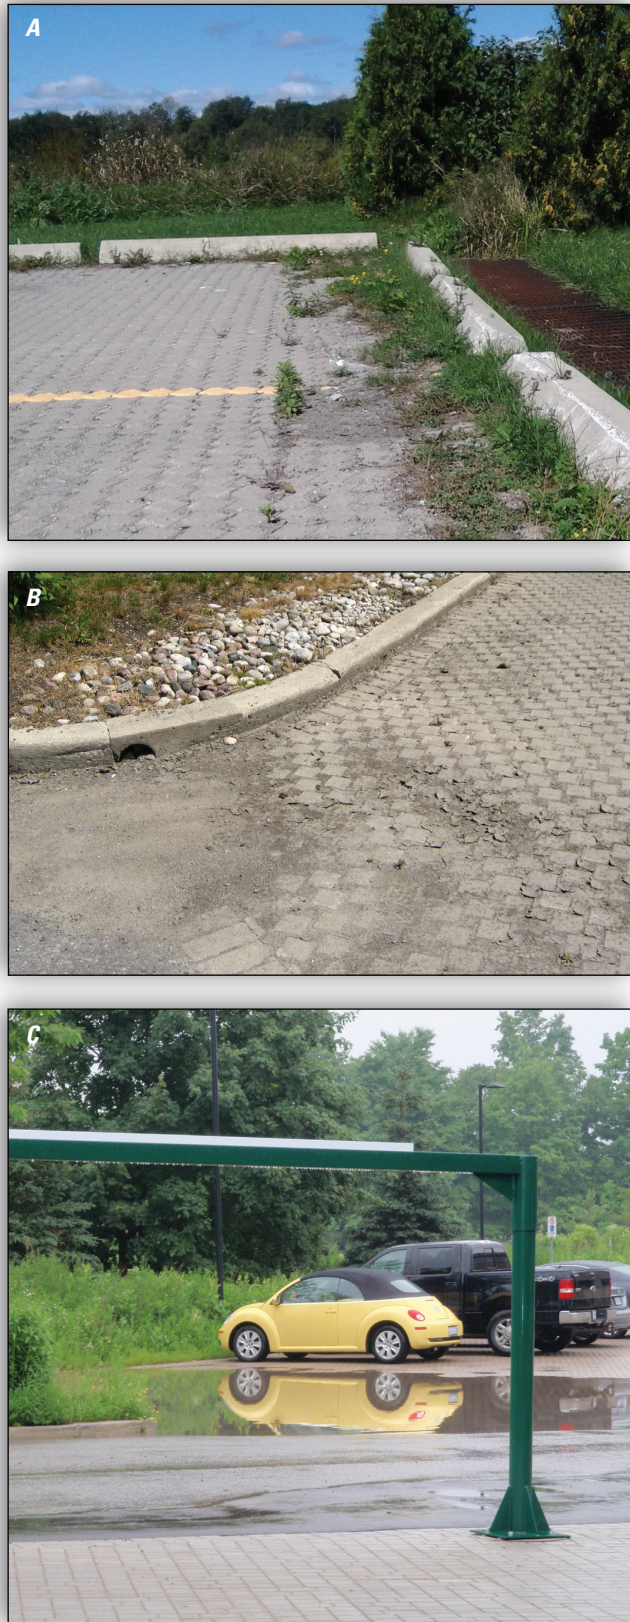
Figure 29. Examples of permeable pavement systems showing accumulation of sediments (A and B) and partial infiltration (C). (Source: Sustainable Technologies Evaluation Program, 2018.)

Performance of GI depends on infiltration to happen. Sediment transported to the site from construction and other activities can greatly reduce infiltration rates through clogging and compaction. Winter sand application clogged some sites after just 1 year when spring runoff carried high sediment loads (Selbig and others, 2019). The area most prone to clogging at permeable pavement sites may be the permeable/impermeable interface where the largest sediment load is deposited (Winston and others, 2015).

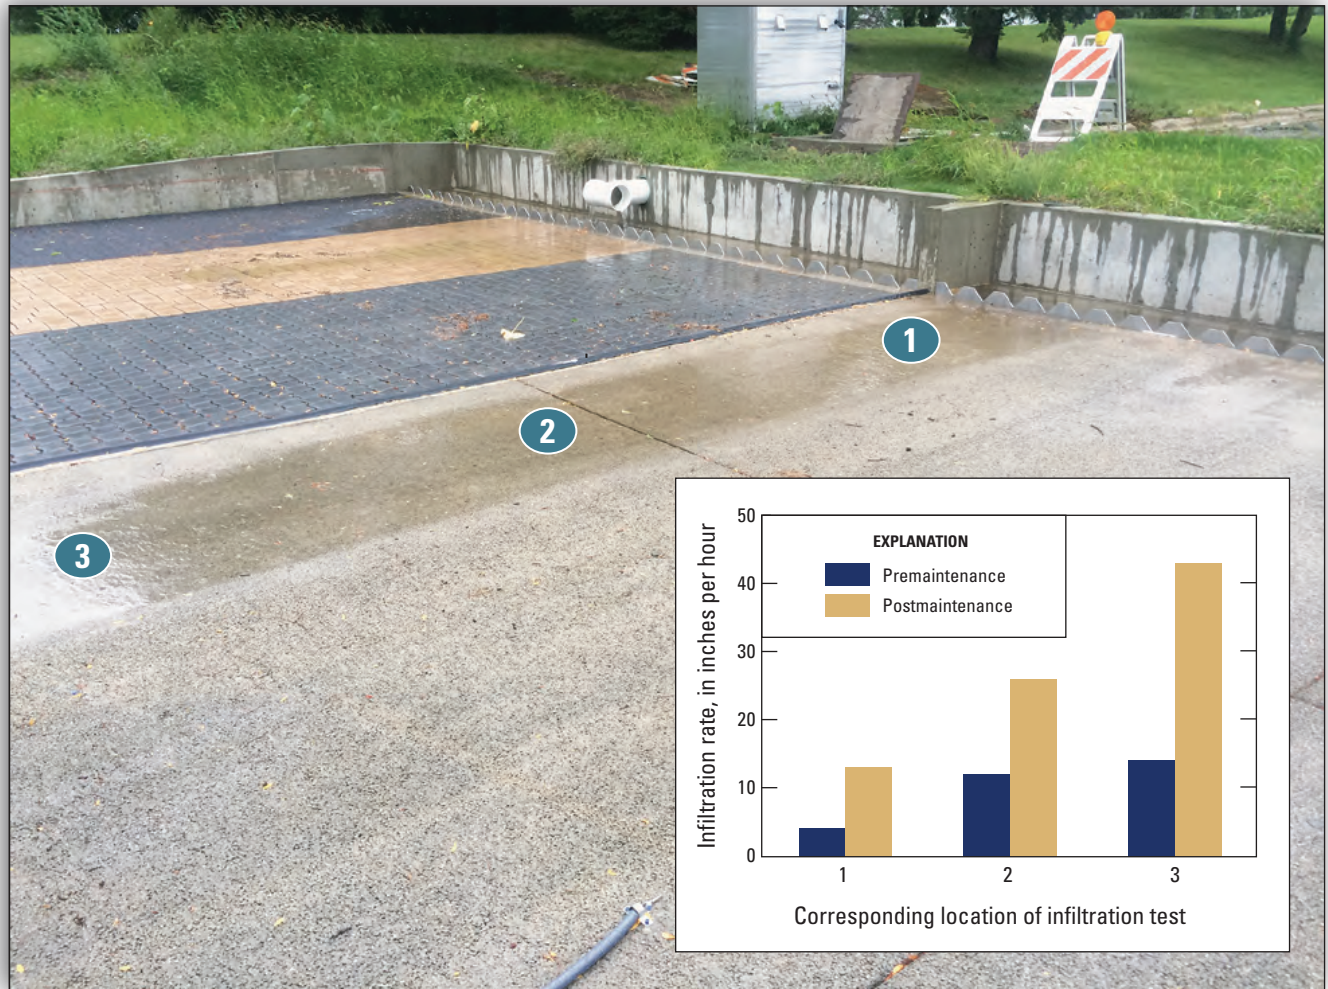
Figure 30. Response in infiltration rates at select locations pre-maintenance and post-maintenance of the pervious concrete surface. (Source: Selbig and Buer, 2018.)
