GEOLOGICAL SURVEY CIRCULAR 736-A

Seismic Engineering
Program Report,
January–March 1976

SEISMIC ENGINEERING PROGRAM REPORT, JANUARY - MARCH 1976

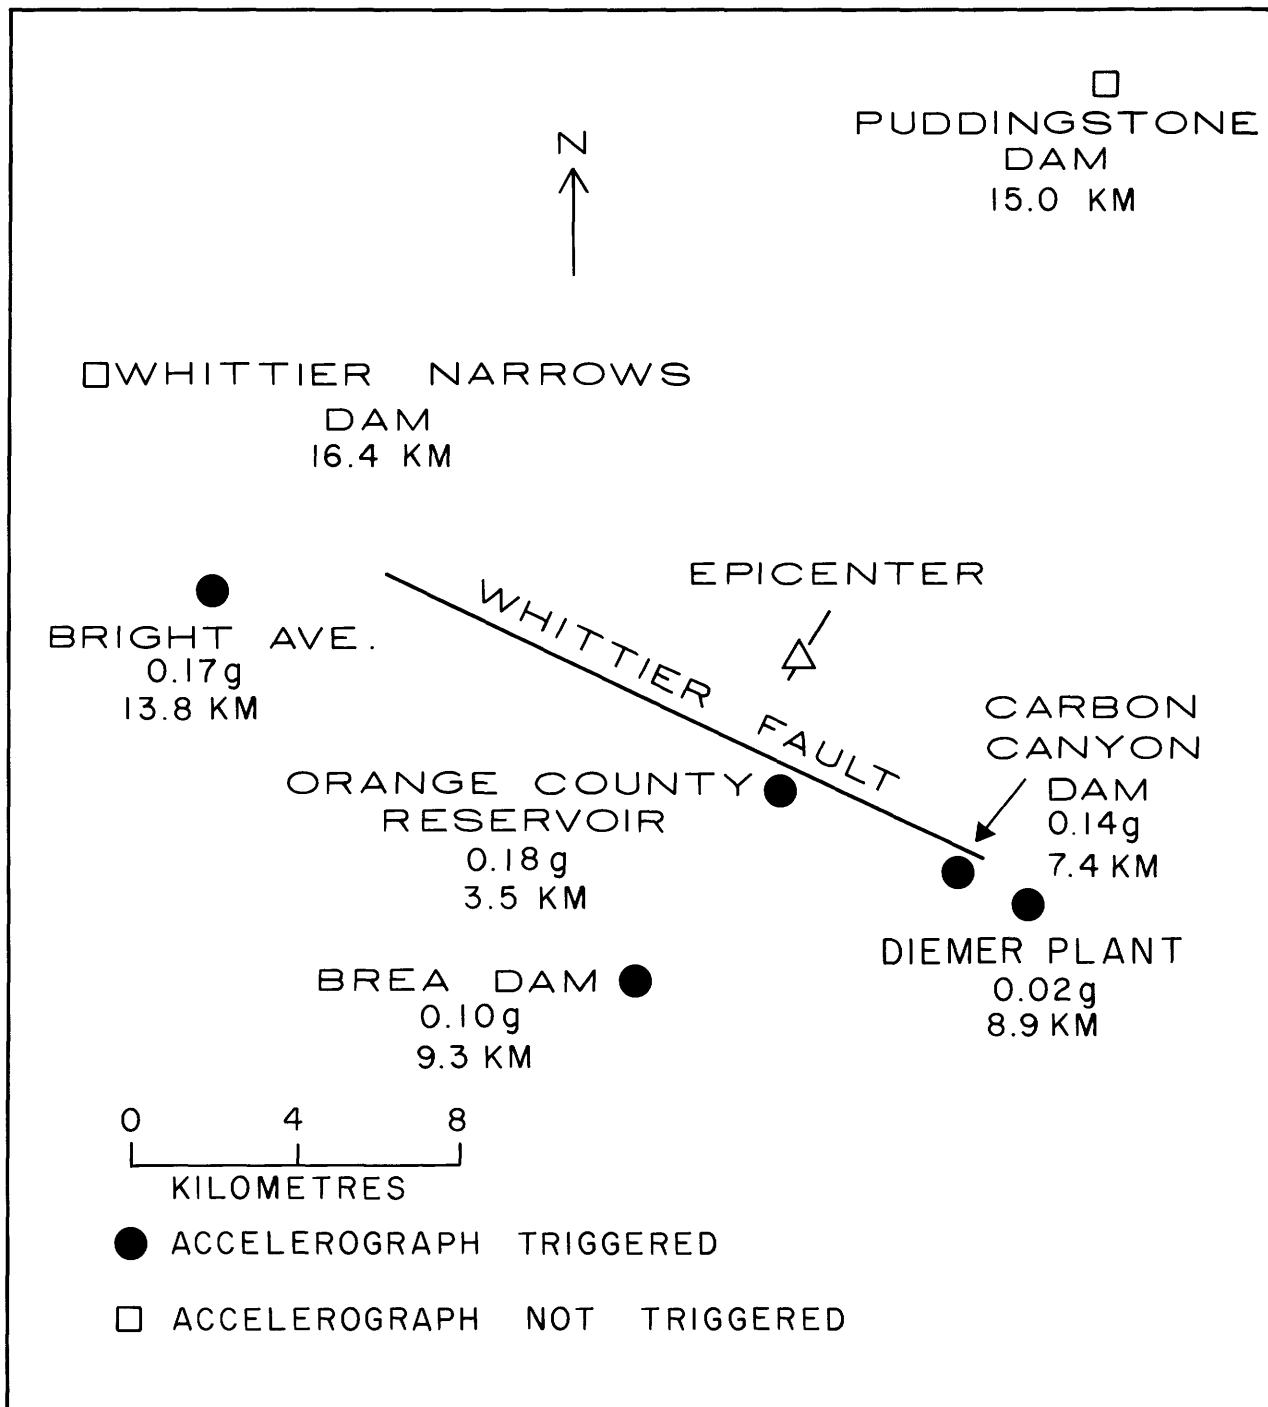
Figure 1.- Accelerograph stations in the vicinity of the January 1 earthquake. Maximum ground level accelerations and epicentral distances are shown below station names.

Eleven strong-motion accelerograph records were obtained from within a 14-km radius of the epicenter (fig. 1). All

stations recorded peak accelerations of 0.10 g or greater, except the two instruments at Diemer Filtration Plant (see table 1). The maximum recorded acceleration (0.28 g) occurred in Whittier, about 13.8 km west of the epicenter. The accelerometer was located at the fifth floor level of the ten-story building at 7215 Bright Avenue. The peak acceleration recorded at the basement level was 0.17 g and at the tenth floor level was 0.19 g. Orange County Reservoir, 3.5 km south of the epicenter, recorded a peak acceleration of 0.18 g. Records produced during the January 1 event are shown in figure 2.

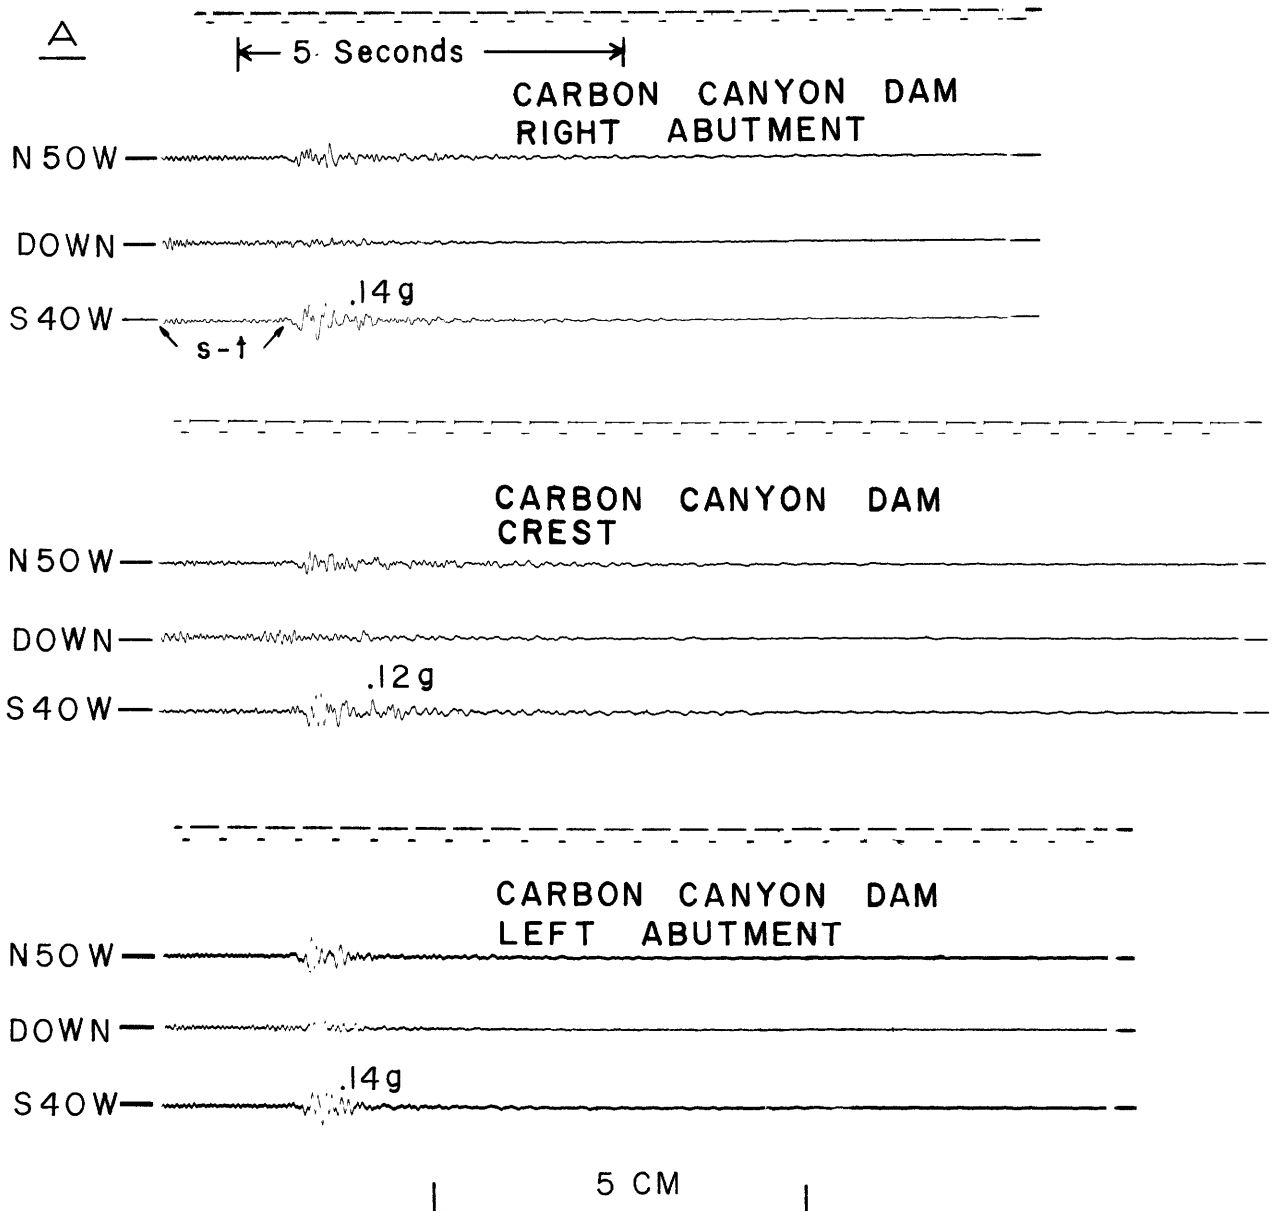
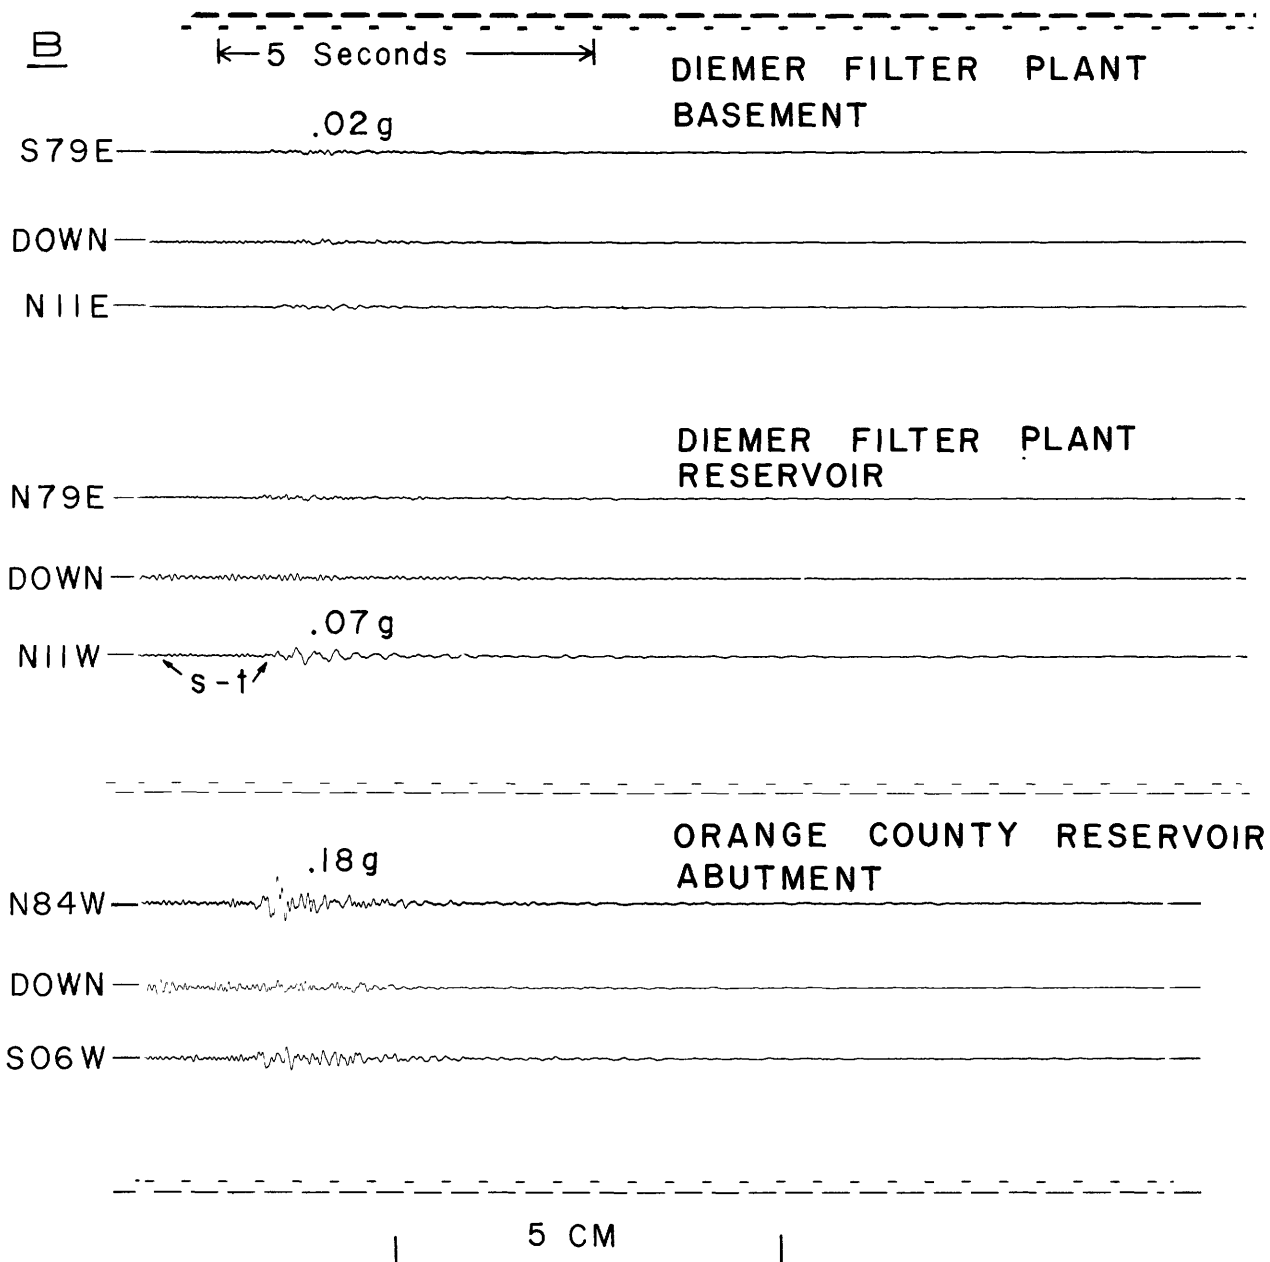
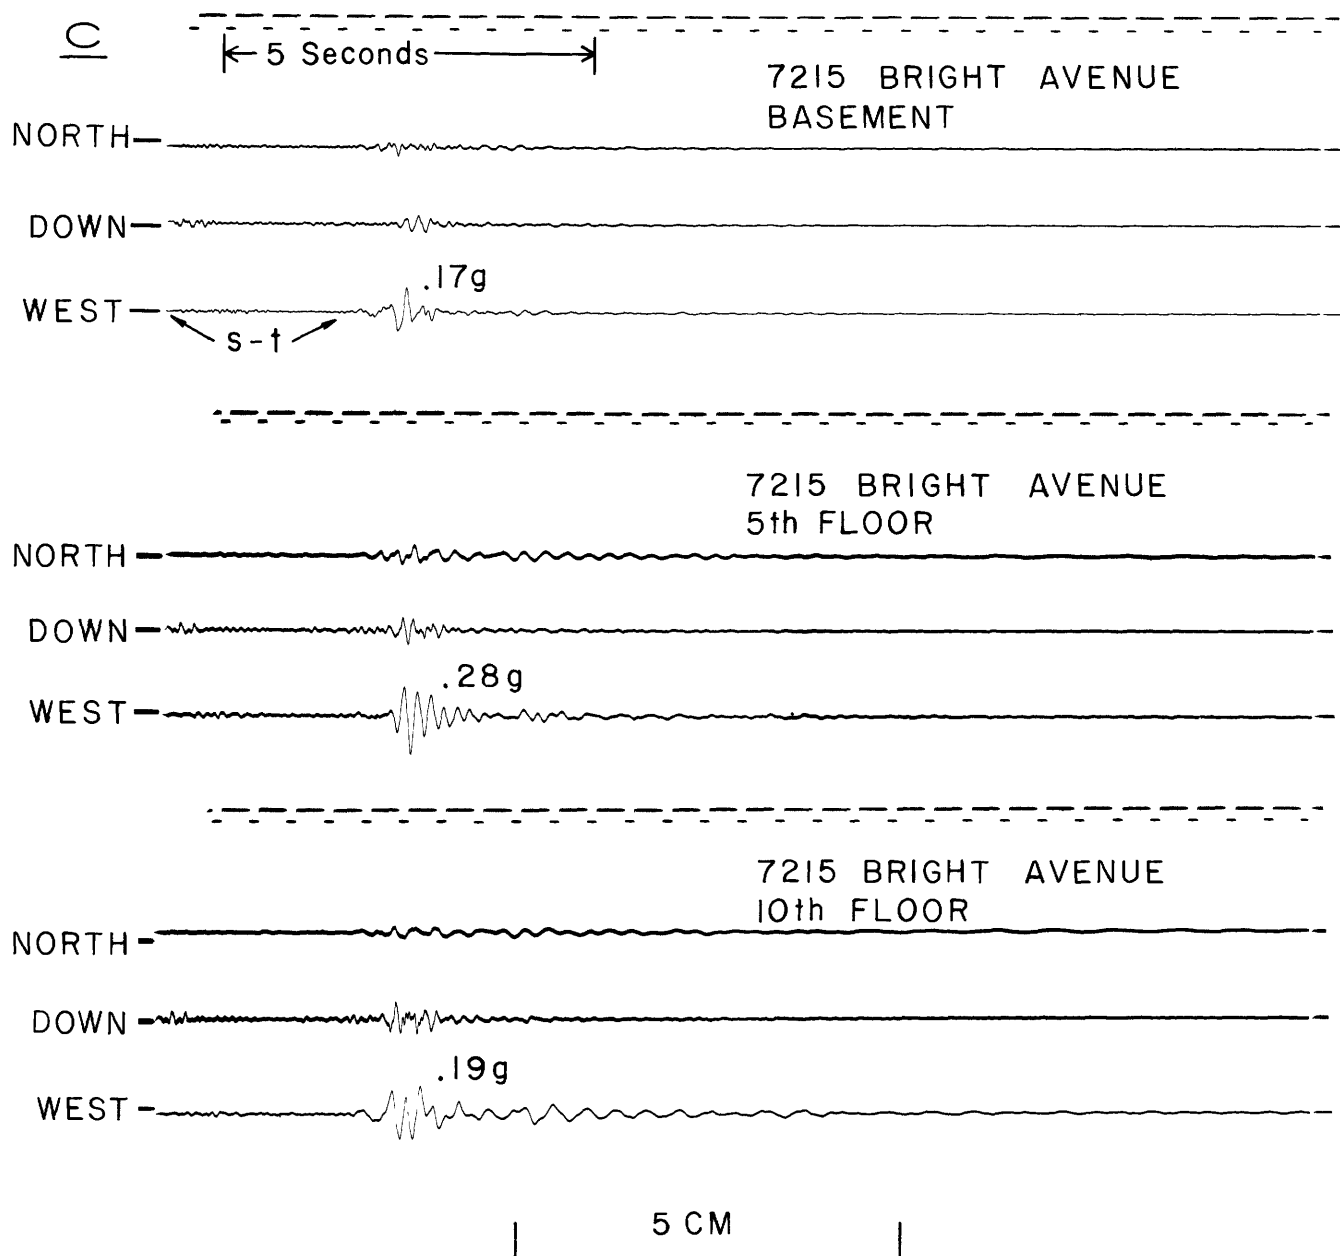
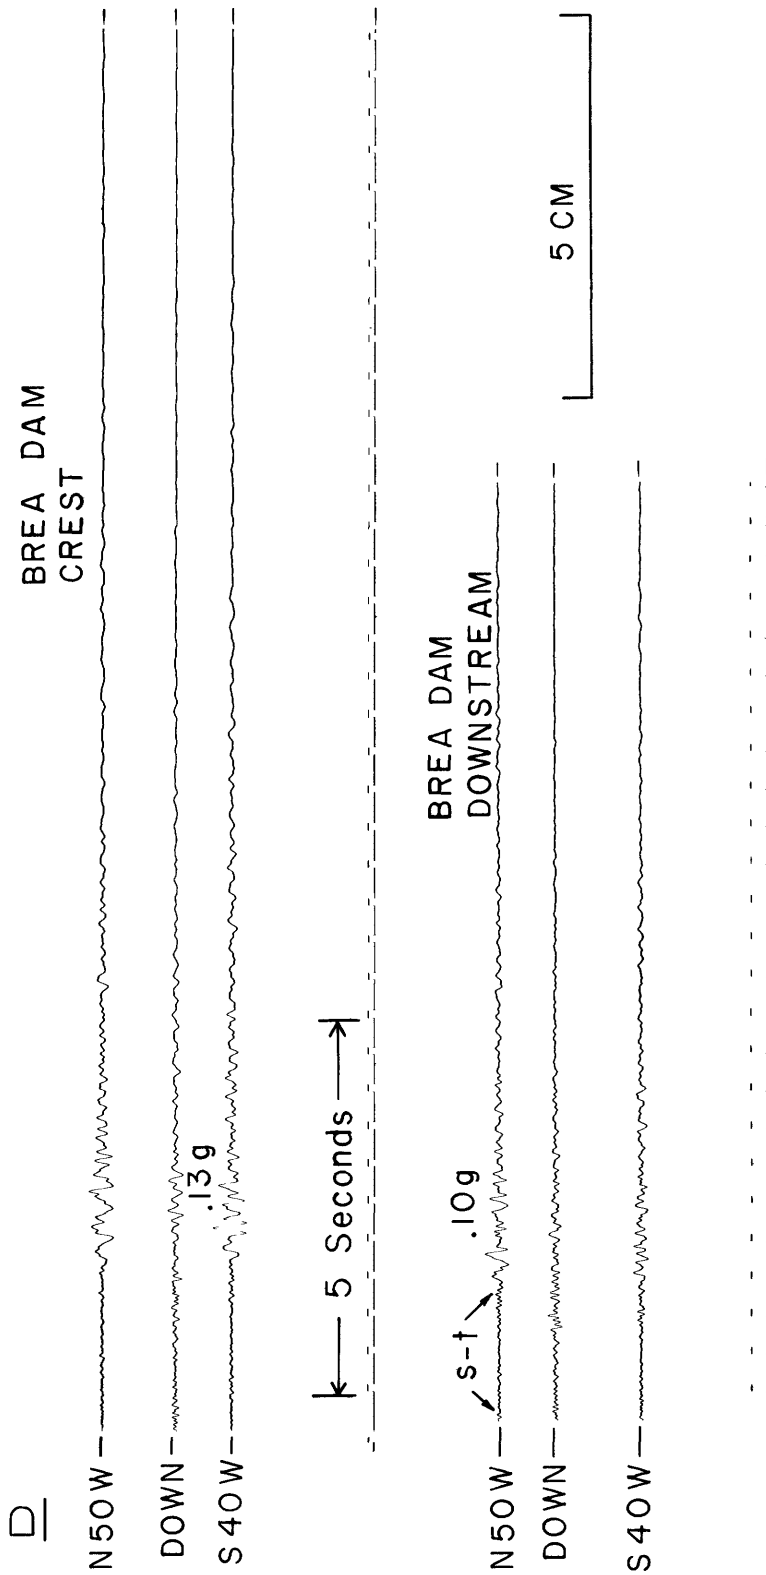
Figure 2.- Accelerograph records from the southern California earthquake of January 1, 1976 (Magnitude 4.2).

Seismograms from the two Carbon Canyon Dam abutment stations show peak accelerations of 0.14 g. The crest station recorded a slightly lower (0.12 g) peak acceleration. The main embankment of the dam is an earthfill structure 30 m (99 ft) high and 578 m (1925 ft) long, constructed across the downstream narrows of Carbon Canyon. It rests on approximately 30 m (100 ft) of Recent alluvium. Three accelerographs, installed in June, 1975, were not interconnected for simultaneous start or time. A comparison of S-wave minus trigger intervals indicates that the three instruments triggered within 0.1 second of one another, thus demonstrating the relative efficiency of the vertical starter. The combined use of vertical starters for triggering, and WWVB radio receivers for simultaneous time, should eliminate the need for interconnecting wire and conduit at such multiple-instrumentation locations as dams.

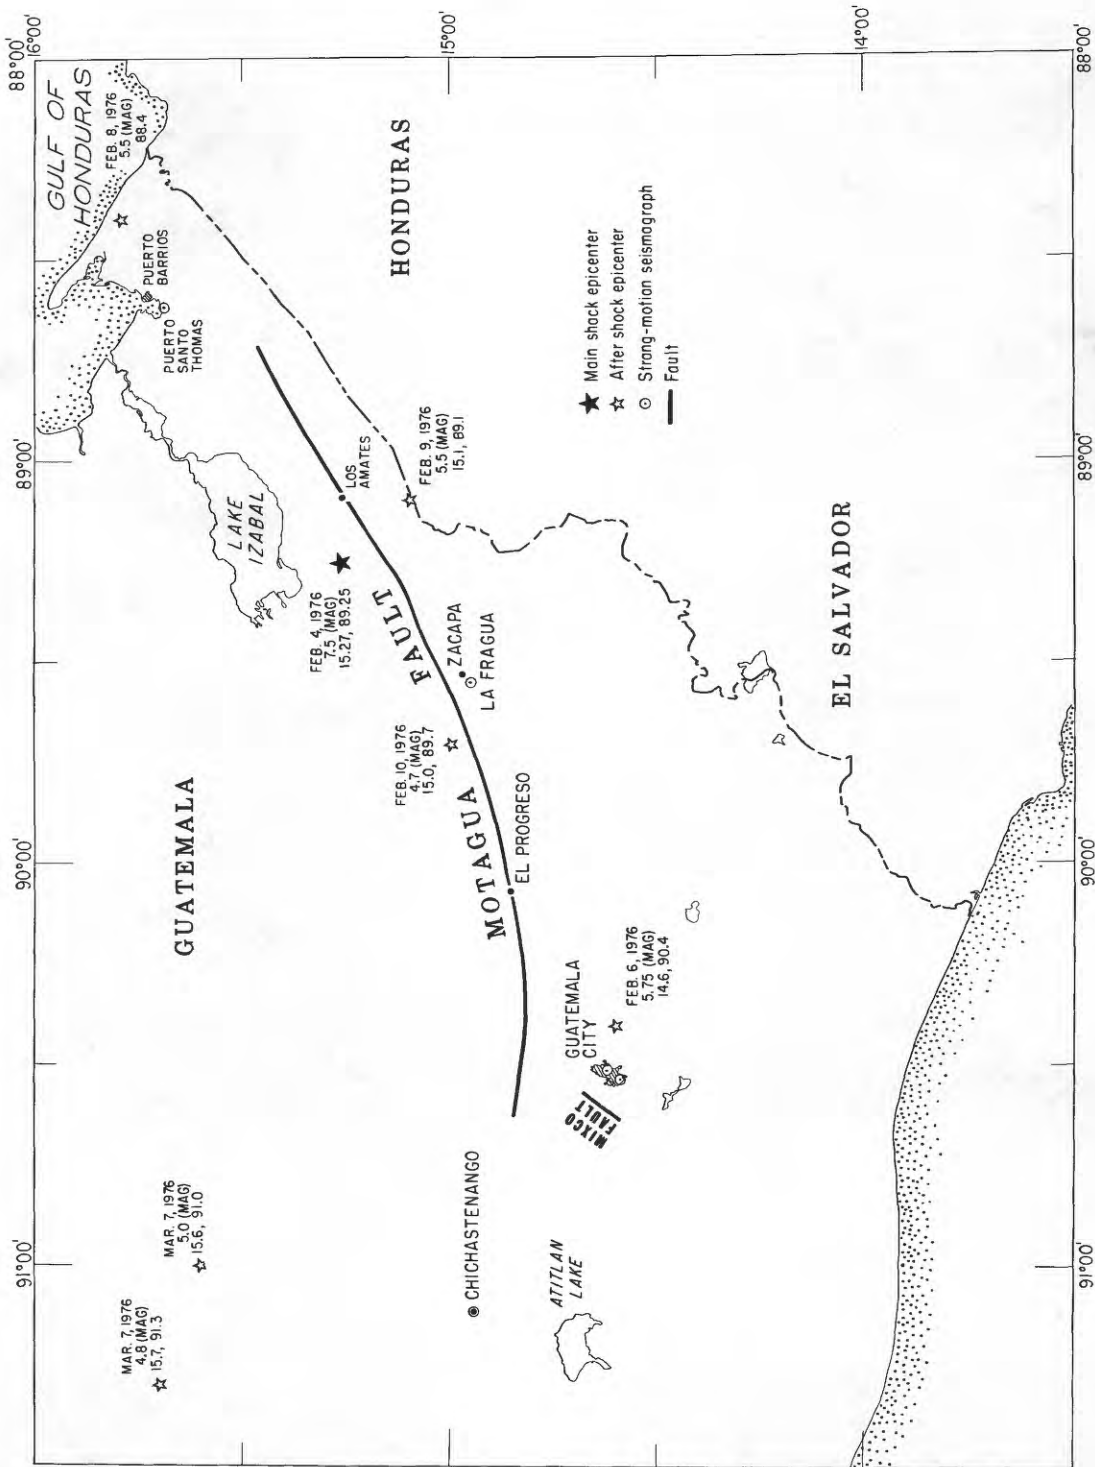
Figure 3.- Locations of February 4, 1976 Guatemala earthquake and aftershocks.

A destructive earthquake of surface wave magnitude 7.5 (National Earthquake Information Service, Feb. 1976) occurred in Guatemala at 09:01:46 Greenwich Civil Time on February 4, 1976. The earthquake (and a series of aftershocks) caused great damage and loss of life in Guatemala, completely destroying many cities and villages. Horizontal displacements of 60 to 120 cm were measured along the Motagua fault for

a distance of over 200 km (fig. 3) (Page, 1976).

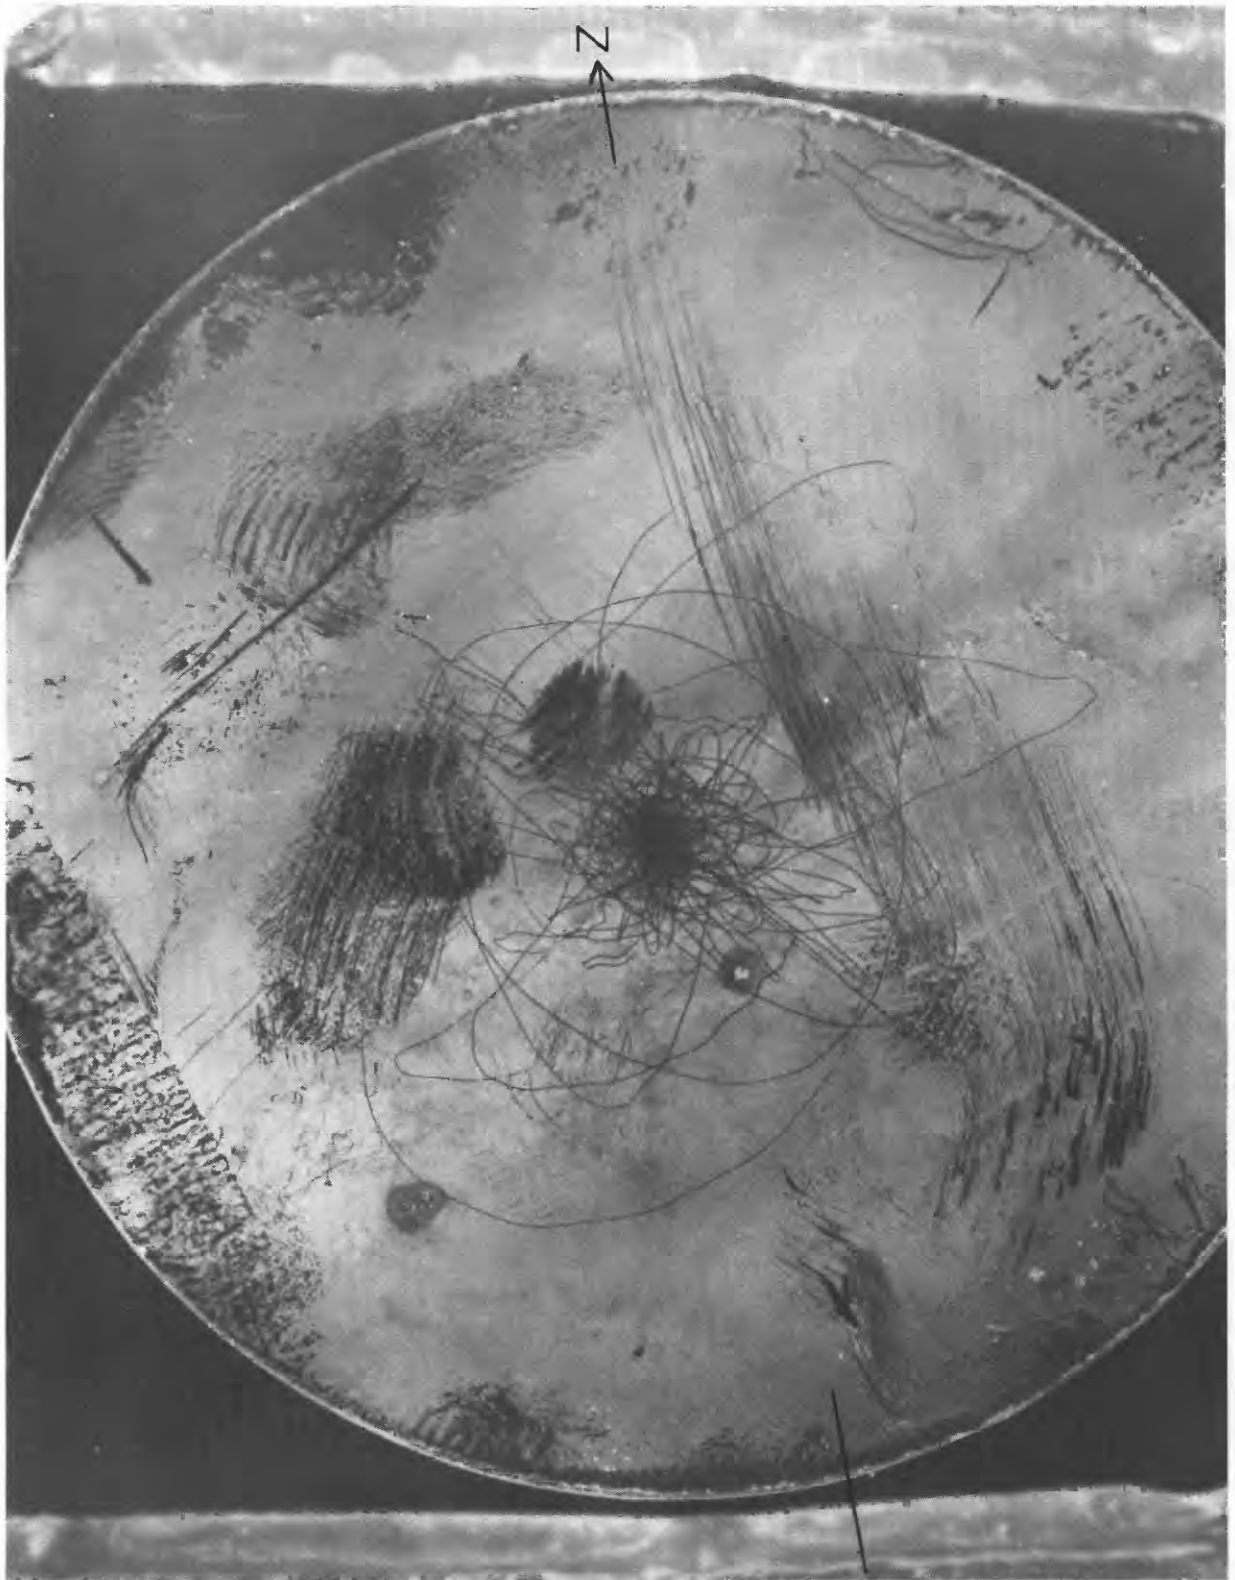
Figure 4.- Seismoscope plate from University Administration Building ground floor location - 3X enlargement.

The Centro De Investigaciones De Ingenieria of Ciudad Universitaria purchased one RFT-250 accelerometer and three seismoscopes in the late 1960's. Two of the seismoscopes were installed in the administration building at the university, one on the ground floor and the other on the roof. The seismoscope that was not installed at the time of the earthquake was subsequently installed alongside the SMA-1 in the IBM building near the center of Guatemala City. A significant event recorded on both the accelerometer and the seismoscope could be useful in the correlation of the two types of strong-motion records. The two seismoscope records were recovered on February 10, 1976. The university is approximately 27 km from the surface rupture that occurred along the Motagua fault. The administration building at the university is a four-story building (approx. 30 x 60 m). The seismoscope plate from the instrument on the roof of the building had been dislodged, and the record shows that motion had exceeded the maximum radius of the plate before it became dislodged. The seismoscope plate from the ground floor level (fig. 4) remained on the instrument and reveals a maximum relative displacement of $S_d = 5.3$ cm. This record will be further analyzed in order to recover ground accelerations.

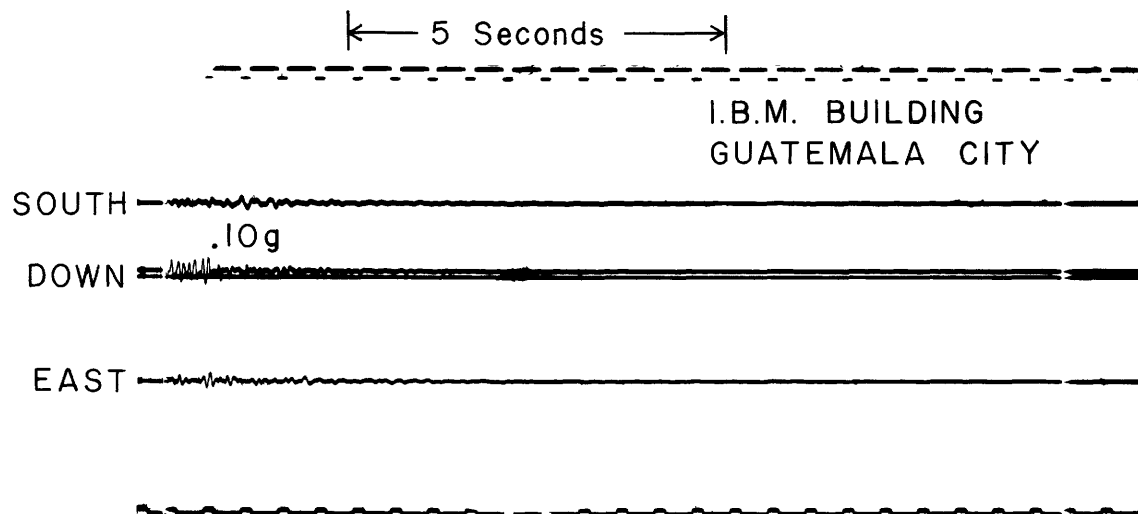
Figure 5.- IBM Building accelerograph record of Guatemala aftershock,
February 18, 1976.

Several aftershocks were recorded on the accelerographs at the Zacapa station, the Observatory station, and the IBM building. Each of these aftershocks was less than 4.0 Richter magnitude. The records obtained show less than .05 g peak acceleration and are considered insignificant. An aftershock was recorded at the IBM building on February 18, 1976 at 03:59 local time. The National Observatory reported this earthquake as having an intensity of III to IV and located it in the region of El Progreso. The record (fig. 5) is interesting in that it shows a peak vertical acceleration of approximately 0.1 g during the initial one second of the record.
