GEOLOGICAL SURVEY CIRCULAR 762-A

Seismic Engineering
Program Report,
January—April 1977

PRELIMINARY REPORT ON THE ROMANIAN EARTHQUAKE OF MARCH 4, 1977

STRONG-MOTION RECORDS FROM THE MAY 1976 GAZLI, U.S.S.R. EARTHQUAKES

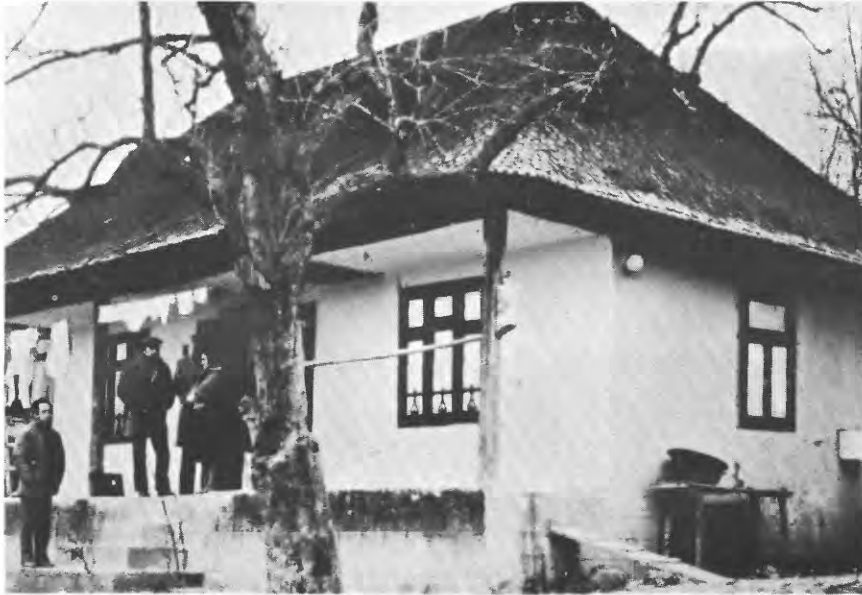
Figure 6.- Typical one-story adobe/wood-wall dwelling in Vrincioaia, 2 km west of the epicenter. With the exception of minor hairline cracks at several locations on the exterior walls, the building was undamaged by the earthquake.

Damage from strong ground shaking was most severe in Bucharest (population approx. 1.7 million), 166 km south of the epicenter, where 35 buildings reportedly collapsed and numerous other buildings sustained structural, architectural, and/or contents damage. In the small town of Vrnicioaia (fig. 1), 2 km west of the epicenter, the effects of strong ground shaking were less severe; superficial cracking of adobe/wood walls in one-story dwellings (fig. 6) was typical

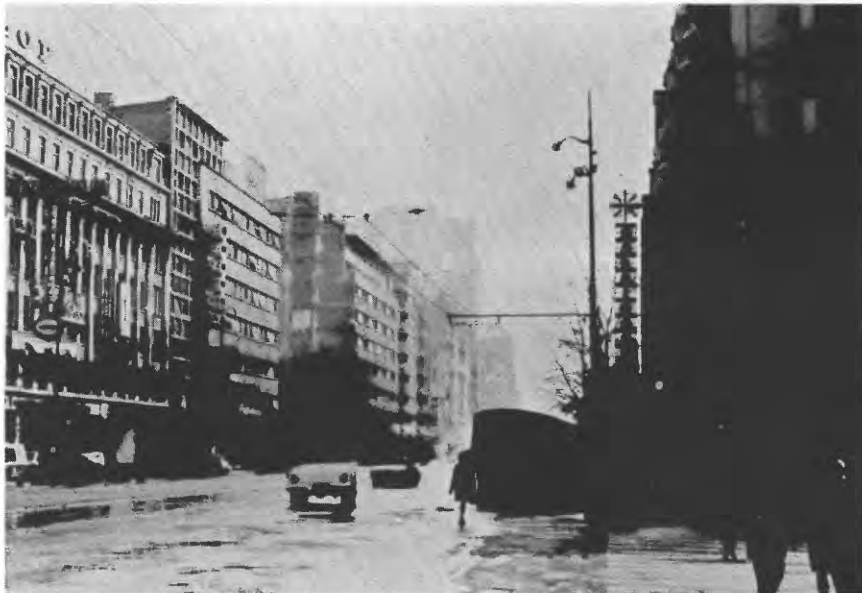
Figure 7.- Main boulevard in the center of Bucharest. Most of the buildings shown here were built prior to the 1940 earthquake (before lateral force building code provisions were adopted), and most sustained severe structural and nonstructural damage. The tall building in the distance (center of photograph is the Intercontinental Hotel, built in 1970. It sustained nonstructural damage in the form of heavily cracked interior masonry walls.

In Bucharest, the greatest destruction occurred in the center of the city (figs. 7 and 8), where 32 older buildings and one recently constructed and engineered building collapsed. In general, the older buildings that collapsed (fig. 8) were non-earthquake resistant structures designed and built before the 1940 earth-

quake, a similarly sized and located earthquake that also destroyed and heavily damaged many buildings in Bucharest. Typically, these older buildings were reinforced concrete frame structures, 7 to 14 stories high, with a soft first story (that is, in comparison to the upper stories where numerous interior and exterior walls provided lateral stiffness, the first floor was relatively open with many windows and few interior and exterior walls). Furthermore, the quality of concrete was poor (mortar could be chipped away with a pen) and there was too little steel and too few ties in the columns and beams, particularly in the column-beam joints. By contrast, modern buildings that were designed in accordance with lateral force code requirements (adopted after the 1940 earthquake) performed better than their older counterparts. With the exception of one collapsed building, a three-story reinforced concrete flat-slab building (fig. 9), structural damage to modern buildings was generally slight. Non-structural damage, on the other hand, was extensive with cracking of in-fill masonry walls being particularly common.

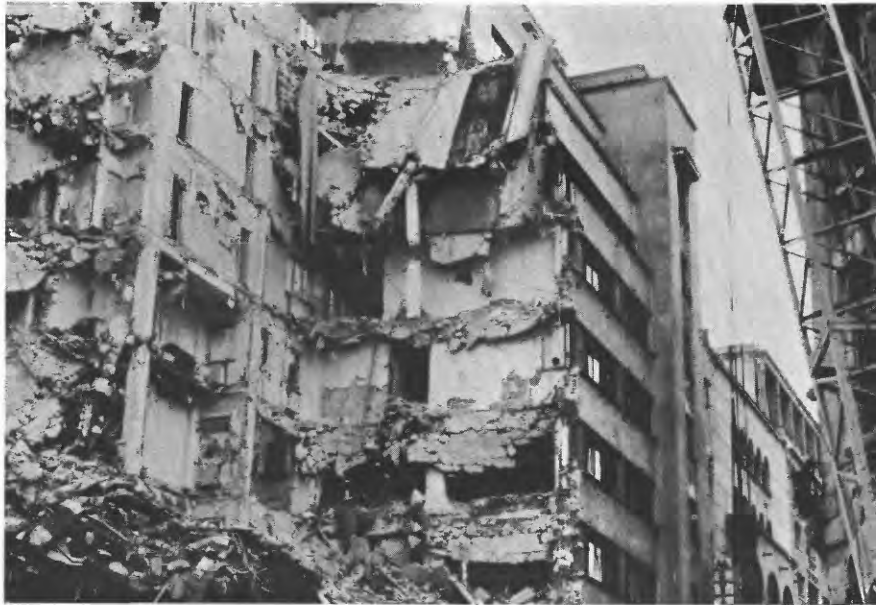
Figure 8.- Partially collapsed reinforced concrete frame and masonry-wall office and apartment building built prior to the 1940 earthquake. Building was located in the center of Bucharest, and extent of damage is similar to that sustained by 31 other older buildings.

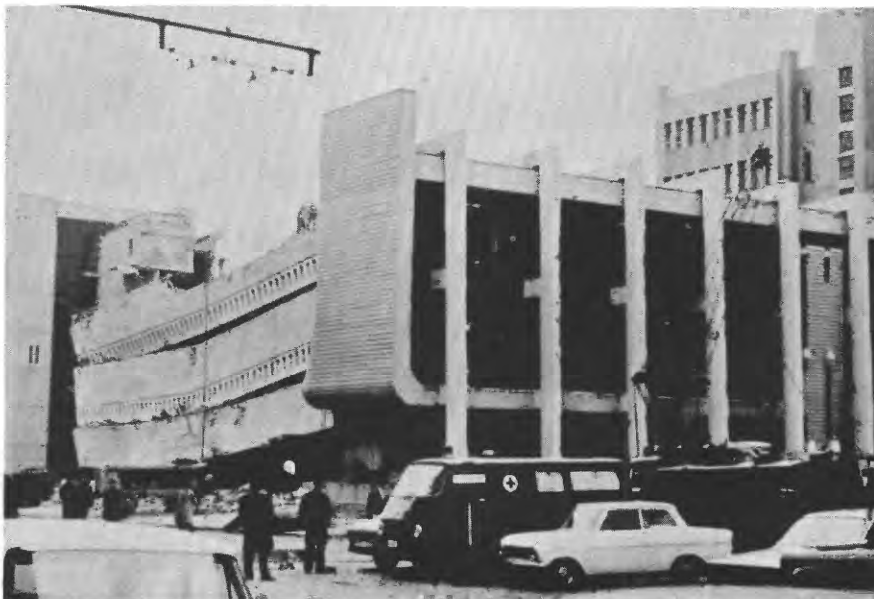
Figure 9.- Computer Center of Ministry of Transportation and Telecommunications, Bucharest. Center part of this three-story reinforced concrete flat-slab building collapsed; service towers at each end remained intact. Three persons died in the collapse.

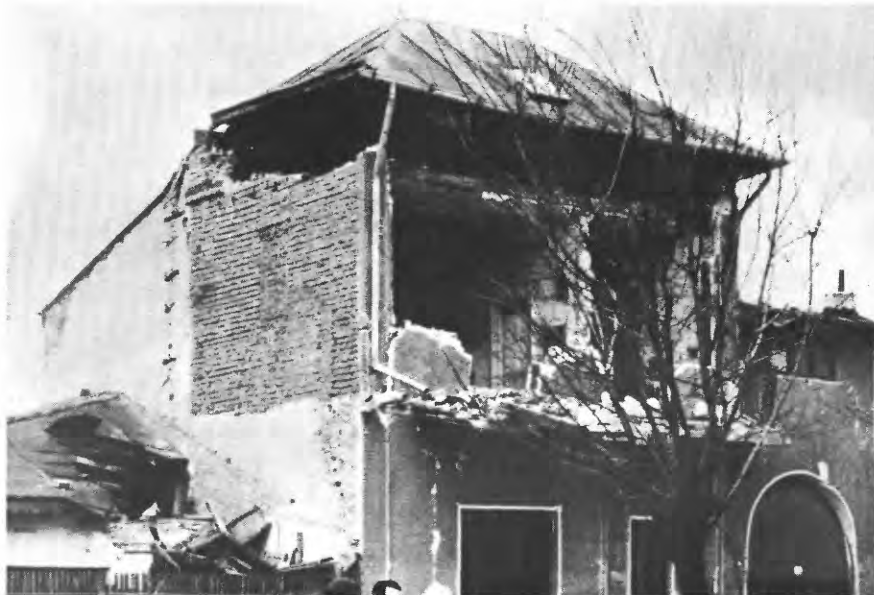
Figure 10.- Typical older two-story unreinforced masonry wall dwelling, Bucharest. Note collapsed exterior wall between second floor and roof.

On the outskirts of the city, two recently constructed multi-story buildings collapsed, and unreinforced masonry walls in many older one- and two-story dwellings were extensively damaged (fig. 10). Of the major types of modern construction in existence at the time of the March 4 earthquake (that is, multi-story reinforced concrete frame buildings with and without a soft first story; multi-story reinforced concrete shear-wall buildings; and large panel buildings composed of large precast reinforced concrete floor and wall elements), the stiffer buildings sustained less structural and nonstructural damage than the more flexible ones. Large panel buildings (fig. 11), in particular, performed very well. Their good performance may be related to the fact that their fundamental or lowest natural frequencies of vibration have been observed to be high (2 to 5 Hz (Diaconu and others, 1970)) in comparison to the predominant frequencies of high-amplitude ground motion in Bucharest (0.6 to 1 Hz).

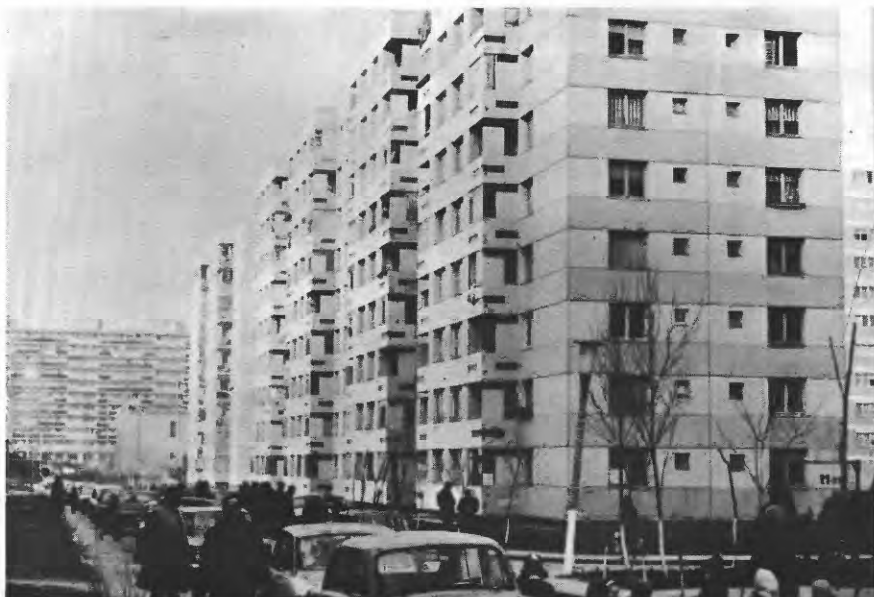
Figure 11.- Typical undamaged reinforced concrete large-panel building on the outskirts of Bucharest. The city is surrounded by several thousand of these buildings and few (based on initial investigations) were damaged by the earthquake.

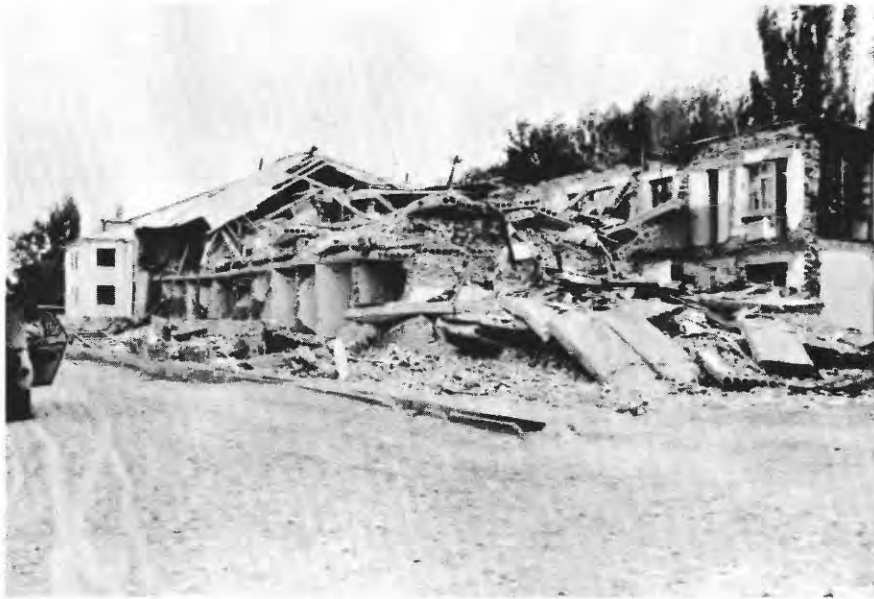
Figure 14.- Partially collapsed two-story unreinforced brick-wall building with precast concrete floor slabs, Gazli, U.S.S.R. Building was damaged by both the April 8, 1976 and May 17, 1976 earthquakes; it was not designed to resist earthquakes (A. A. Lunyov, oral commun., October, 1976.) Photograph by P. Mork.

The main shock of May 17 was felt in Gazli with an intensity of about IX. All brick buildings were substantially destroyed (fig. 14), all panel buildings were seriously damaged (fig. 15), and cracks appeared in asphalt roads and concrete pavements. Fortunately, the entire population of Gazli had been evacuated after the first shock of April 8 and was living in nearby temporary wooden buildings and tents. Consequently, casualties related to the main shock were held to a minimum. At Karakyr Point the only adobe building collapsed, and cracks up to 10 m long and approximately 1 cm wide were observed in the ground.

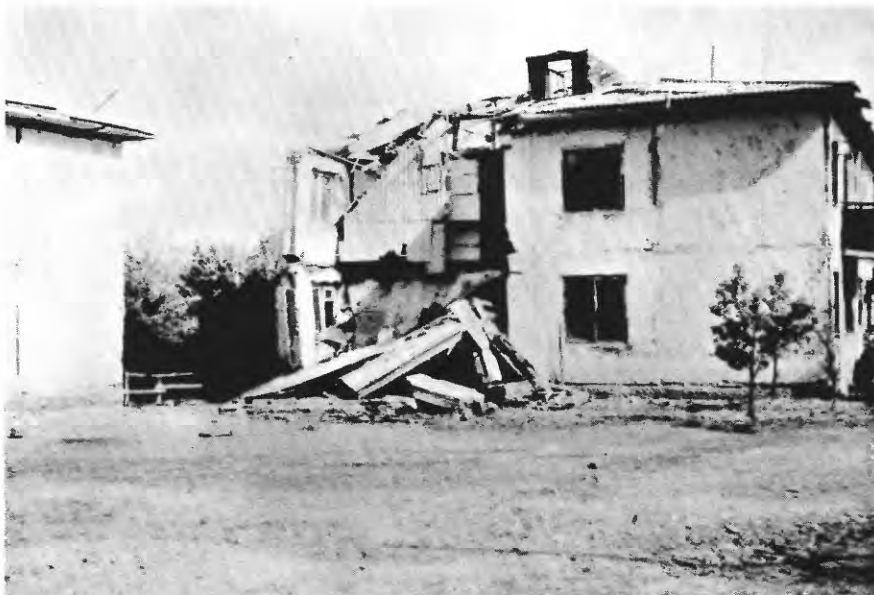
Figure 15.- Partially collapsed two-story large-panel building, Gazli, U.S.S.R. End-wall precast panels, interconnected with two steel rods at each panel corner, separated at construction joint (between panels) and collapsed. Building was damaged by both the April 8, 1976 and May 17, 1976 earthquakes; it was not designed to resist earthquakes (A. A. Lynyov, oral commun., October, 1976). Photograph by P. Mork.
