GEOLOGICAL SURVEY CIRCULAR 781

The Case of the
Shrinking Channels—
the North Platte and
Platte Rivers in Nebraska

By Garnett P. Williams

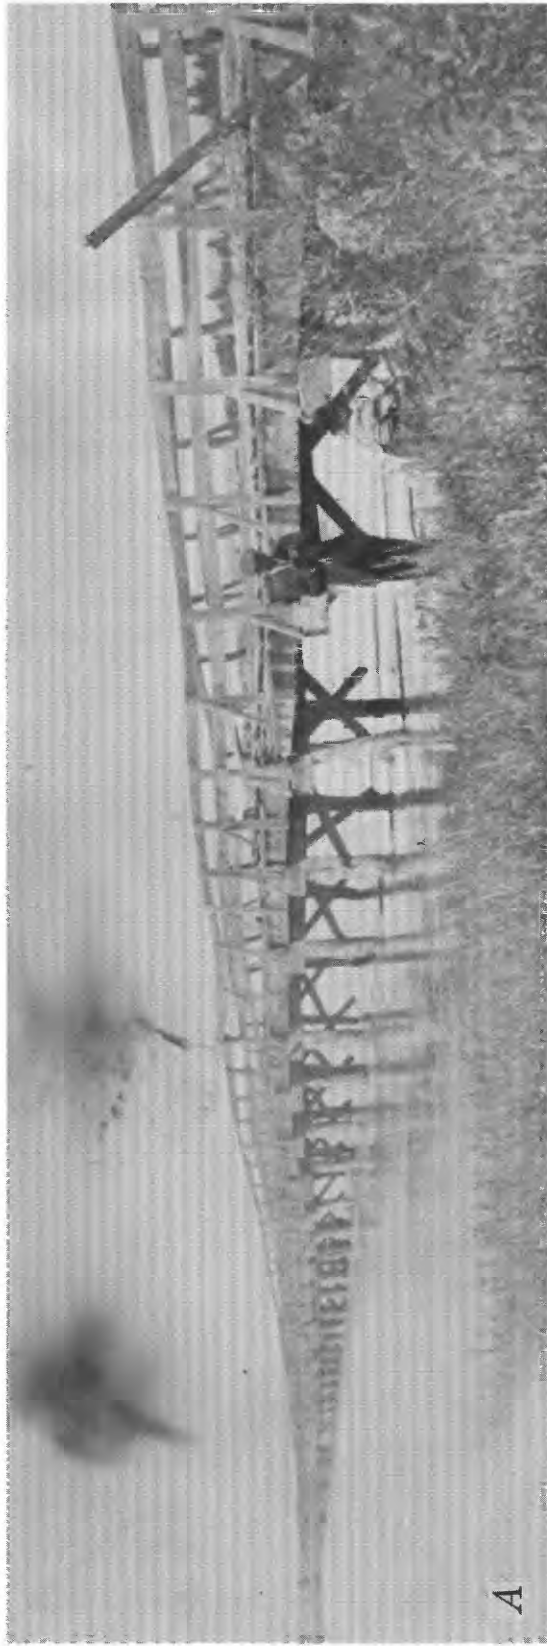
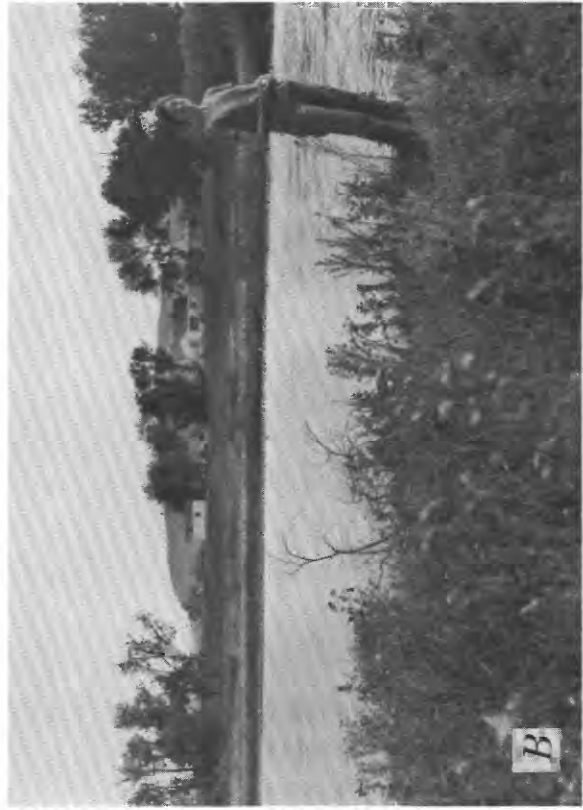
FIGURE 3.—Site of old Bayard bridge. *A*, bridge used from about 1900-1913. Photo from Nebraska State Board of Irrigation, Highways, and Drainage, 1914, p. 172. *B*, 1977 view of same cross section. *C*, piers of 1900-1913 bridge several hundred meters from present (1977) left bank.

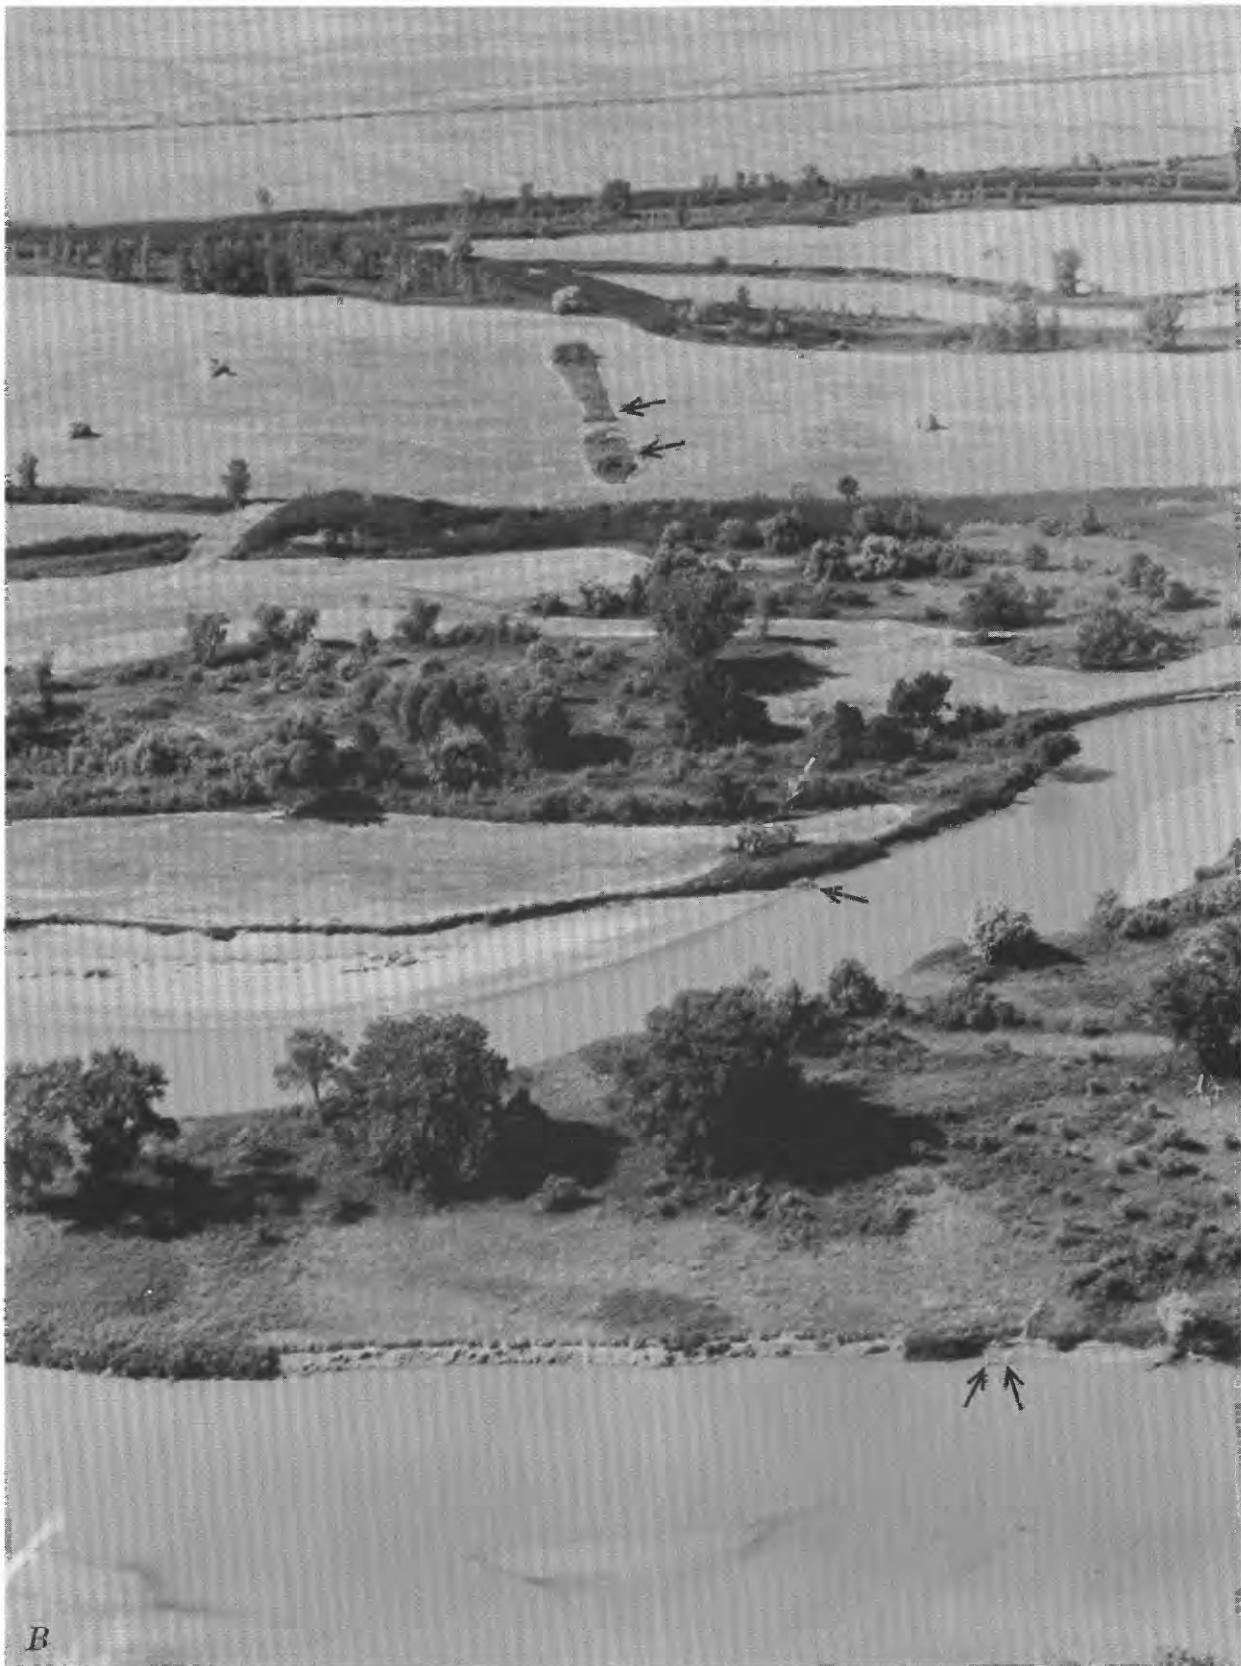
FIGURE 4.—Site of old Camp Clark bridge about 8 km west of Bridgeport. A, bridge used from about 1876-1903. View may be from an island in the river. Photograph from Paul Henderson. B, view of site in 1968. Present bank of river is just below lower edge of photograph. Arrows point to remaining piers of old bridge. Photograph from Joe Fairfield.

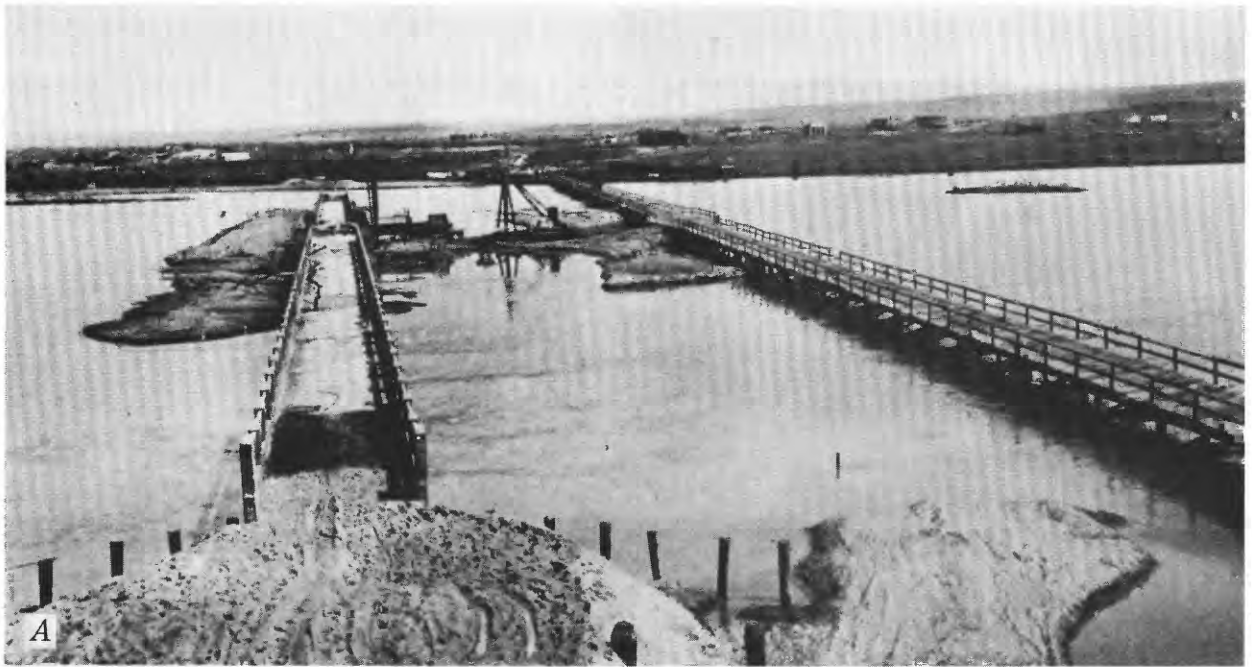
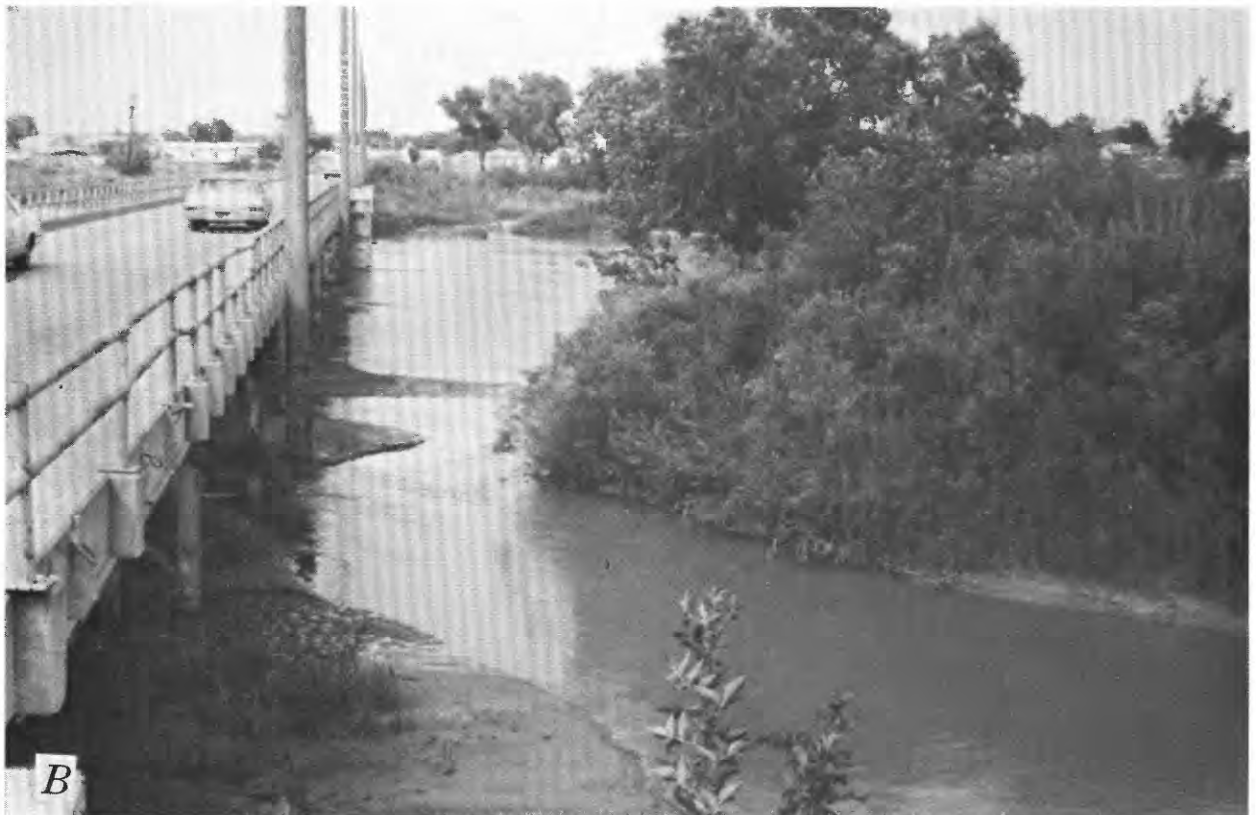
FIGURE 5.—North Platte River at Bridgeport, looking north. *A*, old bridge (right), with newer bridge under construction, about 1913. Photograph from Nebraska State Board of Irrigation, Highways, and Drainage, 1914, p. 188. *B*, the same cross section in 1977.

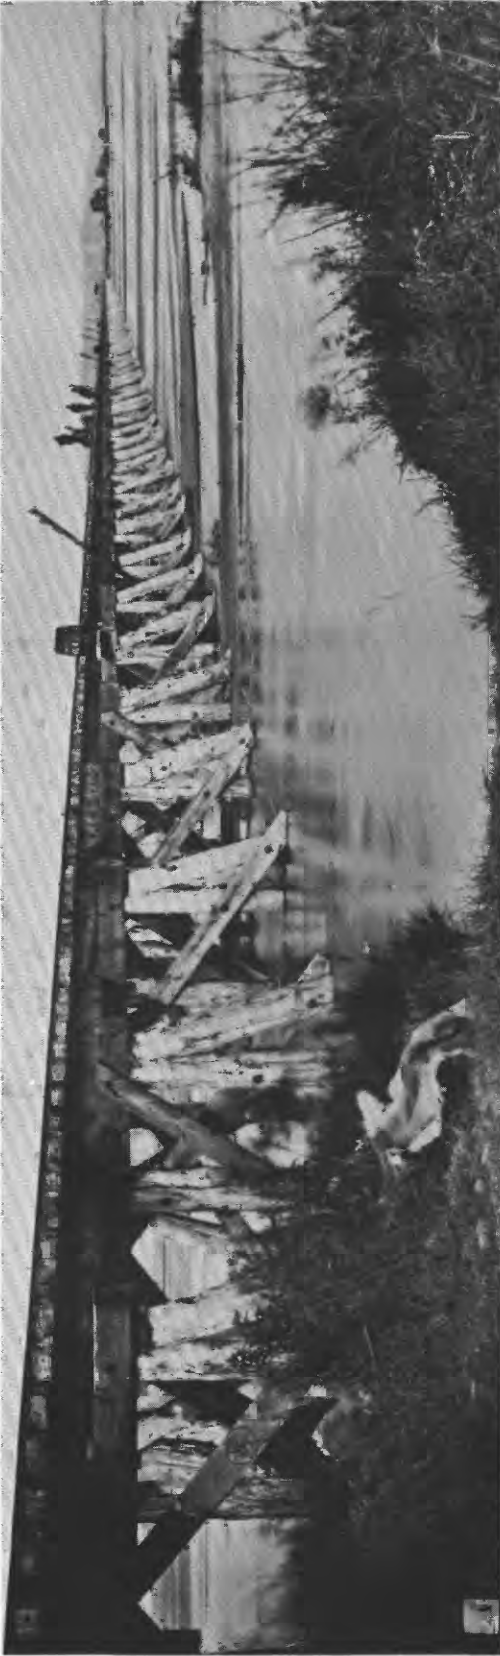
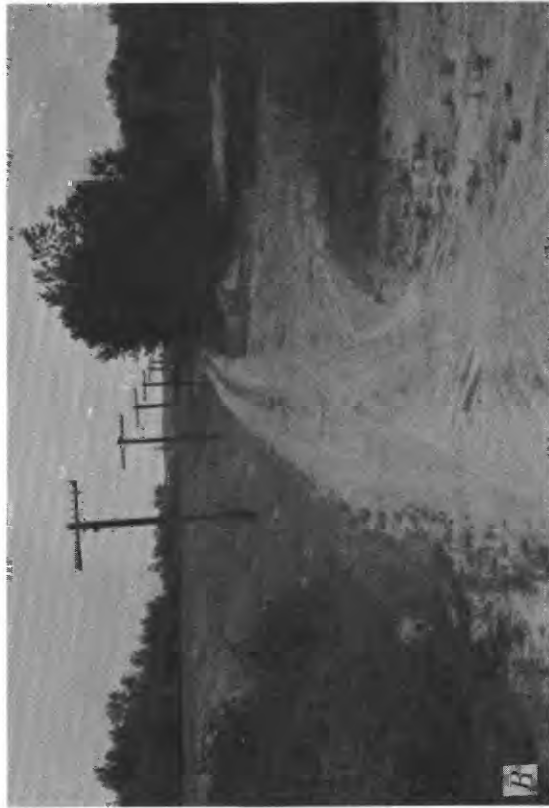
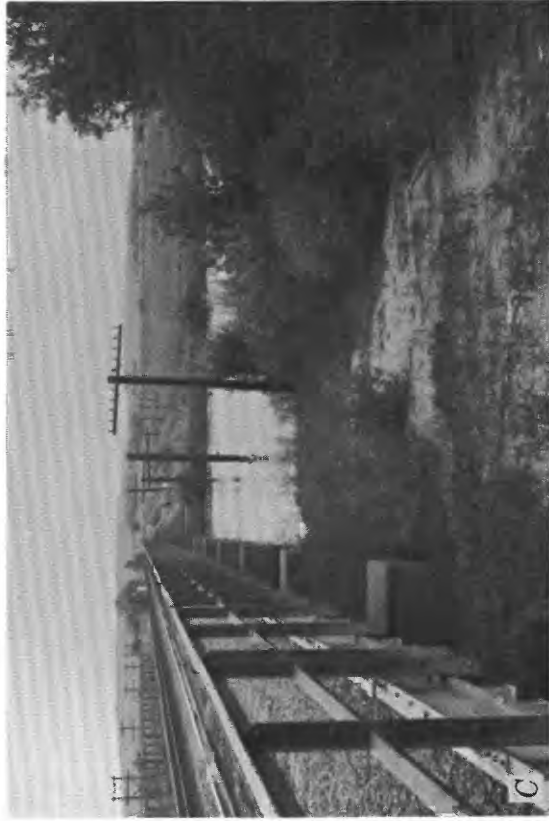
FIGURE 6.—Union Pacific Railroad bridge, North Platte River at North Platte, looking northeast. *A*, 1869 view (W. H. Jackson photograph, from U.S. Geological Survey files); *B*, 1977 view taken from about same location as *A*; *C*, the main channel in 1977.

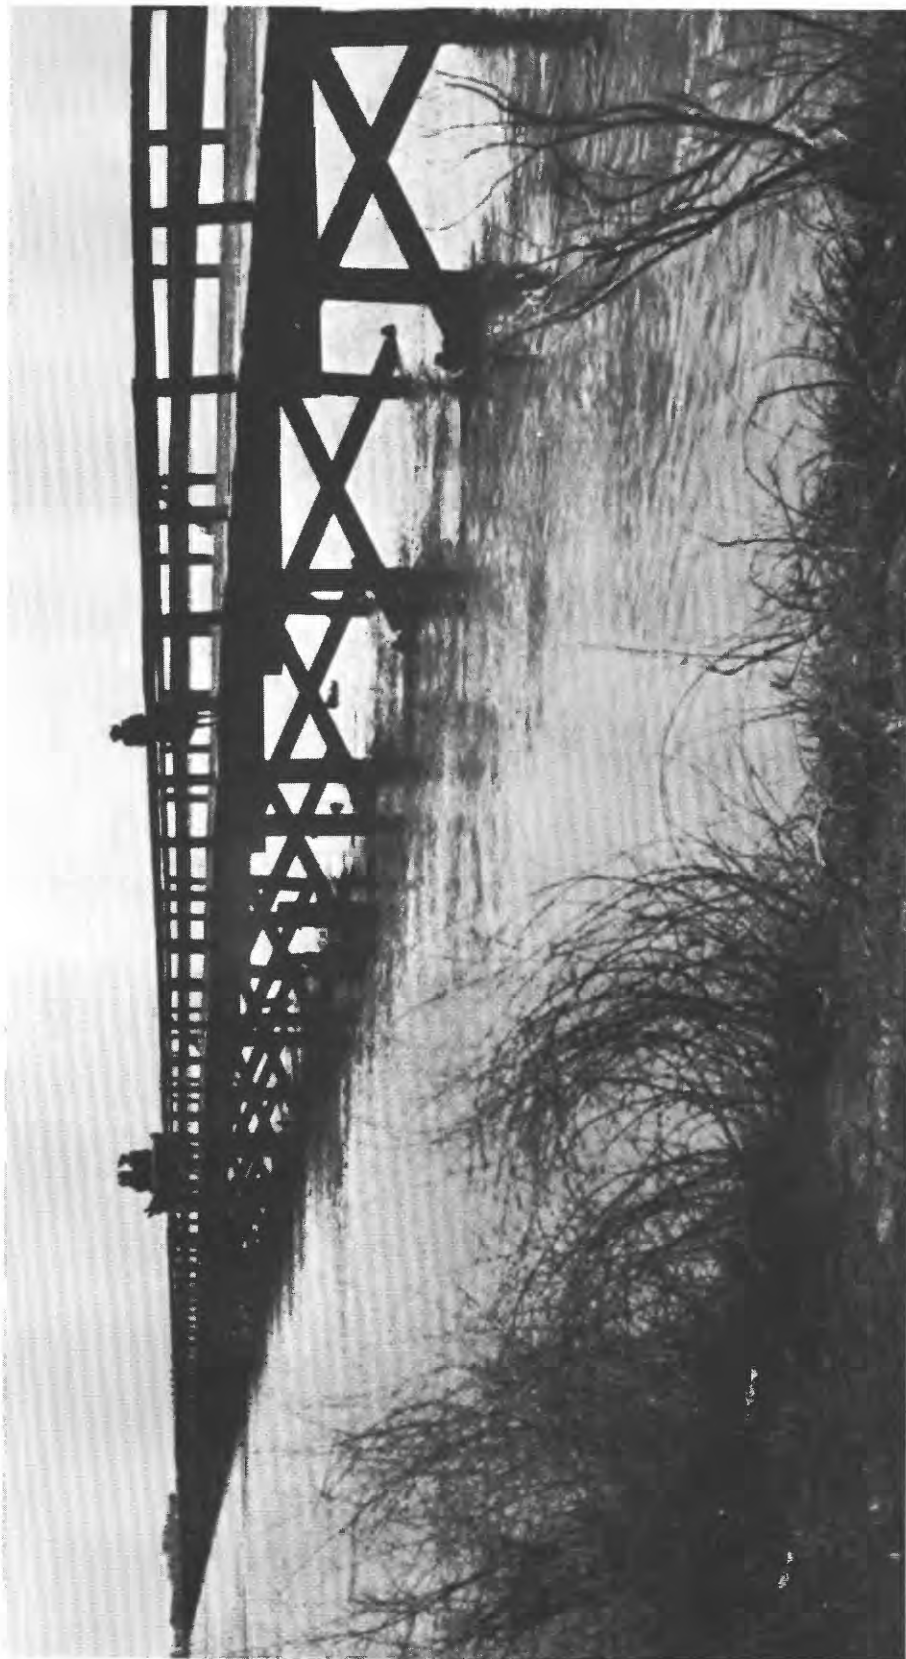
FIGURE 7.—Platte River bridge at Kearney, probably about 1900. Photograph from Nebraska State Historical Society.

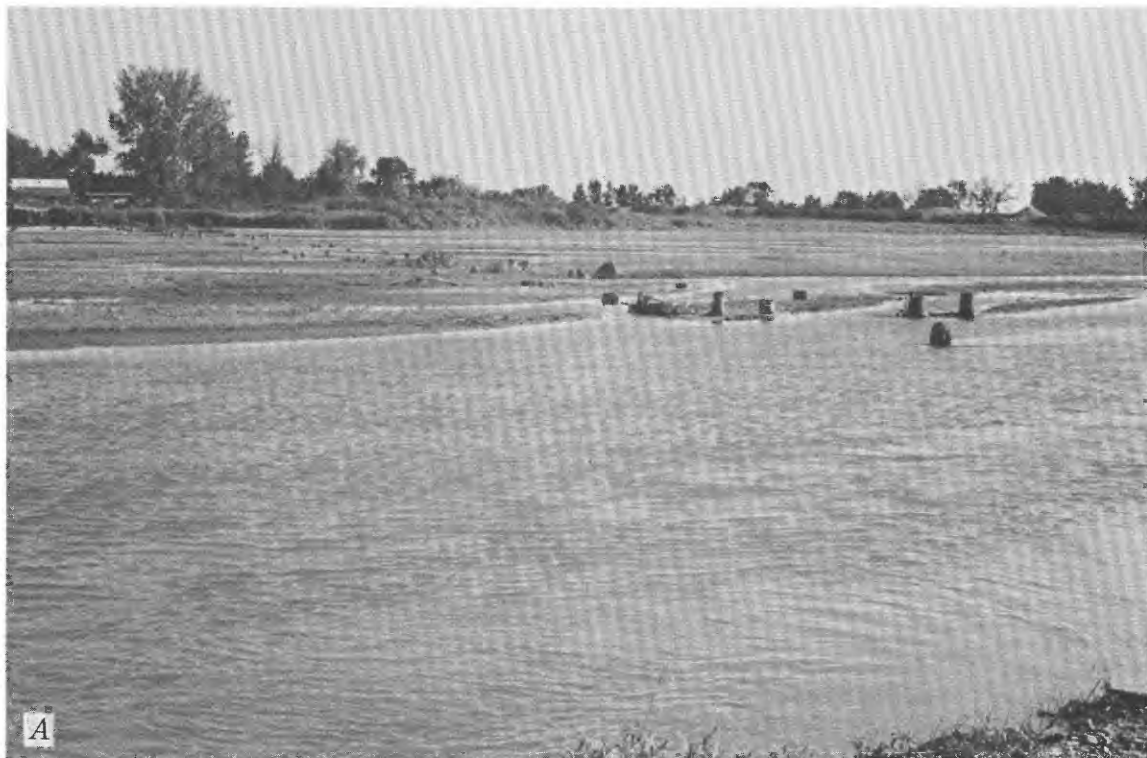
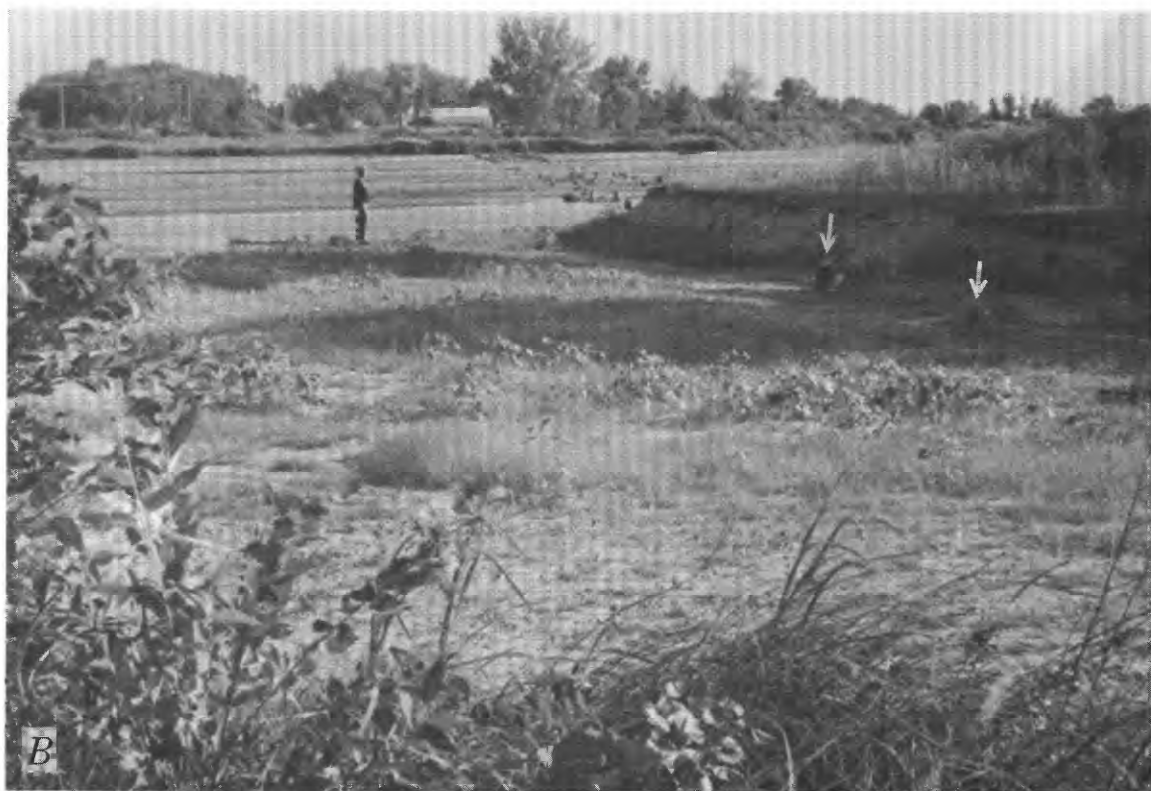
FIGURE 8.—Site of old Platte River bridge at Kearney—1977 views, looking north. *A*, scene from right bank, showing old bridge piers; *B*, view showing old piers (arrows) on present flood plain, as well as piers in channel. Woman standing on top edge of right bank.

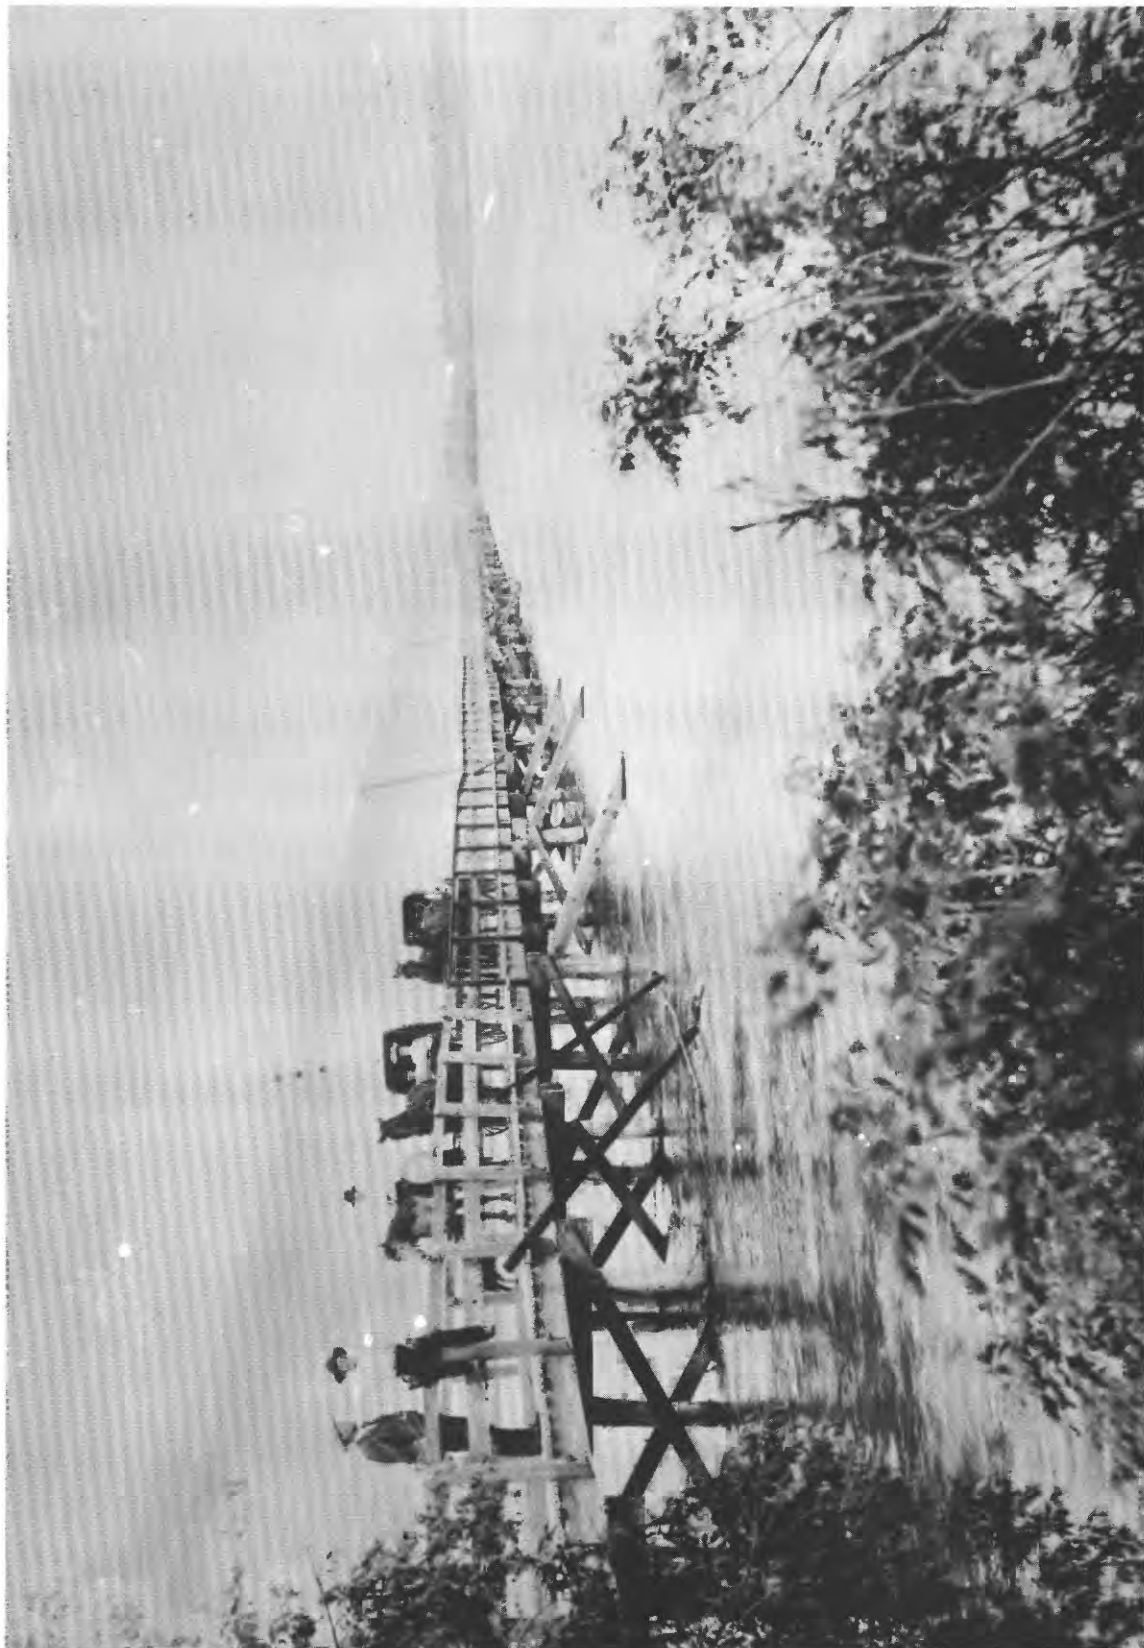
FIGURE 9.—Platte River bridge about 8 km southeast of Grand Island (location of present U.S. Highway 34 bridge), looking southeast, about 1900. Photograph from the Stuhr Museum of the Prairie Pioneer.

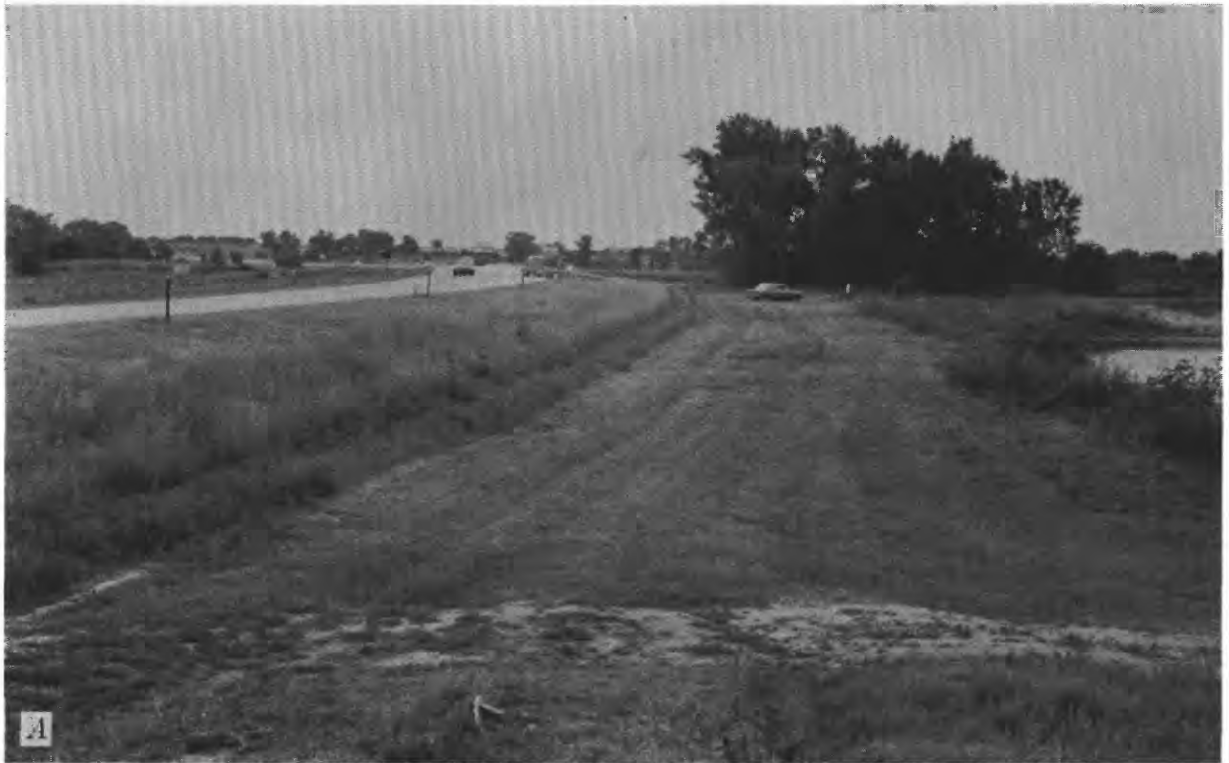
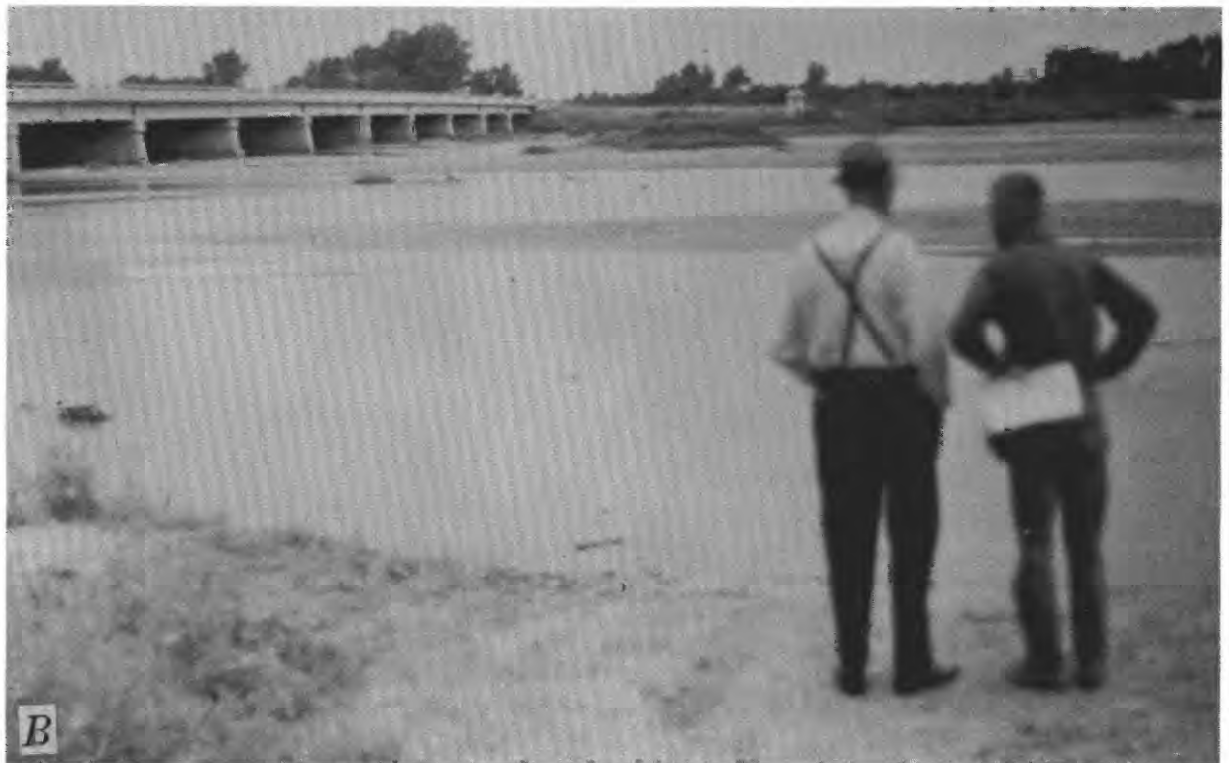
FIGURE 10.—Site of old Platte River bridge (fig. 9) southeast of Grand Island—1977 views. *A*, view of cross section from about same point as fig. 9; *B*, present channel, looking northwest.

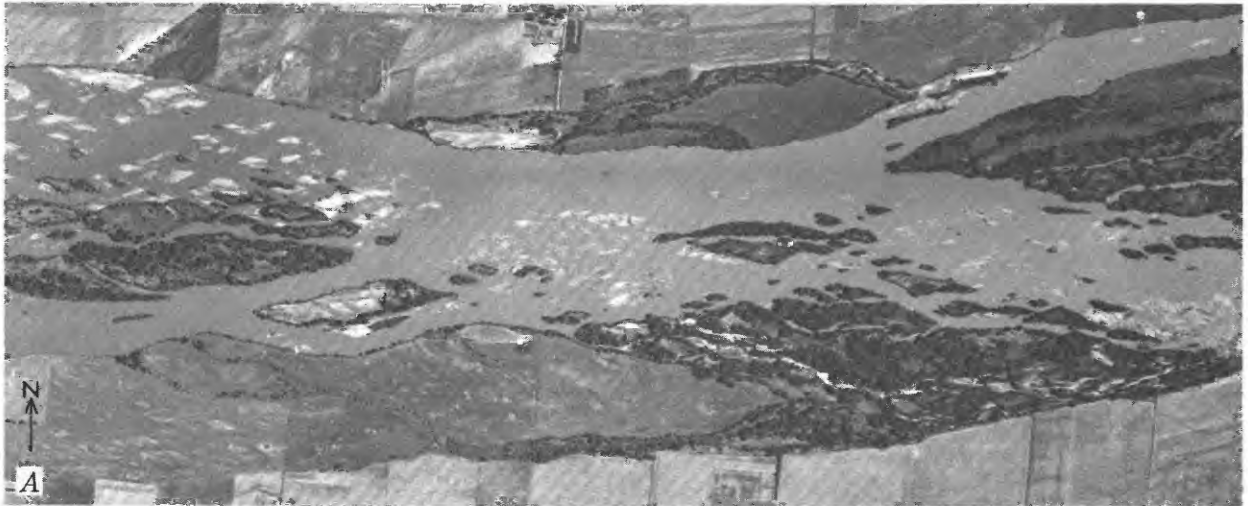
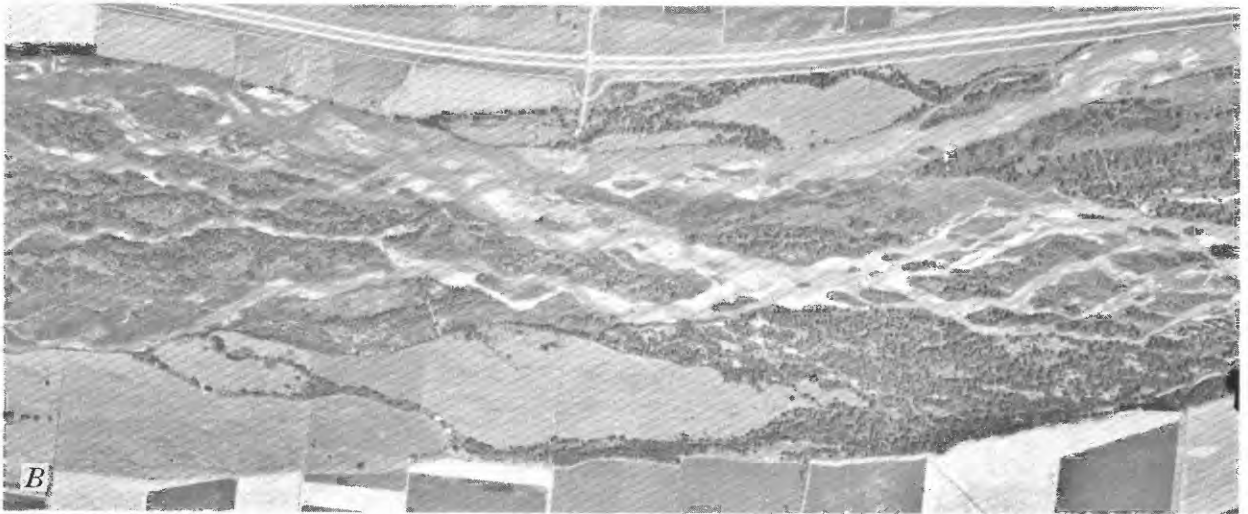
FIGURE 16.—Comparative aerial views of 1938 (A) and 1969 (B) channels of Platte River south of Shelton about 1 km east of Buffalo County-Hall County line and at river km 490. Photos from U.S. Dept. Agriculture.

Today's channel seems to have more trees along the banks than during most of the 19th century. More striking, however, is the lush vegetation, including trees of all sizes, that occupies much of the zone that used to be stream channel (figs. 3-16).
