Mudflows Resulting from the May 18, 1980, Eruption of Mount St. Helens, Washington

By John Cummans

**Hydrologic Effects of the Eruptions
of Mount St. Helens, Washington, 1980**

GEOLOGICAL SURVEY CIRCULAR 850-B

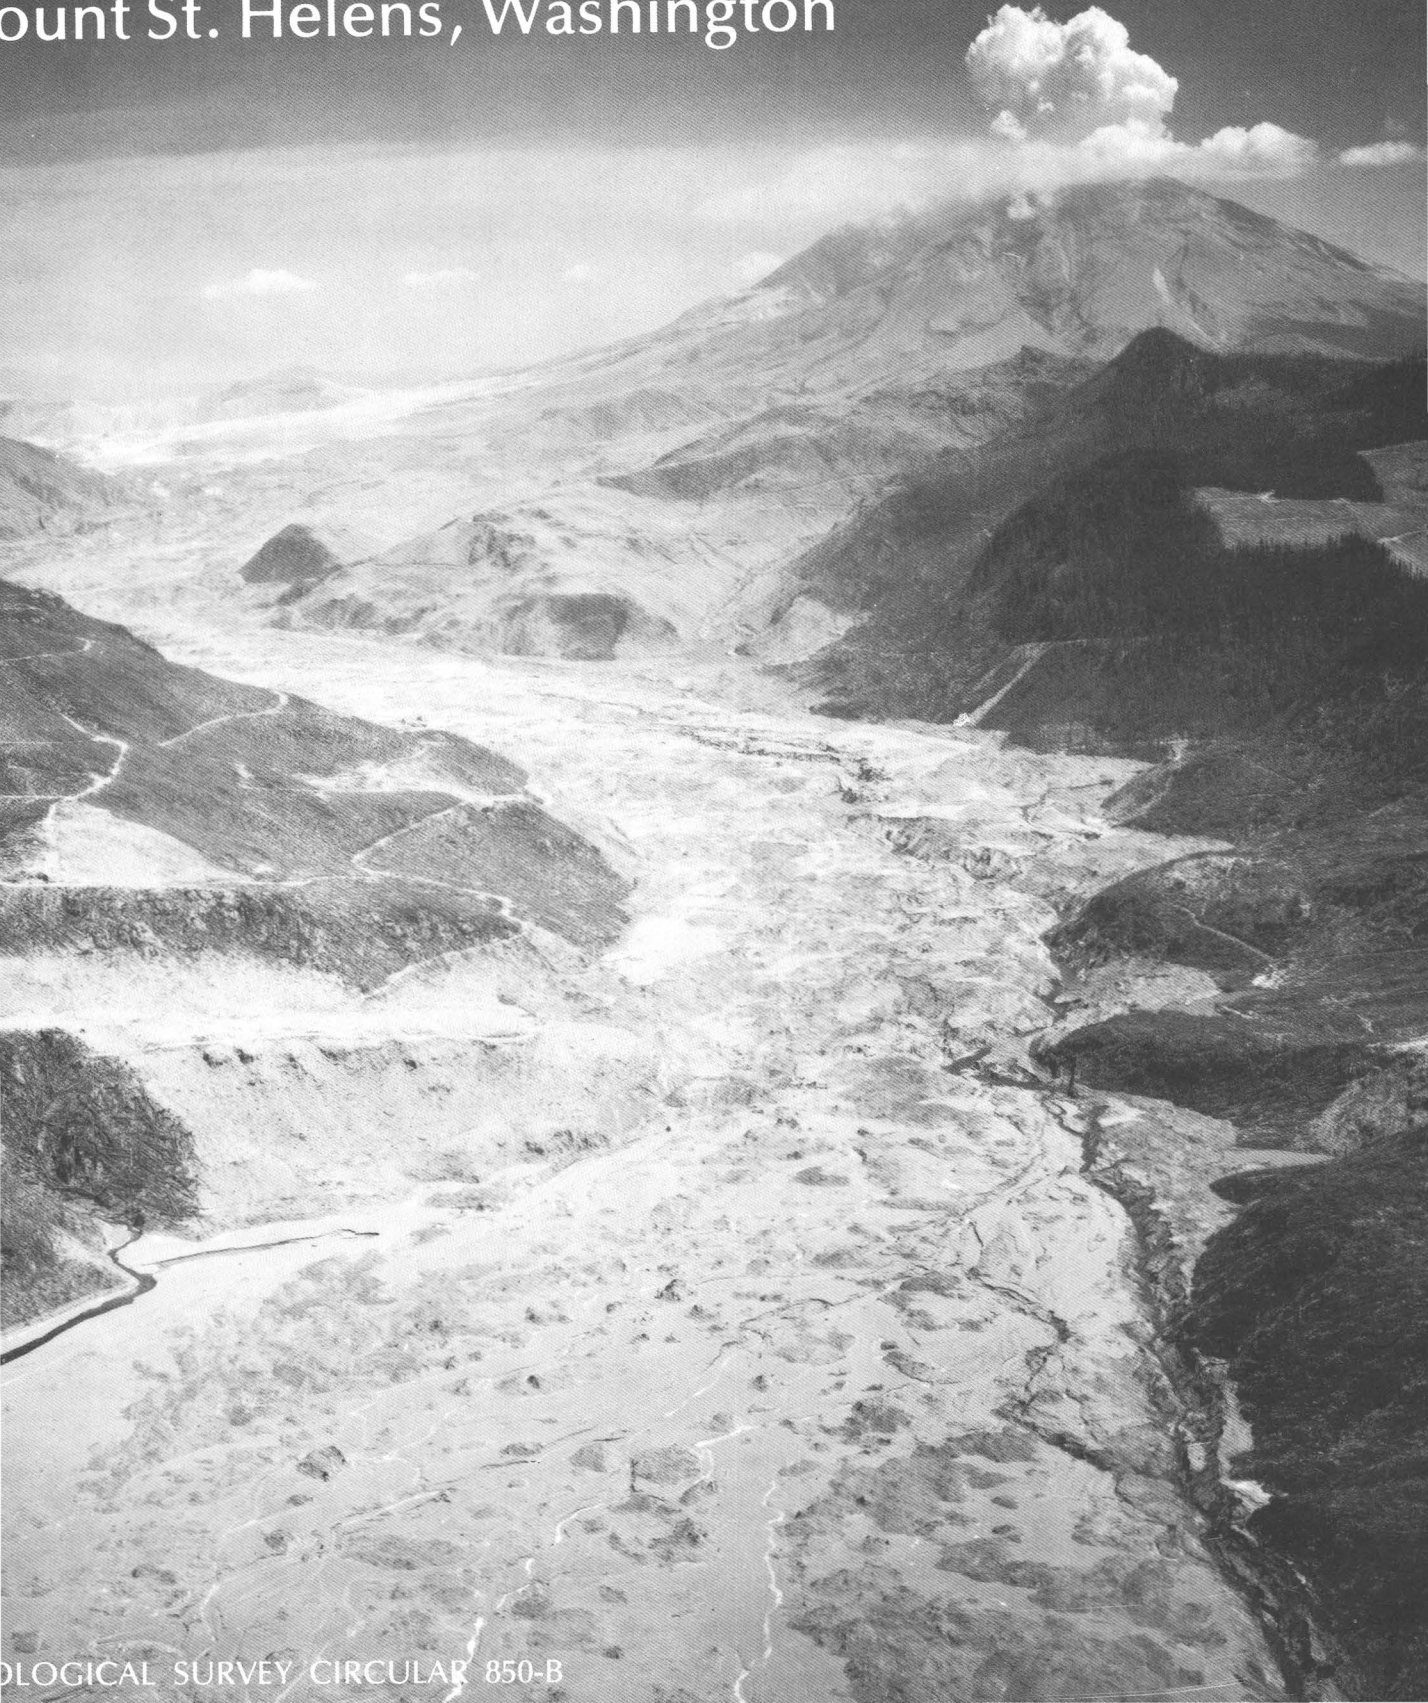
COVER: North Fork Toutle River, June 30, 1980. Volcanic mud flow breccia and debris from the May 18, 1980 eruption of Mount St. Helens (in upper right) are as much as several hundred feet thick in the reach shown. Photograph by Austin Post, U.S. Geological Survey.

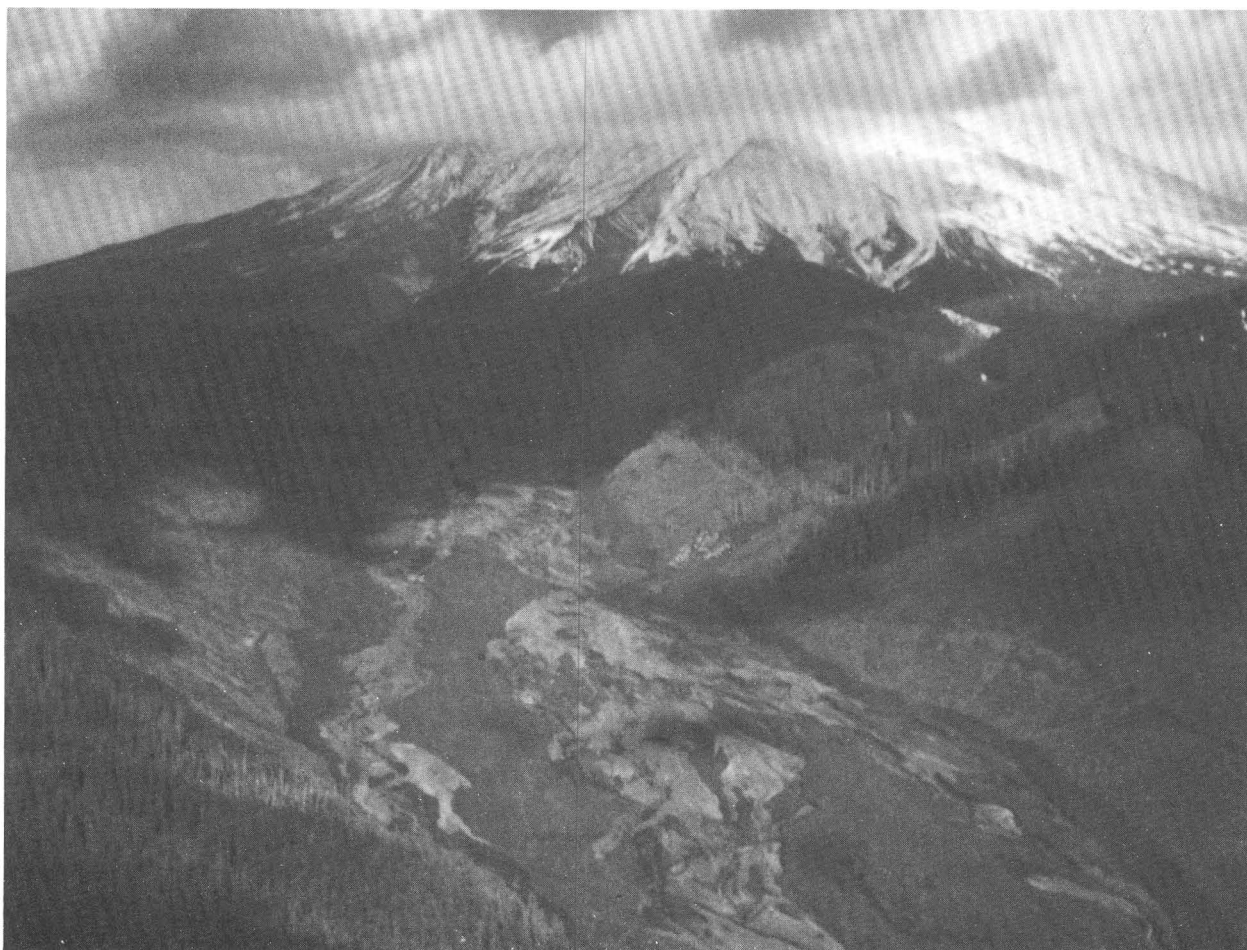
FIGURE 3. - Aerial view of valley mudflow deposits in the upper reaches of the South Fork Toutle River. Photograph taken May 23, 1980.

A photograph (fig. 3) taken May 23, five days later, shows the mudflow deposits in these upper reaches of the South Fork valley.

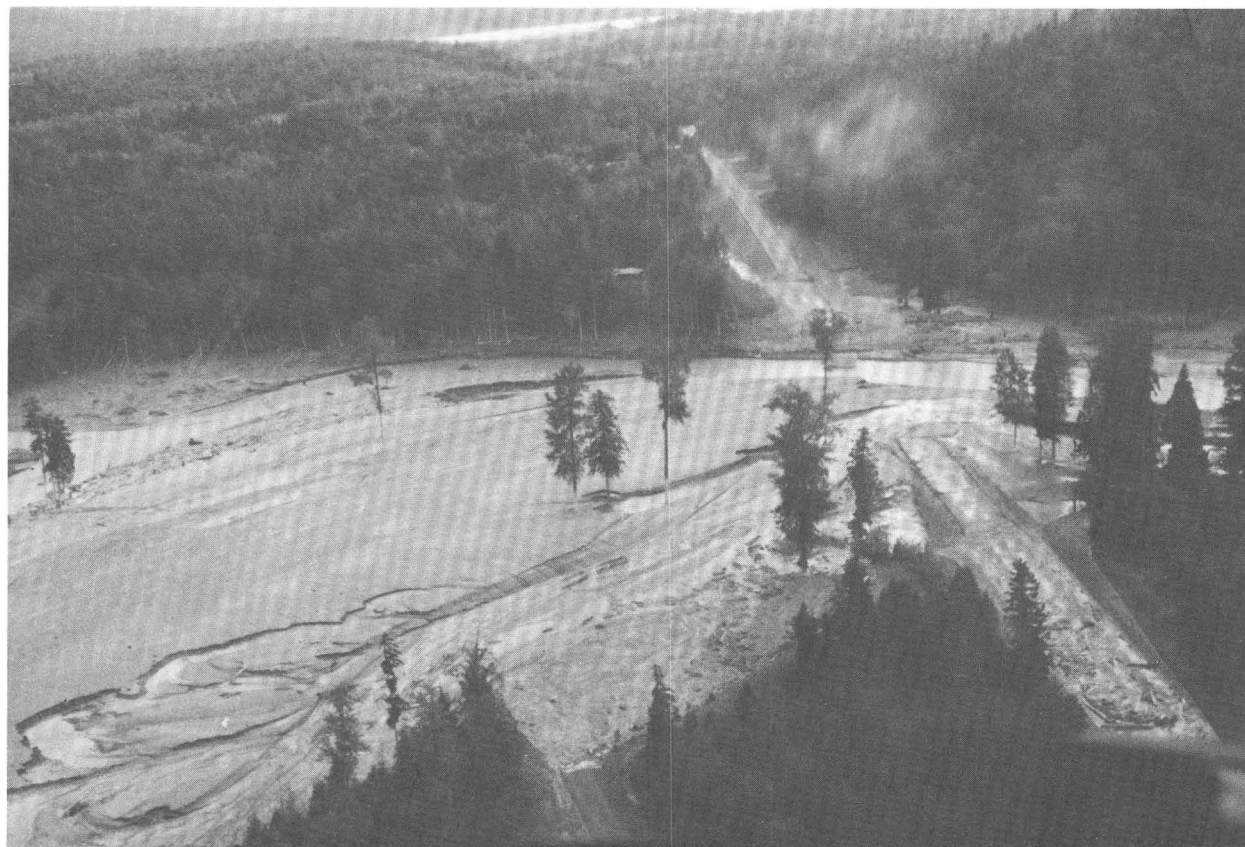
FIGURE 9.—Flooded area at destroyed Highway 504 Bridge just below the confluence of the North and South Forks Toutle River. Photographs taken May 19, 1980.

reach, and apparently was caused by a massive log jam at the entrance to the constricting gorge, which is located 0.8 mile downstream from the confluence of the North and South Forks. The blockage and ponding may have been aided by debris arriving from the secondary mudflow observed by David Crockett on the upper South Fork at 2:00 p.m. Figure 9 shows the resultant devastation just downstream from the confluence, in the area of the destroyed Highway 504 Bridge.
