**Development of Sinkholes Resulting
From Man's Activities in the Eastern
United States**

By J. G. Newton

U.S. GEOLOGICAL SURVEY CIRCULAR 968

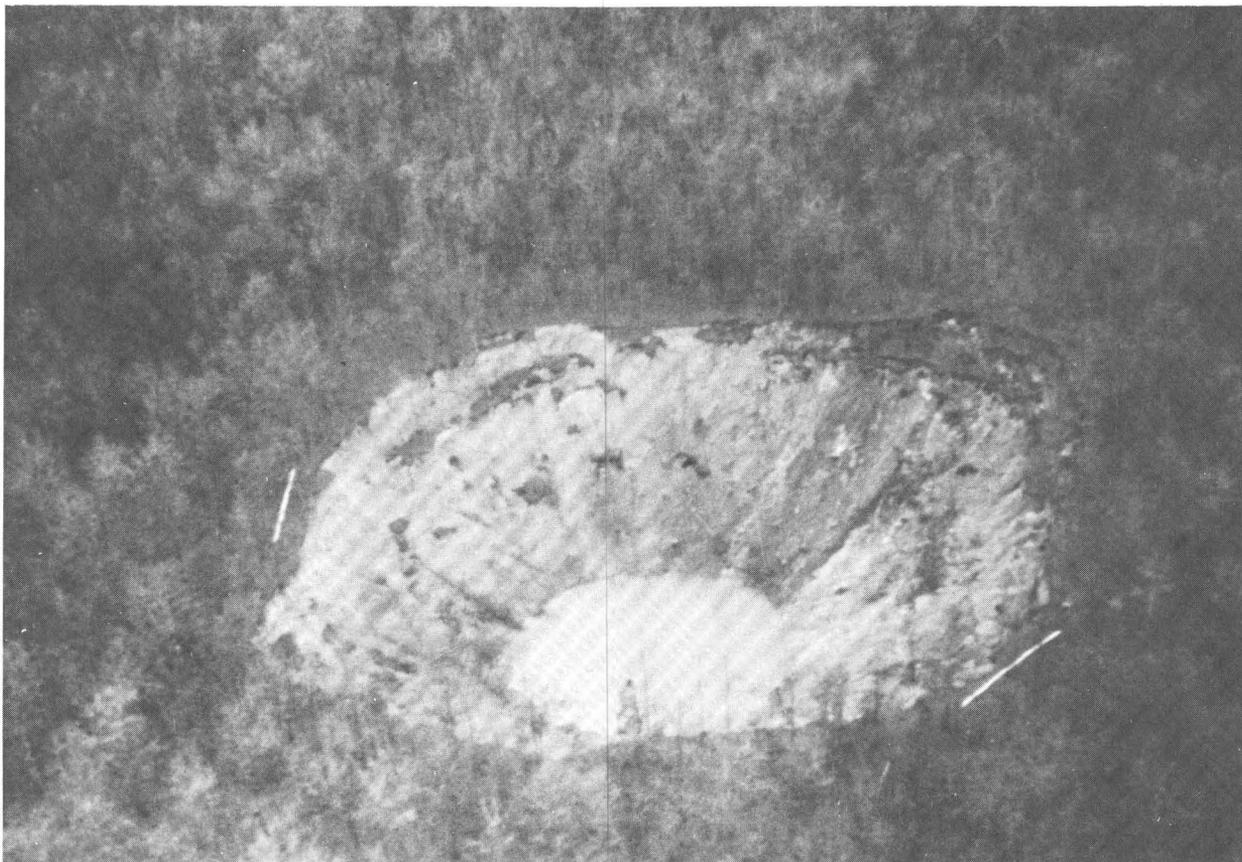
FIGURE 1.—Collapse forming new sinkhole in Shelby County, Ala., 1972. (Photograph by T.V. Stone.)

The development of sinkholes commonly poses hazards to man. The danger depends more on where and how rapidly they form than on their size. For instance, the largest collapse in Alabama (fig. 1) occurred in a wooded area in 1972. Even though it apparently occurred very rapidly, it posed little hazard because of its location. In contrast, a small but dangerous collapse (fig. 5) oc-

the Greenwood area was about 20 feet long, 13 feet wide, and 7 feet deep. In Shelby County, Ala. (figs. 1, 28), six collapses had diameters approaching or exceeding 100 feet. Generally, collapses with diameters ranging from 25 to 50 feet were common. Some observed near Sylacauga, Ala., have surface dimensions of 30 to 100 feet. In Hershey Valley, Pa., 100 new sinkholes were reported to be 1 to 20

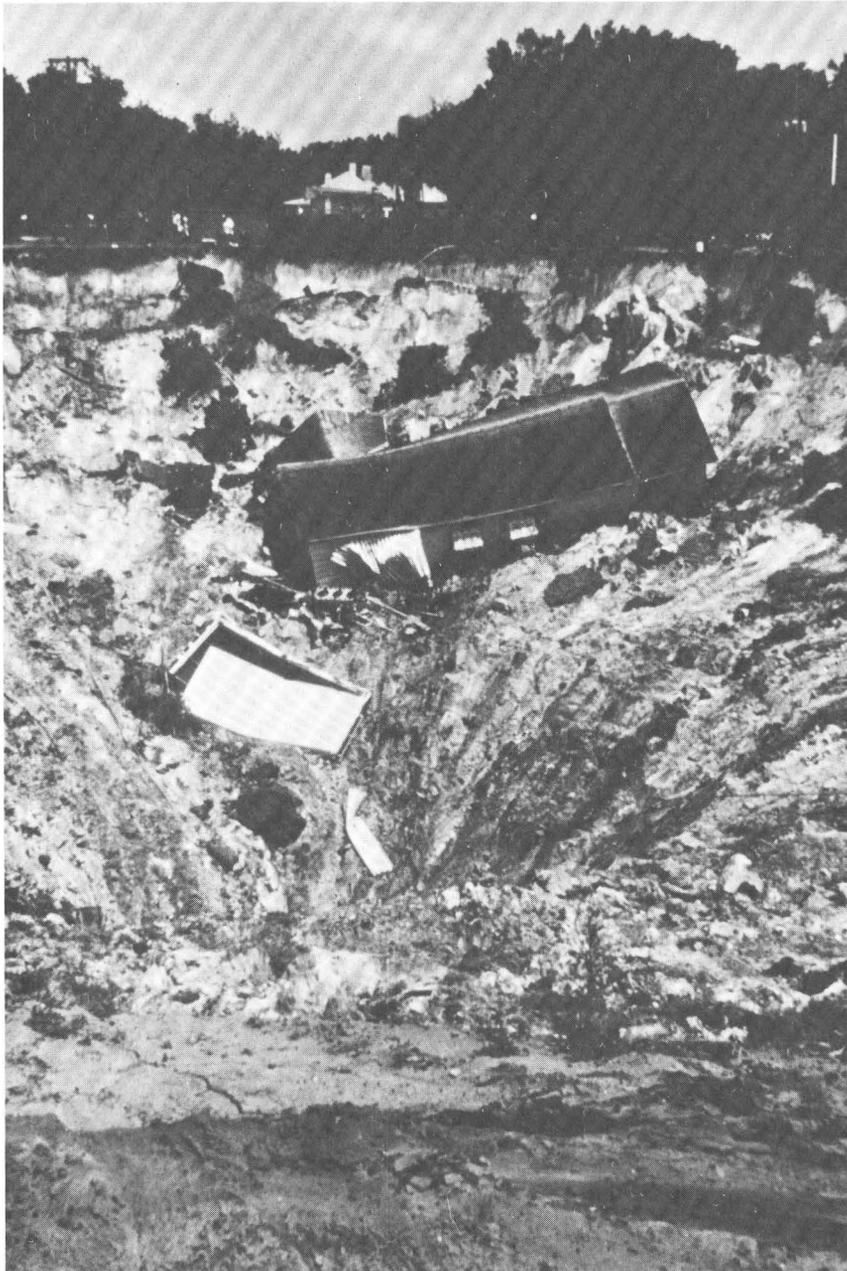
FIGURE 2.—Collapse forming new sinkhole in Winter Park, Fla., 1981. (Photograph by A.S. Navoy.)

Sudden large collapses of the land surface during the formation of sinkholes in recent years (figs. 1, 2) have focused attention on a little-understood geologic hazard. Few people realize that thousands of similar but smaller sinkholes have formed in the United States since 1950. Costly damage and accidents have resulted from their sudden development beneath highways, railroads, buildings, sewers, dams, reservoirs and other impoundments, pipelines, vehicles, and, in some instances, people and animals. Sinkholes have also resulted in, or are potential sources of, pollution of water supplies. Concern about the problem has increased with the growing awareness that much, if not most, active sinkhole development in many areas is induced (accelerated or caused) by man's activities and that most of these activities involve changes in the hydrologic environment.

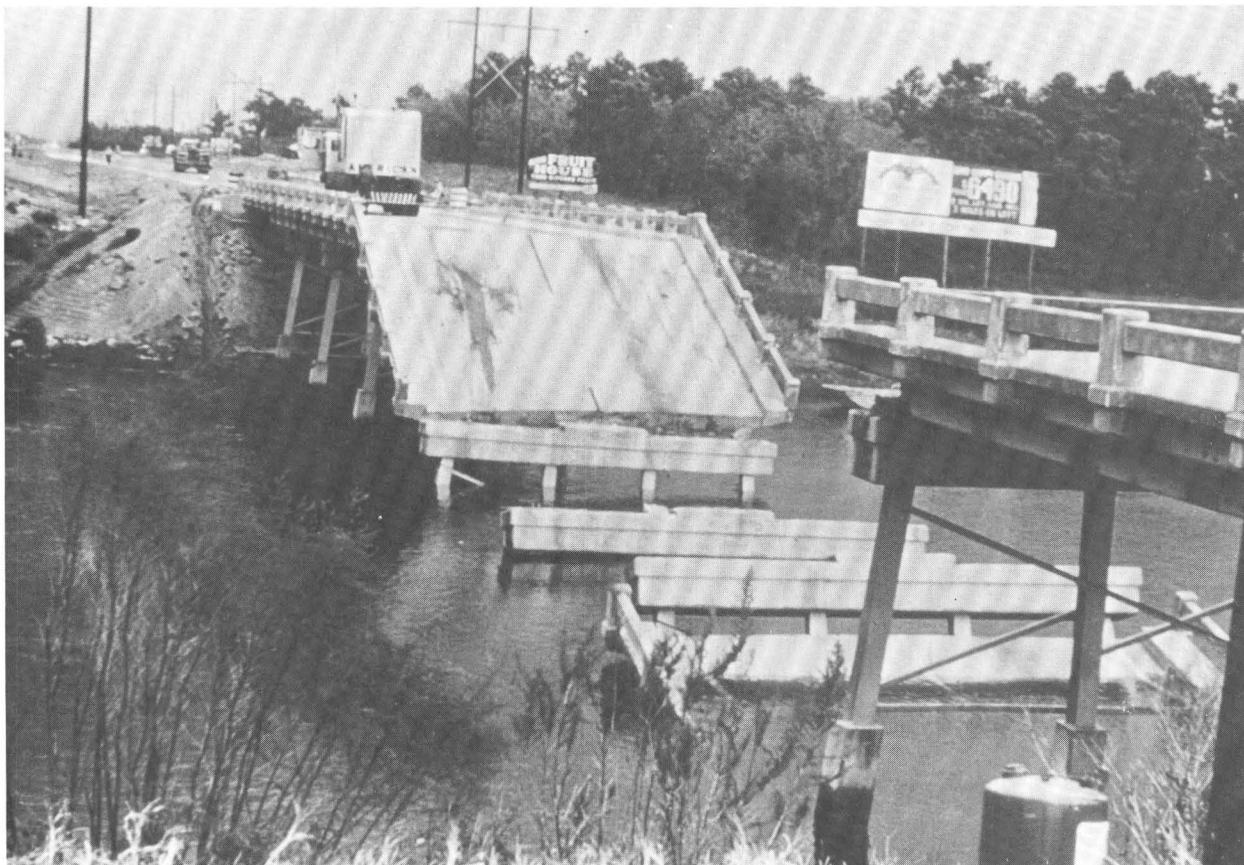
FIGURE 6.—Collapse of bridge over Anclote River near Tarpon Springs, Fla., in 1968. (Photograph by J.W. Stewart.)

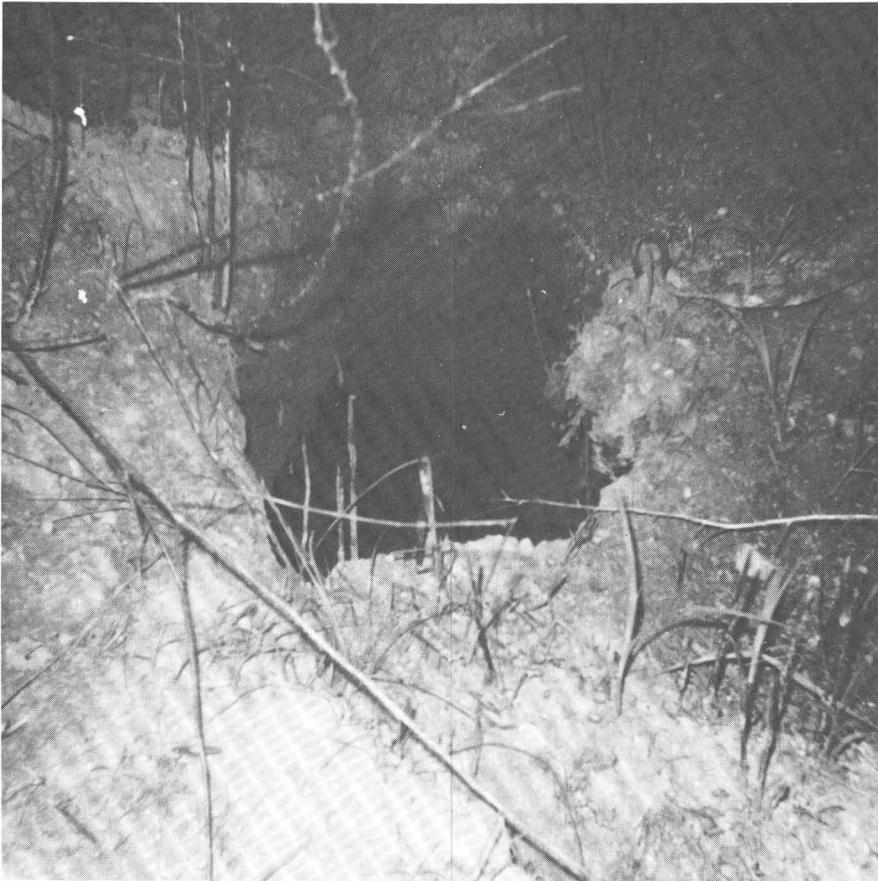
FIGURE 9.—Inclined opening adjacent to cavity in residual clay in November 1970 in Birmingham, Ala.

rence of pinnacles or irregularities in the top of bedrock. The walls are usually vertical as the opening grows toward the land surface. This configuration, however, can be modified by the configuration of the underlying openings in bedrock and by variations in the cohesion or competence of overlying beds. The configuration of the typical opening can change if its upward growth reaches a more competent bed. The roof flattens, the growth continues laterally, and the walls taper toward the opening in bedrock (fig. 8B). These stages of growth in one cavity were photographed and observed through a small adjacent opening (figs. 9–11). The cavity enlargement, occurring dur-

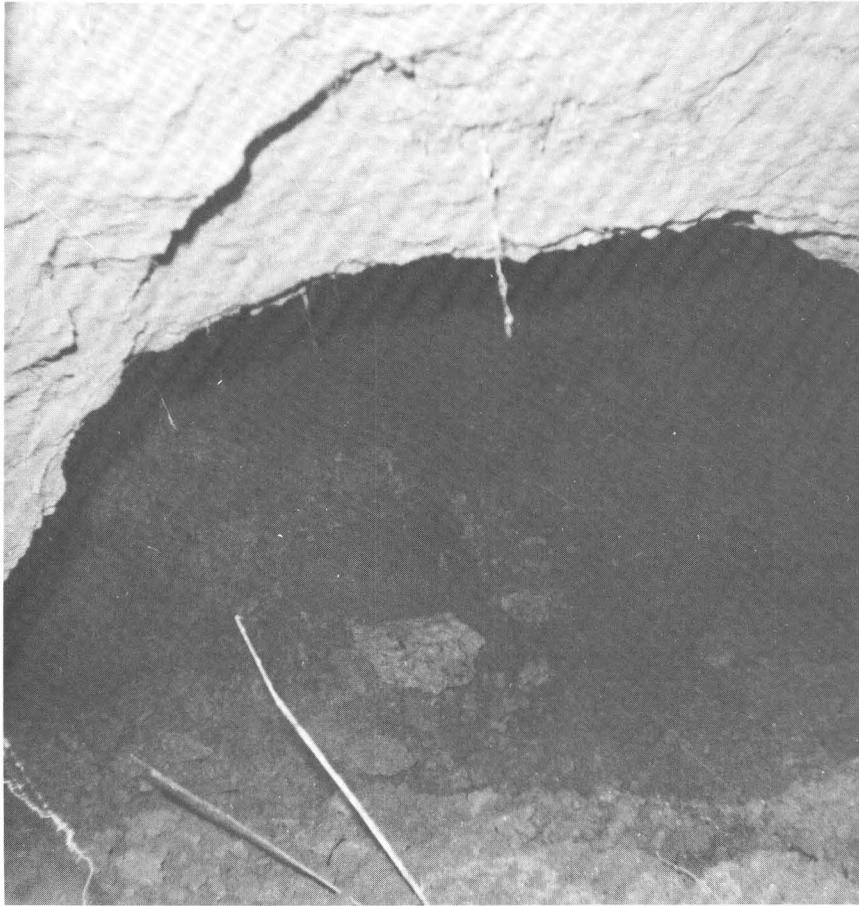
FIGURE 10.—Cavity in residual clay in November 1970 in Birmingham, Ala.

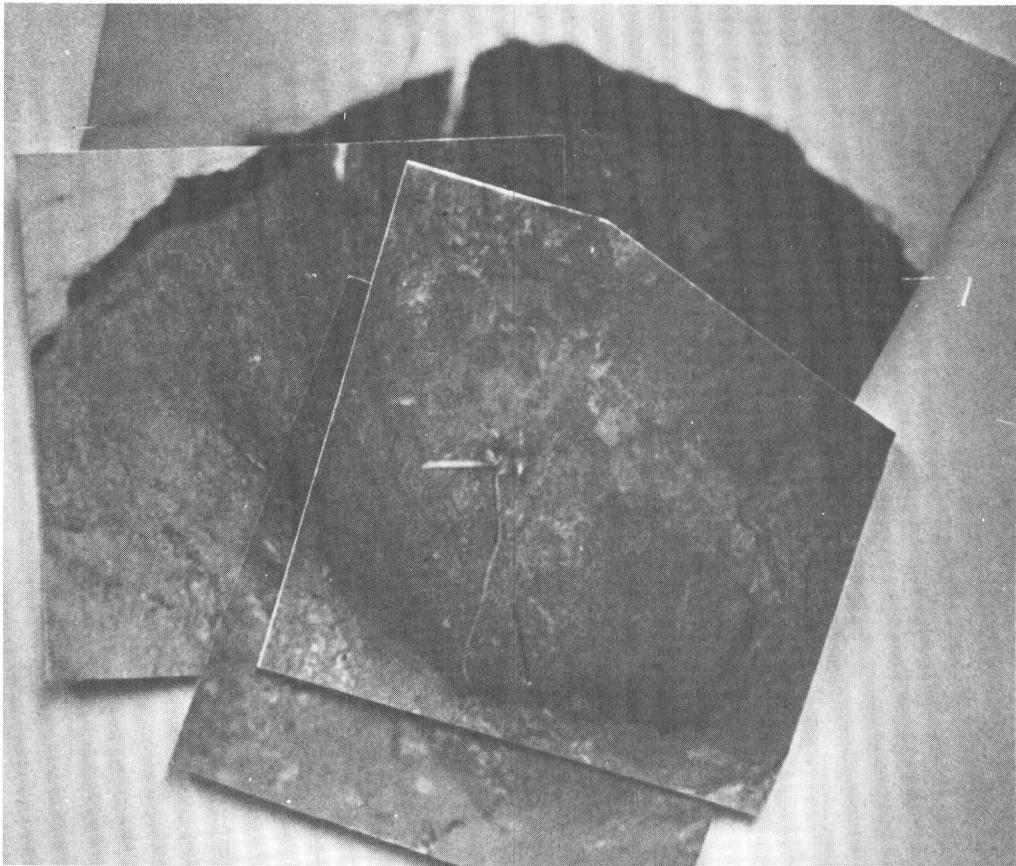
FIGURE 11.—Composite photograph of cavity in residual clay in April 1971 in Birmingham, Ala.

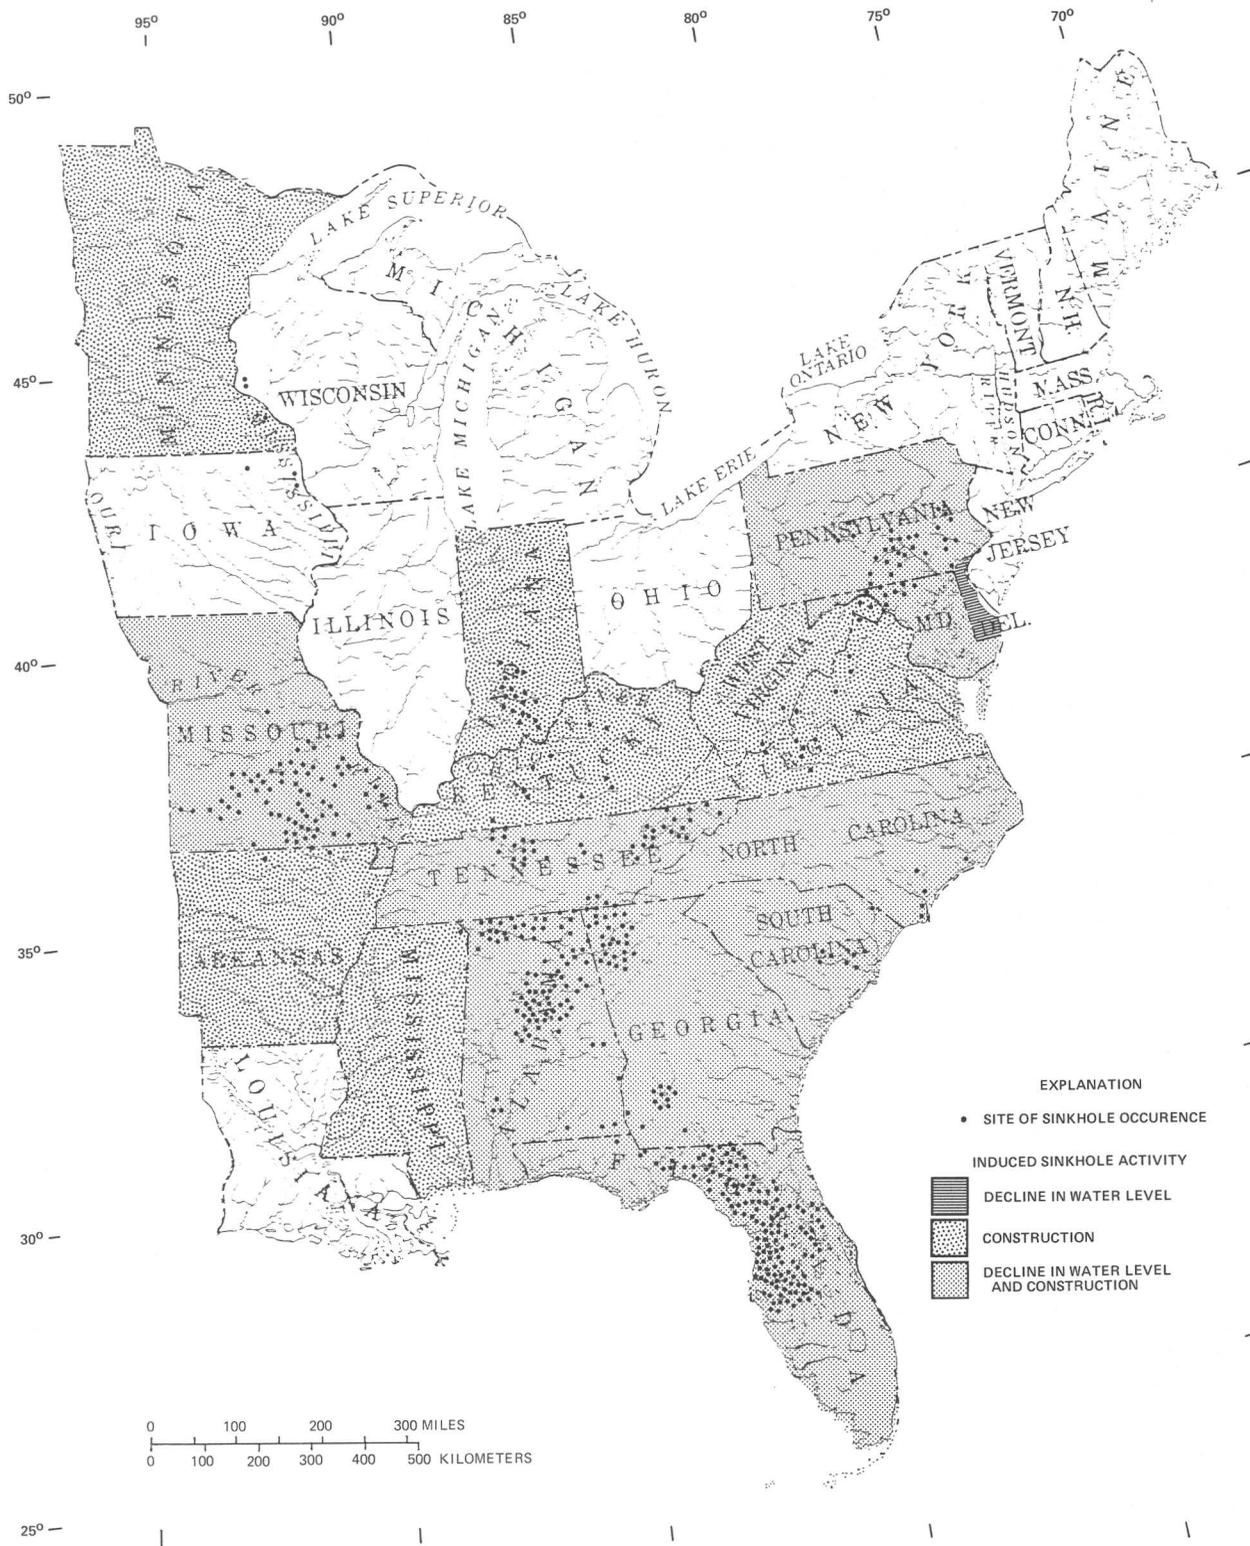
FIGURE 12.—Areas of induced sinkhole activity.

ified by Newton (1976a), who categorized induced sinkholes as those caused by declines in water levels due to ground-water withdrawals and those caused by construction. Sinkholes resulting from construction include those caused by erection of structures, by impoundment or diversion of surface water, and by modifications of the land surface. Types of induced sinkhole activity identified in the States in the area of study are shown in figure 12.

The first recognizable sinkhole activity identified in the literature as resulting from groundwater withdrawals occurred near Sylacauga, Ala., when pumpage from a spring caused sinkholes one-half mile away (Prouty, 1916). The occurrence of this type of activity is not restricted to Alabama. Sites in the Eastern United States in which similar sinkhole activity has been investigated or reported are shown in figure 12, and selected sites are described in table 1.

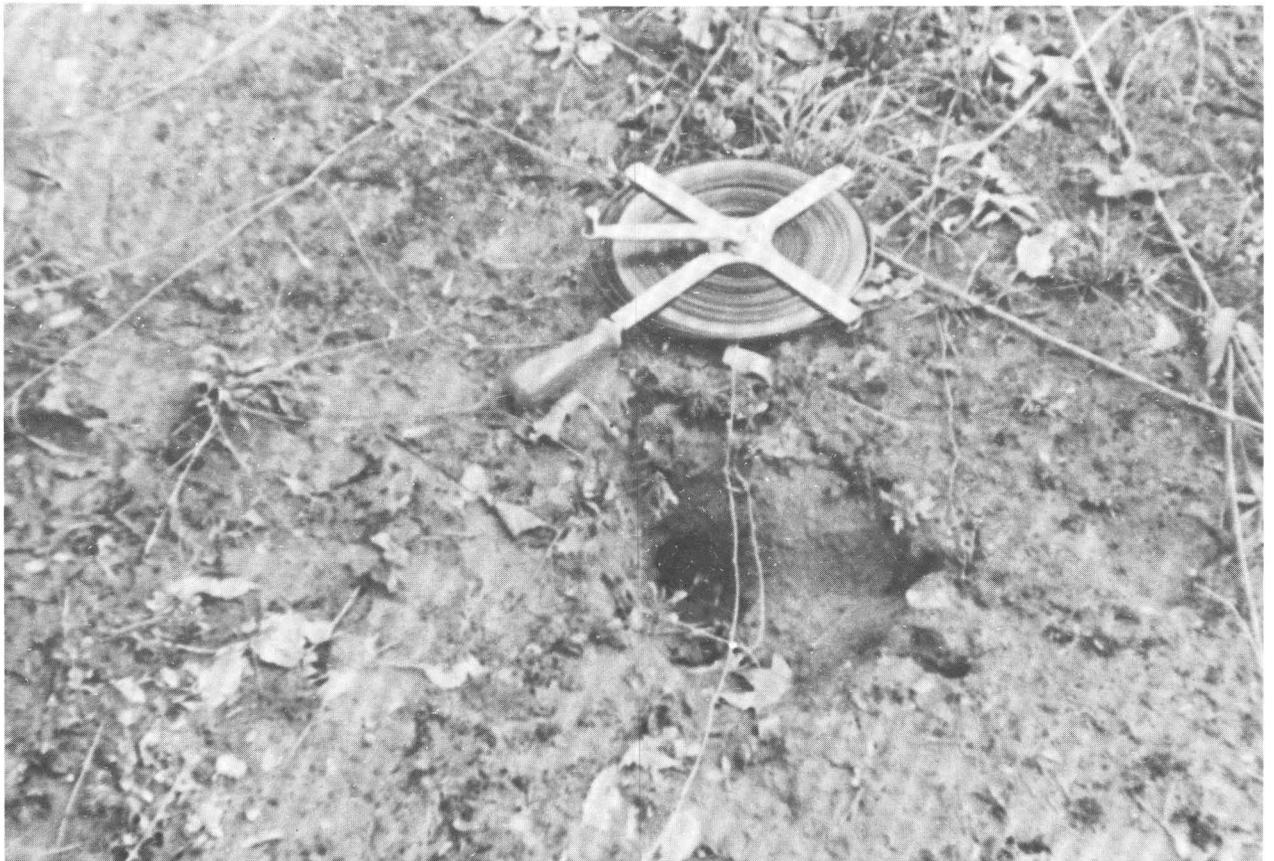
FIGURE 19.—Erosion of soil into rotted-out root opening.

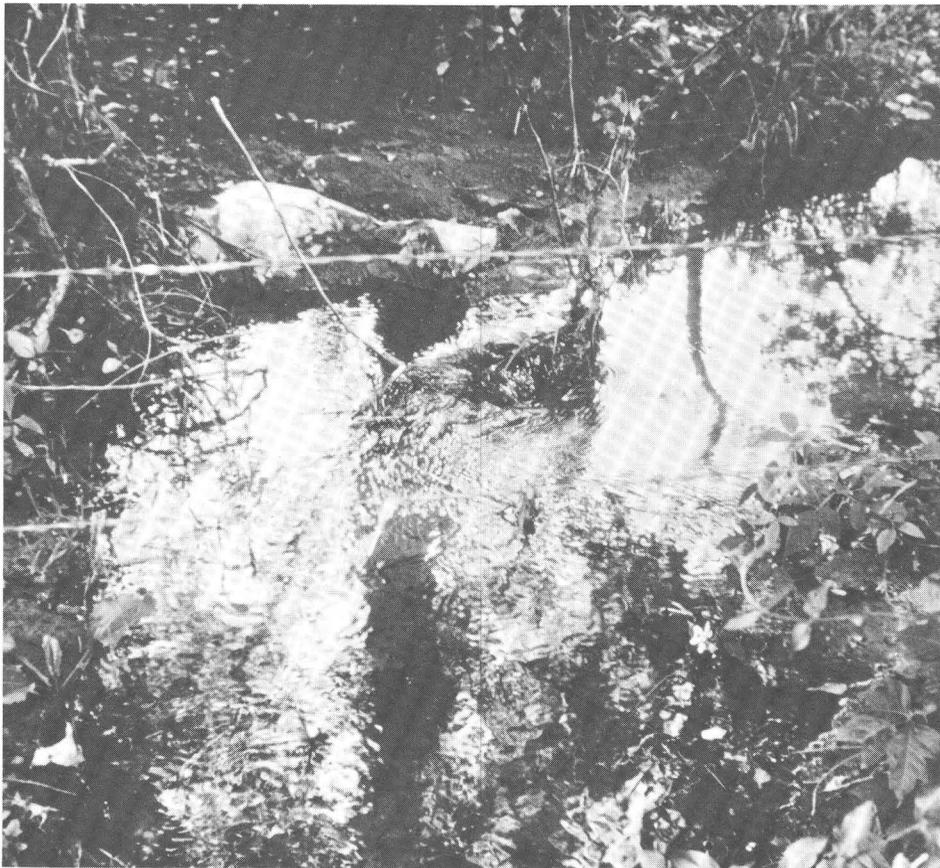
FIGURE 21.—Induced recharge forms vortex in stream in Shelby County, Ala.

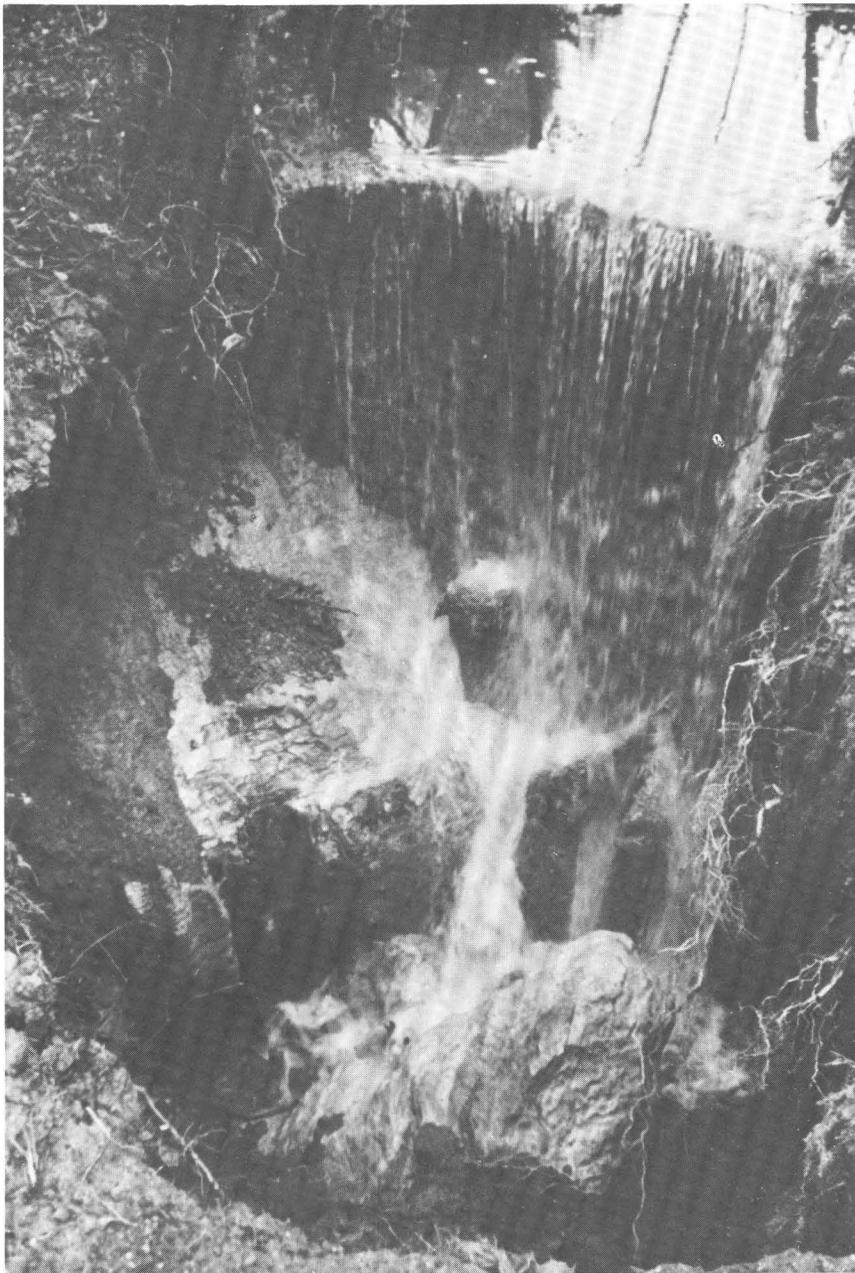
FIGURE 22.—Collapse and loss of streamflow in Shelby County, Ala.

A surface opening and underlying cavity formed by piping illustrated at location 5 in figure 13*B* and in figure 20*B* are the same as those shown in photographs in figures 9, 10, and 11. The process is also illustrated in figures 21 and 22. Figure 21 shows a vortex, or small whirlpool, in a stream caused by induced recharge entering the subsurface where openings in bedrock have been dewatered. The collapse that occurred at the site a few days later (fig. 22) resulted in the loss of

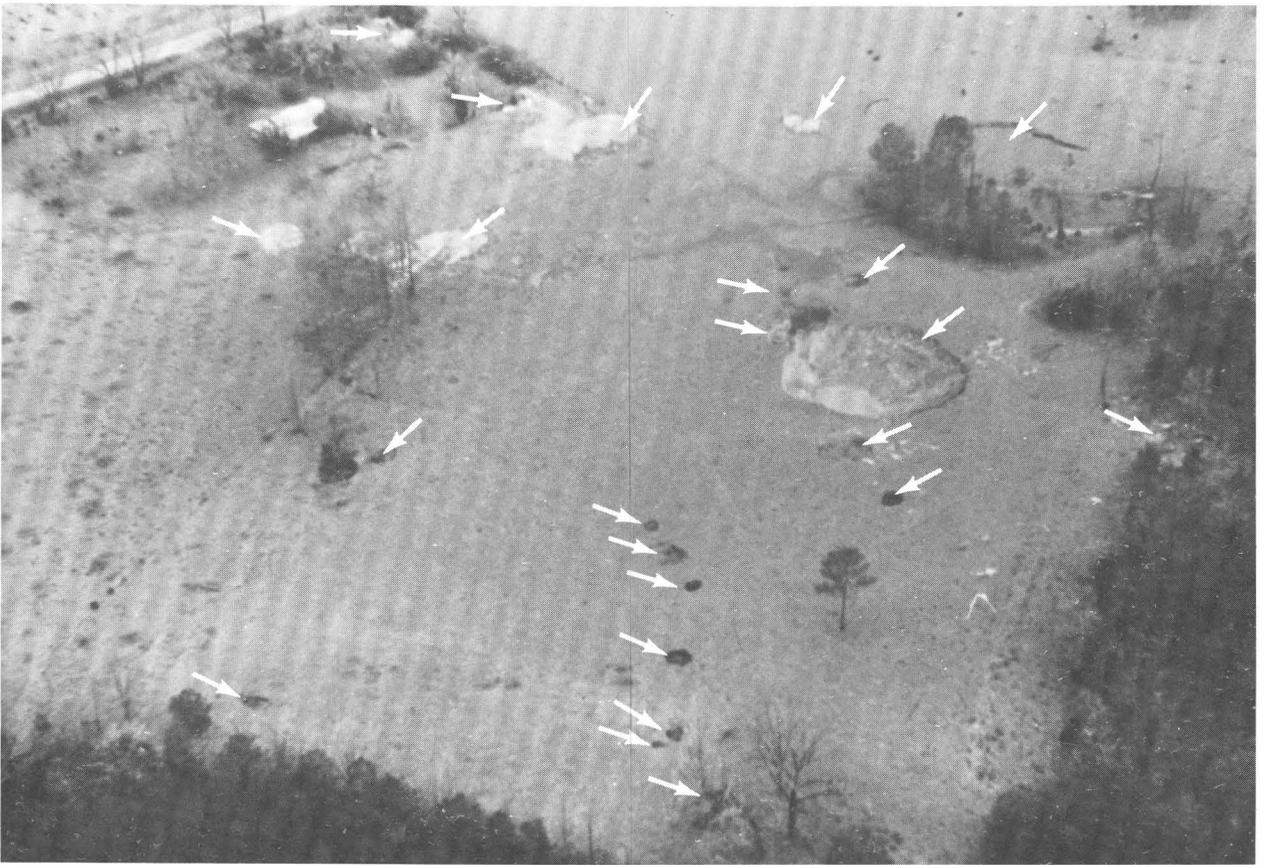
FIGURE 23.—Collapses in open area in Shelby County, Ala. (white areas are repaired collapses). (Photograph by T.V. Stone.)

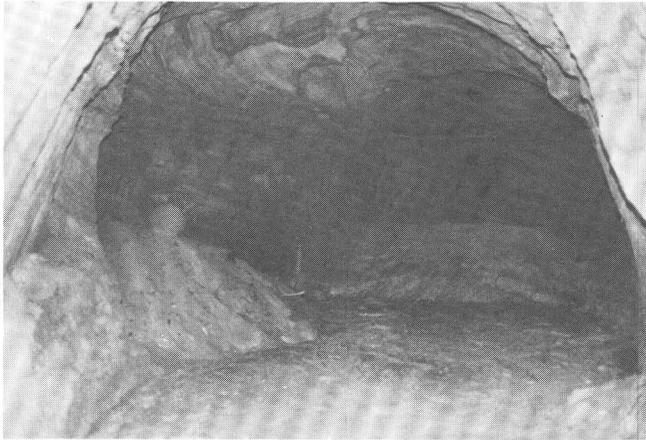
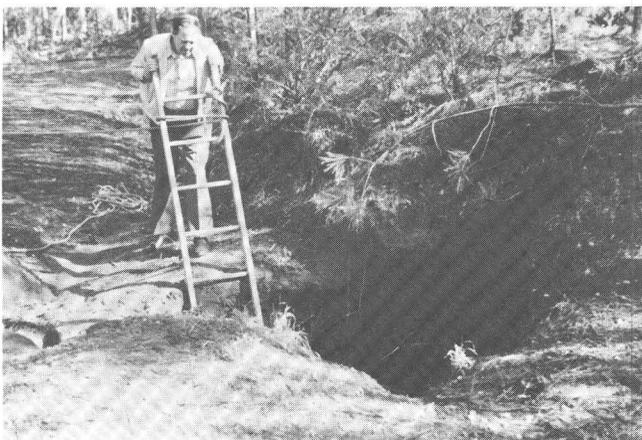
B. Cavity resulting from subsurface erosion

A. Growth and collapse of cavity

C. Tunnel resulting from subsurface erosion

D. Collapse where water enters opening at surface

FIGURE 24.—Growth and collapse of cavity due to piping near Centreville, Ala.

including horizontal tunneling along the top of bedrock and in associated overlying unconsolidated deposits (fig. 24), were also observed.

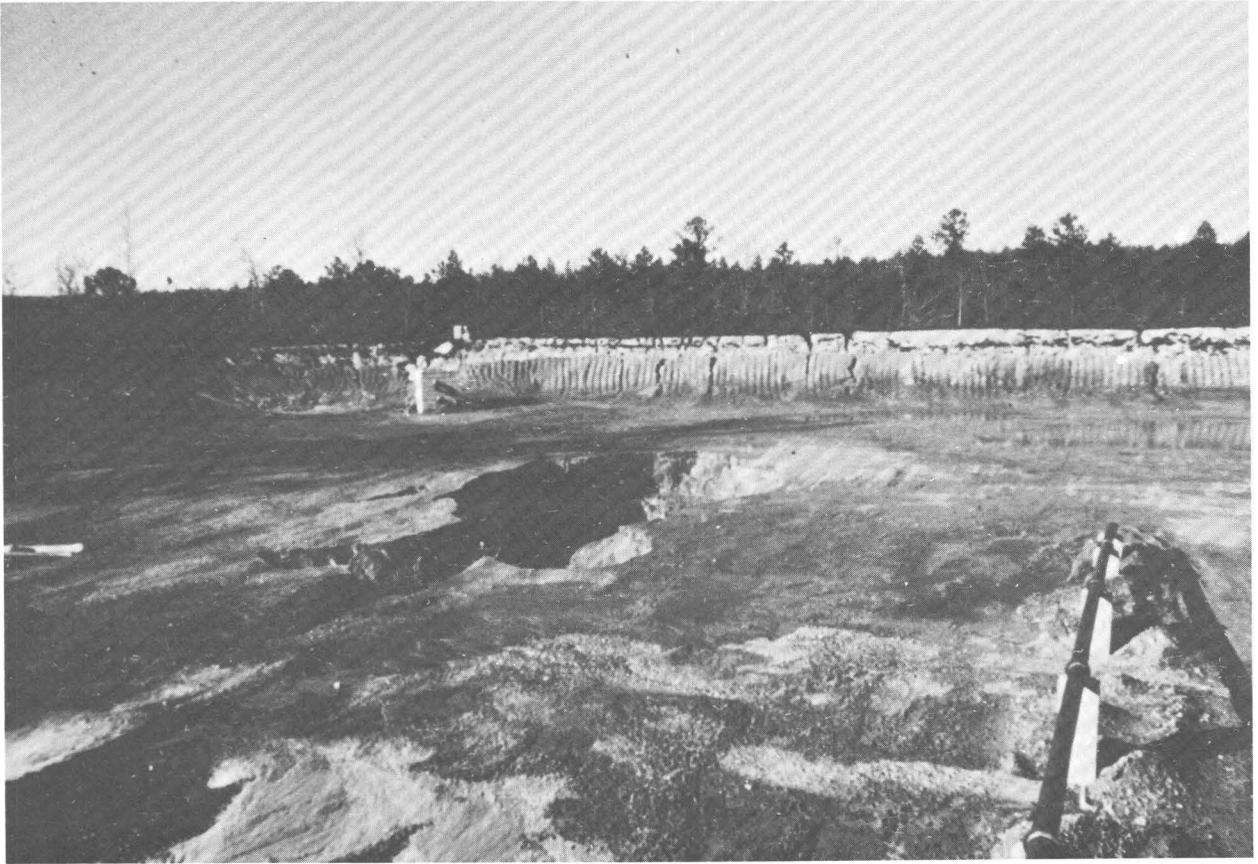
FIGURE 25.—Collapse beneath sewage lagoon in Bibb County, Ala., in 1972.

where the water table is naturally below the top of bedrock and openings at the surface are connected with those in bedrock, a collapse can result from the piping process. Collapses due to saturation and piping causing the draining of sewage treatment ponds in Alabama have been described by Warren (1974). One of these is shown in figure 25.

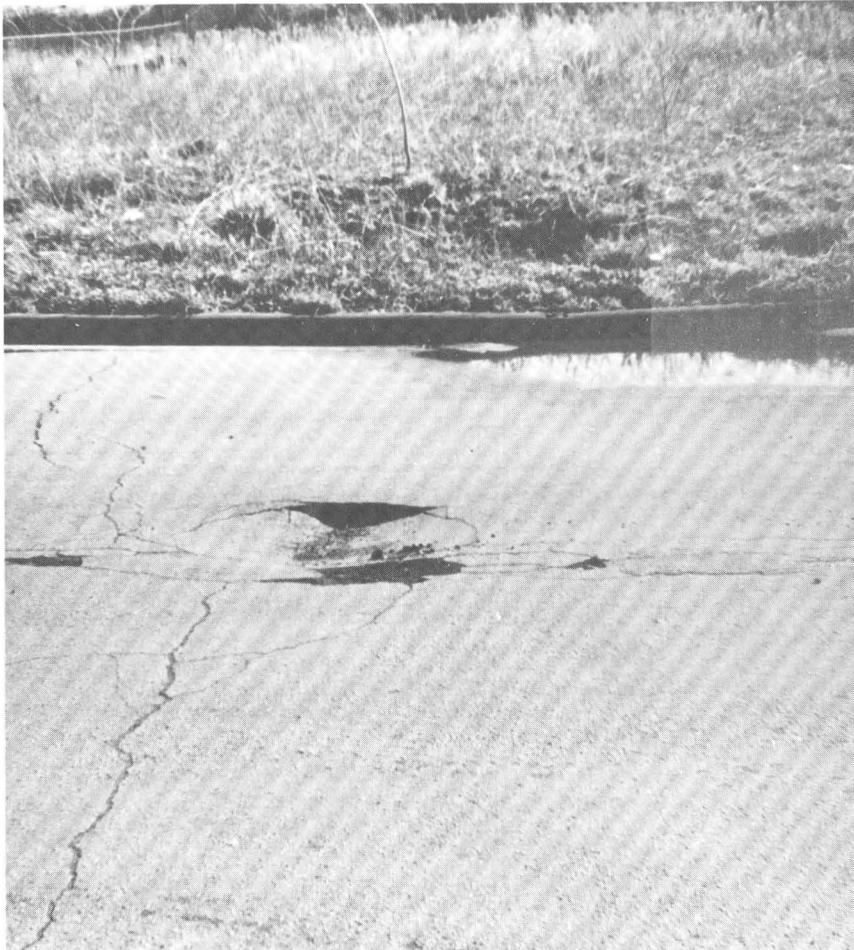
FIGURE 26.—Circular fracture in asphalt.

1. Circular and linear cracks or fractures in soil, asphalt (fig. 26), paving, floors, walls, and foundations resulting from subsidence. These features are often accompanied in buildings by jammed doors and windows. Loud, sharp cracking noises in or under a structure often accompany foundation damage.
2. Formation of depressions in soil or pavement that commonly result in the ponding of water (fig. 27).
3. Slumping, sagging, tilting, or warping of highways, rails, fences, curbing, pipes, poles,

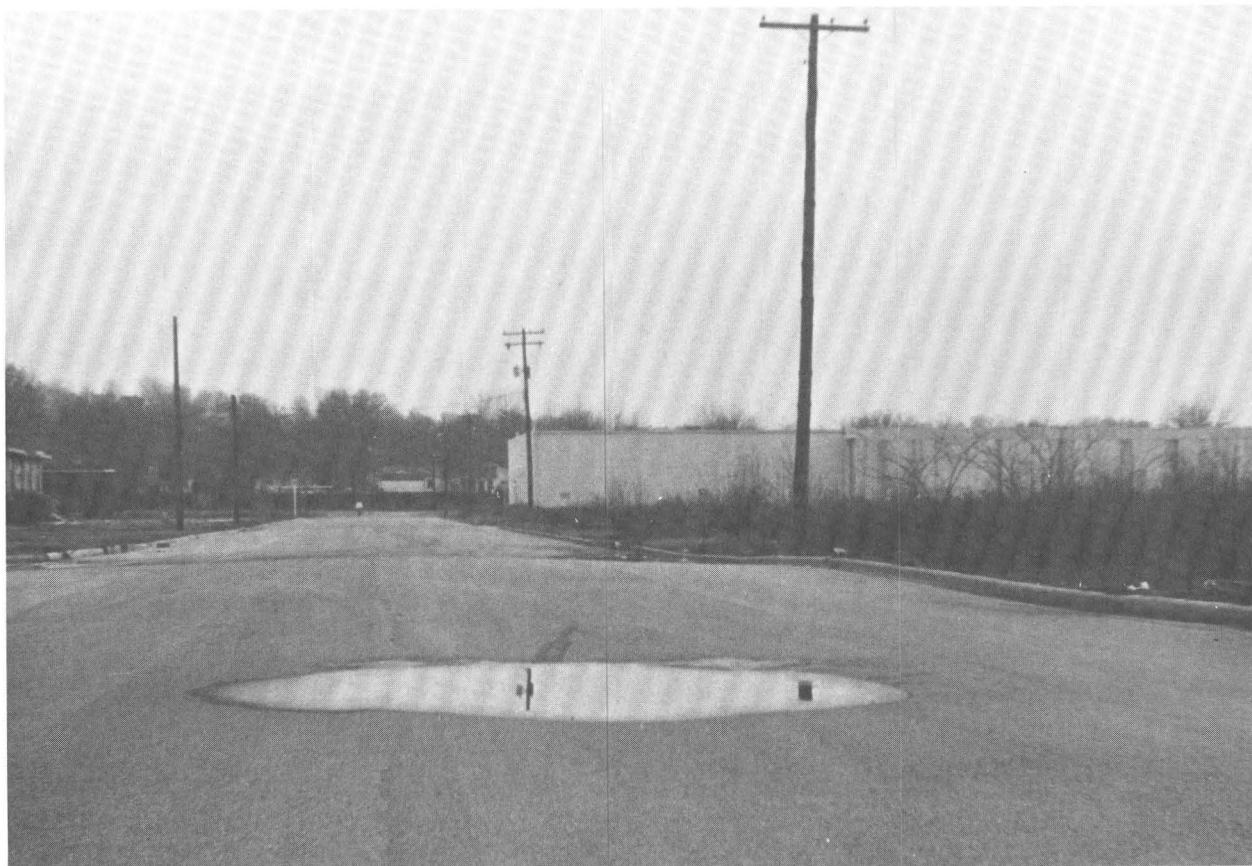
FIGURE 27.—Ponding of water in depression.
