# Landslides of Eastern North America

U.S. GEOLOGICAL SURVEY CIRCULAR 1008

ARTHUR P. SCHULTZ and C. SCOTT SOUTHWORTH, editors

Papers Presented  
at the Southeastern Section  
Geological Society of America  
Symposium, March 26, 1987

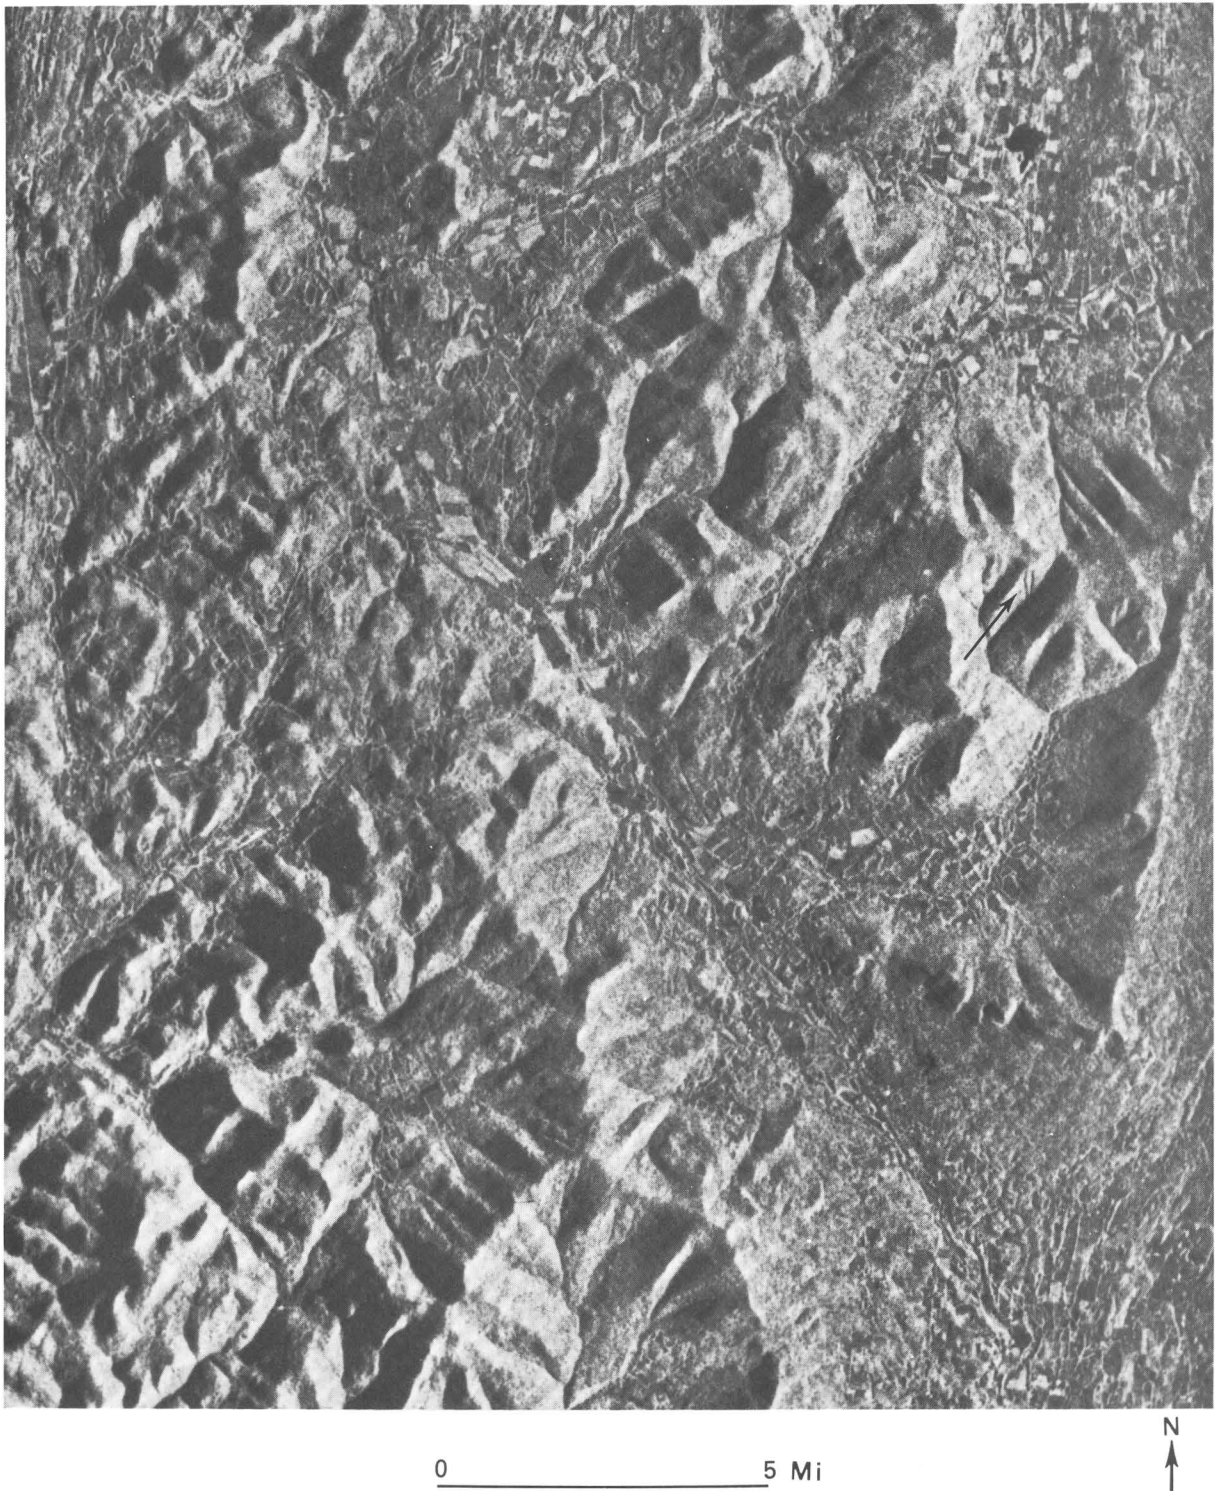
**Figure 1.2.** View of Dorset Mountain slide scars (arrow) as seen on a synthetic aperture radar (SAR) image. The location of this feature is on the east side of the village of Dorset. See figures 1.1 and 1.3.

Standard aerial photographic, synthetic aperture radar (SAR) (fig. 1.2), and some infrared photographic images were examined for evidence of recent slope movements, such as soil slopes with rills and exposed bedrock cliffs ( $>10$  m). In addition, slope configurations indicative of potential failure, such as steep ( $>27^\circ$ ) soil-covered slopes, and evidence of older slope movements, such as old headscarps and hummocky slopes, were identified. Field investigations verified what we saw on the remotely sensed images and also located historic and recent slope movements that were not obvious on the images. Geologic and engineering data, such as areal measurements, thicknesses of slide masses, types of deposit, material types, and estimates of material strength, were collected in the field to help determine the causes and mechanics of failure.

Intense precipitation is the major factor contributing to most of the Vermont slope failures. Heavy rains associated with Hurricane Belle triggered four debris flows on the southern side of Dorset Mountain (figs. 1.1–1.3) in 1976 (Ratté and Rhodes, 1977). Several heavy rainstorms in May and June of 1984, which followed a period of above-normal precipitation, caused numerous slope movements throughout central Vermont as well as other sites around the State. In May 1986, several debris flows and rock falls occurred at Smugglers Notch near Stowe (fig. 1.1) as a result of a late spring storm (Burlington Free Press, 1986).

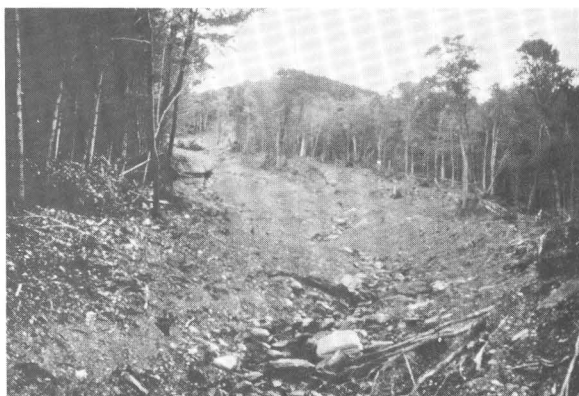
**Figure 1.3.** View of a portion of the 3.5-mile-long debris flow channel on Dorset Mountain.

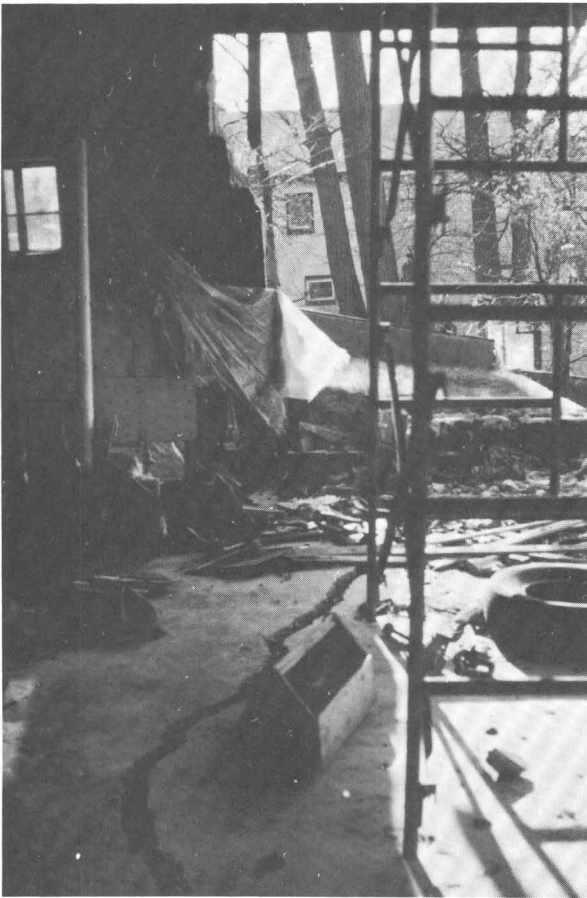
**Figure 2.2.** Slope failure in Patapsco Formation southeast of Baltimore. Note the floor crack in the concrete slab and the slanted trees.

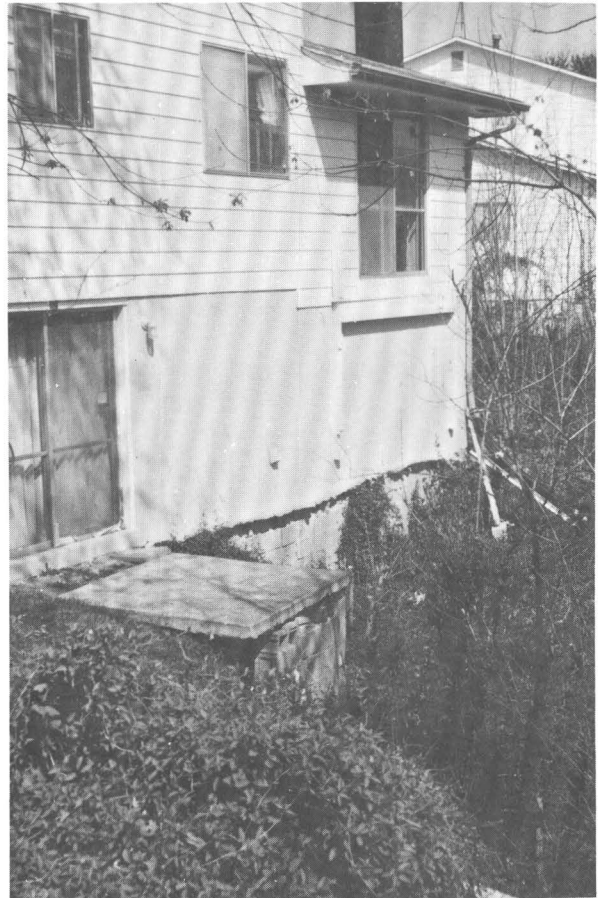
**Figure 2.3.** Failure of Marlboro Clay and overlying fill in backyard south of Washington, D.C.

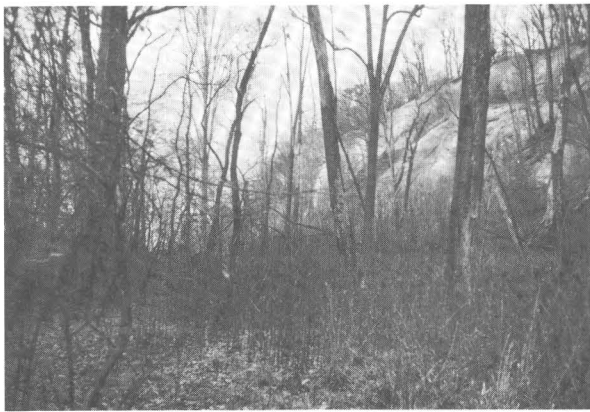
**Figure 2.4.** Slightly tilted old slump surface overlying Potomac Group clay, Elk Neck peninsula at head of Chesapeake Bay. Bare steep slope in background is head scarp.

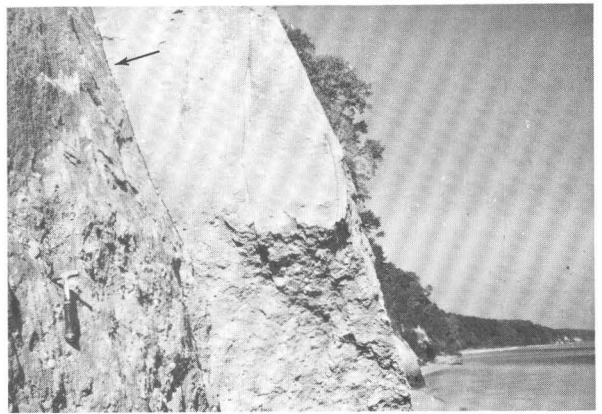
**Figure 2.5.** Steeply dipping stress release joint in fossiliferous silty clay, Chesapeake Group, Calvert Cliffs. Slickensides along joint face indicate planar movement.

The removal of support of the overlying sediments results in a collapse failure. Translational (planar) movements at shallow depths controlled by subvertical stress release joints may result from the failure of the overlying, mainly sandy material. Spalling takes place both above and below the seepage line along subvertical joints dipping steeply toward Chesapeake Bay (fig. 2.5). This process is continuous throughout the year but accelerates during the cooler months when freezing and thawing occur along the joints.

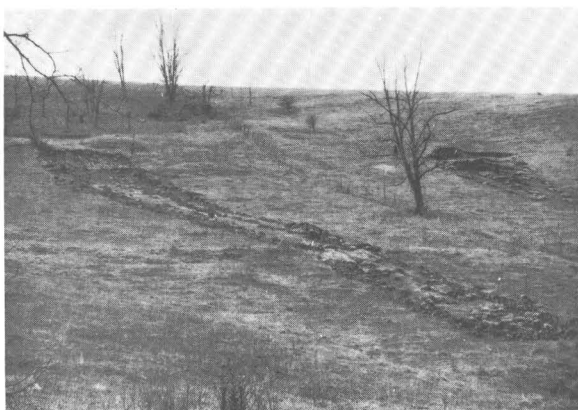
**Figure 4.4A.** Slump-mudflows triggered by the November storm on gentle slopes underlain by fine-grained residuum weathered from the Martinsburg Shale.

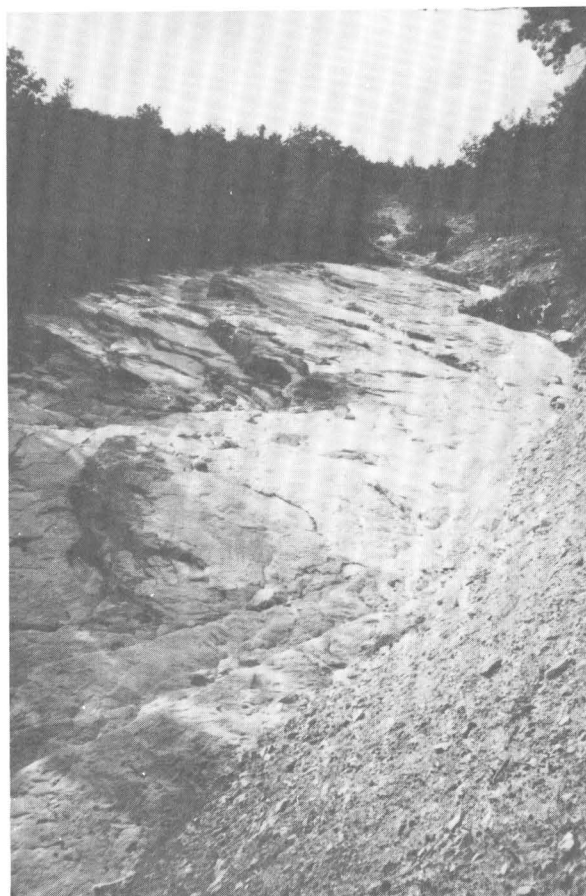
**Figure 4.4B.** Source-area scar of a large debris avalanche in Upper Tract 7.5-minute quadrangle, West Virginia. This failure began on a 36° dip slope underlain by Tuscarora Sandstone.

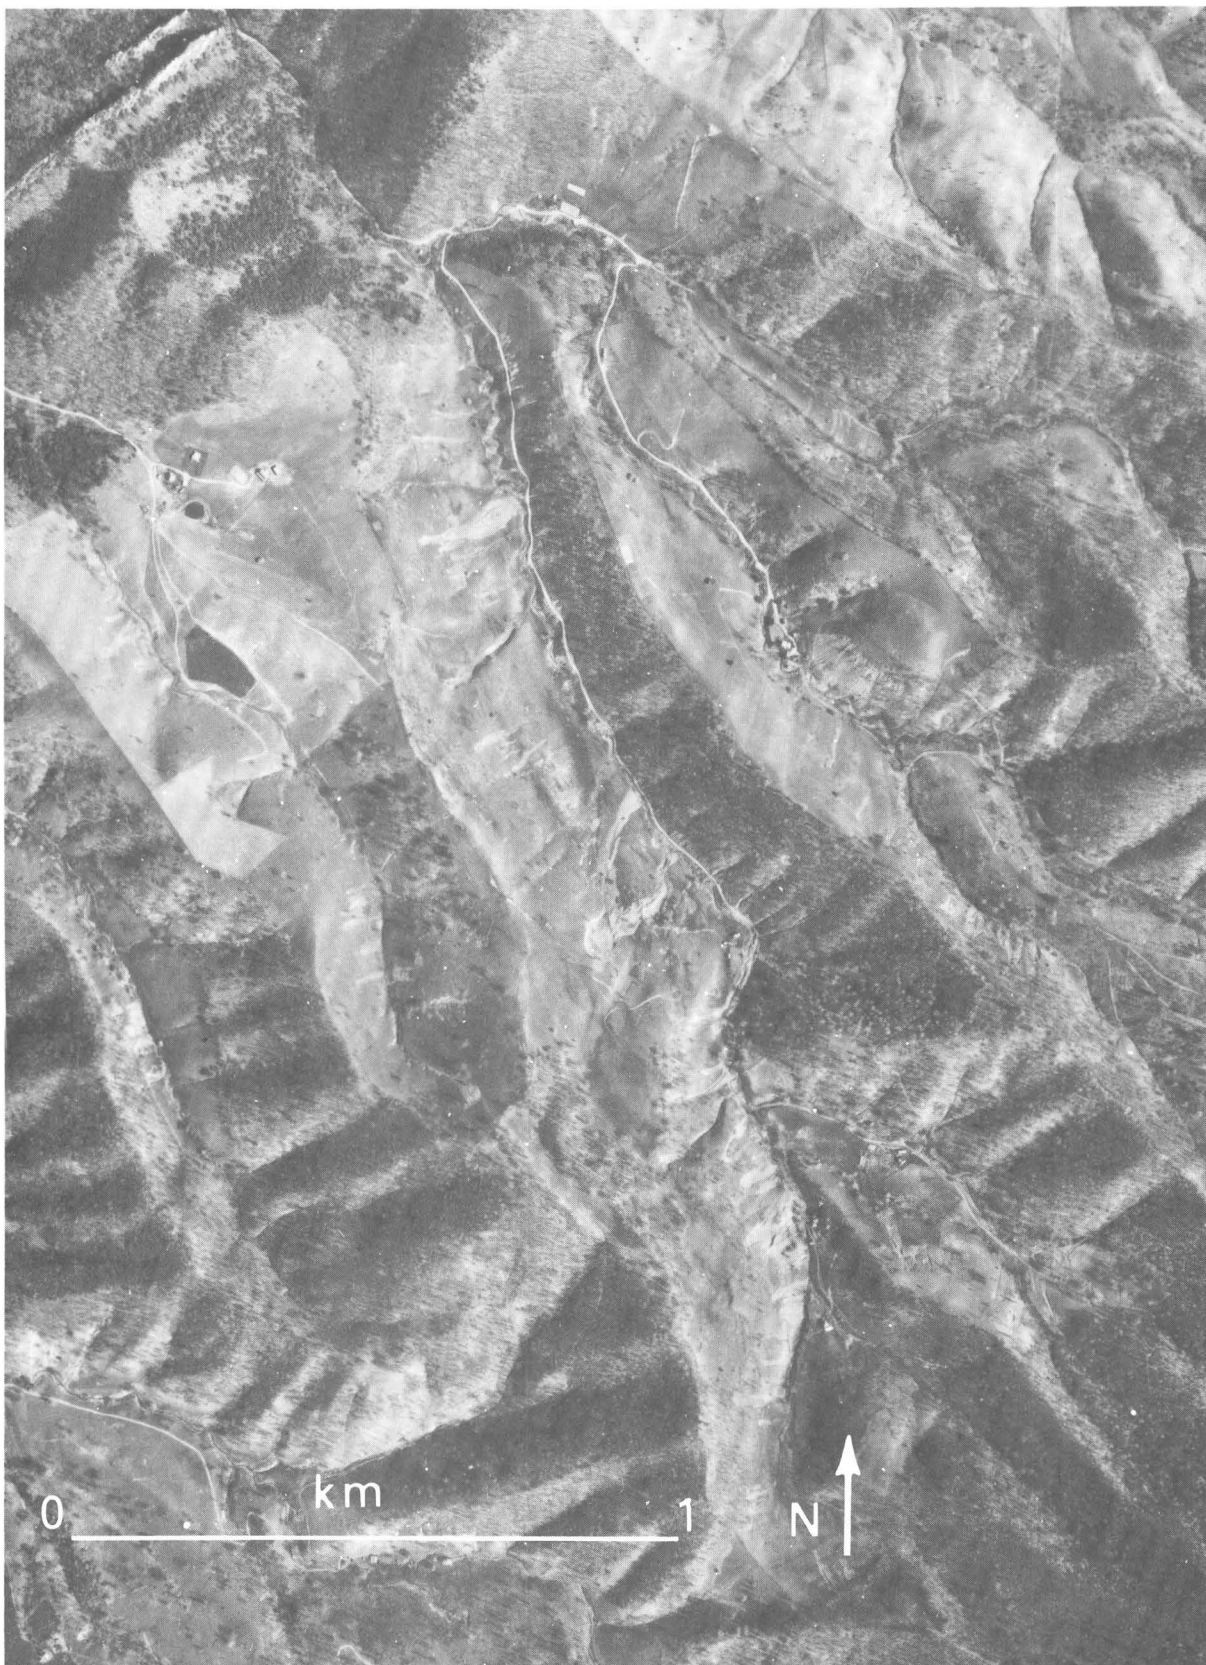
**Figure 4.5.** Aerial photograph of a small drainage basin underlain by Martinsburg Shale in the Circleville 7.5-minute quadrangle, West Virginia. Many failures can be seen on pastured slopes; a high proportion are slump-mudflows that delivered sediment directly to stream channels.

Slumps and slump-mudflows triggered by the November 3–5 storm are abundant on slopes underlain by residuum of the Martinsburg Shale and some slopes underlain by carbonates. The aerial photograph in figure 4.5 shows a small drainage basin in the northern half of the Circleville 7.5-minute quadrangle where failures in Martinsburg Shale residuum are especially numerous. Close inspection of figure 4.5 shows that many slump-mudflows delivered sediment directly to streams, an observation that has led us to hypothesize that stream channel erosion and flood damage are closely tied to upstream slope failures. Preliminary observations also suggest that, for failures triggered by this storm, there are no generally preferred slope aspects and that more failures occurred on pasture land than on forest-covered slopes.

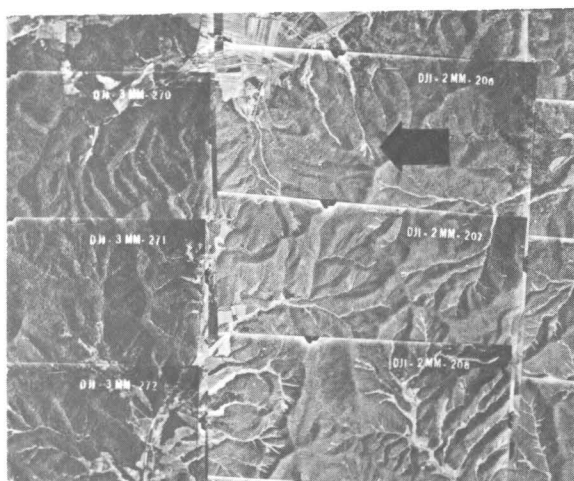
**Figure 5.2.** Index of 1971 aerial photographs of a portion of the Horseshoe Mountain 7.5-minute quadrangle that was affected by debris avalanches induced by Hurricane Camille in 1969. Arrow refers to avalanche chutes in figure 5.3 that are indicated there by the largest arrow.

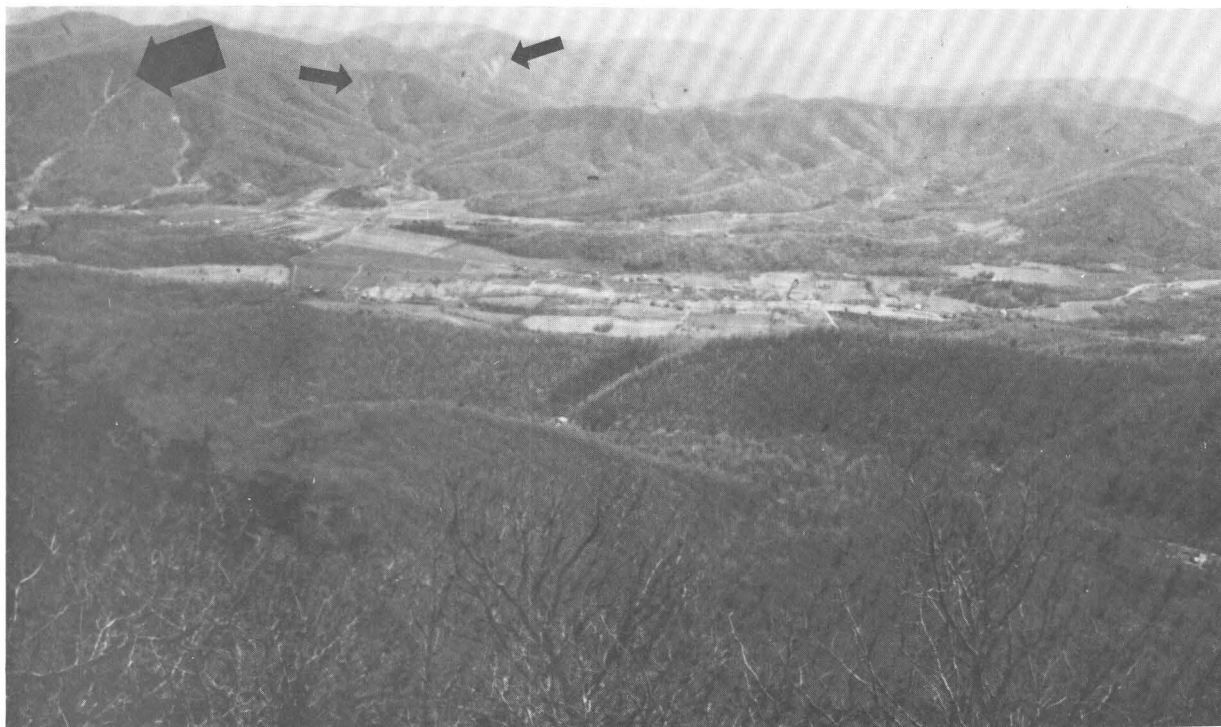
**Figure 5.3.** The Virginia Blue Ridge as seen from Blackrock Mountain at the Wintergreen recreational area (view is southeastward). Arrows point to debris avalanche chutes scoured along naturally steep slopes during Hurricane Camille in 1969. Large arrow denotes same set of avalanche chutes indicated by arrow in figure 5.2.

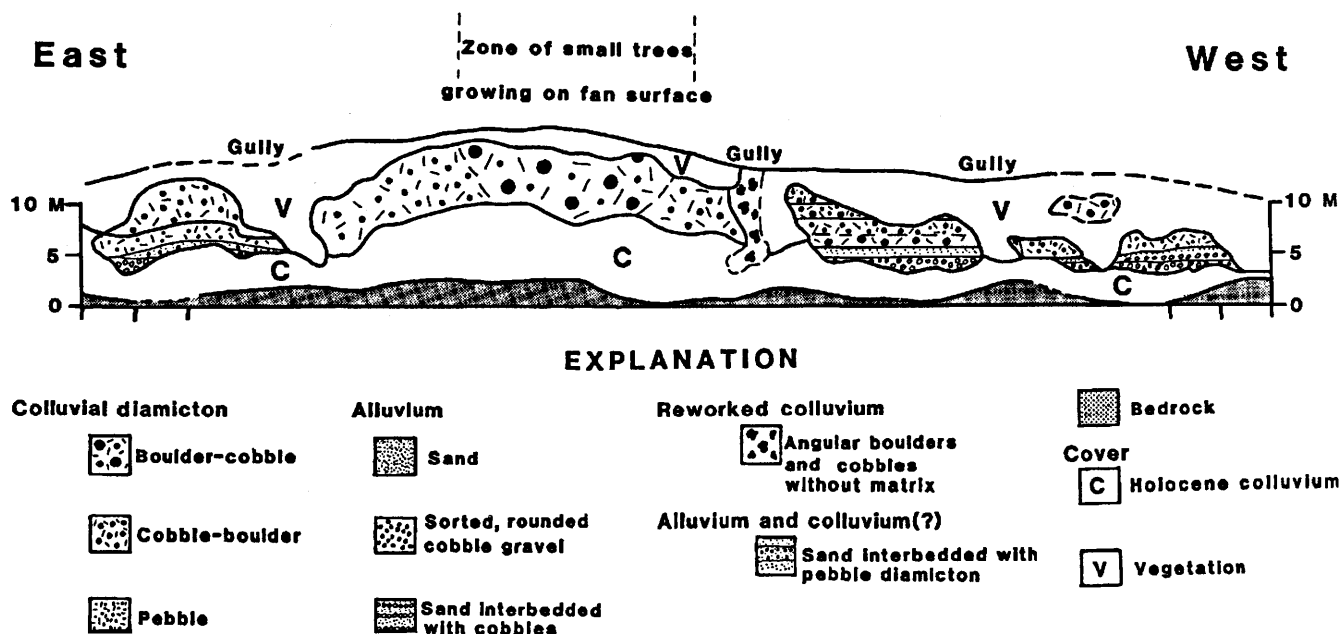
**Figure 8.1.** Stratigraphic cross section of a Quaternary colluvial fan-alluvial terrace complex near Cabins, West Virginia. Top line represents the fan surface; bottom line represents the water level of the North Fork South Branch Potomac River on September 26, 1986. No vertical exaggeration.

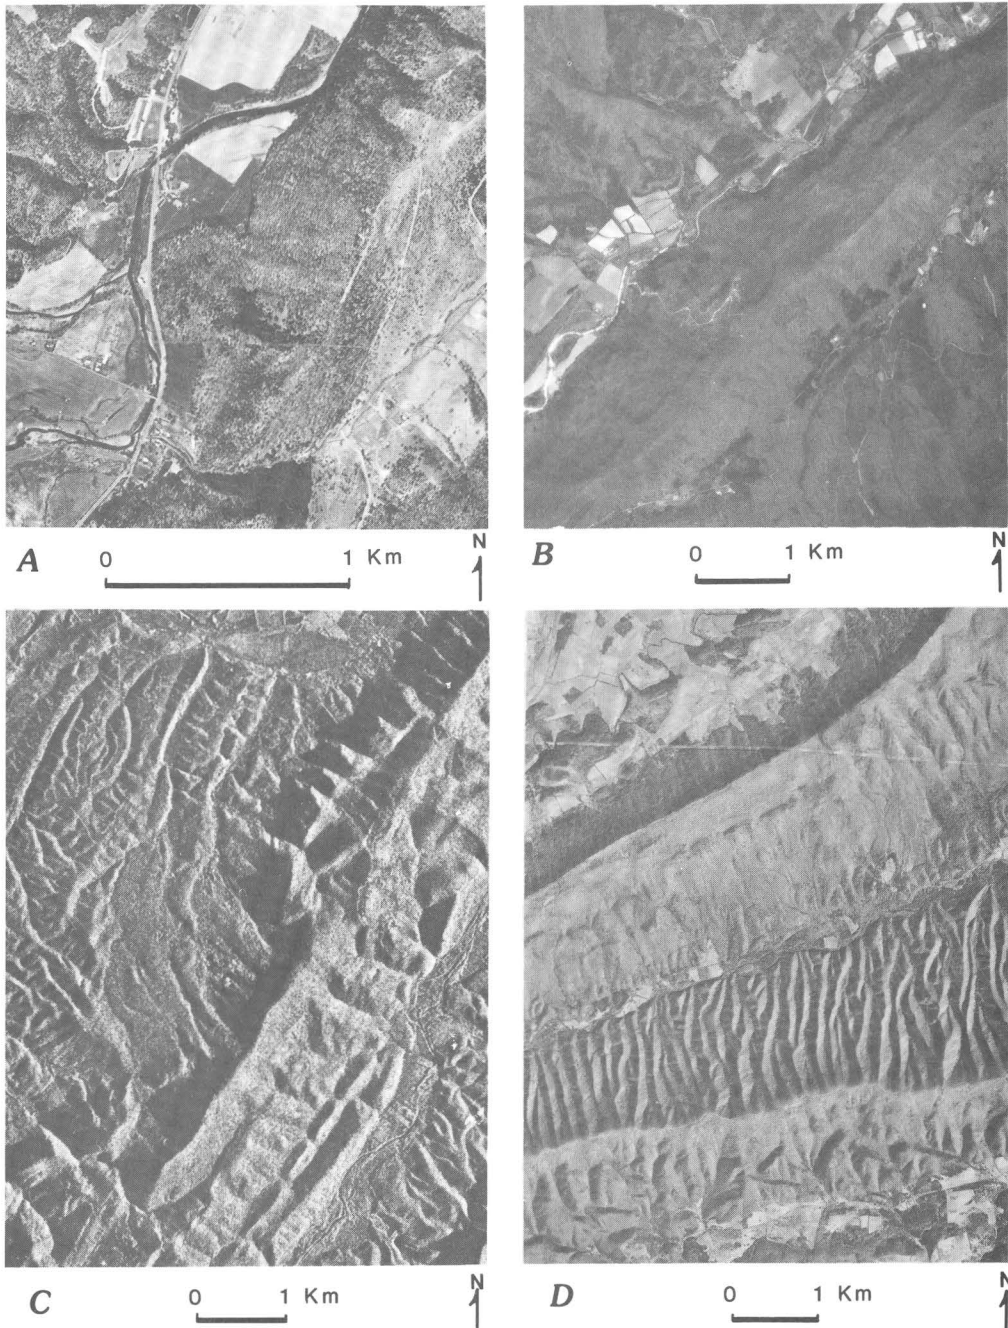
**Figure 9.2.** *A*, Medium-altitude vertical aerial photograph of the Lost River (West Virginia) debris avalanche ( $38^{\circ}57'30''\text{N}$ ,  $78^{\circ}48'\text{W}$ .) (USGS NHAP 83 513-104, acquired April 11, 1984). *B*, Medium-altitude vertical aerial photograph of the Mill Ridge (Virginia/West Virginia) rock slump ( $37^{\circ}39'33''\text{N}$ ,  $80^{\circ}8'\text{W}$ .) (USGS NHAP 80 458-146, acquired April 23, 1982). *C*, Side-looking airborne radar (SLAR) image of Elkhorn Mountain (West Virginia) rock avalanche ( $38^{\circ}57'\text{N}$ ,  $79^{\circ}2'30''\text{W}$ .) (USGS SLAR CAPA 9-70 near-range, acquired September 15, 1982). *D*, Medium-altitude vertical aerial photograph of a portion of the Sinking Creek Mountain (Virginia) rock block slide complex ( $37^{\circ}20'\text{N}$ ,  $80^{\circ}21'\text{W}$ .) (USGS NHAP 80 589-8, acquired April 1, 1982). All data available from the EROS Data Center, Sioux Falls, South Dakota. Approximate scene centers given.

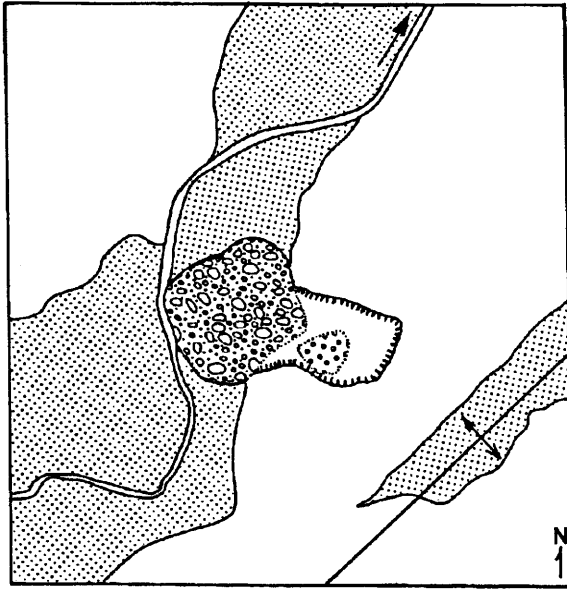
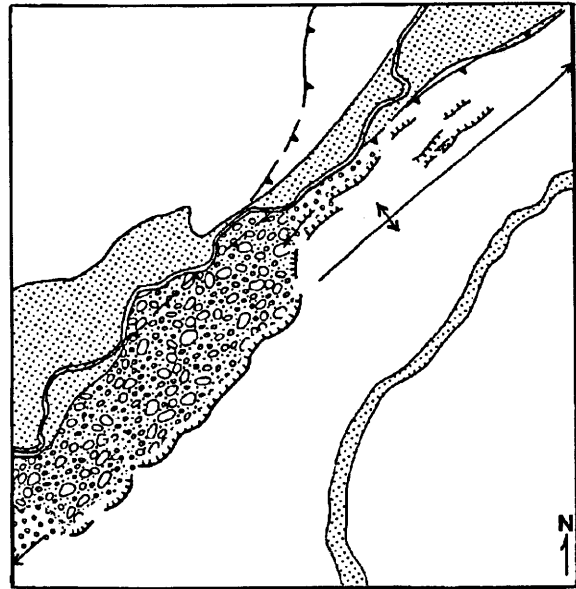
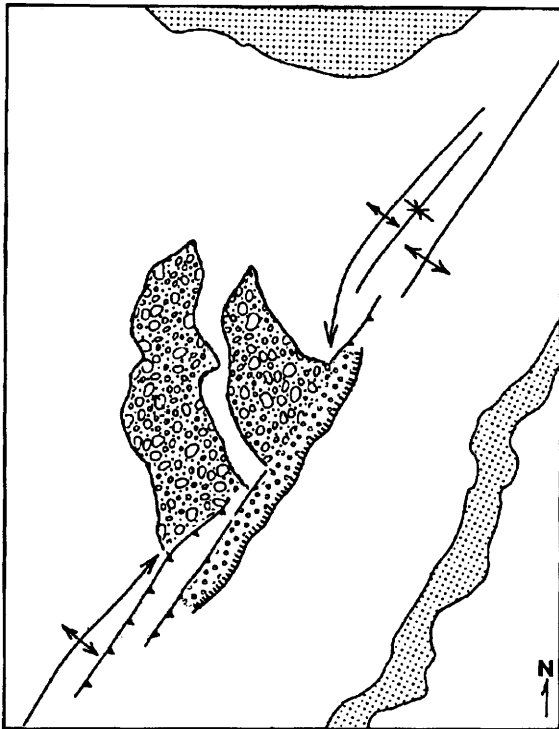
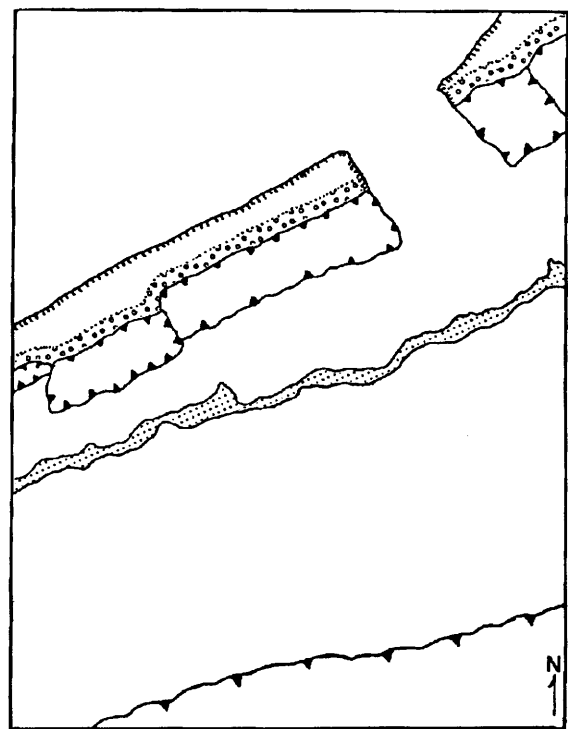
**Figure 9.3.** Generalized geologic maps of the (*A*) Lost River (West Virginia) debris avalanche, (*B*) Mill Ridge (Virginia/West Virginia) rock slump, (*C*) Elkhorn Mountain (West Virginia) rock avalanche, and (*D*) Sinking Creek Mountain (Virginia) rock block slide complex. Each map covers the corresponding area shown in figure 9.2. Bar scales are 1 km.

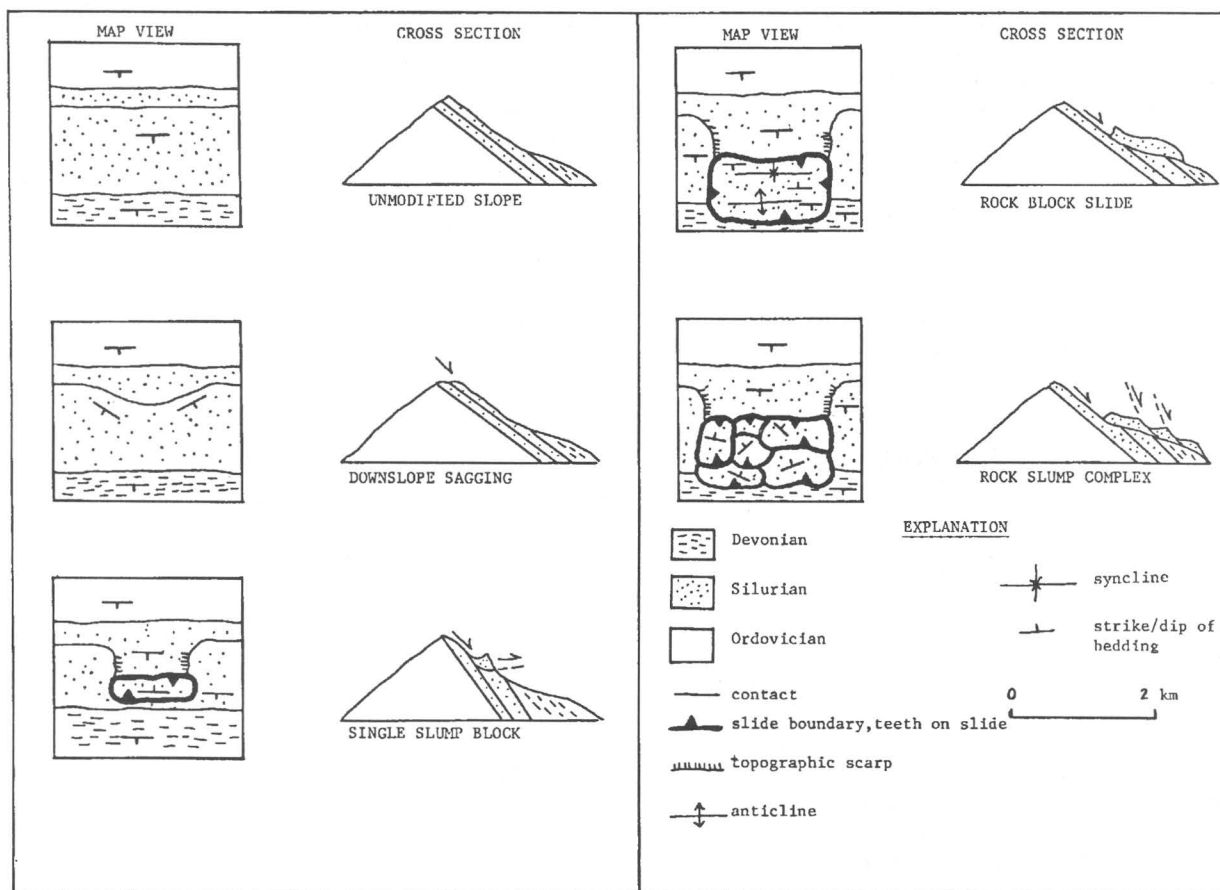
**Figure 10.1.** Schematic maps and cross sections showing various stages of failure of giant rock block slides and slumps.

The kinematics of the giant rock failures can be inferred from the variety of rockslides present in the Valley and Ridge province. Early rockslide failure (fig. 10.1) involves downslope sagging and bulging. Bedding along the toe and outside margins of the slide is folded. Anomalous valleys along the ridge crest form in response to the early separation. These internally drained depressions may have facilitated further instability by increasing the ground water flow along the base of the unstable block. Anticlinal folding of the toe of the rockslide occurs to accommodate shortening. The anticlines are preserved only in rock block slides with minimal displacement. Continued downslope transport of the slides occurred with brittle fracture along lateral break-away scarps. Following these early stages of rockslide failure, two types of rockslides developed: rock block slides or rock slumps. Where dips of beds are relatively high (45 degrees or more), relatively small slump blocks (fig. 10.1) formed with little downslope displacement. During emplacement, possible rotation of the blocks about a horizontal and (or) vertical axis may have resulted in both a topographic and structural reversal high on the dip slope. Where dips are less than 30 degrees, relatively large rock block slides formed that moved downslope as coherent sheets (fig. 10.1). These sheets overrode their folded toes and were folded as they slid across the detachment and shear plane and eventually across the preexisting erosion surface of the lower slope. In some cases, the frontal sections of the rock block slides were further modified by later rock fall and rock slumping. In other cases, formation of large slump complexes (fig. 10.1)

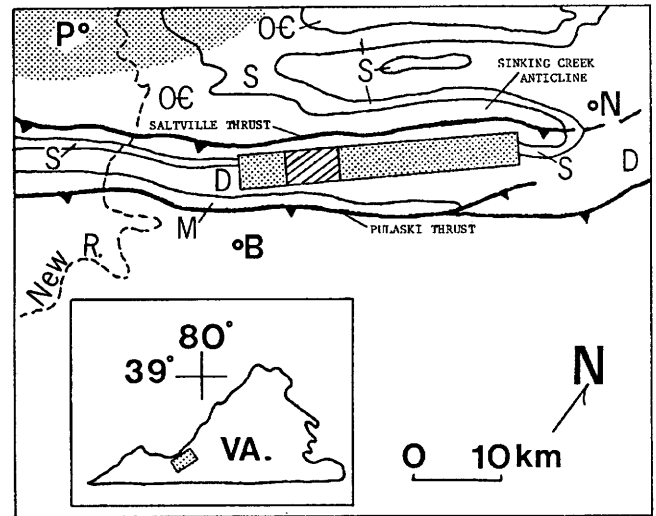
**Figure 16.1.** Regional index map and geologic map of the Sinking Creek slide complex. Circles with letters are B, Blacksburg, Virginia; N, Newport, Virginia; and P, Pearisburg, Virginia. Age designations are M, Mississippian; D, Devonian; S, Silurian; Oe, Ordovician through Cambrian. Dot pattern in rectangle is extent of Sinking Creek slide complex; diagonally ruled area shows location of area in figure 16.2. Dot pattern in upper left corner is part of Giles County seismic zone.

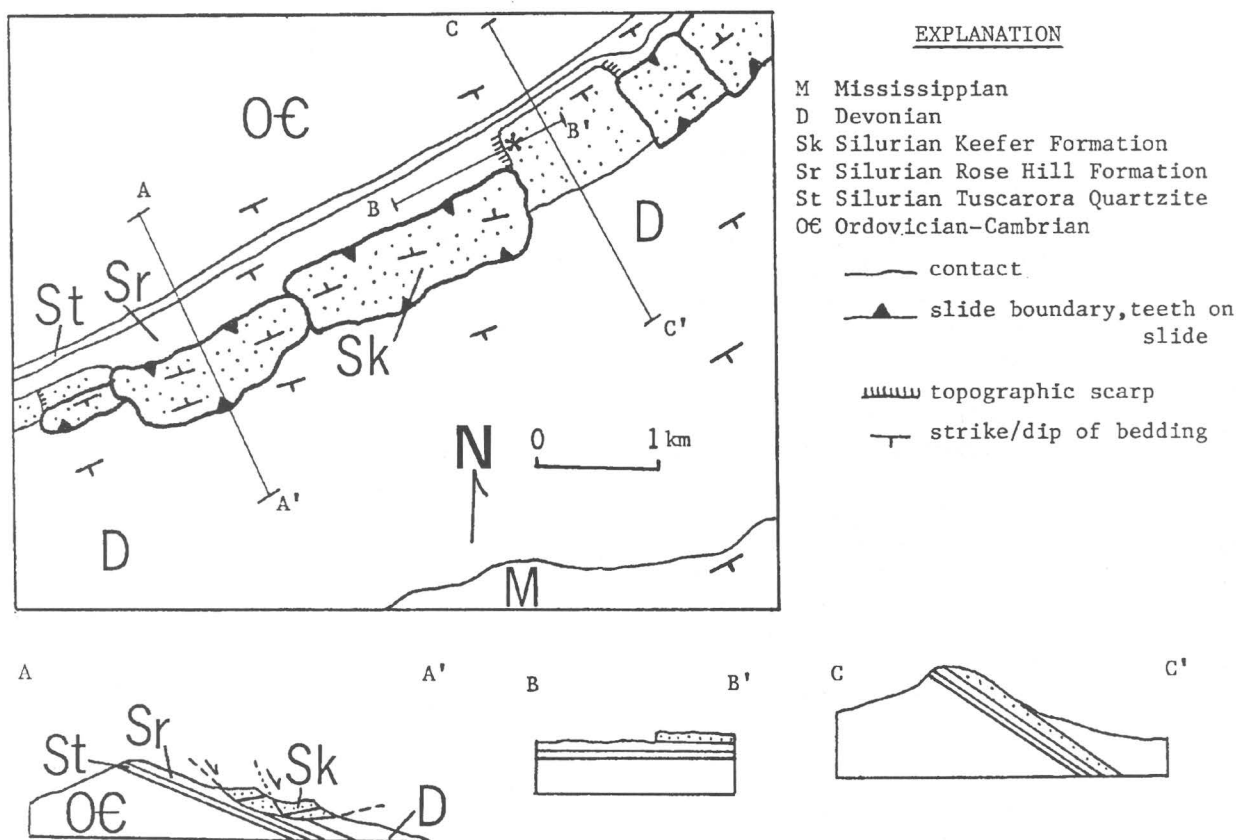
Figure 16.2. Geologic map and cross sections of a portion of the Sinking Creek slide complex that is seen from stop 3.

The topographic, structural, and stratigraphic data suggest that large sections (100 to 500 million cubic meters) of the southeast flank of Sinking Creek Mountain detached along bedding planes and joints and slid downslope. Initial detachment was probably near the Rose Hill-

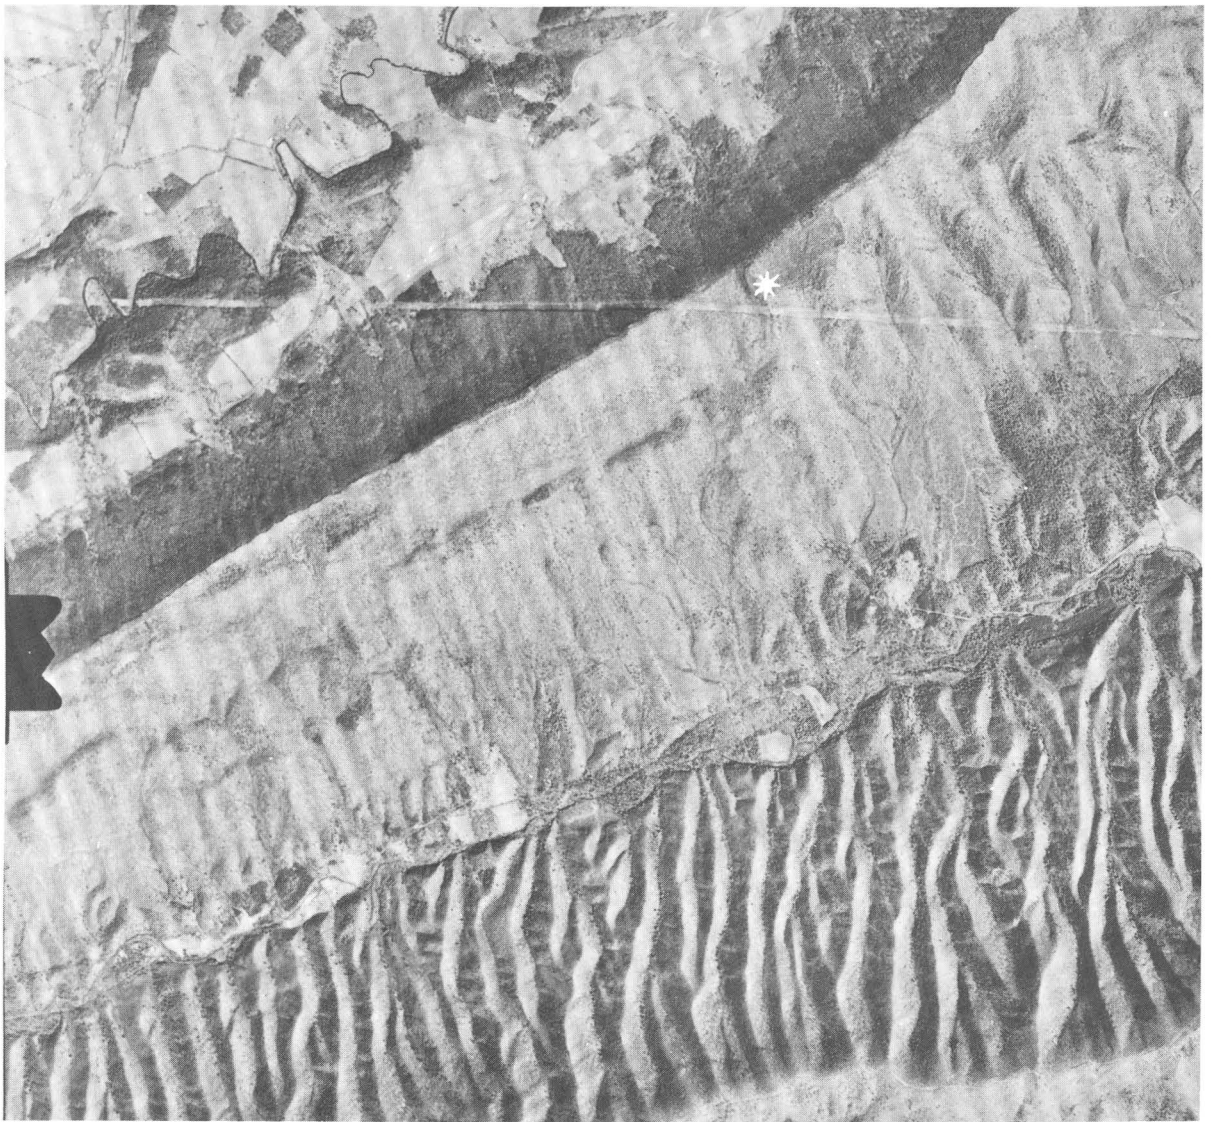
**Figure 16.3.** Aerial photograph of area in figure 16.2. Asterisk on photograph is in same position as on figure 16.2 near the power line.
