GEOMORPHIC CHANGES ON THE MISSISSIPPI RIVER  
FLOOD PLAIN AT MILLER CITY, ILLINOIS, AS A RESULT OF  
THE FLOOD OF 1993

By Robert B. Jacobson and Kevin A. Oberg

Floods in the Upper Mississippi River Basin, 1993

U.S. GEOLOGICAL SURVEY CIRCULAR 1120-J

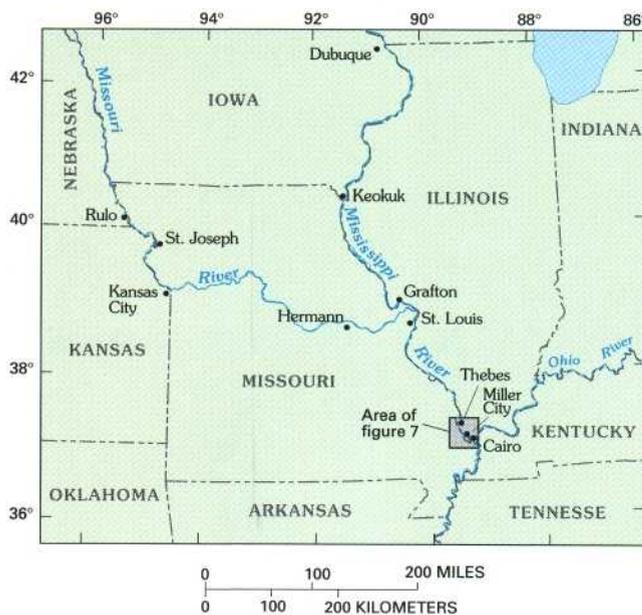
Figure 1. Part of the upper Mississippi and Missouri Rivers.

Downstream from the junction of the Ohio and the Mississippi Rivers (fig. 1), the magnitude of the flood was not severe because of low flows on the Ohio River in July and August 1993.

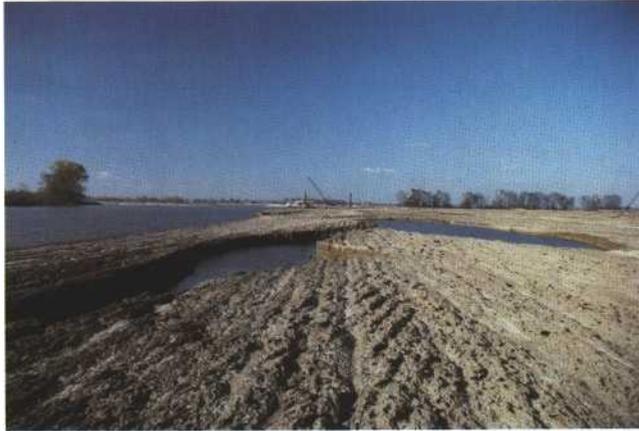
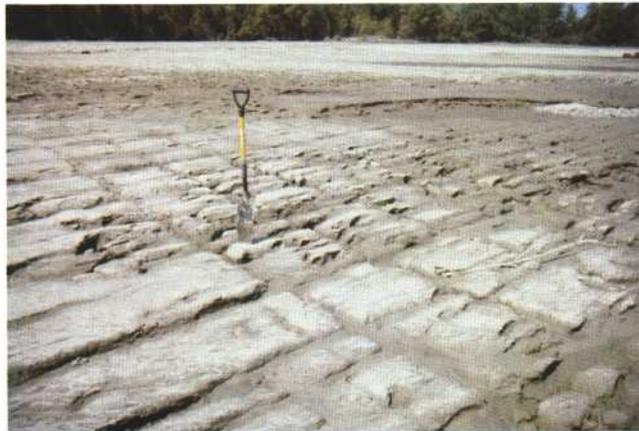
Downstream from the levee break, the scour zone is skirted with a zone where erosion generally is less than 50 cm deep. This zone is referred to as the “stripped zone” (figs. 2, 3) because the plow horizons and rooted horizons of the soil are typically stripped,

which leaves less erodible B-horizons and plow pans. Stripped zones commonly have shallow, rounded scours near their upstream margin and are characterized by abundant grooves (fig. 3). Some grooves are parallel to flow directions and seem to have been carved by debris carried by the floodwaters, whereas other grooves are evidently related to preexisting weaknesses in the soil, such as those caused by plowing (fig. 3).

**Figure 3.** Examples of stripped surfaces from the Miller City, Illinois, levee-break complex. A, Flow was toward the viewer; B, Flow was from left to right; with grooves.

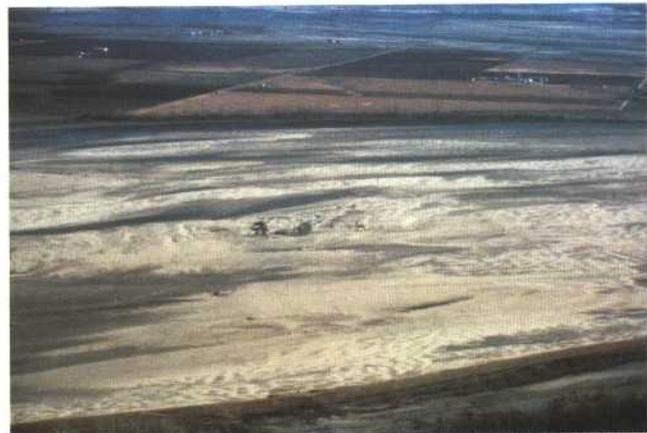
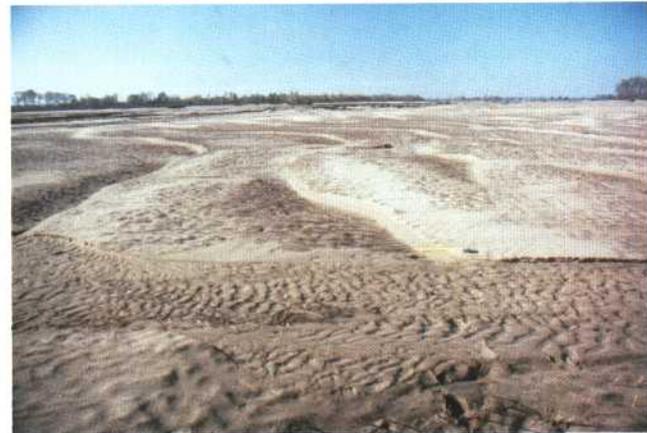
current ripples; commonly, areas of dunes and current ripples are draped with mud that was deposited during recession of the floodwaters or by subsequent floods (fig. 4). Extensive areas of the flood plain used for agriculture were covered with sand deposits, some of which were as much as 4 m thick; according to Vance (1994), some sand deposits were as much as 6 m thick on the Missouri River flood plain. Mud deposition seemed to be minor in extent. Mostly, mud was left as thin deposits in eddies or slackwater areas or was deposited during recession of the floodwaters in low areas that existed before the flood. The geomorphic effects of mud deposition were minor.

**Figure 4.** Sand dunes on the Missouri River flood plain between Kansas City and Hermann, Missouri, and in the Miller City, Illinois, levee-break complex. A, Missouri River Flood plain between Kansas City and Hermann, Missouri. View is to the north; flow was from left to right; B, Miller City, Illinois, levee-break complex. View is to the northwest; flow was from right to left.

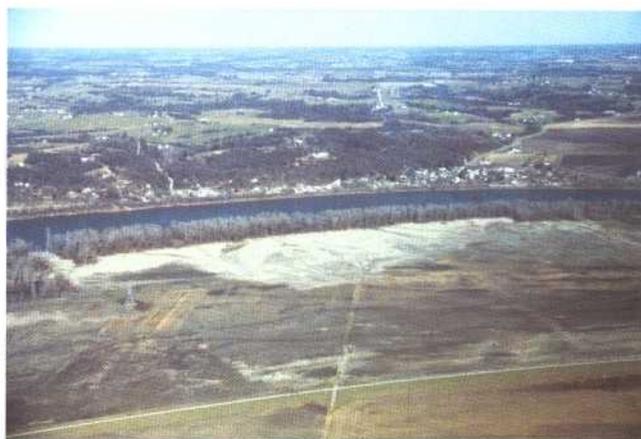
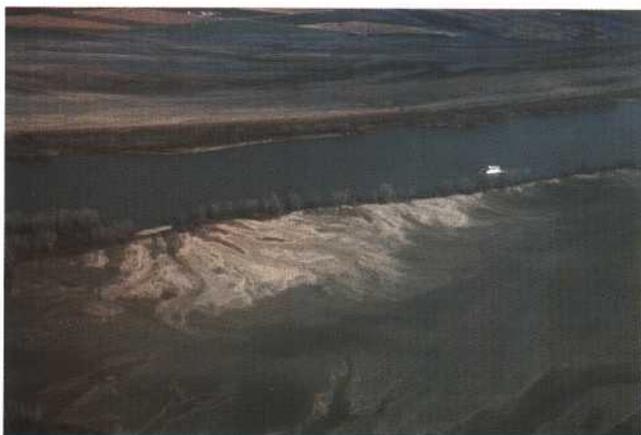
Scour zones and sand deposits in levee-break complexes are by far the most dramatic geomorphic effects of the 1993 flood. In contrast, geomorphic changes in nonleveed areas consisted of minor bank erosion and sedimentation in natural levees and crevasse-splay features (fig. 5). Natural-levee sedimentation was prominent in nonleveed bank areas with dense woody vegetation. Crevasse-splay features, which consist of a scour (crevasse) and associated sand deposits (splay), are similar but much smaller natural analogs for levee-break complexes. Crevasse splays occur where a weakness in the natural levee, or flow concentration, results in erosion of a crevasse channel through which sediment is transported from the channel onto the flood plain (Collinson, 1978).

**Figure 5.** Natural levee and crevasse splays on the Missouri River flood plain between Kansas City and Hermann, Missouri. A, Natural levee; B, Crevasse splay.

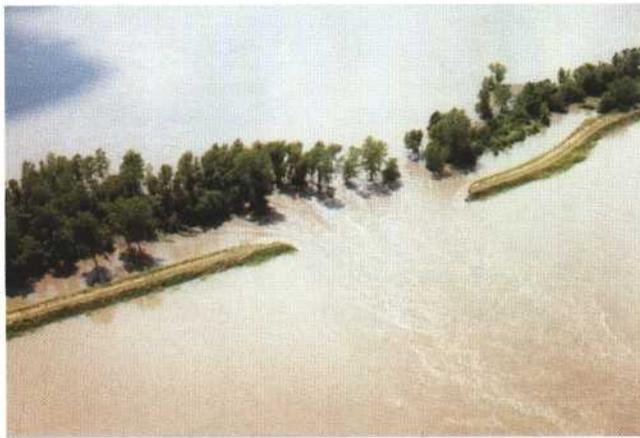
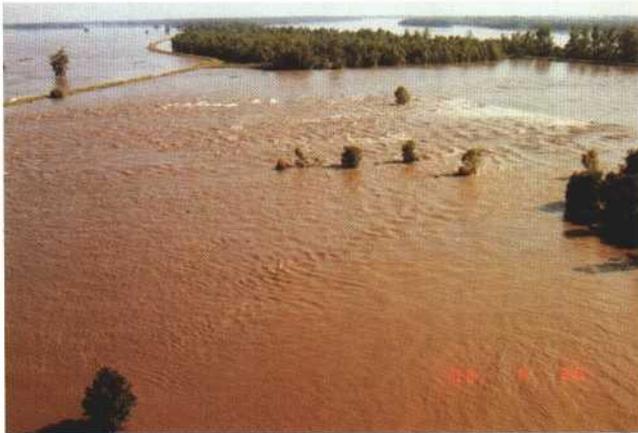
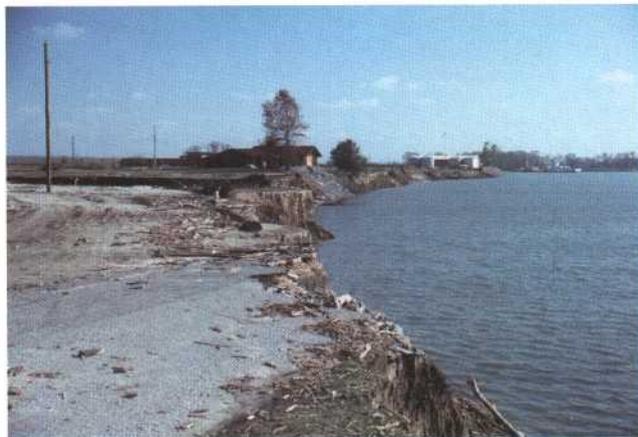
The levee broke on July 15, 1993, at about 1:00 p.m. local time. According to anecdotal evidence from several witnesses, the levee was inspected 15 minutes before the break. At the time of the break, the water level on the channel side of the levee was estimated to be as much as 2 m below the levee crest. [For comparison, at the U.S. Geological Survey (USGS) streamflow-gaging station at Thebes, which is about 16 km upstream, the daily mean stage was 104.68 m on July 15; on July 20 and August 7, the daily mean stage at Thebes peaked at 105.24 m (table 1)]. An eyewitness related that a loud noise drew his attention at 12:50 p.m. When he looked at the levee from a distance of about 500 m, he saw a near-horizontal, 15- to 30-cm-diameter fountain of water gushing out of the side of the levee. The hole quickly enlarged, and a section of the levee failed. As the levee eroded and widened, water began to fill the area between the main levee and a cross levee (fig. 8A). During the first few days after the break, flow through the break was extremely turbulent (fig. 9) with standing waves<sup>1</sup> that were about 1 m high.

**Figure 9.** Miller City, Illinois, levee-break complex. *A*, Turbulence at northern end (Illinois Department of Transportation); *B*, Turbulence and vortices in center (Illinois Department of Transportation), and; *C*, Northern margin of main scour, October 1993.

After the cross levee was breached, flow through the main levee was concentrated in the 1820 channel, and floodwater that moved through the secondary scour immediately downstream of the cross levee (location A, fig. 8A) reversed direction and flowed northeastward. By July 26, flow was 5,570 m<sup>3</sup>/s from the Mississippi River main channel into the break, and 8,000 m<sup>3</sup>/s of flow was measured near the peak discharge on August 7. From July 17 through August 10, the northern (left) bank of the main scour eroded laterally more than 60 m (location B, fig. 8A). In the process, more than 680 m of a county road was removed, as well as a house, a machine shed, and the front yard and front porch of another house (fig. 9).
