# Open Skies Aerial Photography of Selected Areas in Central America Affected by Hurricane Mitch

U.S. Geological Survey Circular 1181

**By Bruce F. Molnia and Cheryl A. Hallam**

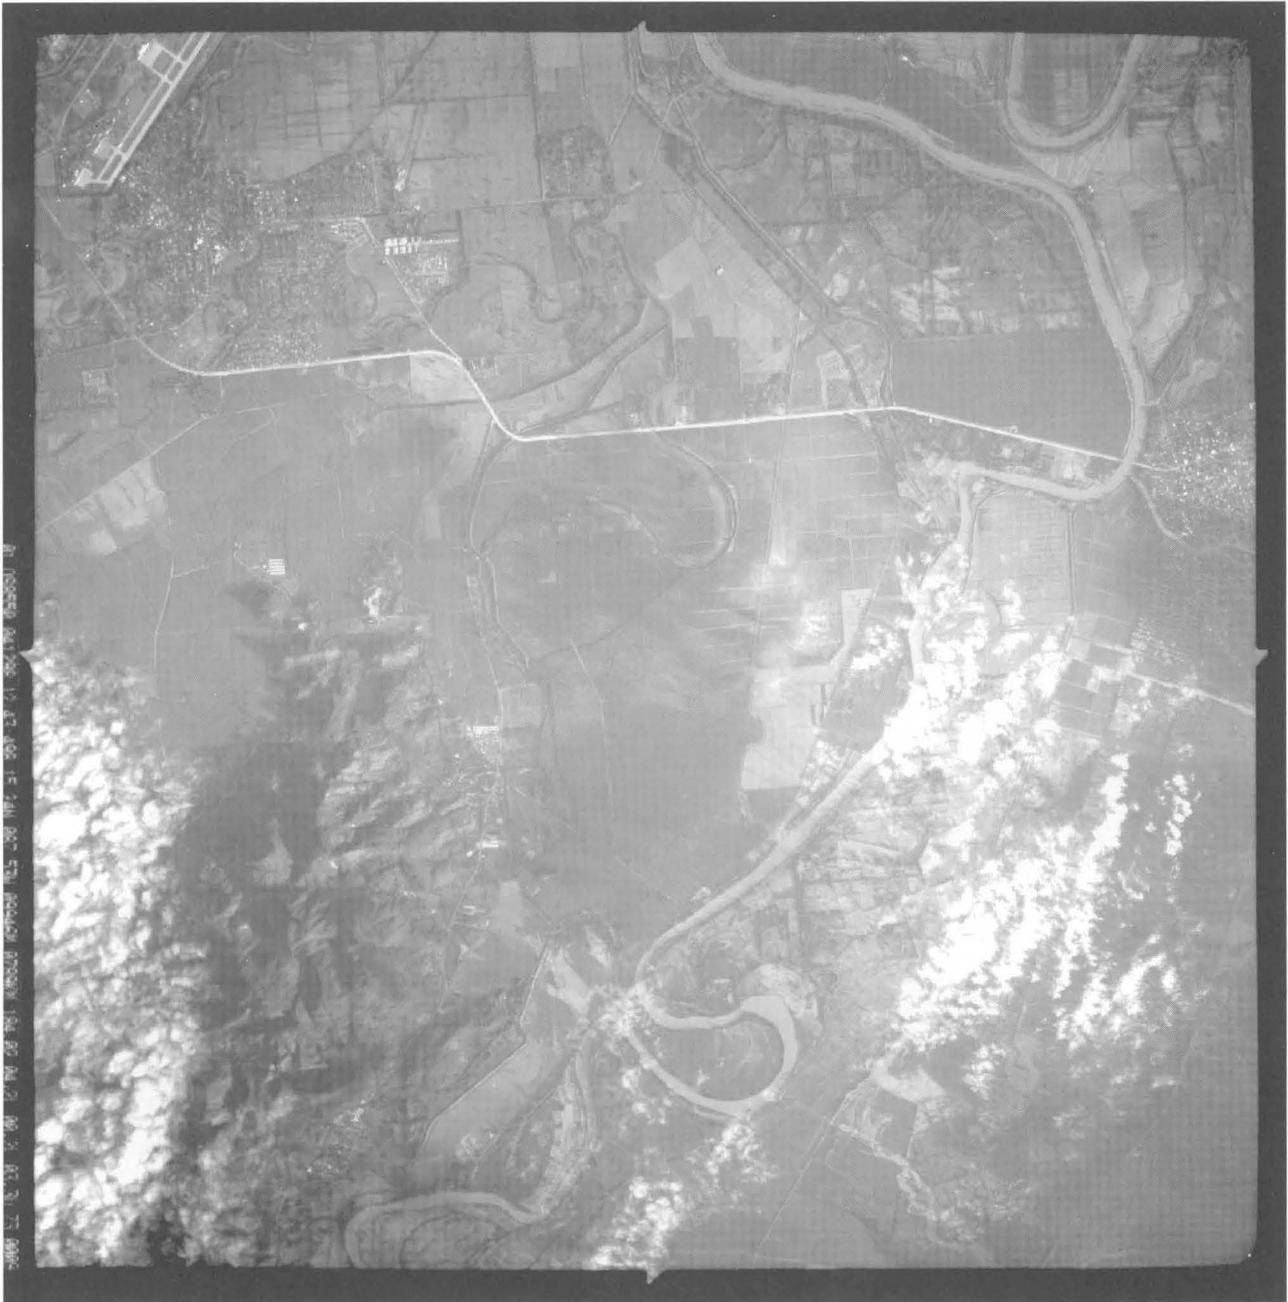
Frame 9-December 4, 1998-12:43:50

Black-and-white vertical photograph of the Sula Valley and the La Lima - El Progreso area southeast of San Pedro Sula, Honduras. Much of the land adjacent to the meandering Uluá River was flooded. Some of the farm fields and banana groves in the Sula Valley still show evidence of having standing water, more than a month following the storm.

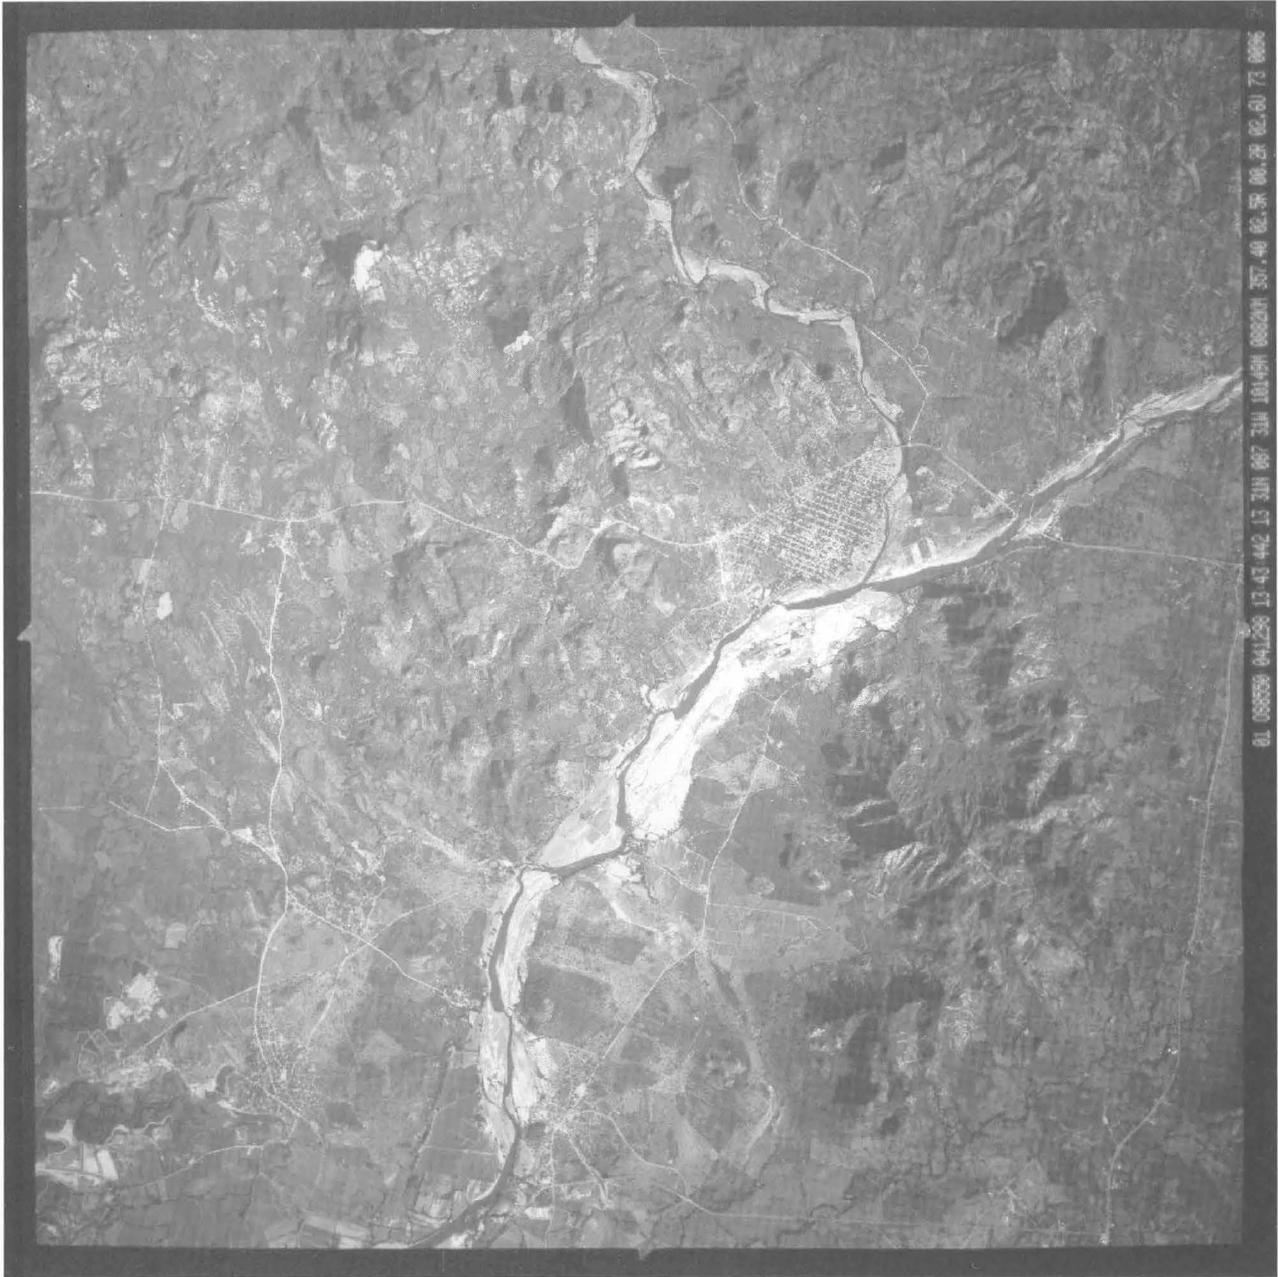
Frame 96-December 4, 1998-13:43:44

Black-and-white vertical photograph of southern Honduras near the city of Nacaome. Flooding deposited large quantities of sediment along the banks and on the floodplain of the Rio Nacaome, especially in the southern half of the area shown in the photograph. Many manmade structures on the floodplain were destroyed, and much of the city and adjacent farmland was flooded.

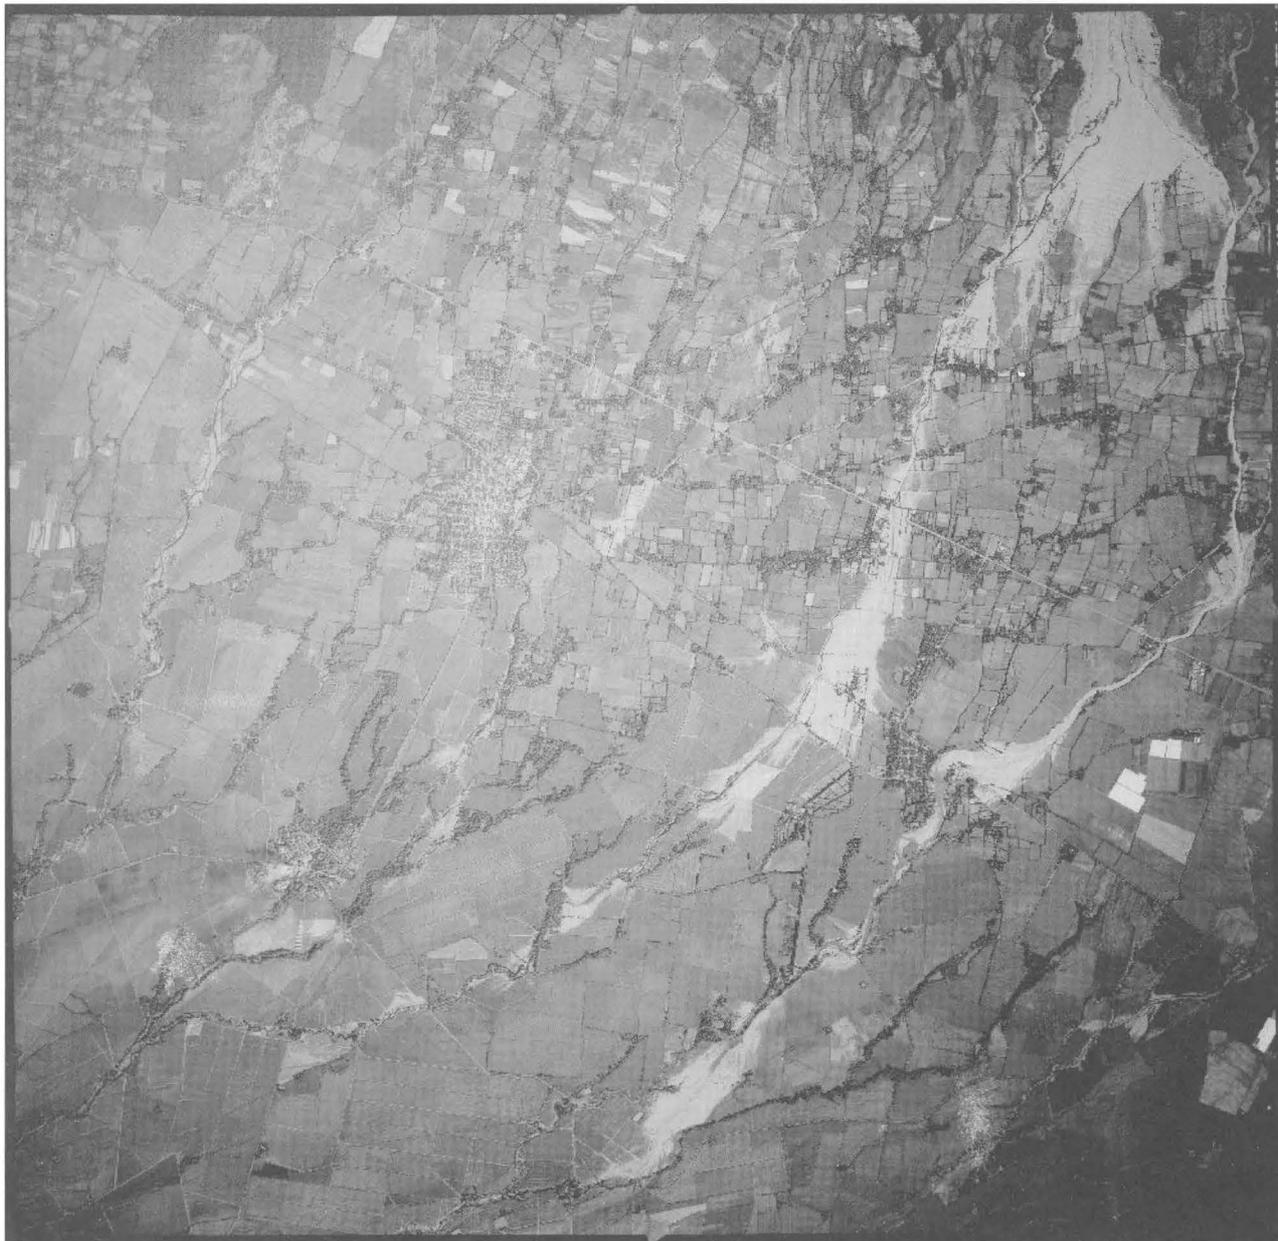
Frame 140-December 4, 1998-14:19:50

Black-and-white vertical photograph of the area south of Casita Volcano showing the lower 3/4 of the large bifurcating volcanic debris flow that destroyed the villages of El Porvenir and Rolando Rodriguez, killing about 2,500 people. Both villages were located in the Municipality of Posoltega, Nicaragua. The large triangular debris flow in the top right corner of the photograph originated as a rock avalanche from the southeast flank of the volcano. It contained more than 200,000 cubic yards of sediment and traveled about five miles prior to bifurcating. The flows continued downslope in existing channels before covering and breaching the Inter-American Highway and the local railroad line. The eastern limb reached the village of Posoltega, where it destroyed houses on the east side of town. (See enlargements beginning on page 45.) Sediment deposited by the debris flow also buried many agricultural fields. Combine this photograph with photograph 141 to see the entire debris flow.

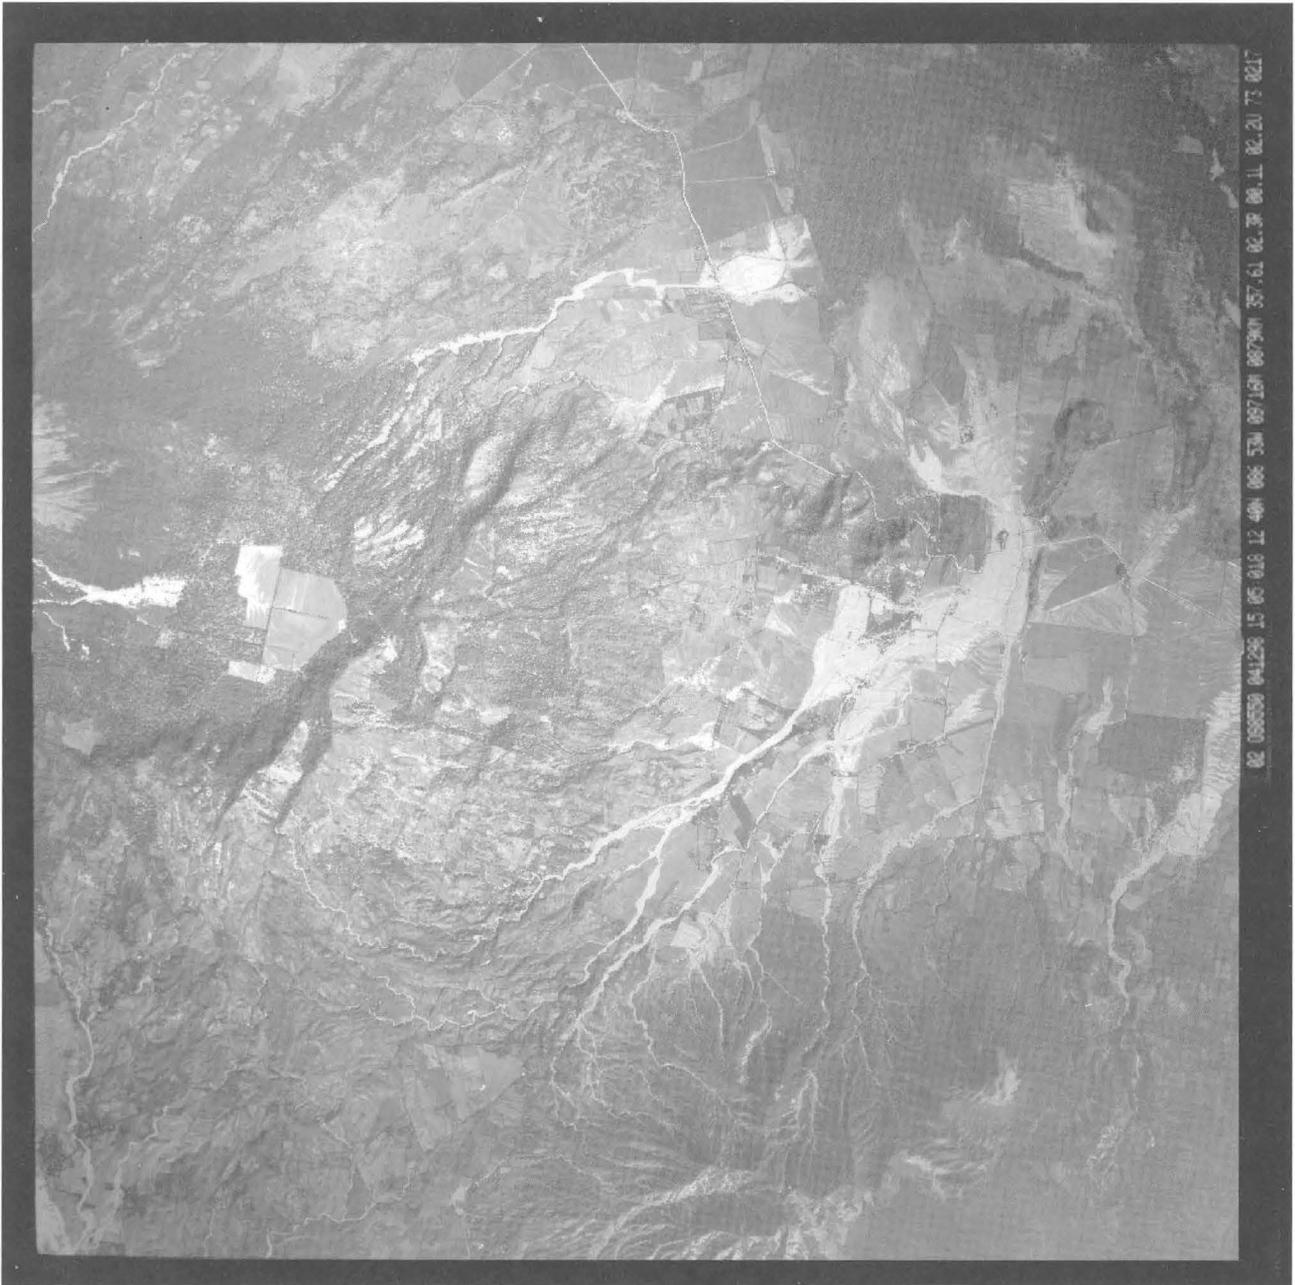
Frame 217-December 4, 1998-15:05:02

Black-and-white vertical photograph of the area east of the crater of Casita Volcano showing several large debris flows that traveled east and northeast from the eastern flank of the volcano. The northernmost flow inundated the village of El Higueral, while the larger of the debris flows traveled more than 4 miles, flowing through the village of Las Marias and west of Agua Caliente. These debris flows breached local highways in at least three locations. Many small landslides also originated on the east flank of the volcano. The debris flow at the middle right-hand margin of the photograph originated on the east flank of Telica Volcano.

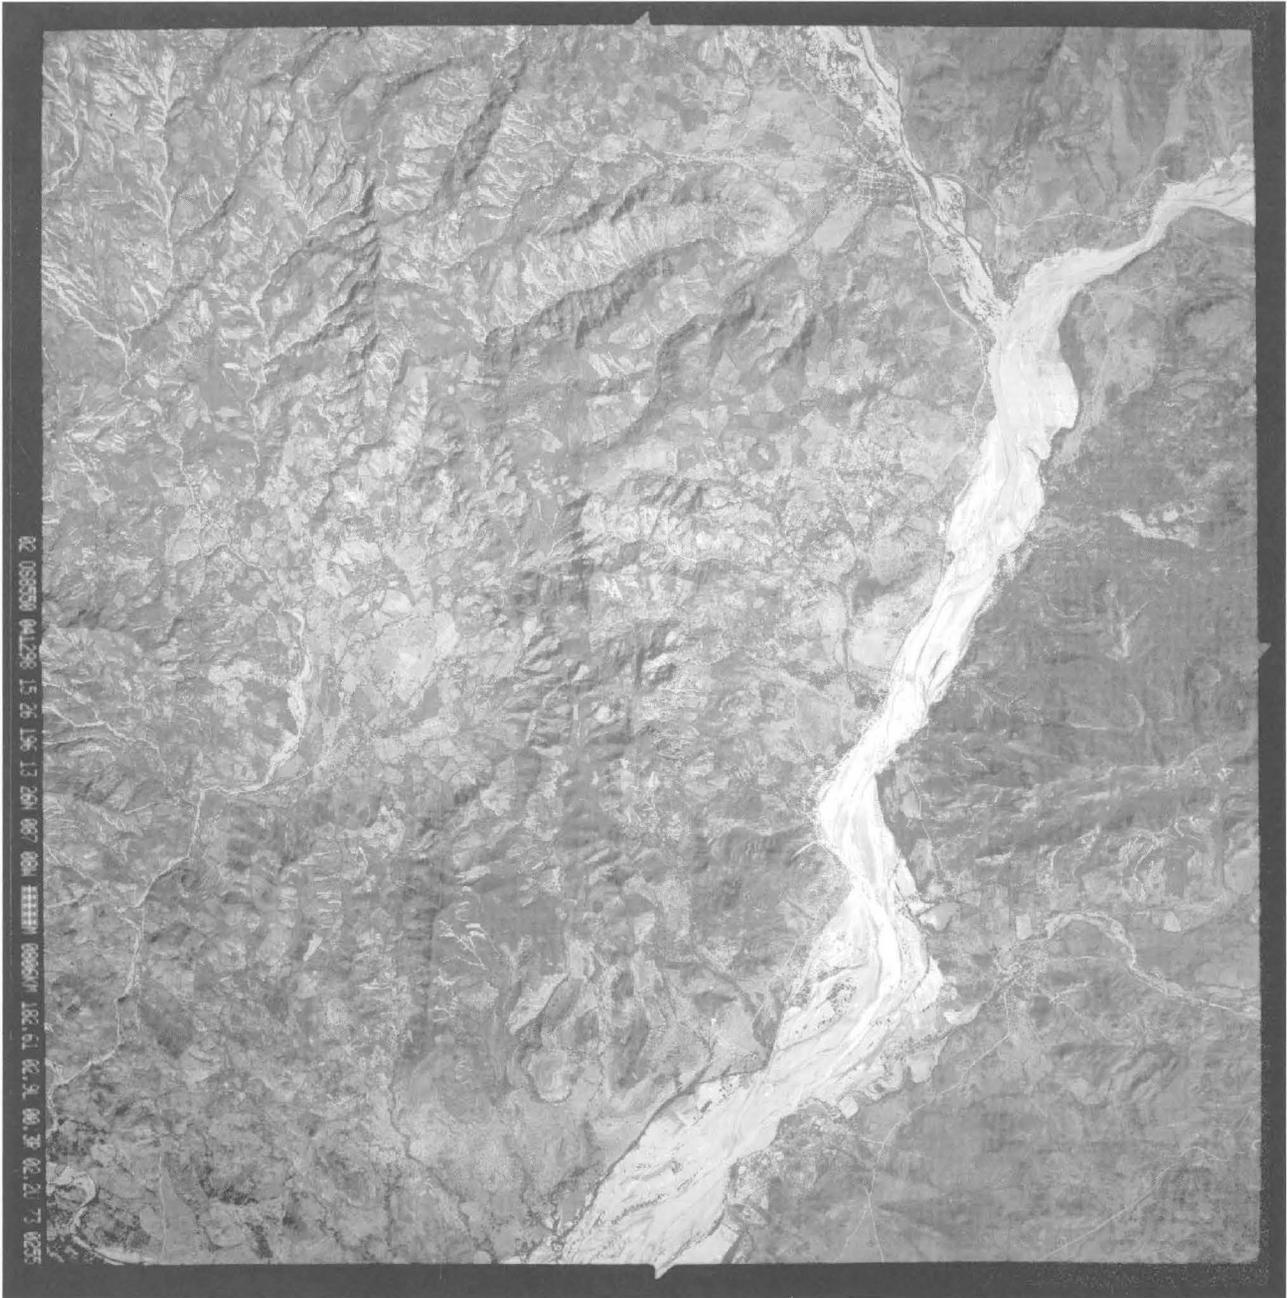
Frame 255-December 4, 1998-15:08:41

Black-and-white vertical photograph of southern Honduras, north of the city of Choluteca. Flooding deposited large quantities of sediment on the floodplain of the meandering Choluteca River. In places, the braided channel has widened to more than a mile in width. Nearly all manmade structures on the floodplain were destroyed and much of the adjacent farmland was flooded. Hundreds of small landslides cover the hillsides on both sides of the Choluteca River. More than two dozen large parallel landslides occurred west of San Antonio de Padua, the city on the west side of the large tributary that flows into the Choluteca River from the north.

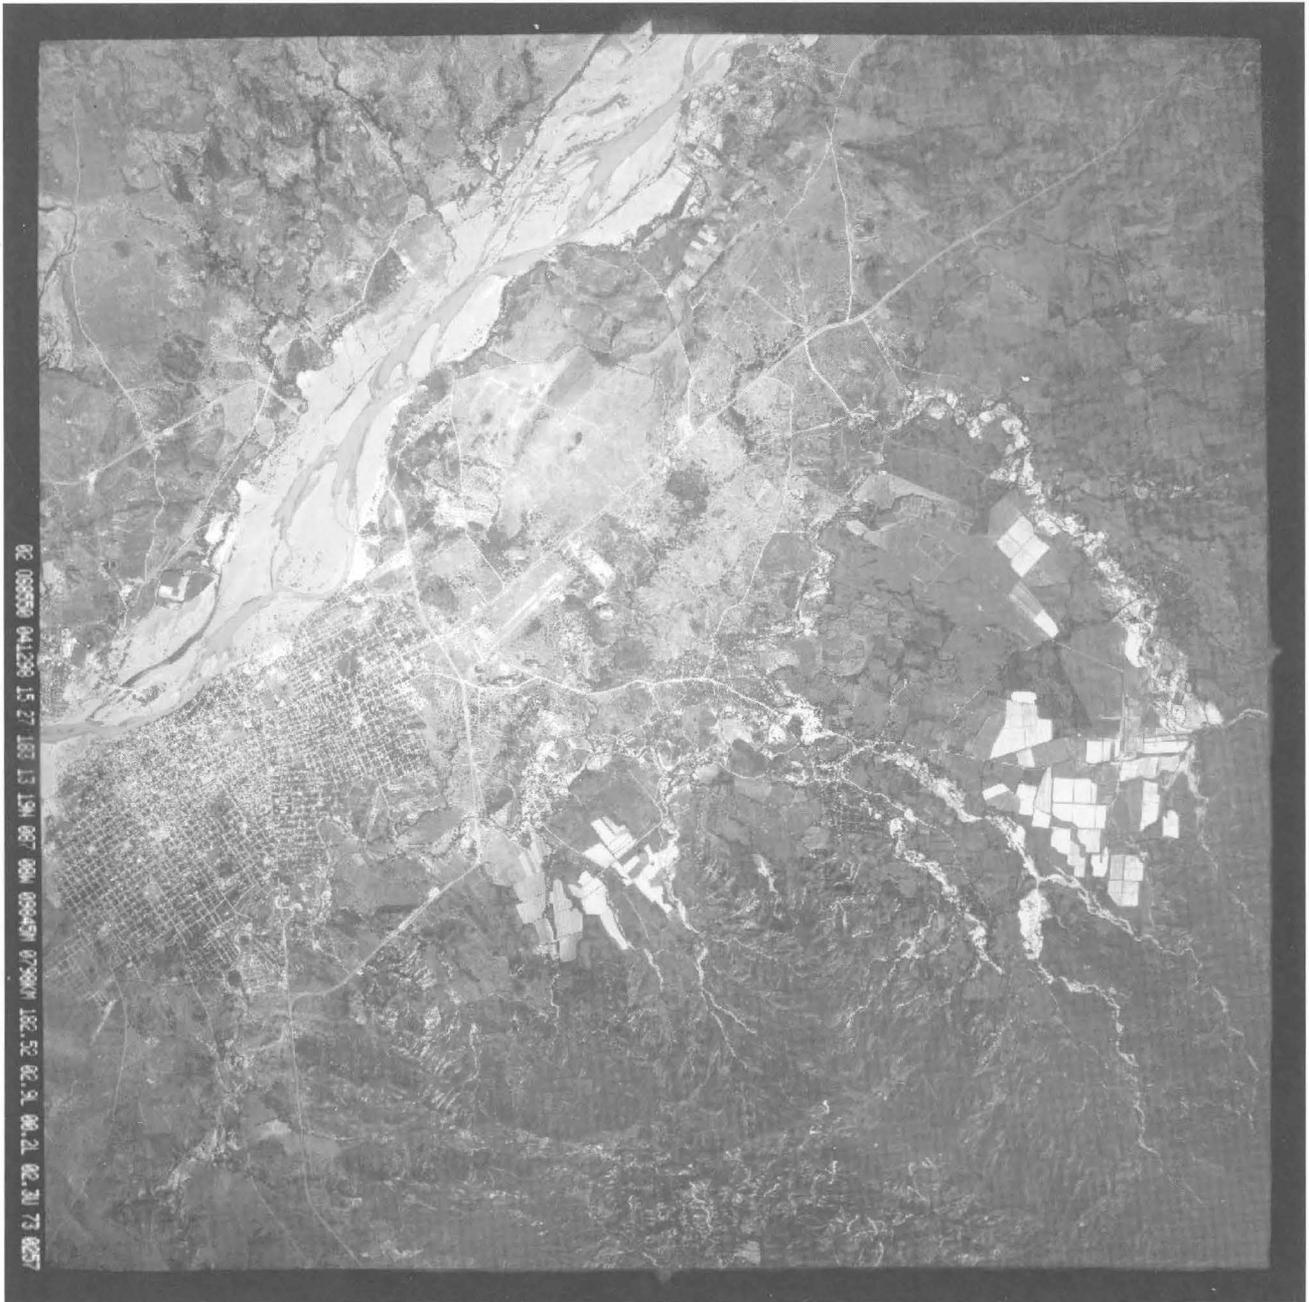
Frame 257-December 4, 1998-15:27:18

Black-and-white vertical photograph of the city of Choluteca and the Choluteca River southern Honduras. Flooding deposited large quantities of sediment in the northern part of the city and destroyed a number of neighborhoods in the city. Sediment was also deposited along the banks and on the floodplain of the Choluteca River. Nearly all manmade structures on the floodplain north of the city were destroyed, including the bridge approaches to the new crossing of the Inter-American Highway, leaving the central span of the bridge as an isolated, free-standing structure. The "old bridge" across the Choluteca River, built by the U.S. Army Corps of Engineers in the 1930's, survived the flooding, but the northern approach was destroyed when the Choluteca River temporarily changed course during the flood.

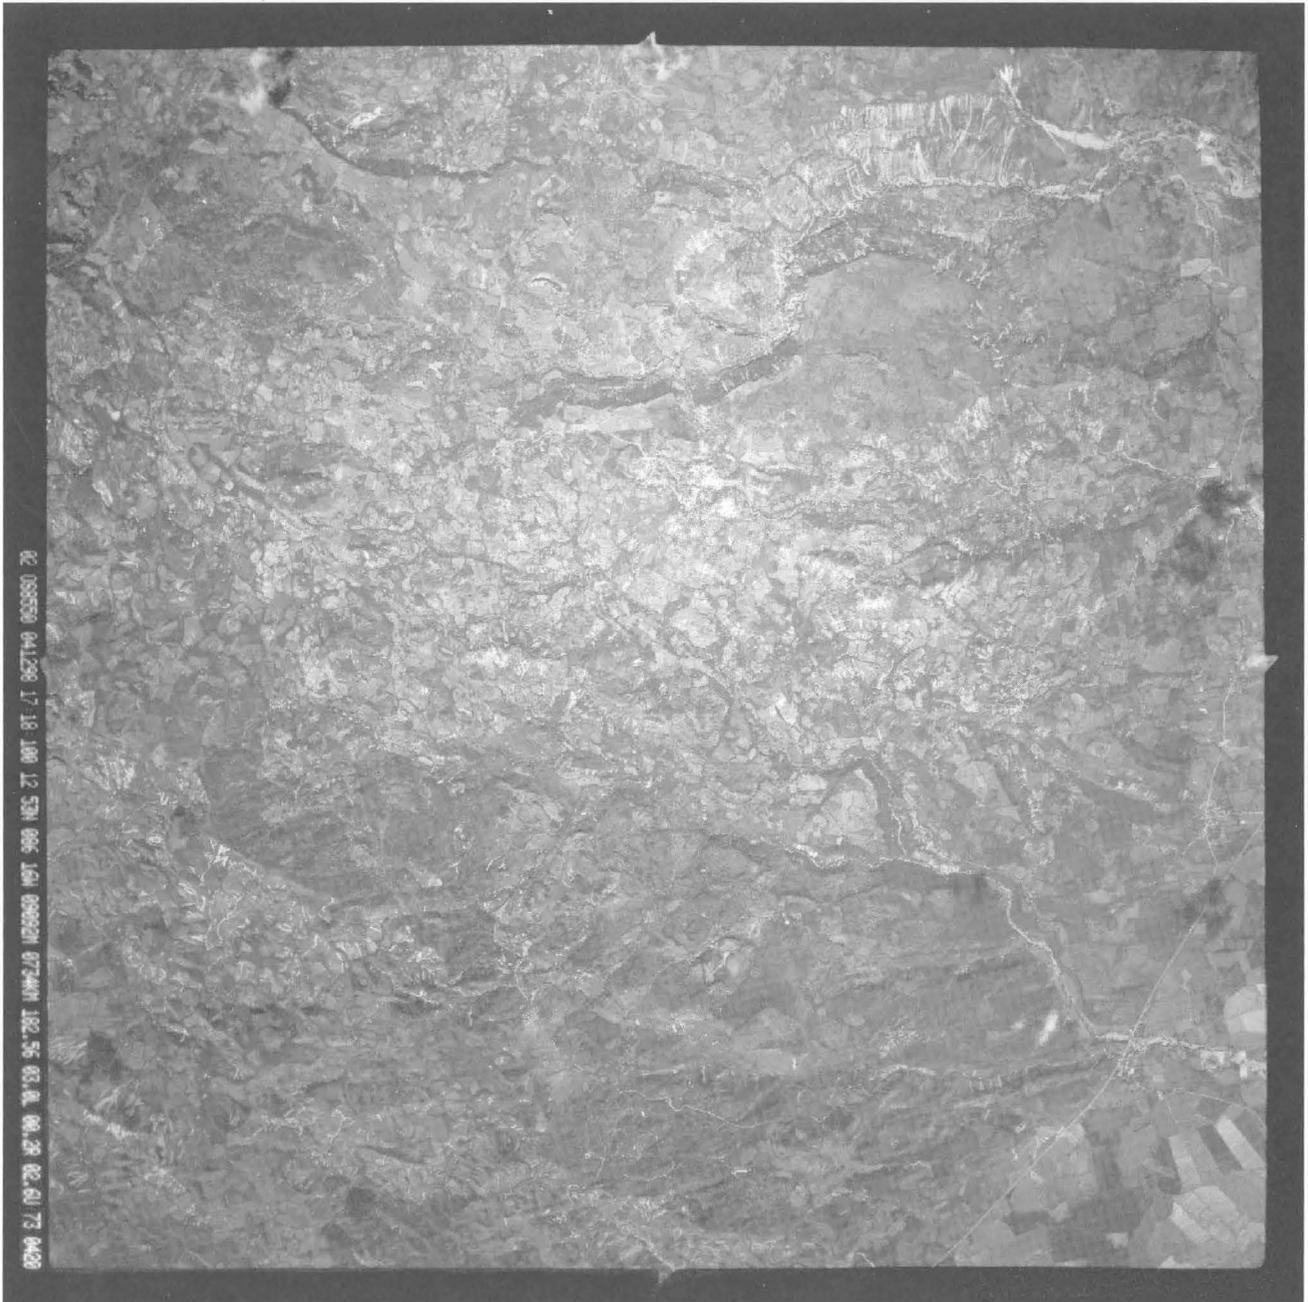
Frame 420-December 4, 1998-17:18:10

Black-and-white vertical photograph of southwestern Nicaragua, showing numerous small landslides in the upland area north of Managua.

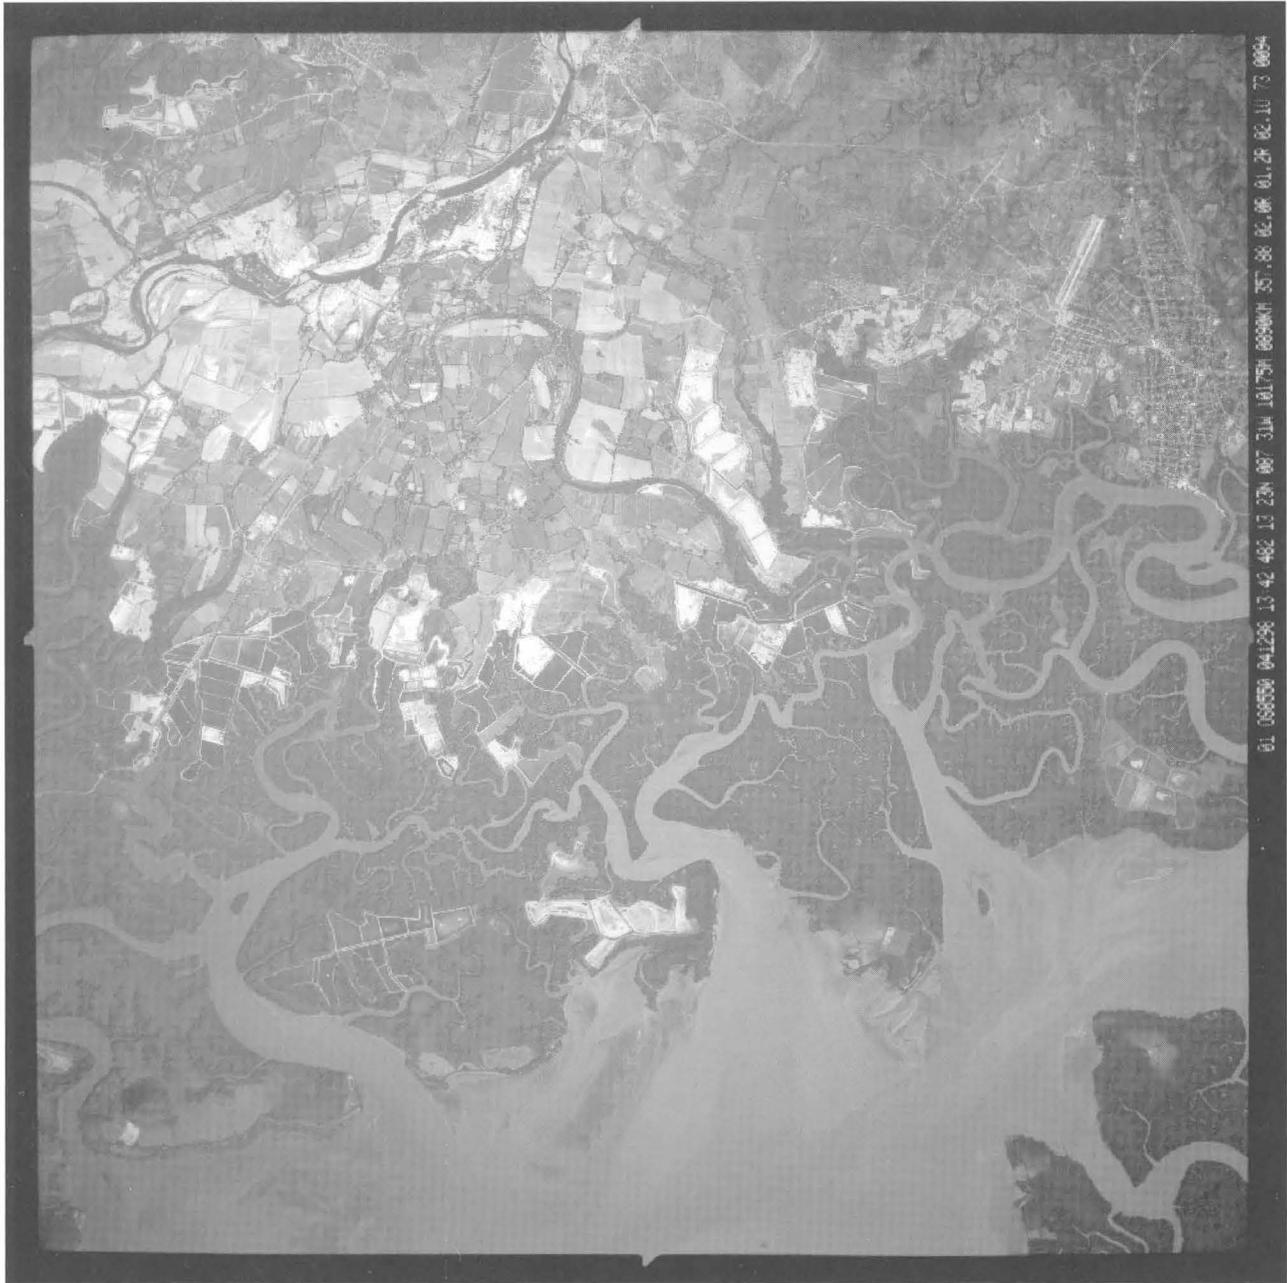
Frame 94-December 4, 1998-13:42:48

Black-and-white vertical photograph of the coastal wetlands along the northeastern side of the Gulf of Fonseca, near San Lorenzo, Honduras. The wetlands were flooded during the height of the storm and experienced significant changes in salinity. Large quantities of sediment were deposited in the diked shrimp farm ponds, on the floodplains of the Rio Nacaome, and on other coastal-plain river and estuary channels throughout the area of the photograph.

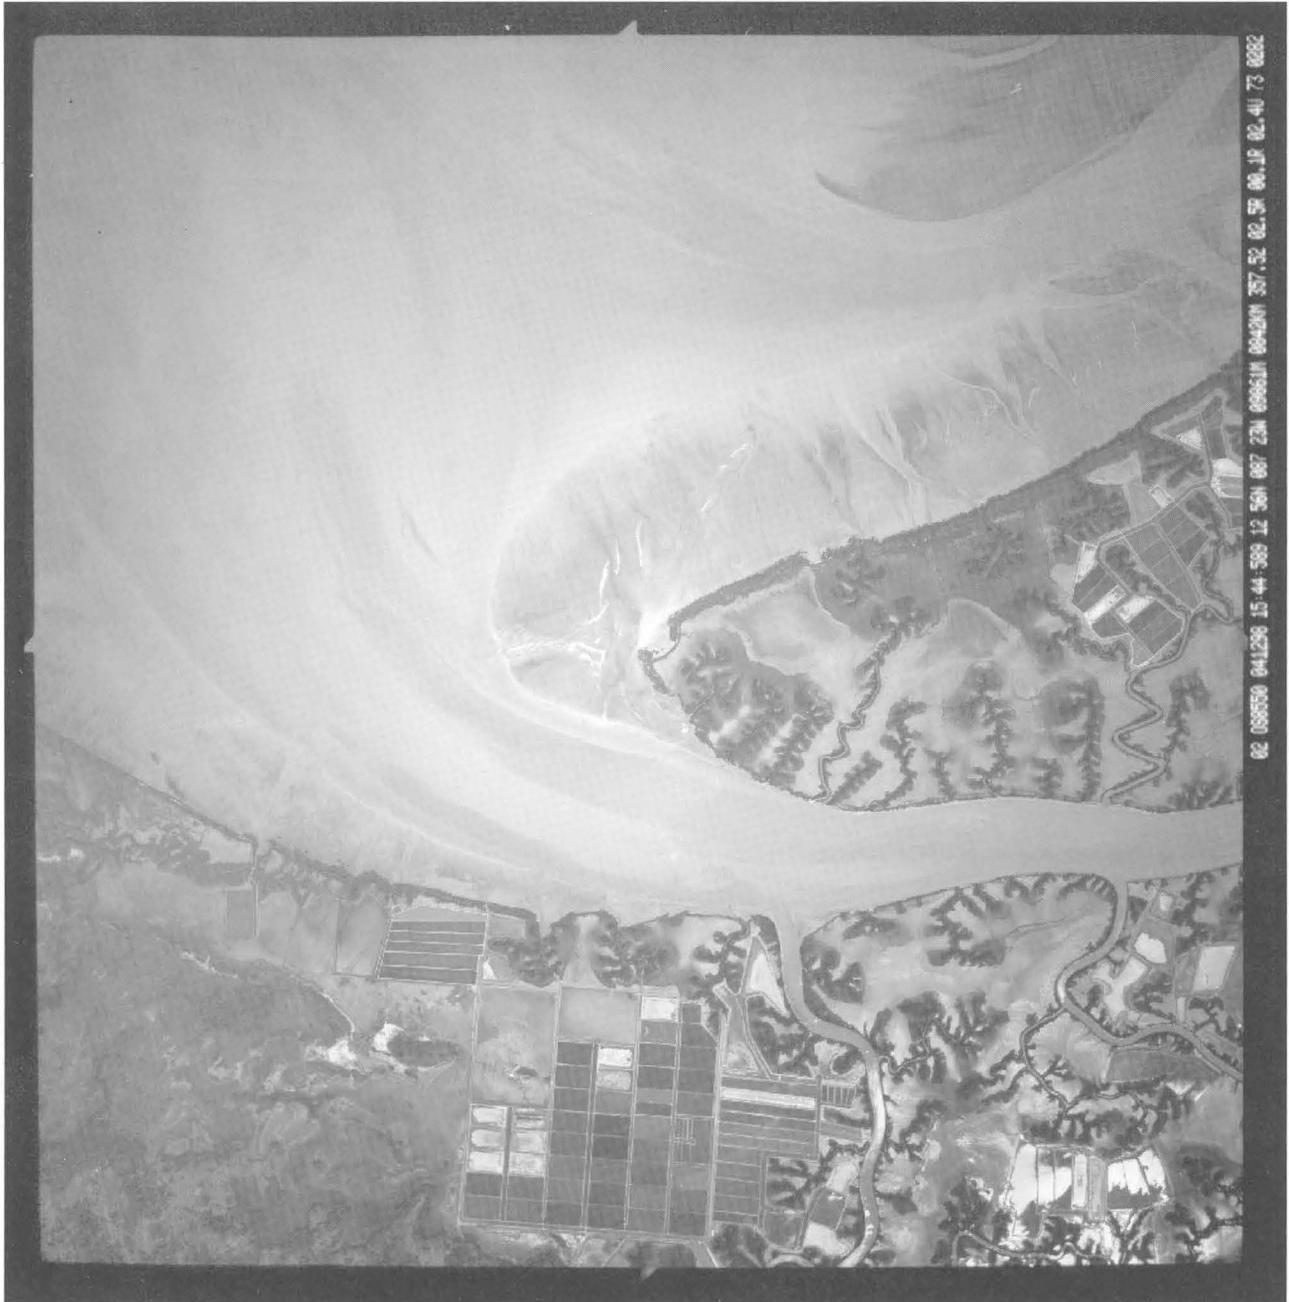
Frame 282-December 4, 1998-15:44:59

Black-and-white vertical photograph of the coastal area and wetlands along the southeastern end of the Gulf of Fonseca, west of Chinandega, Nicaragua. All of the wetland area adjacent to the Estero (Estuary) Dos Aguas Grandes was flooded during and after the storm, significantly affecting the numerous shrimp farms located to the south and east. Several areas still show standing water. Large quantities of sediment were deposited in many wetland channels and on the banks of the southern coastal-plain rivers.

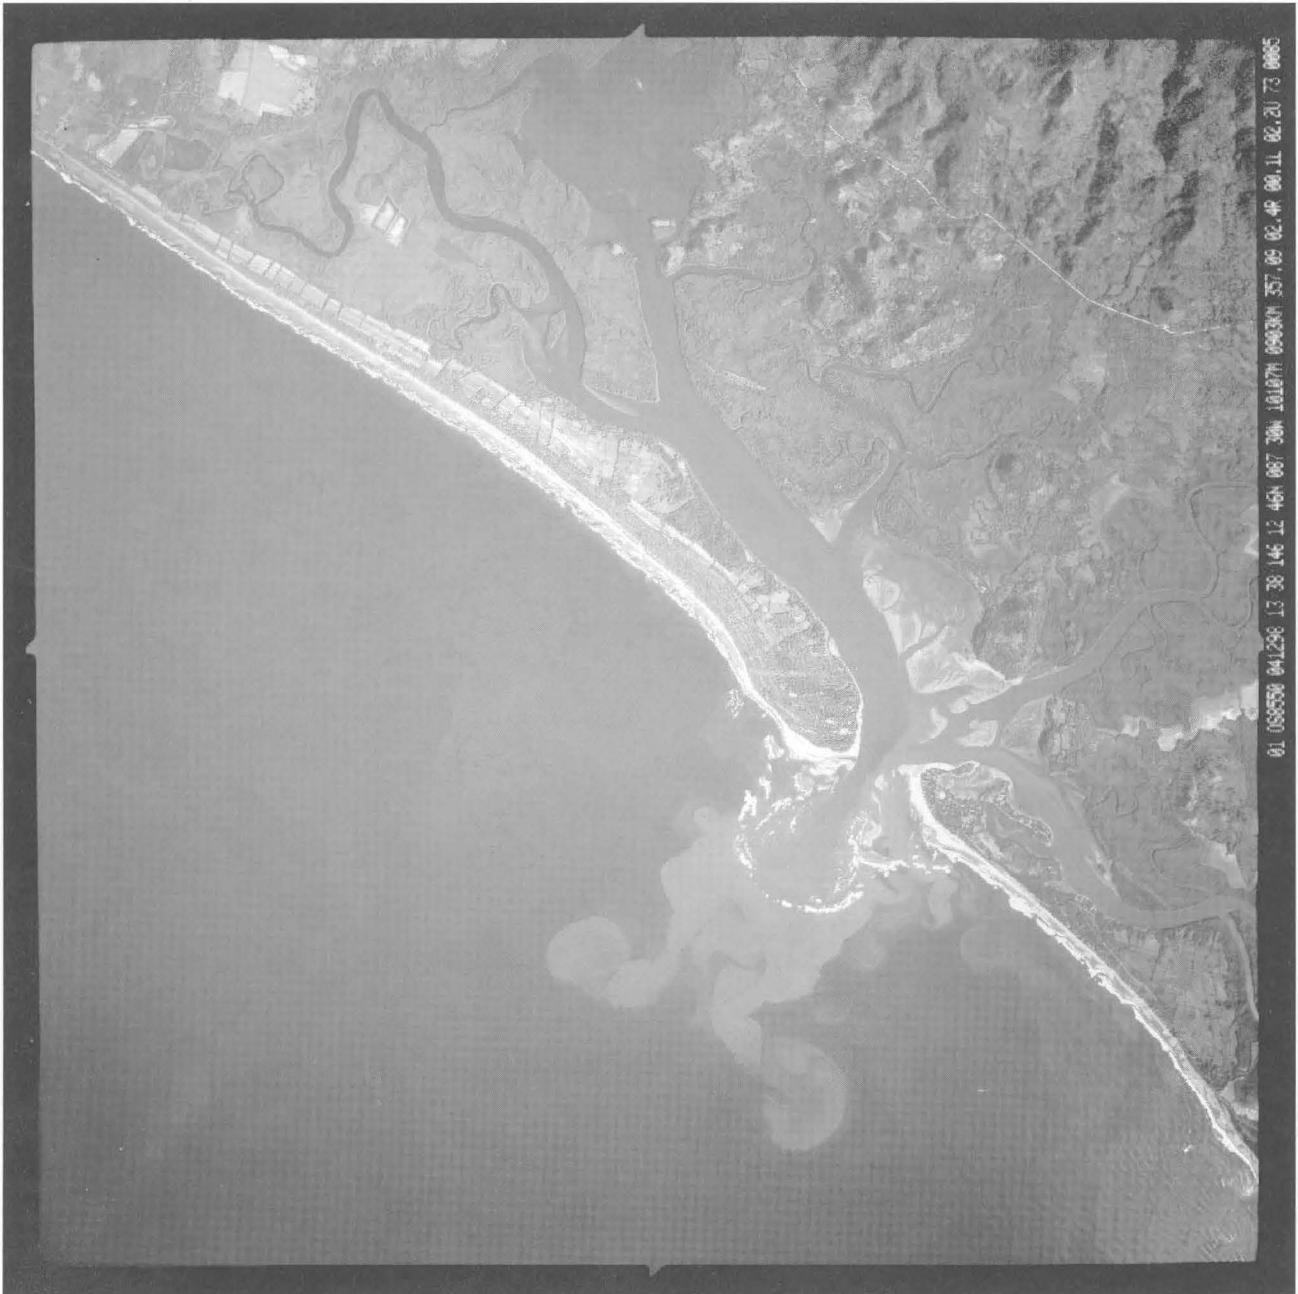
Frame 85-December 4, 1998-13:38:15

Black-and-white vertical photograph of the Pacific Ocean coastal area and wetlands at the Estero (Estuary) Padre Ramos northwest of Jiguililo, Nicaragua. Sediment deposited at the mouth of the estuary has contributed to building a large delta, nearly blocking the inlet and creating a hazard to navigation. Other Pacific Ocean estuary and river mouths show similar sedimentation. Although this photograph was made 5 weeks after the storm, a large quantity of suspended sediment is still flowing into the Pacific Ocean as a plume. Much of the wetland area was flooded. Several areas still show standing water, and large quantities of sediment were deposited in many wetland channels. Frame 347 is a color image of the same area.

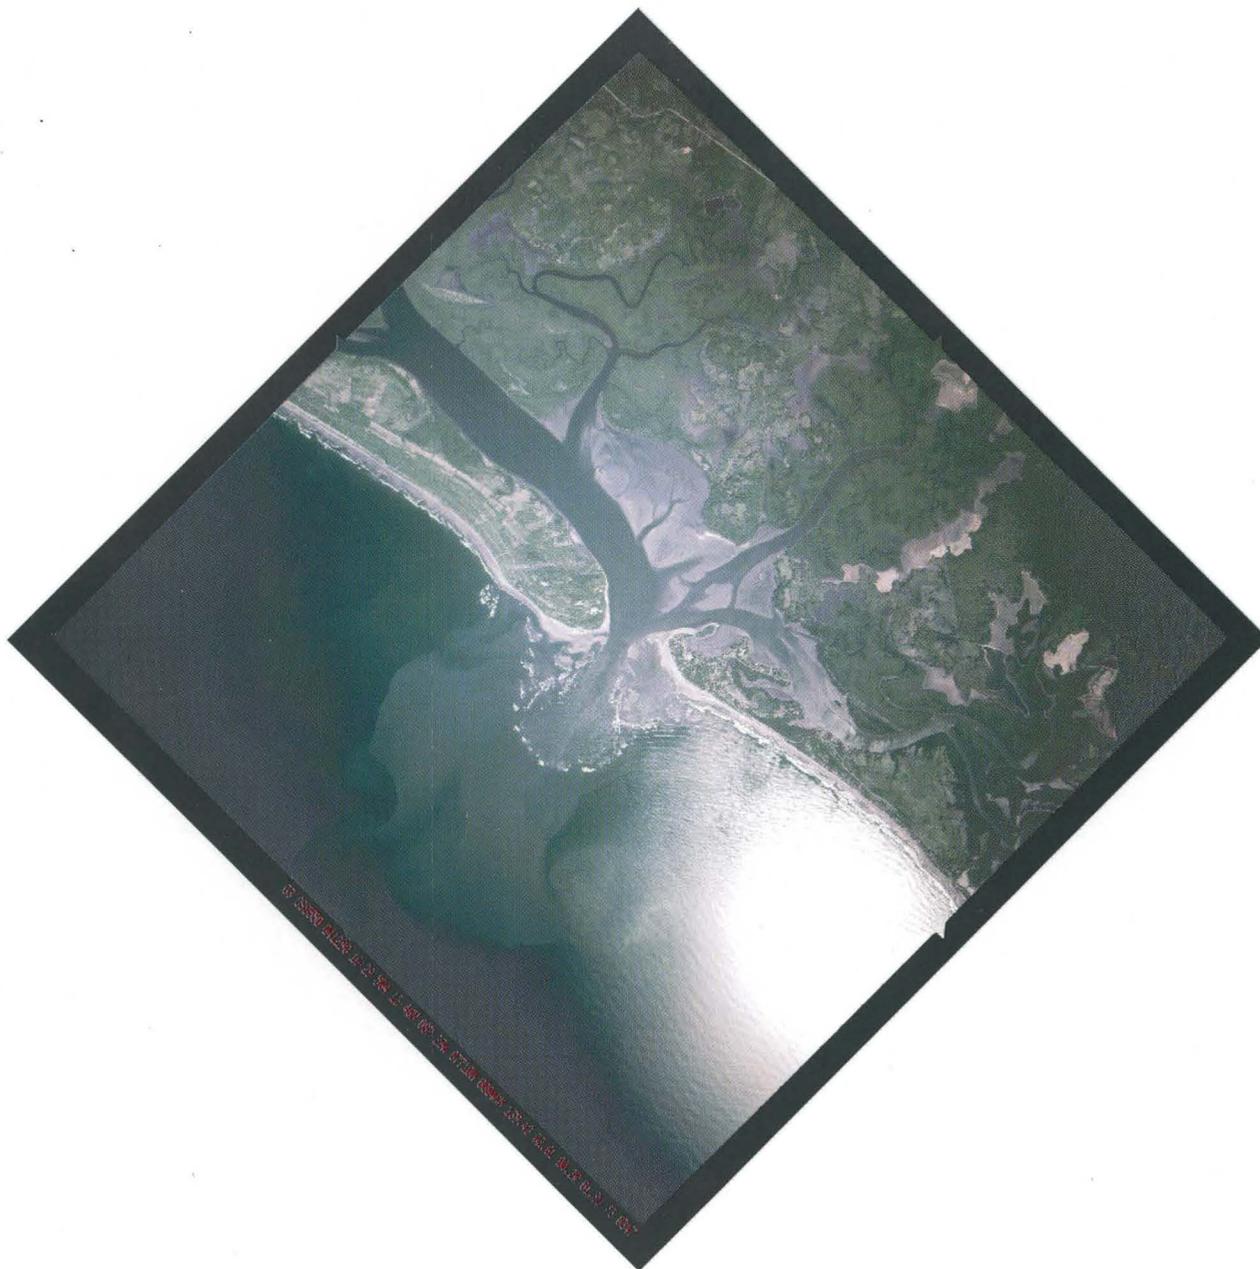
Frame 347-December 4, 1998-16:29:50

Color vertical photograph of the Pacific Ocean coastal area and wetlands at the Estero (Estuary) Padre Ramos northwest of Jiguililo, Nicaragua. Sediment deposited at the mouth of the estuary has contributed to building a large delta, nearly blocking the inlet and creating a hazard to navigation. Other Pacific Ocean mouths show similar sedimentation. Although this photograph was made 5 weeks after the storm, a large quantity of suspended sediment is still flowing into the Pacific Ocean as a plume. Much of the wetland area was flooded. Several areas still show standing water, and large quantities of sediment were deposited in many wetland channels. Frame 85 is a black-and-white image of the same area.

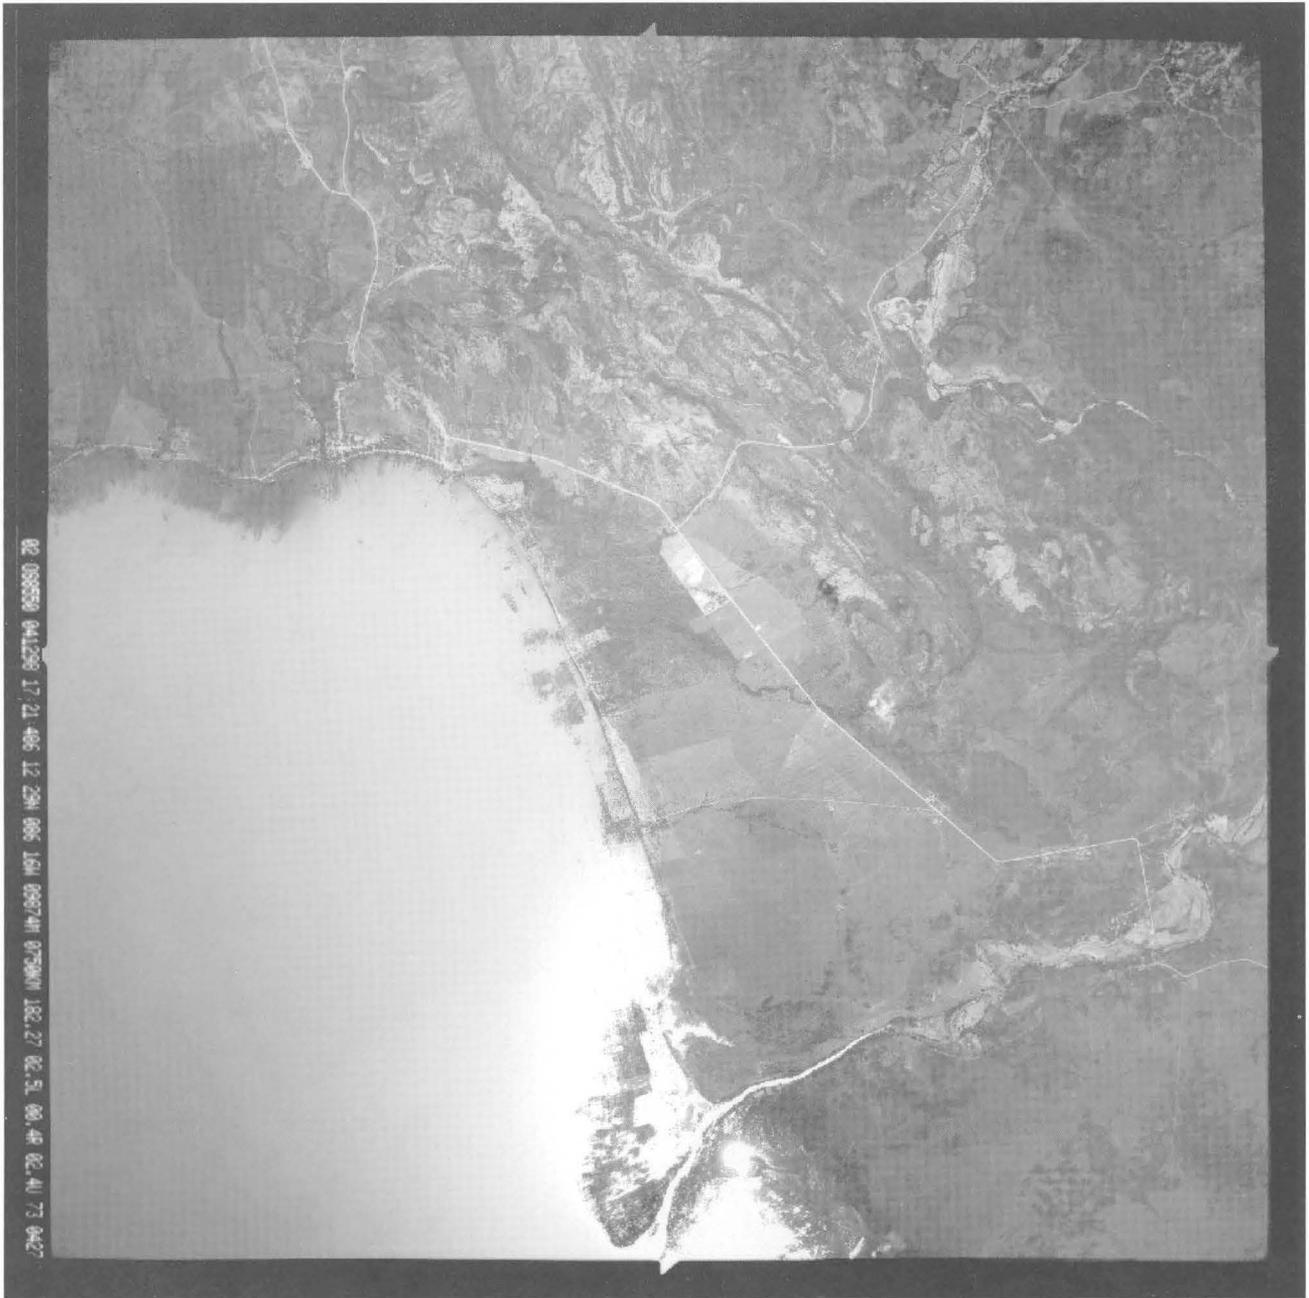
Frame 427-December 4, 1998-17:21:49

Black-and-white vertical photograph of southwestern Nicaragua, showing flooding along the shoreline and the high water level in Lago de Managua, northwest of Managua. Five weeks after the storm, numerous farms and settlements were still under water. The level in this large lake rose about 15 feet.
