# Open Skies Aerial Photography of Selected Areas in Central America Affected by Hurricane Mitch

U.S. Geological Survey Circular 1181

**By Bruce F. Molnia and Cheryl A. Hallam**

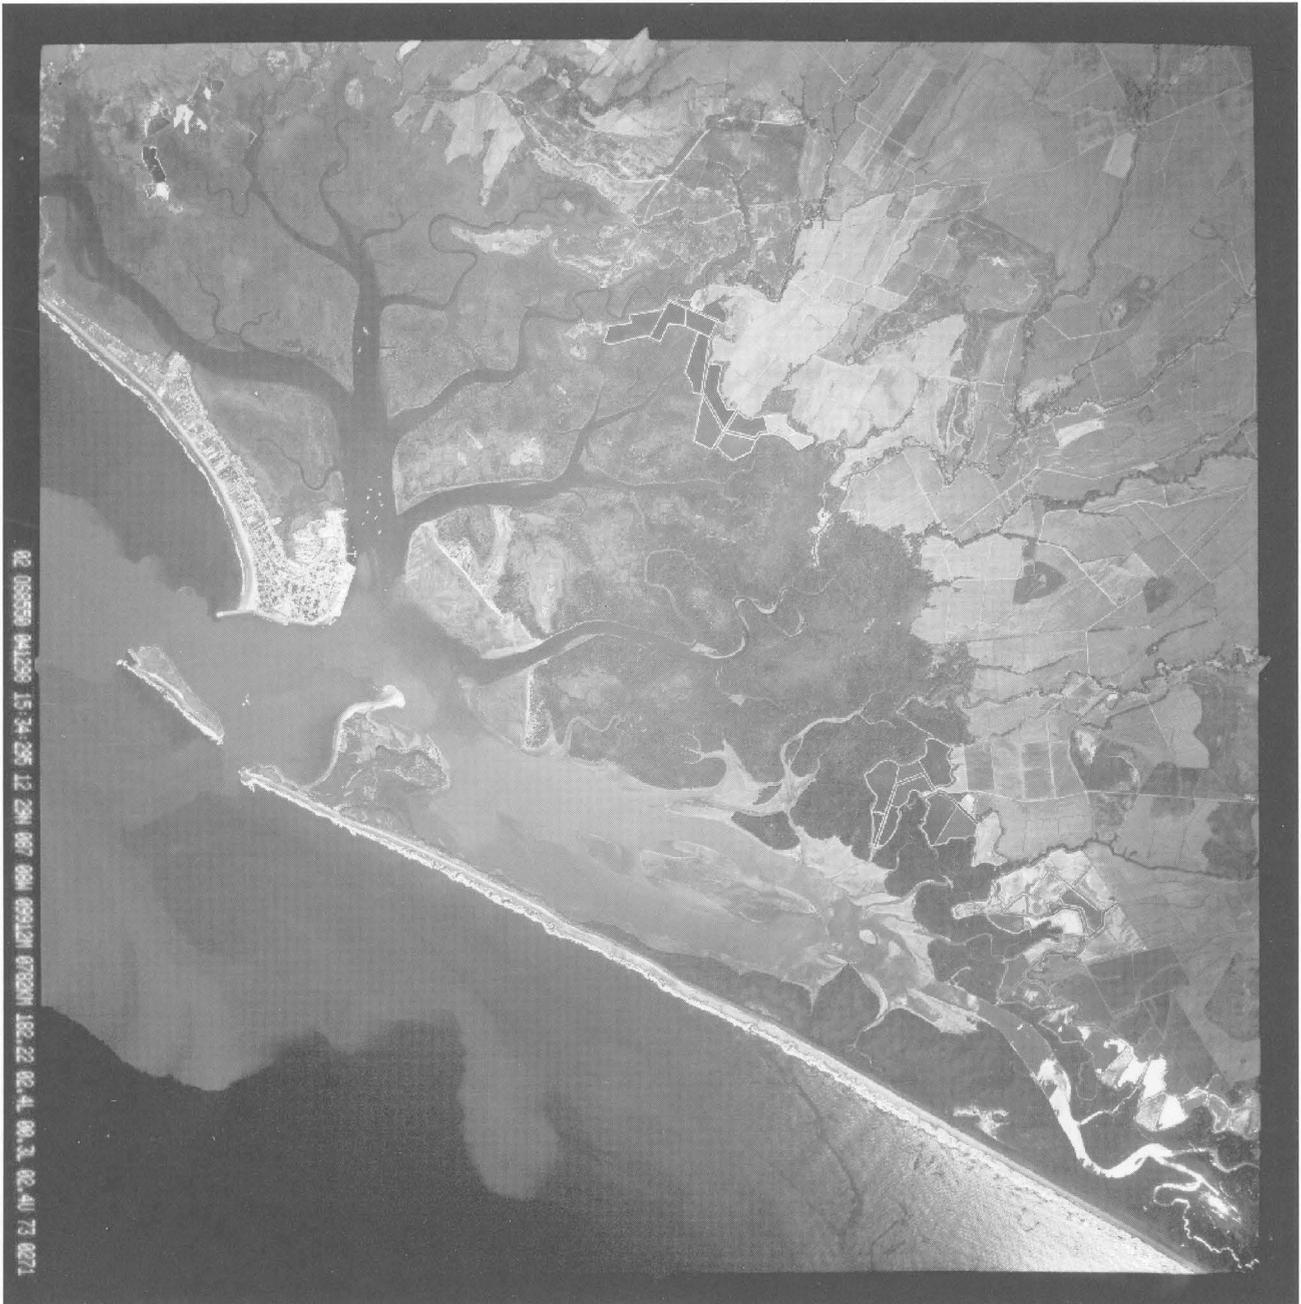
Frame 271-December 4, 1998-15:34:29

Black-and-white vertical photograph of the Pacific Ocean coastal area and wetlands at the Estero (Estuary) Aposentillo southwest of Chinandega, Nicaragua. Although this photograph was made 5 weeks after the storm, a large quantity of suspended sediment is still flowing into the Pacific Ocean as a distinct plume. All of the wetland area behind the coastal barrier islands was flooded following the storm. Several areas still show standing water. Large quantities of sediment were deposited in the wetland channels and in some of the diked ponds.

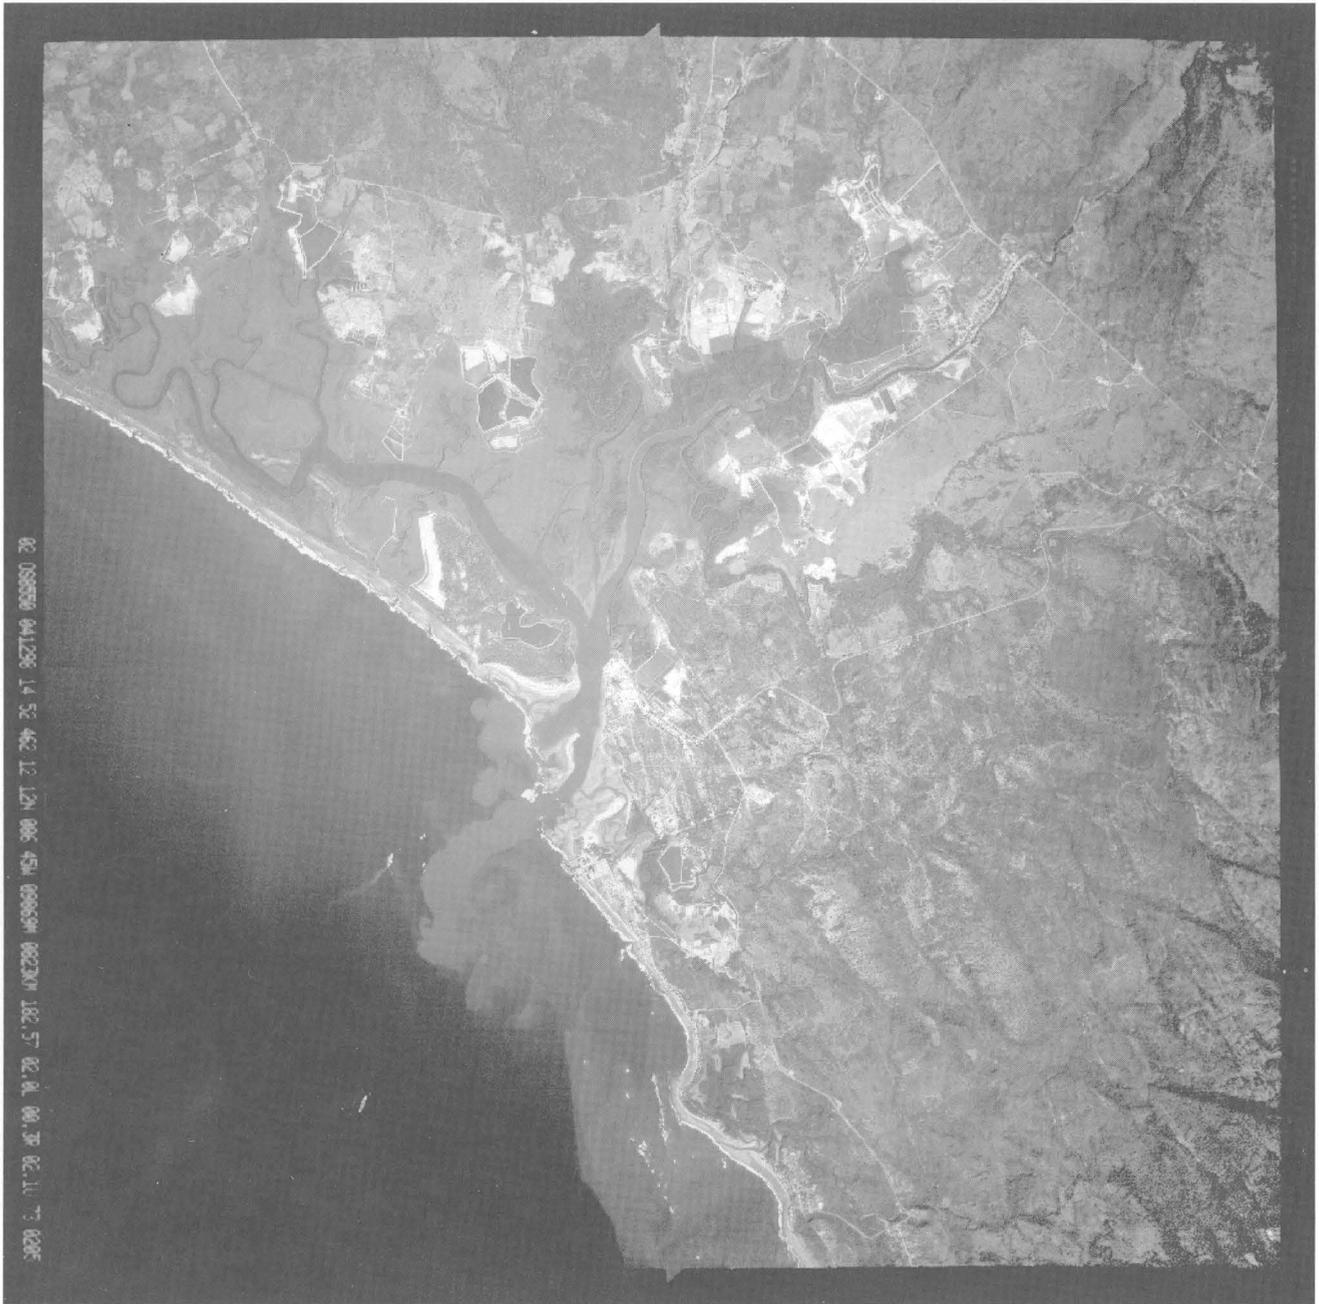
Frame 205-December 4, 1998-14:52:46

Black-and-white vertical photograph of the Pacific Ocean coastal area and wetlands near El Tamarindo, Nicaragua. Much sediment was deposited along the banks of the Rio Tamarindo, in the diked salt ponds, at the mouth of the bay, and in the coastal wetlands. Although this photograph was made 5 weeks after the storm, a large quantity of suspended sediment is still flowing into the Pacific Ocean as a plume. Part of the wetland area was flooded and experienced significant changes in salinity.

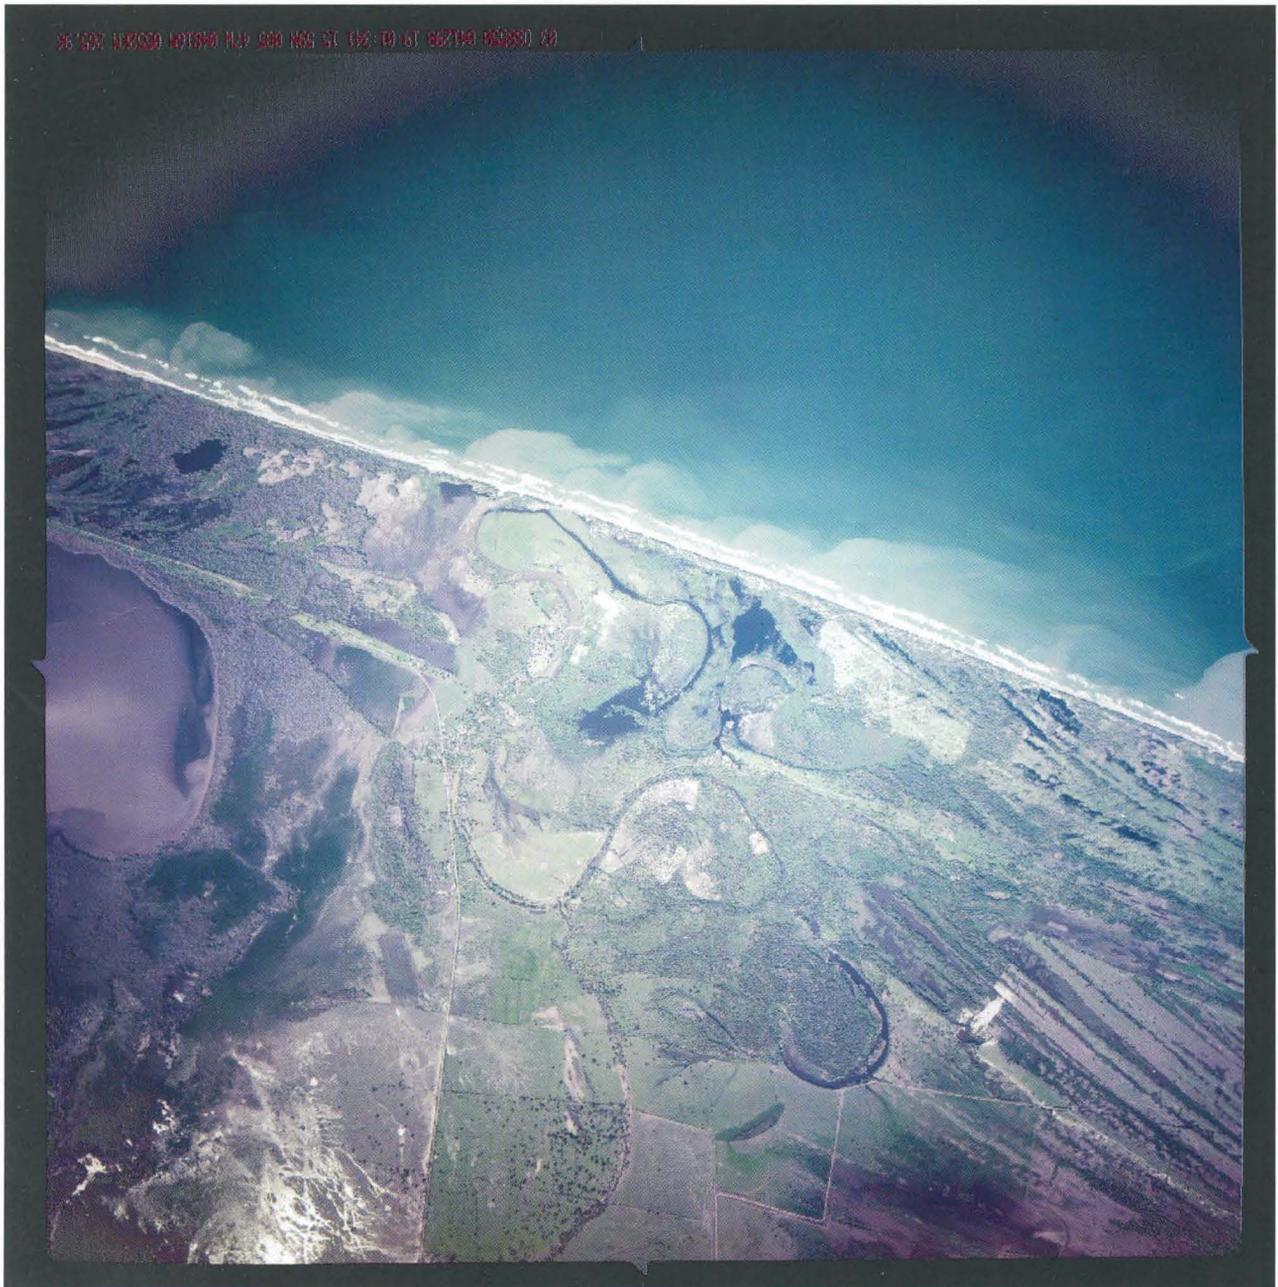
Frame 549-December 4, 1998-19:01:34

Color vertical photograph of the Caribbean Sea coastline and adjacent wetlands, east of Trujillo, Honduras. Many beaches were covered by large quantities of logs and other debris transported by flooding rivers from the interior of Honduras. A large amount of sediment was still being transported eastward, 5 weeks after the storm. Several inland areas show evidence of flooding and sediment deposition from high water.

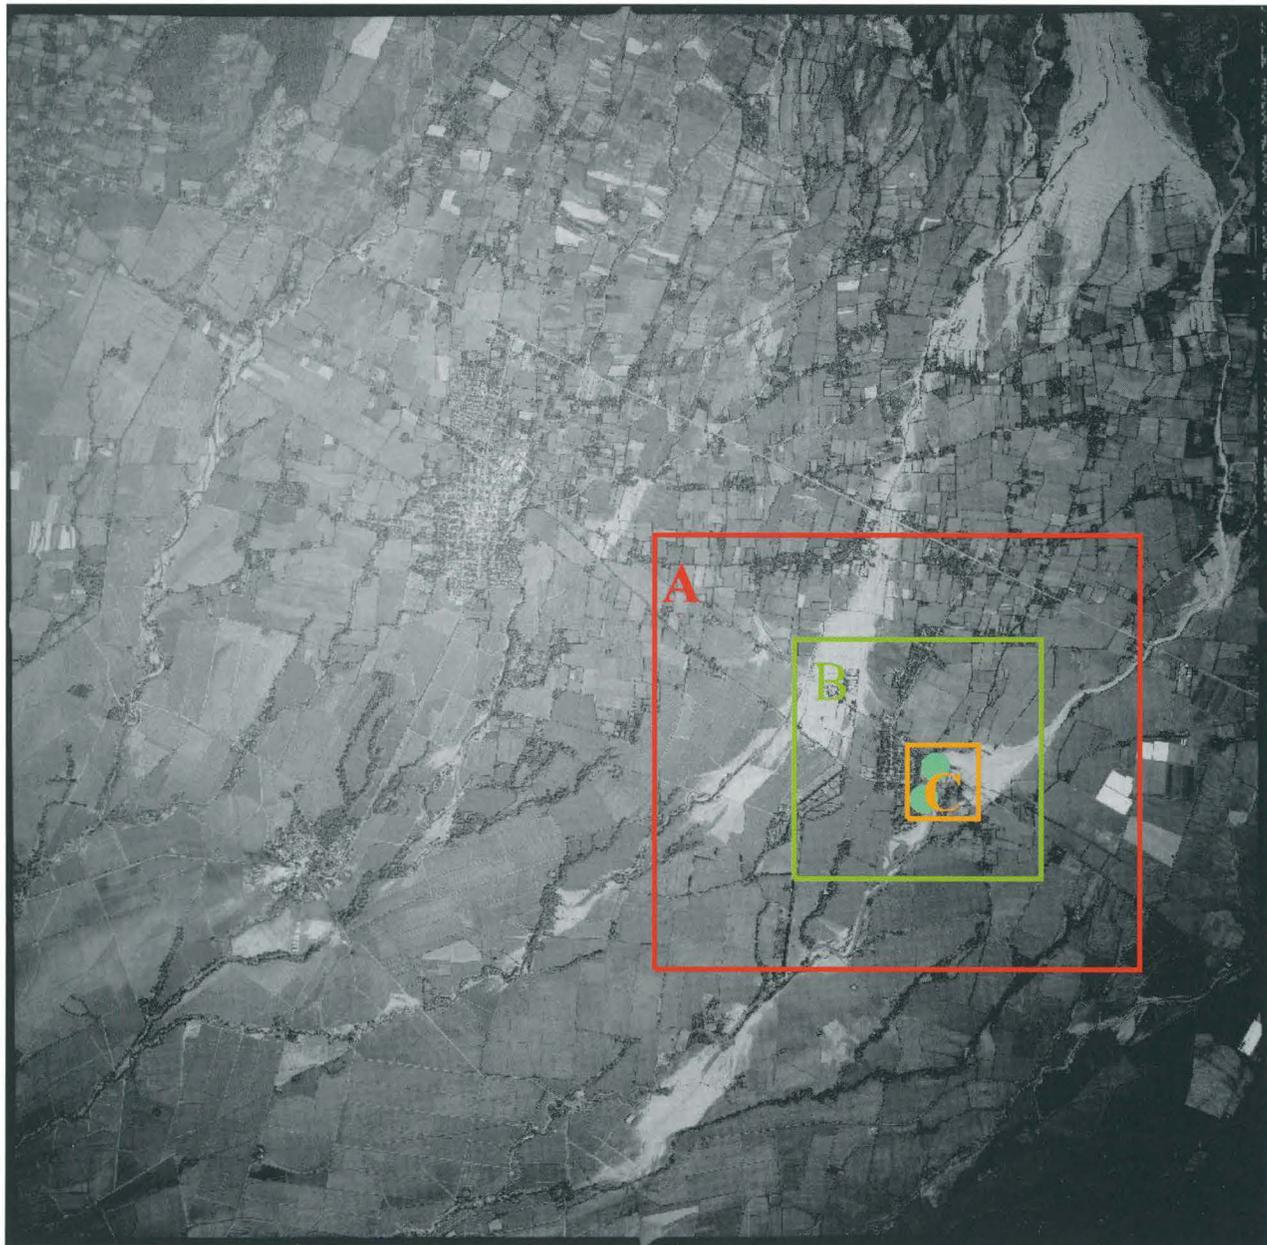
## Frame 140

Locations of enlargements A, B, C, D1, and D2 are shown as red, green, and orange boxes, and two blue dots. Enlargements are ~2.5x, ~5x, ~17x, ~45x, and ~45x, respectively.

Although full-frame photographs are useful for getting an impression of the impacts of Hurricane Mitch at regional and subregional scales, high-resolution aerial photography can be enlarged to provide much more detailed site-specific information. To demonstrate the substantial information content of the Open Skies photography, multiple enlargements at increasing magnification, some at more than 50 times, were made of two areas south of Casita Volcano, Nicaragua.

Each set consists of a full-frame photograph and at least four successive enlargements, labeled Frame 140, 140-A, 140-B, 140-C, 140-D1, and 140-D2, and frame 141, 141-A, 141-B, 141-C, and 141-D. Latitude and longitude are displayed on enlargements 140-A, 140-B, 141-A, and 141-B. Both sets of enlargements center on parts of the Casita Volcano massive rock avalanche and debris flow that killed more than 2,000 people.

The rock avalanche originated with the detachment of a large slab of rock, about 1.5 times the area of a football field and more than 65 feet thick, from just below the summit of the Casita Volcano. More than 200,000 cubic yards of rock material avalanched down the flank of the volcano and traveled as much as 2 miles, moving as fast as 50 feet per second. This rock avalanche mass destroyed the village of Bella Vista. Several hours later, a debris flow originated from the avalanche deposit and traveled downslope, following existing gullies, including the Quebrade El Mono Muerto. The debris flow, which was about 10 feet high, destroyed the villages of El Porvenir and Rolando Rodriguez, located about 2 miles downstream from the avalanche mass. More than 2,000 people were killed at these locations. Another 1.5 miles downstream, the debris flow expanded to its maximum width of about a mile. Most of the remaining sediment was deposited in this area, but two narrow fingers of debris flowed an additional 10 miles downstream, following existing channels. The eastern finger of the debris flow material reached the village of Posoltega, where it destroyed houses on the east side of town. Many other villages were partially or completely destroyed by the rock avalanche and debris flows. These include Argelia, Santa Teresa, Santa Narciso, and Las Botijas.

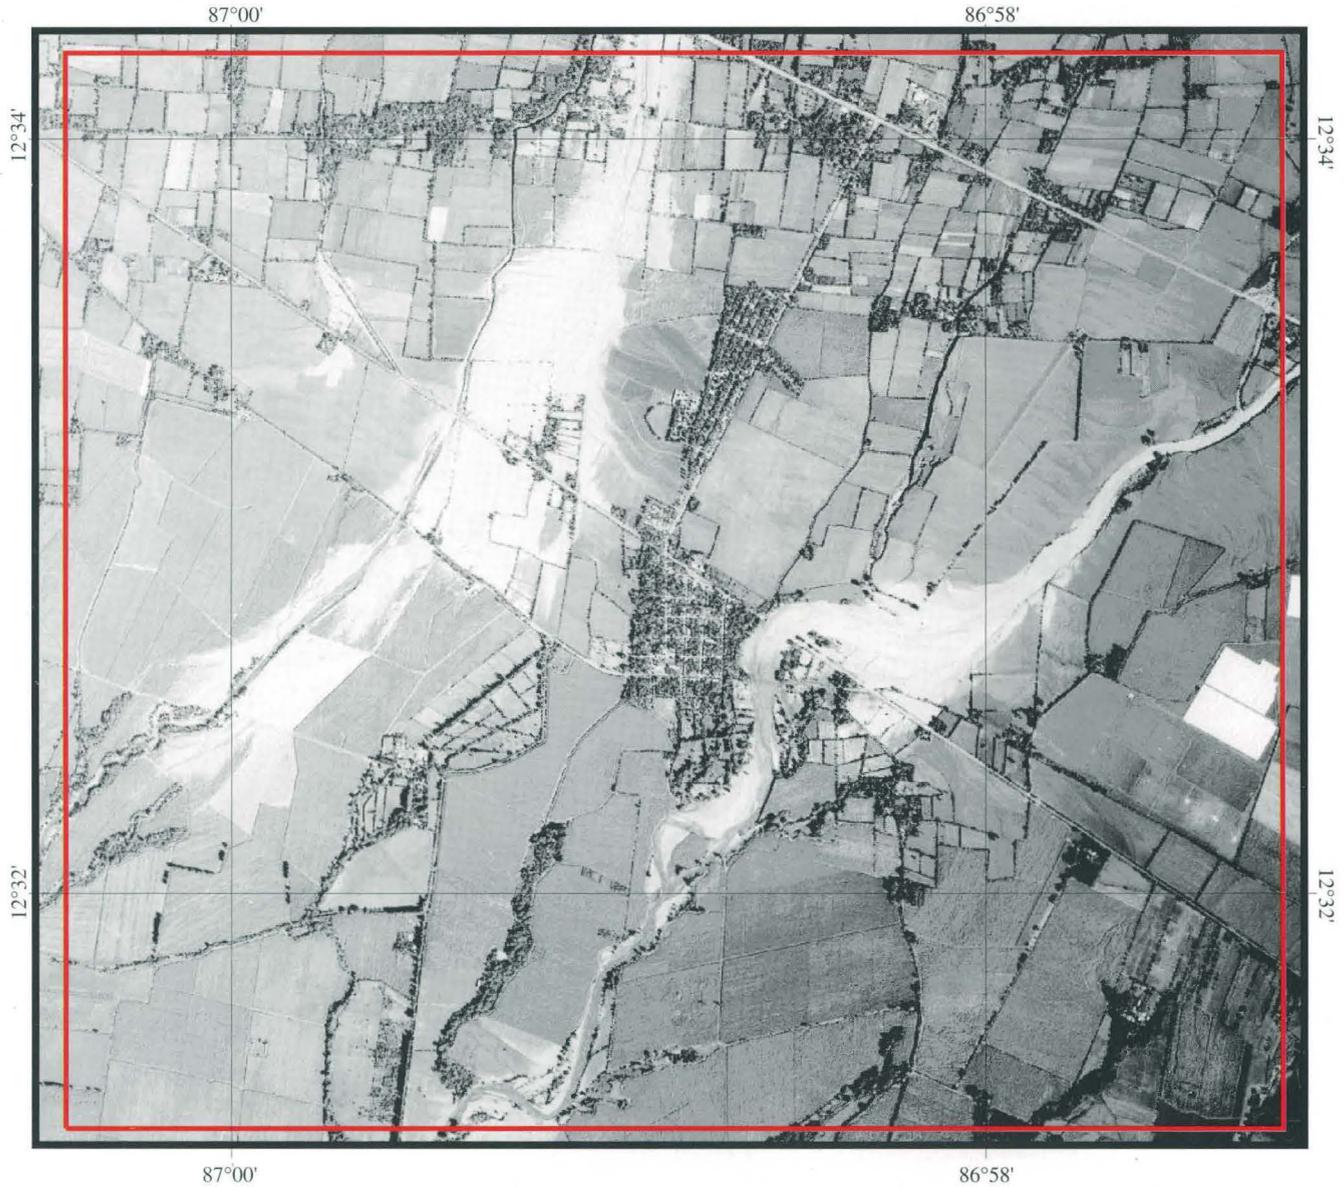
Frame 140-A; Enlargement: ~2.5x

Frame 140-A, a 2.5x enlargement, showing the path of two finger-like limbs of the southern end of the Casita Volcano debris flow, which covered and breached the Inter-American Highway and the local railroad line. The eastern limb flowed through the village of Posoltega, while the western limb flowed through the Valle Las Mayorga. Manmade structures were destroyed at both locations.

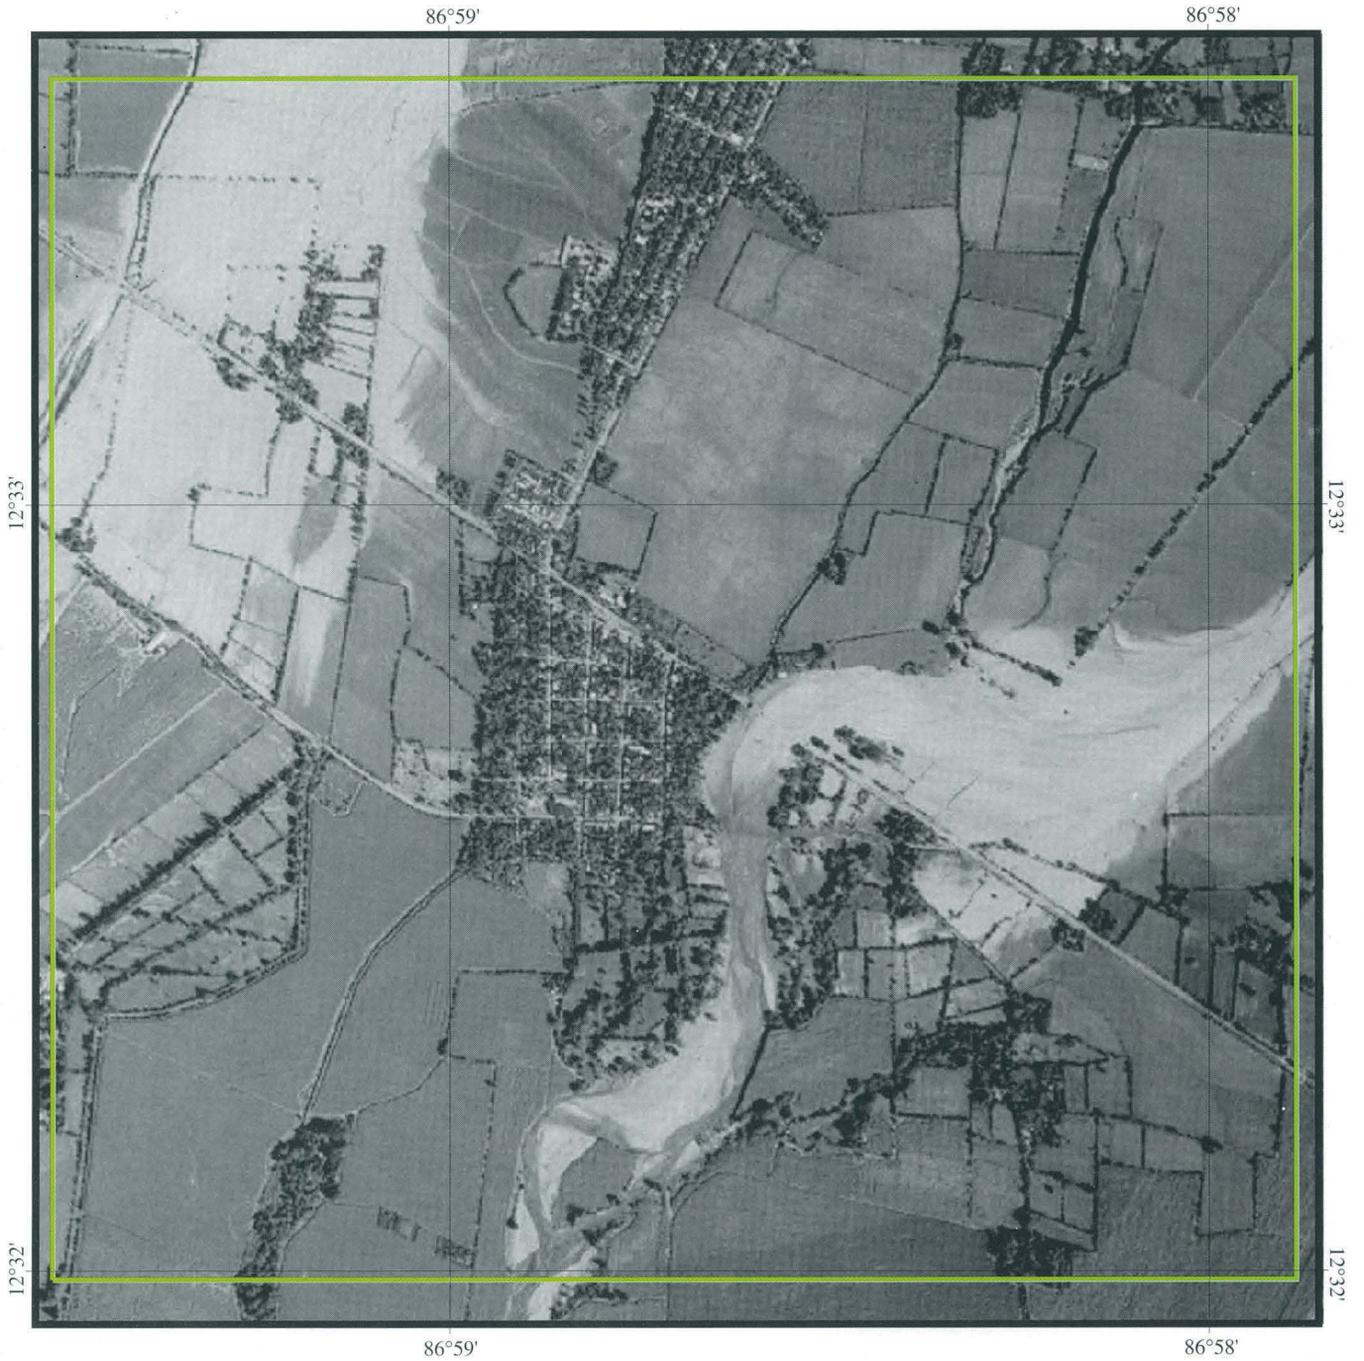
Frame 140-B; Enlargement: ~5x

Frame 140-B, a 5x enlargement, showing parts of the path and the deposits of the Casita Volcano debris flow near the village of Posoltega and the Valle Las Mayorga.

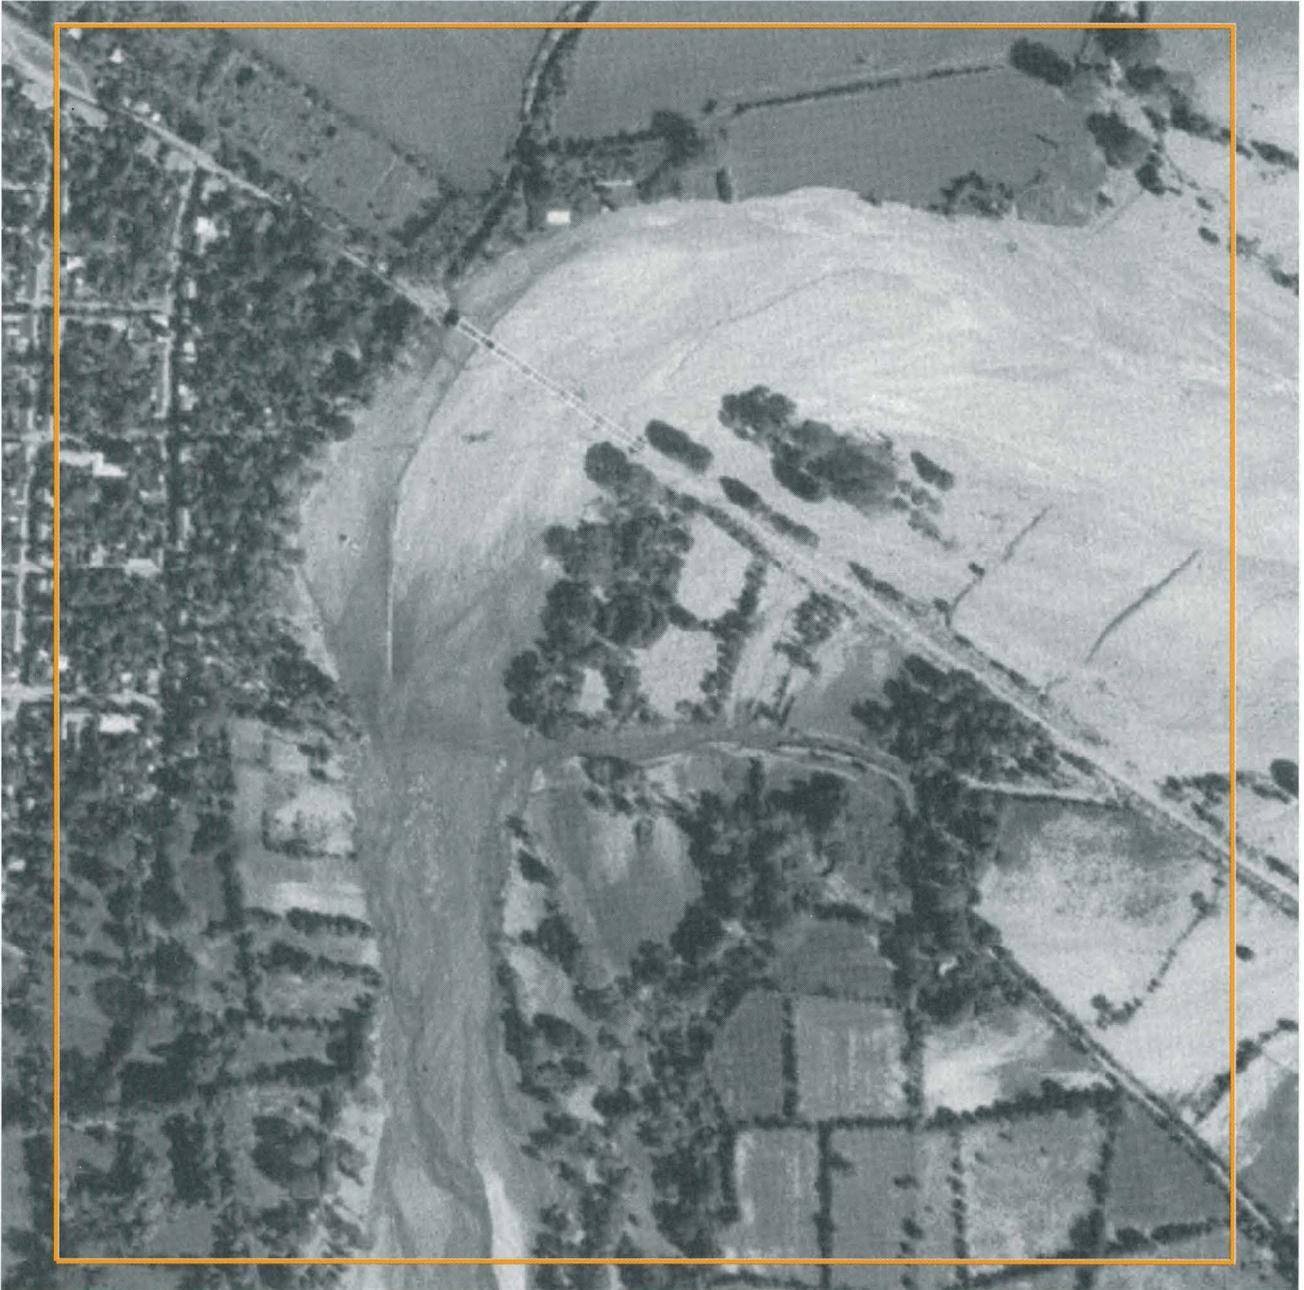
Frame 140-C; Enlargement: ~17x

Frame 140-B, a 17x enlargement, showing the path, the deposits, and some of the damage to manmade structures in the village of Posoltega caused by the Casita Volcano debris flow.

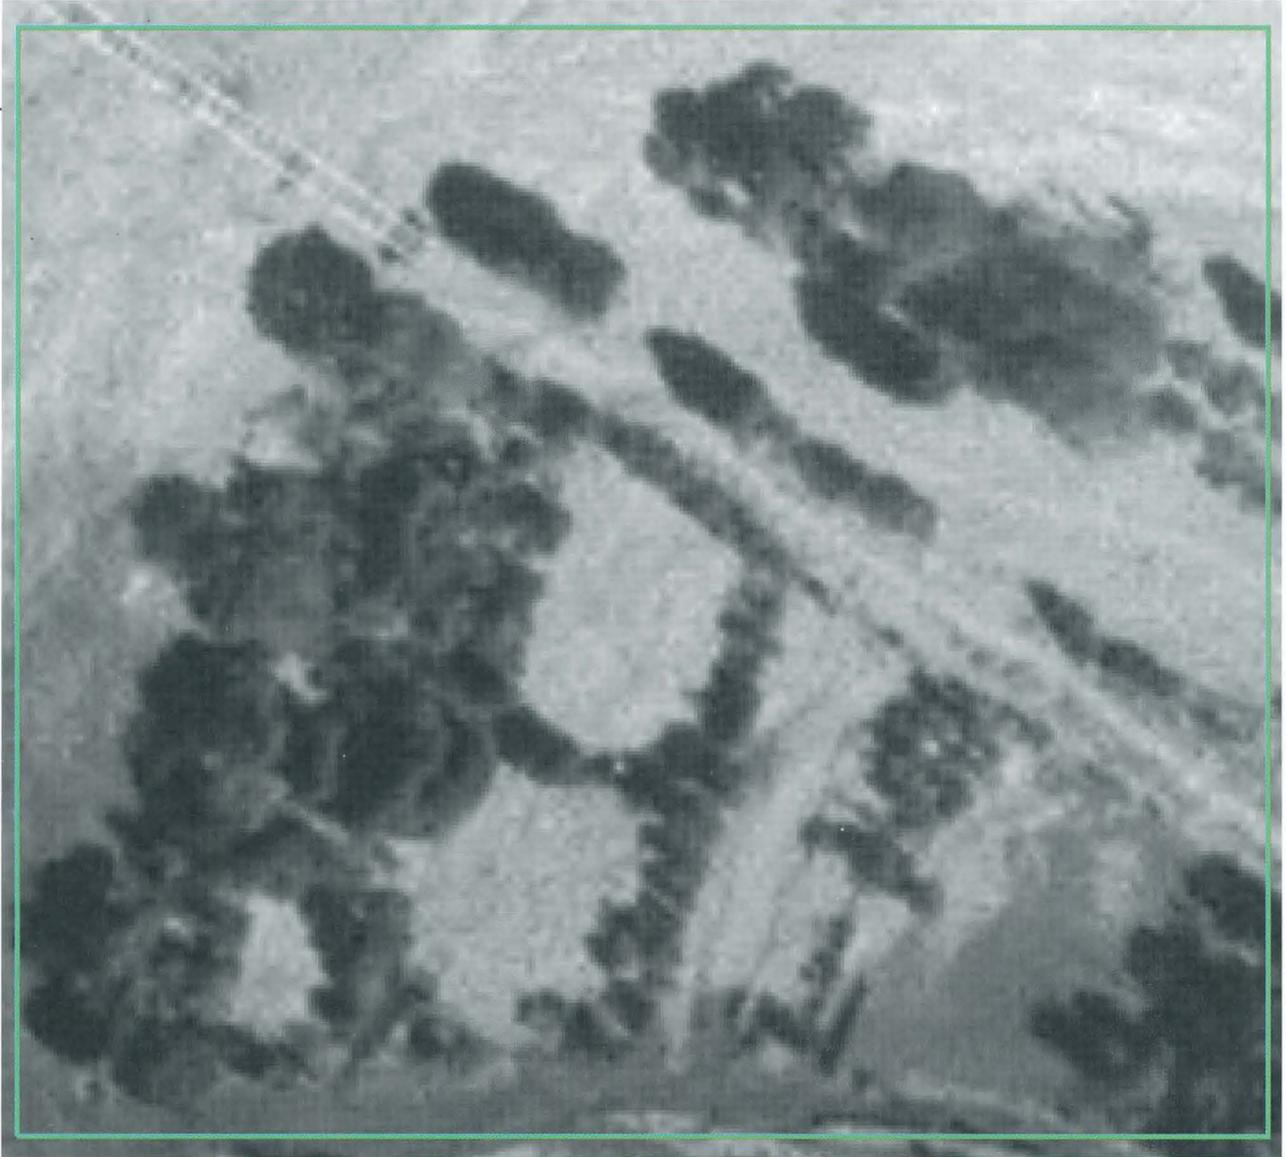
Frame 140-D1; Enlargement: ~45x

Frame 140-D1, a 45x enlargement of the destroyed railroad tracks east of Posoltega. Individual boulders show as bright reflections in the volcanic debris flow deposits.

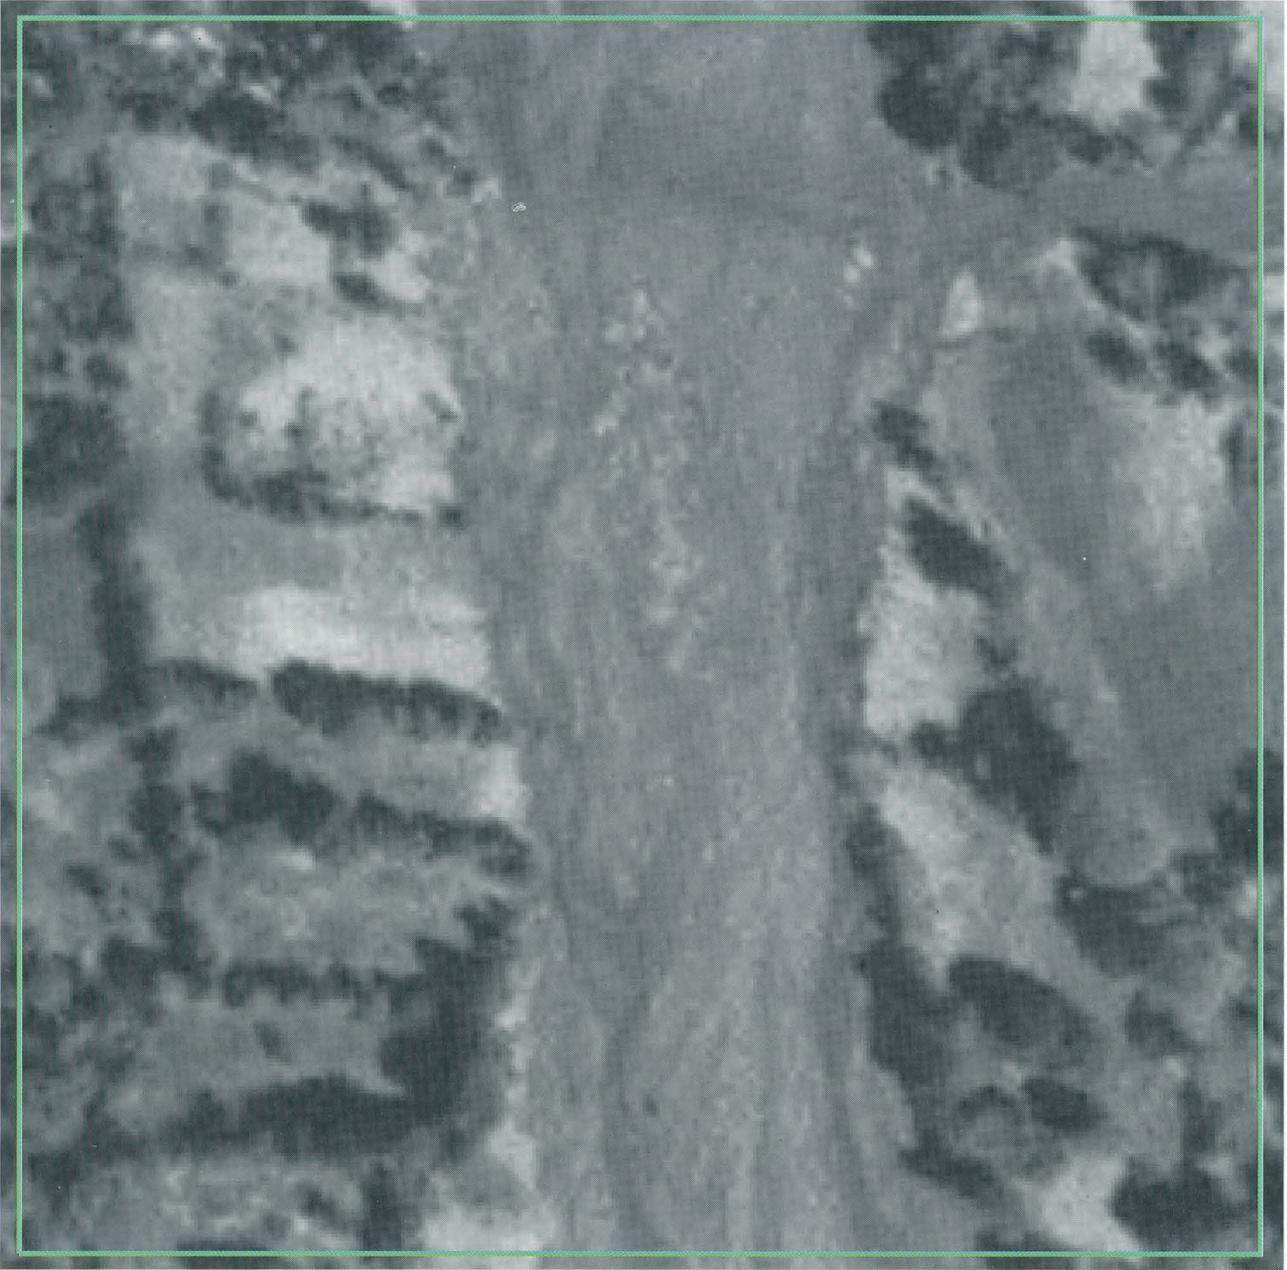
Frame 140-D2; Enlargement: ~45x

Frame 140-D2, a 45x enlargement of the main pathway of the volcanic debris flow through the east side of the village of Posoltega. Many houses and other structures were destroyed at this location.

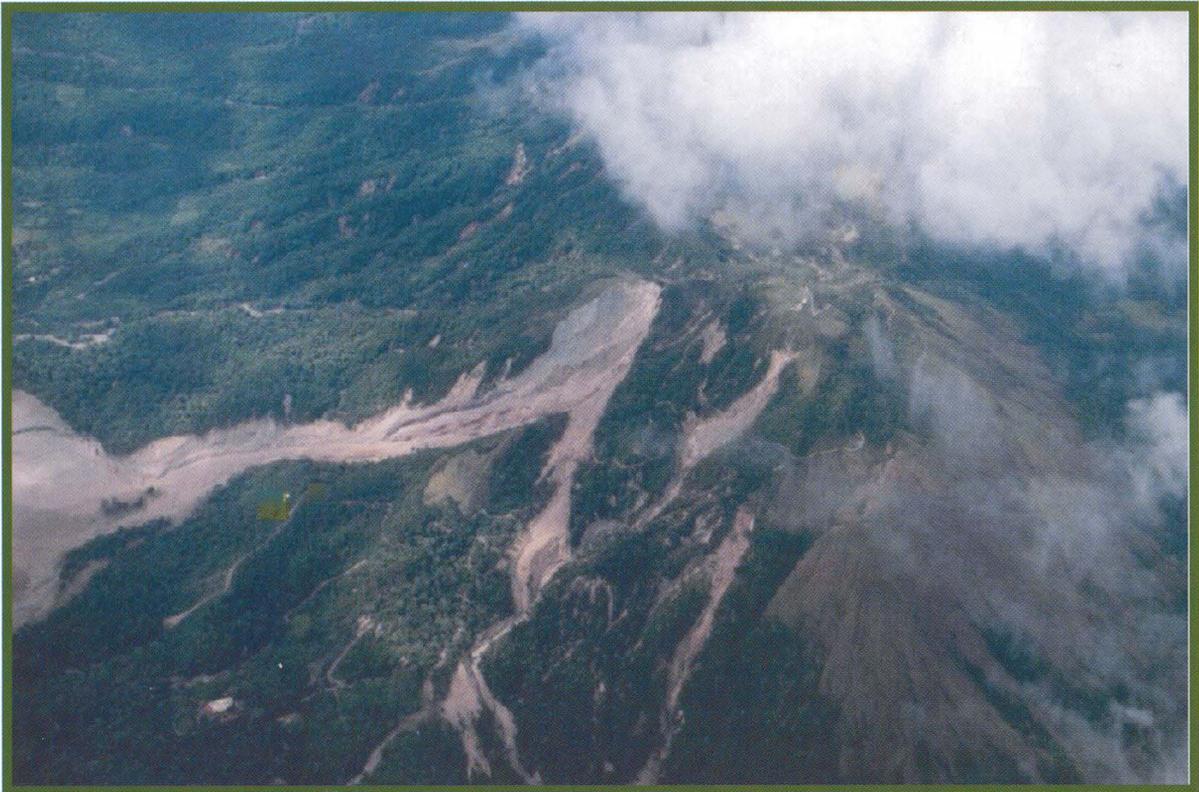
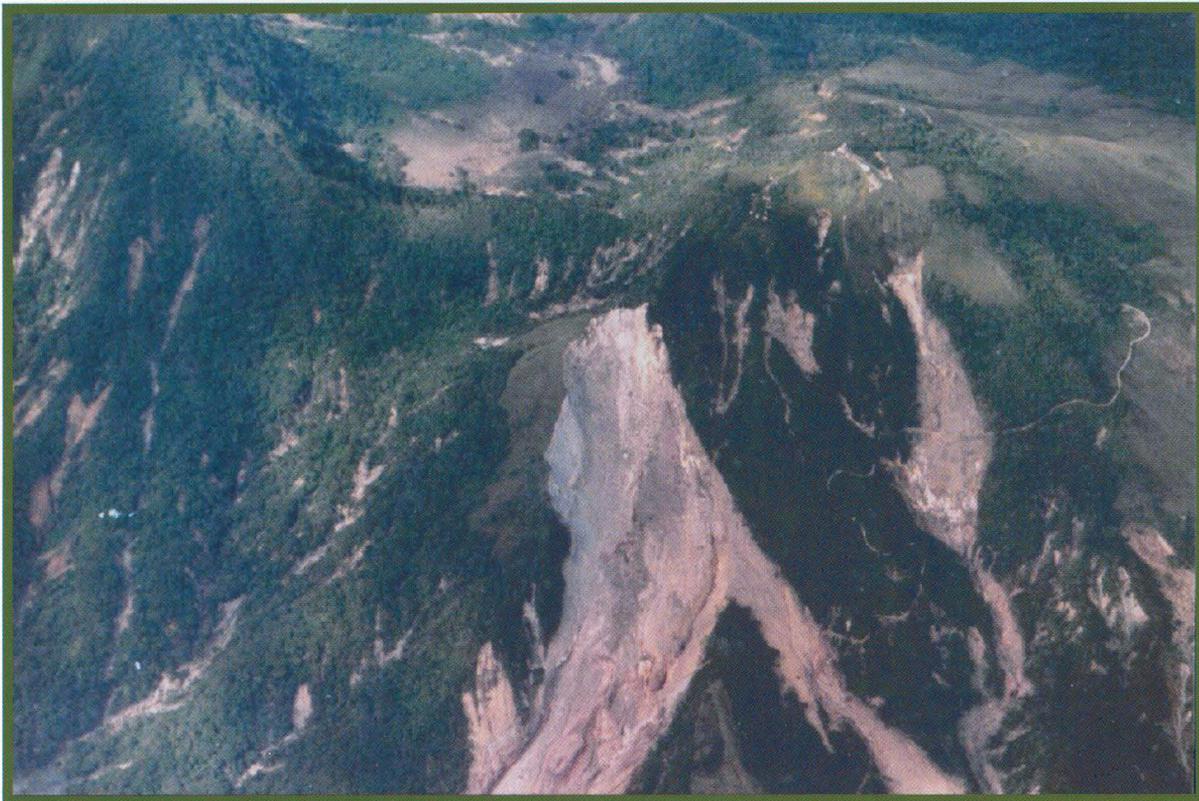
# Casita Volcano

These oblique color photographs show the point of origin near the summit of Casita Volcano of the large rock avalanche and debris flow shown in the next series of enlargements. Additional oblique photographs begin on page 67. (USGS photographs by Bruce F. Molnia – OS-3 at top and OS-4 at bottom – December 15, 1998)

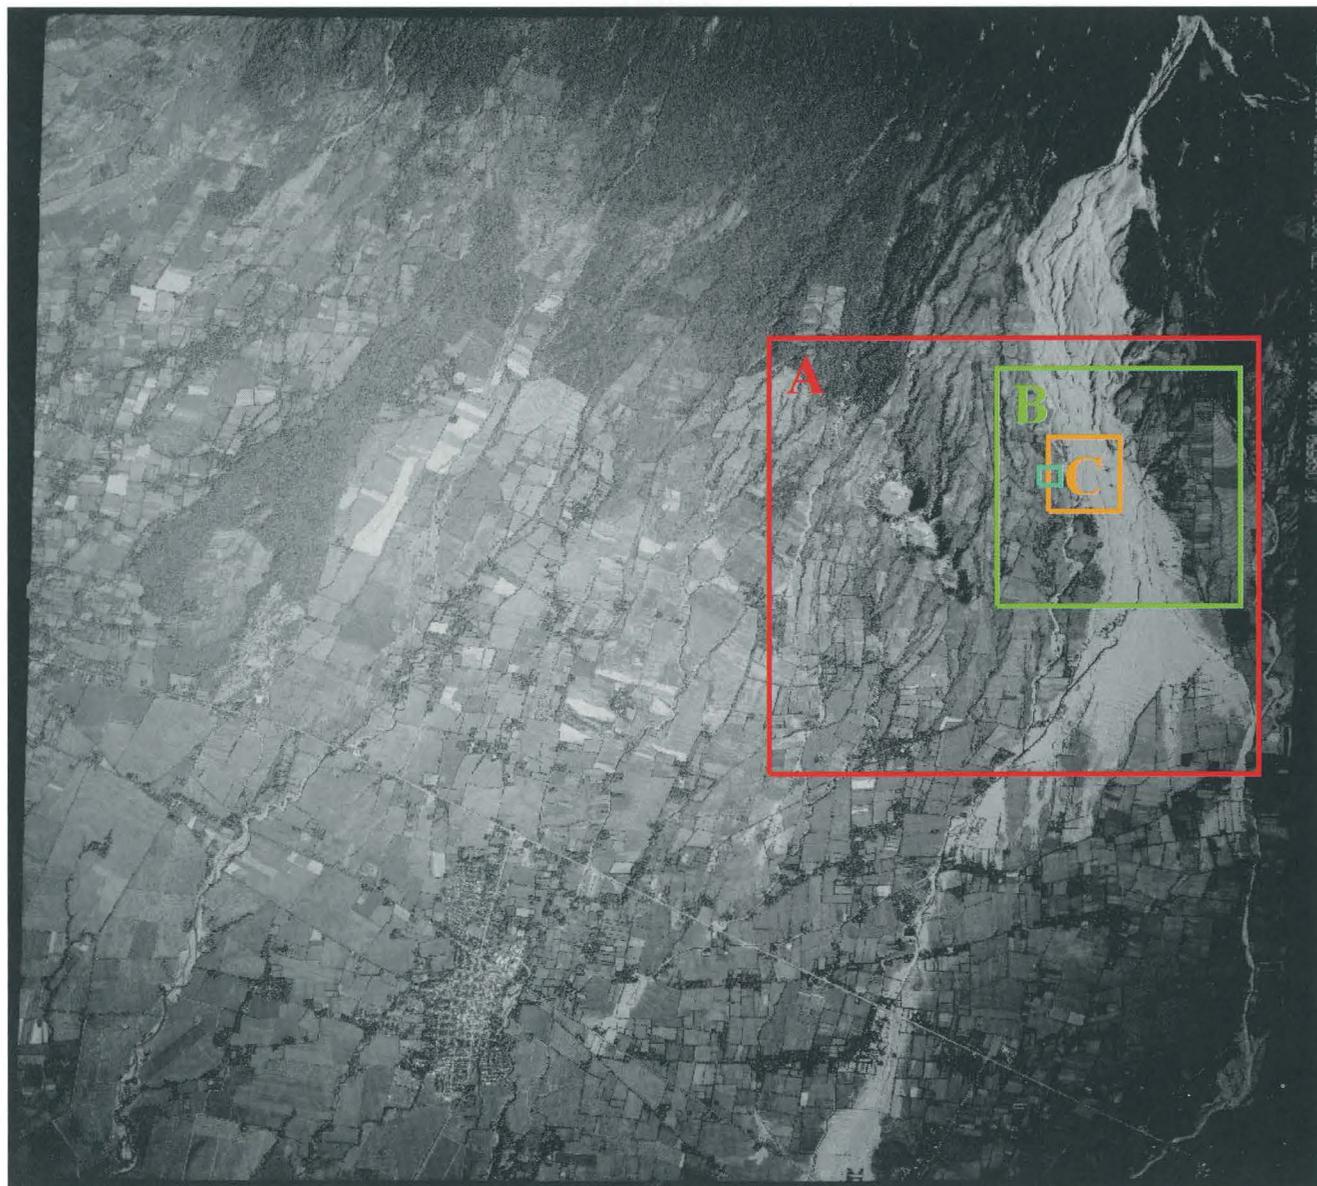
Frame 141

Locations of enlargements A, B, C, and D are shown as red, green, orange, and blue boxes. Enlargements are ~2.5x, ~5x, ~17x, and ~55x, respectively.

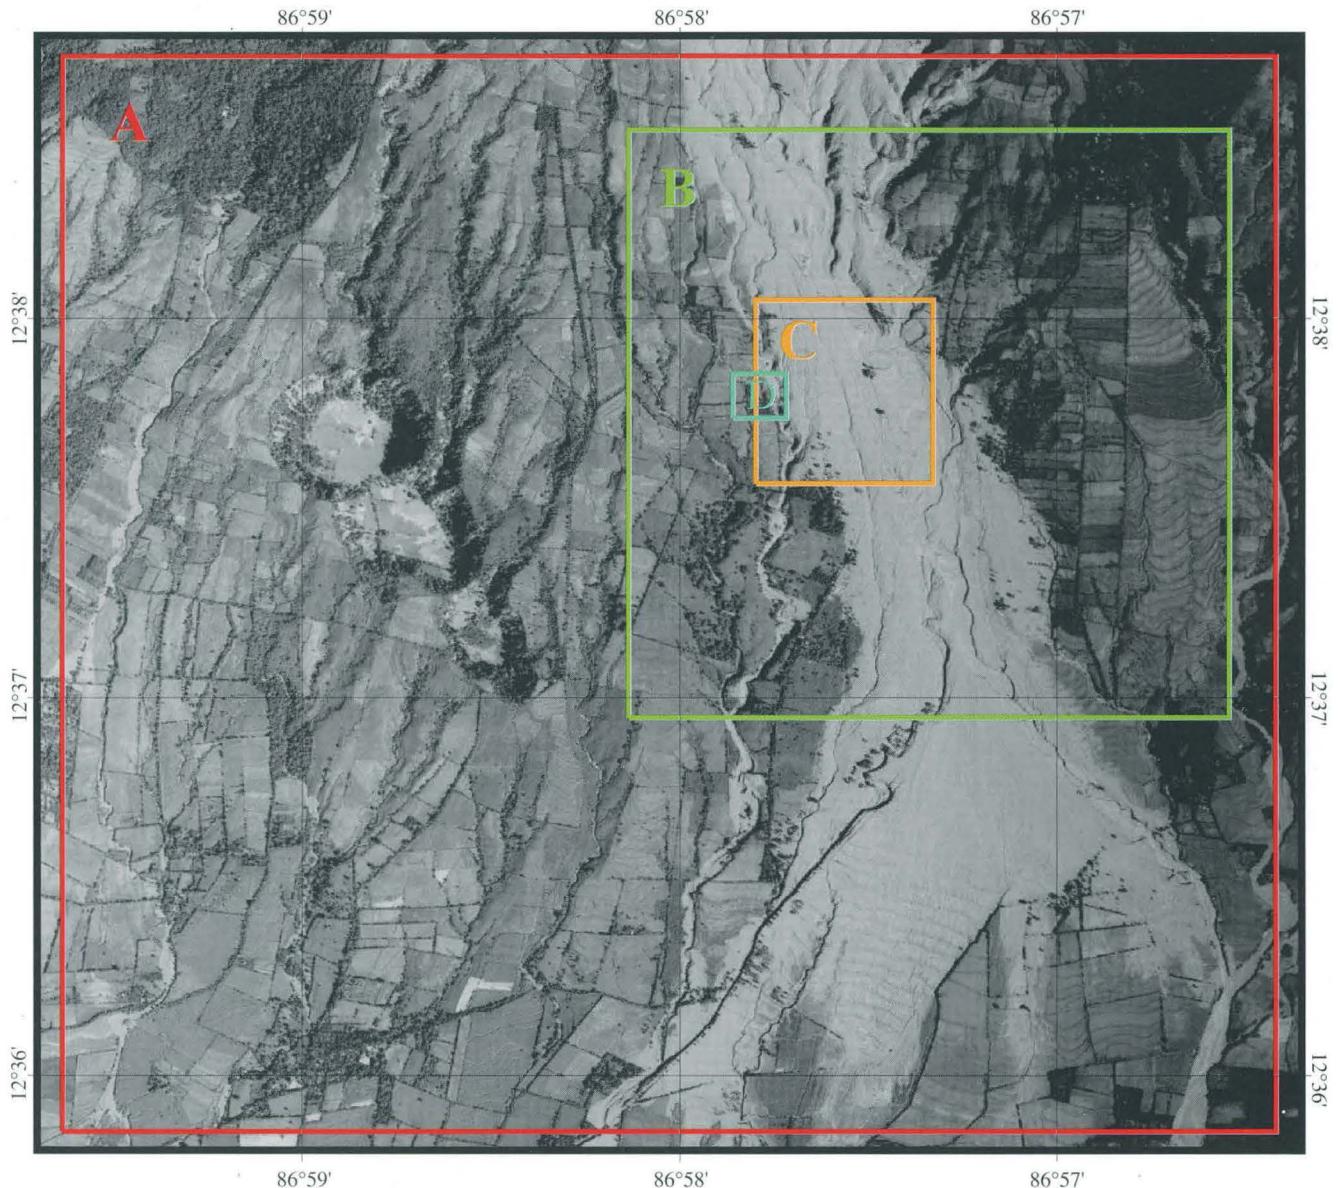
## Frame 141-A

The green, orange, and blue boxes represent the locations of the three areas shown as Enlargements B, C, and D on the following pages. The location of El Porvenir is shown on the accompanying map. Rolando Rodriguez, located to the east of El Porvenir, is not shown because its construction postdates the printing of the map.
