# Open Skies Aerial Photography of Selected Areas in Central America Affected by Hurricane Mitch

U.S. Geological Survey Circular 1181

**By Bruce F. Molnia and Cheryl A. Hallam**

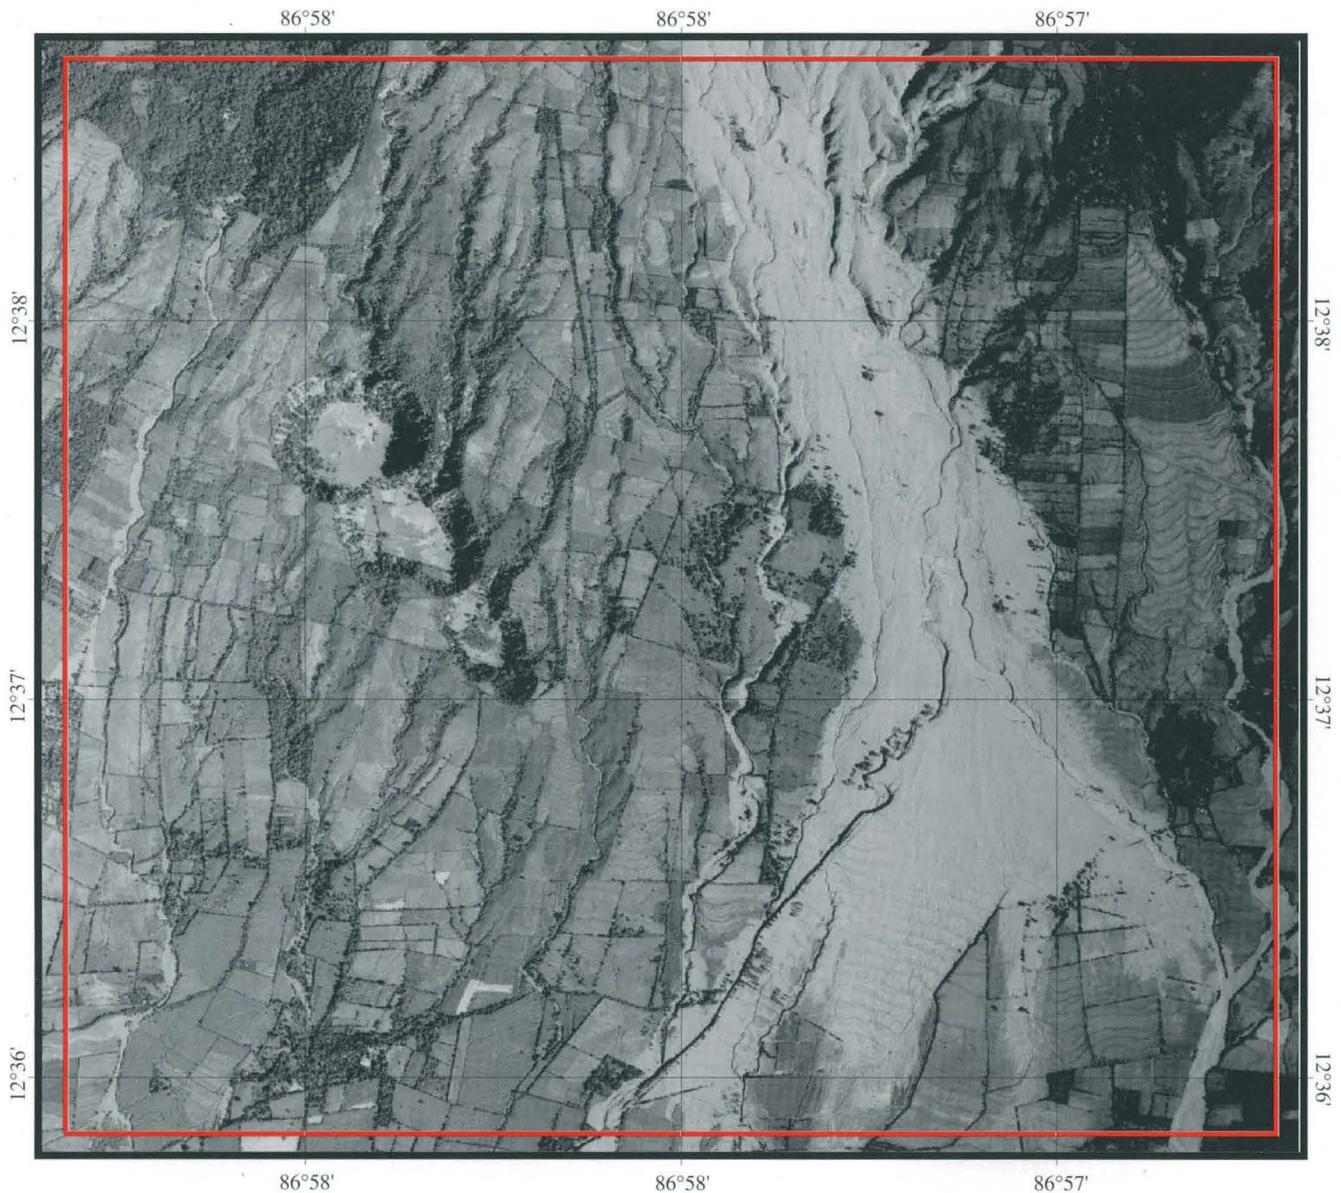
Frame 141-A; Enlargement: ~2.5x

Frame 141-A, a 2.5x enlargement, showing agricultural fields and most of the upper part of the debris-flow deposits in the vicinity of the villages of El Porvenir and Rolando Rodriguez. The location of El Porvenir is shown on the accompanying map. Rolando Rodriguez, located to the east of El Porvenir, is not shown because its construction postdates the printing of the map.

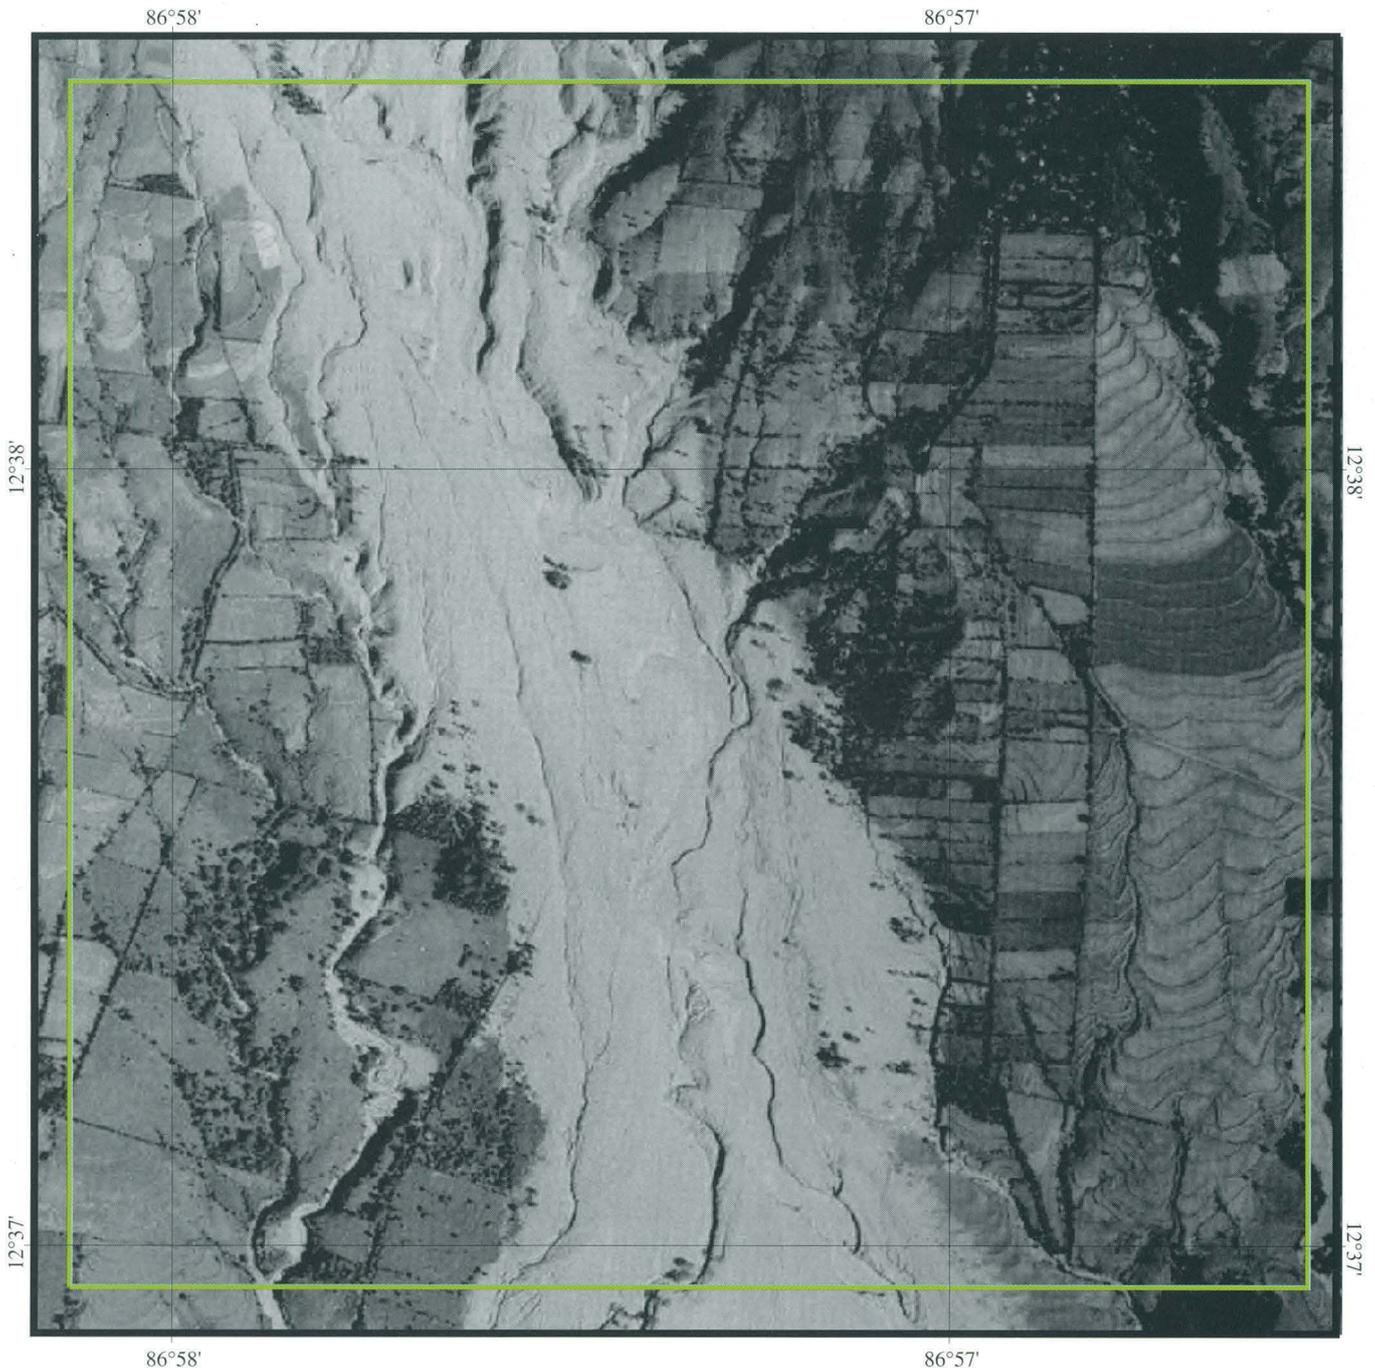
Frame 141-B; Enlargement: ~5x

Frame 141-B, a 5x enlargement, showing the main path of the volcanic debris-flow that covered the villages of El Porvenir and Rolando Rodriguez. Channels in the sediment deposits and sediment-covered terraces in adjacent farm fields can be seen. No trace of either village can be seen. The location of El Porvenir is shown on the accompanying map. Rolando Rodriguez, located to the east of El Porvenir, is not shown because its construction postdates the printing of the map.

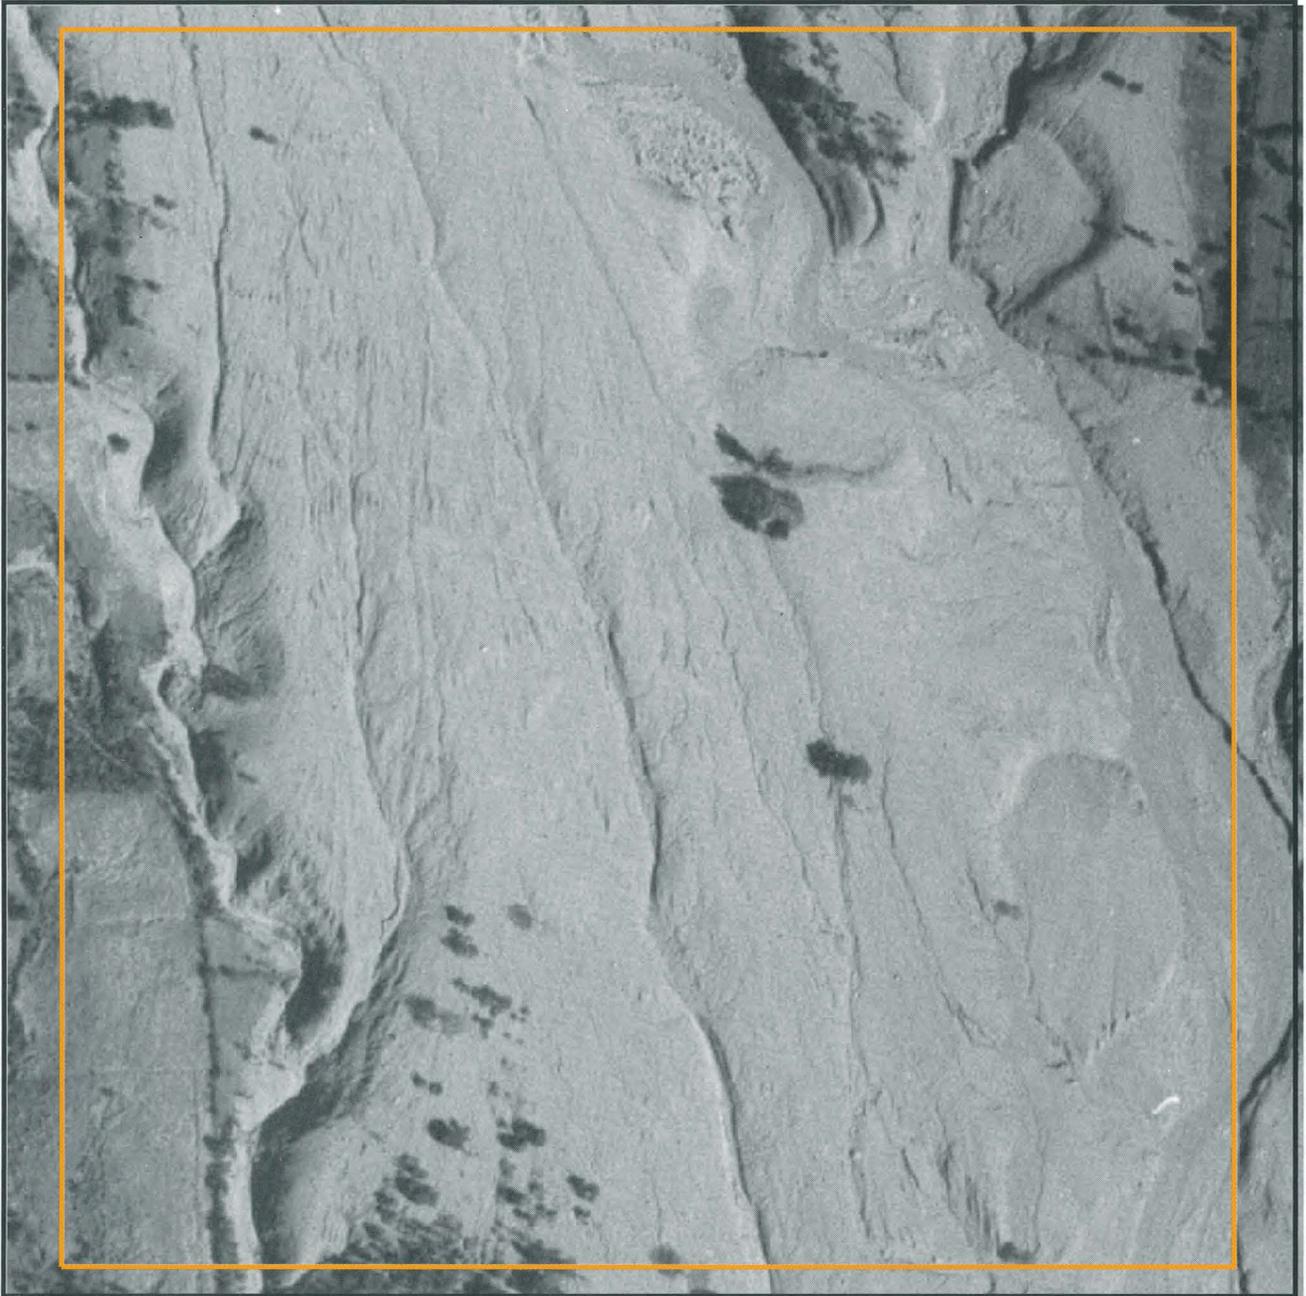
Frame 141-C; Enlargement: ~17x

Frame 141-C, a 17x enlargement, showing the area previously occupied by the villages of El Porvenir and Rolando Rodriguez. Both villages were completely destroyed by the debris flow. The location of El Porvenir is shown on the accompanying map. Rolando Rodriguez, located to the east of El Porvenir, is not shown because its construction postdates the printing of the map.

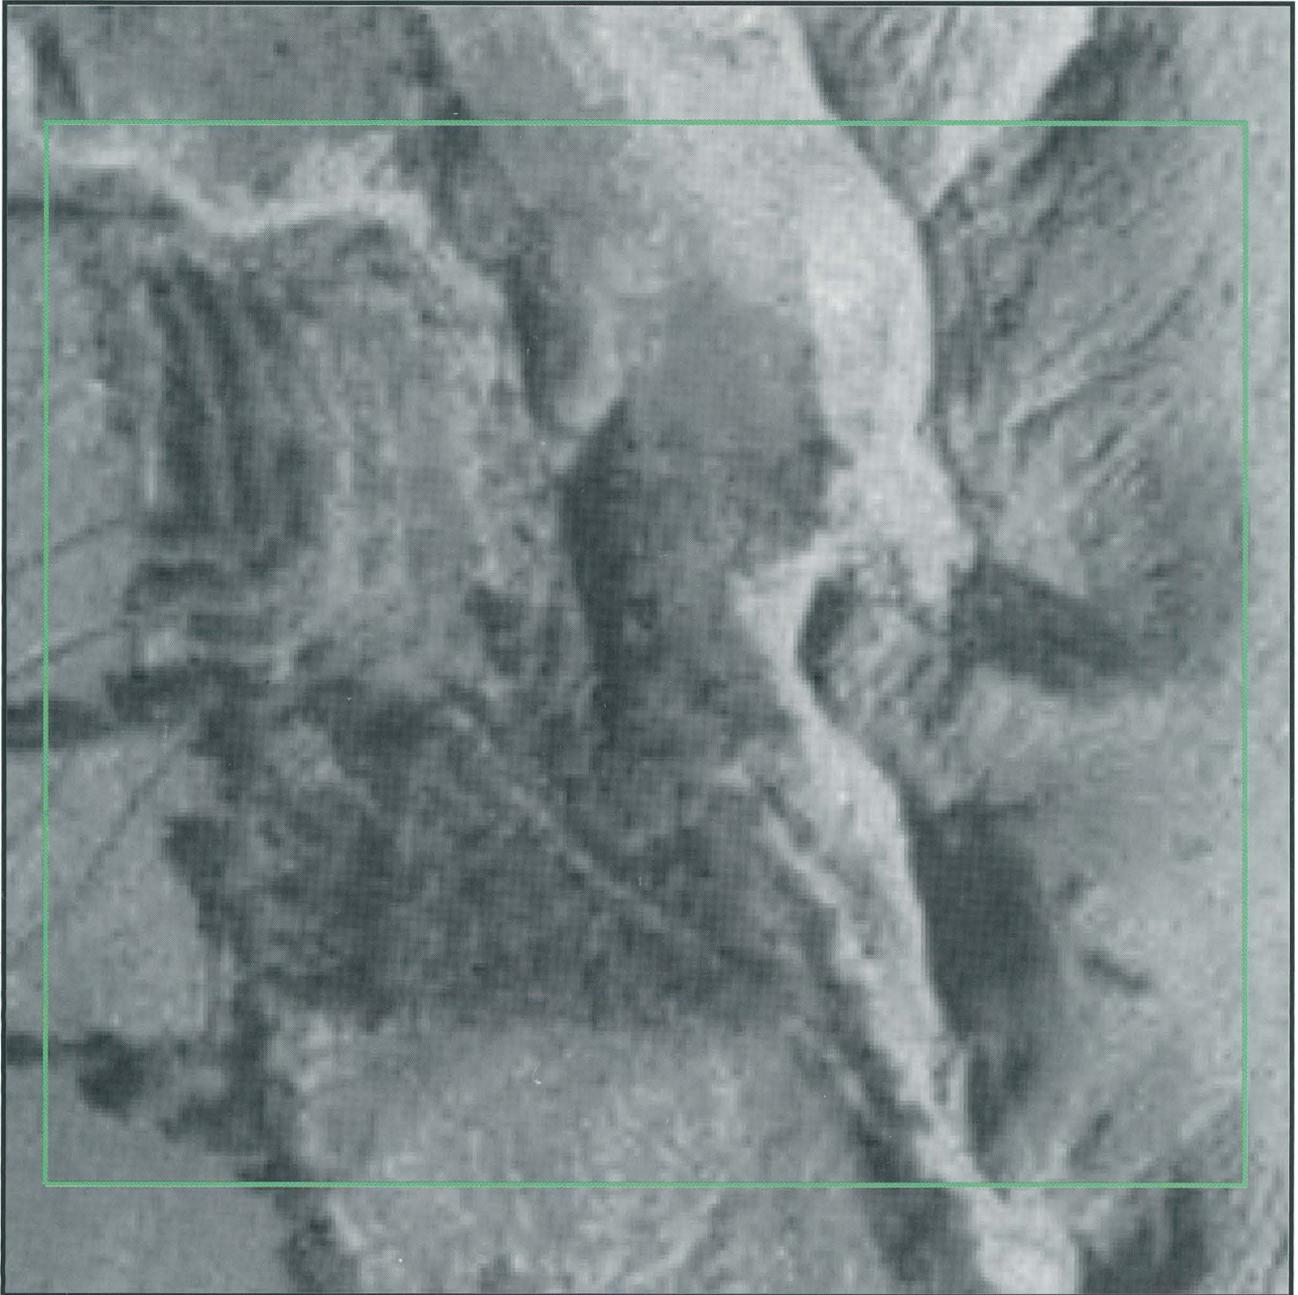
Frame 141-D; Enlargement: ~55x

Frame 141-D, a 55x enlargement, showing a channel and levee that developed on the west side of the debris-flow deposits near the site of the village of El Porvenir. The village was located on the right edge of the photograph. The former location of the main road to the village cuts across the center of the enlargement.

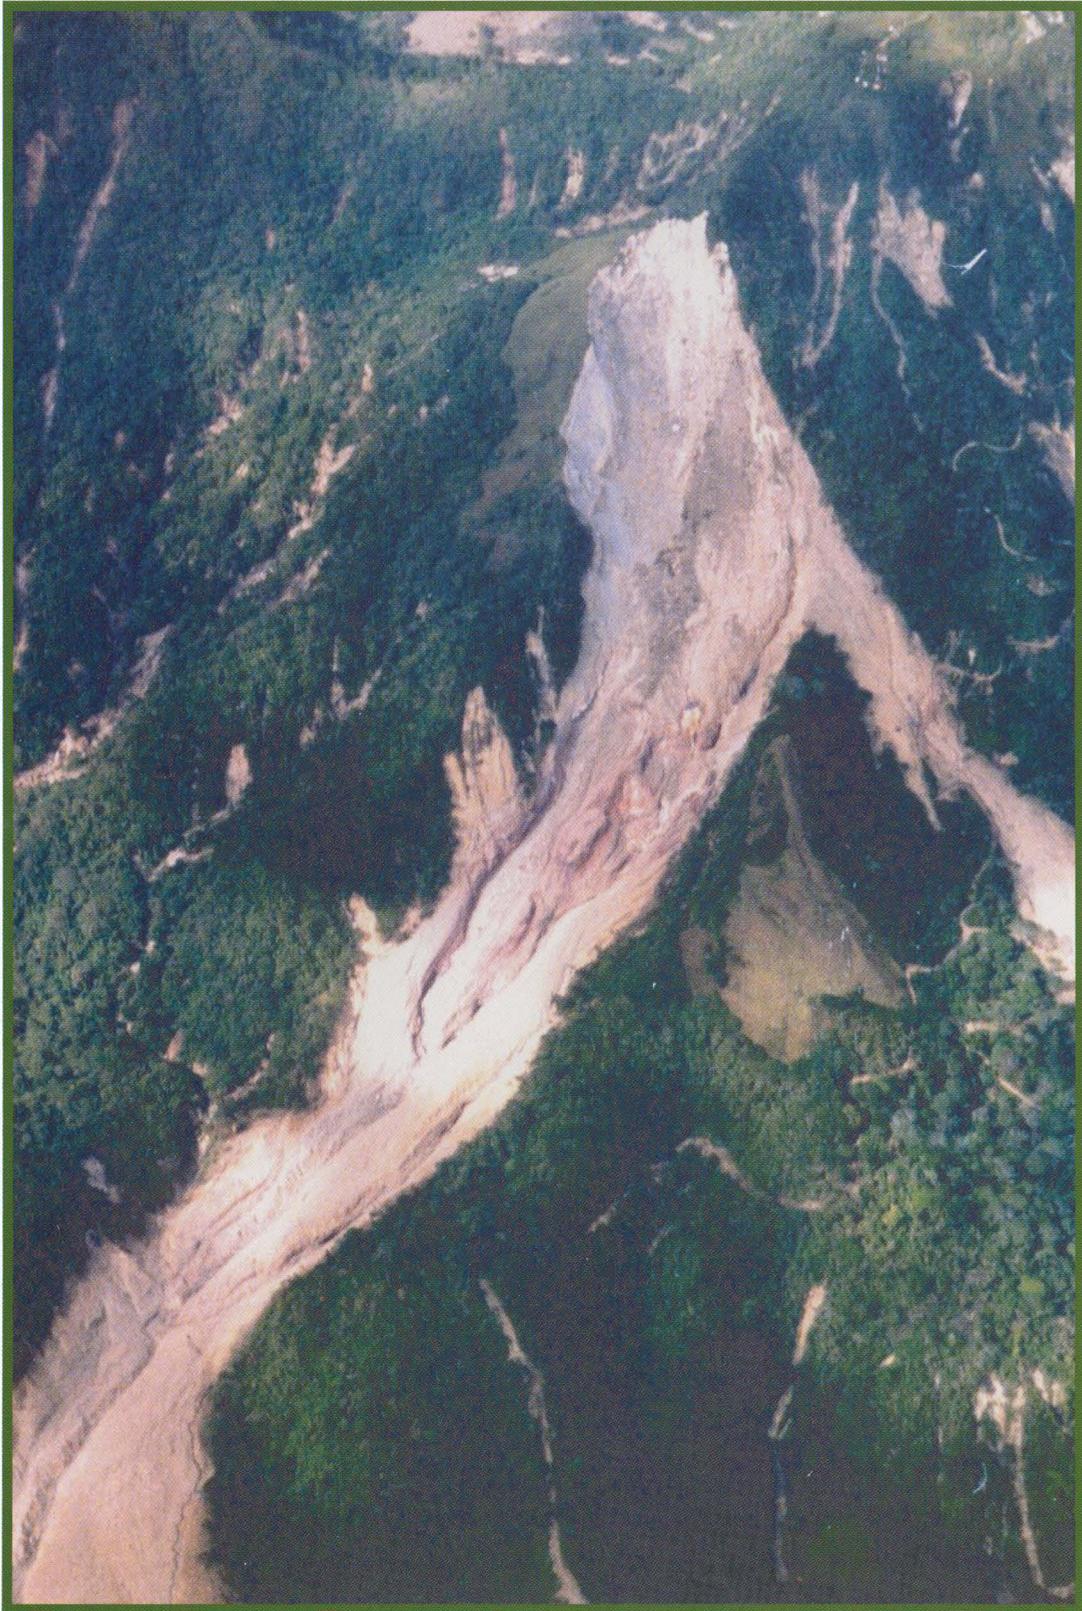
OS-34. A close-up of the location of the large rock avalanche on the south flank, just below the summit of Casita Volcano. Many smaller landslide scars are also visible. Compare with Open Skies vertical black-and-white frame 141 and oblique color photograph OS-1.

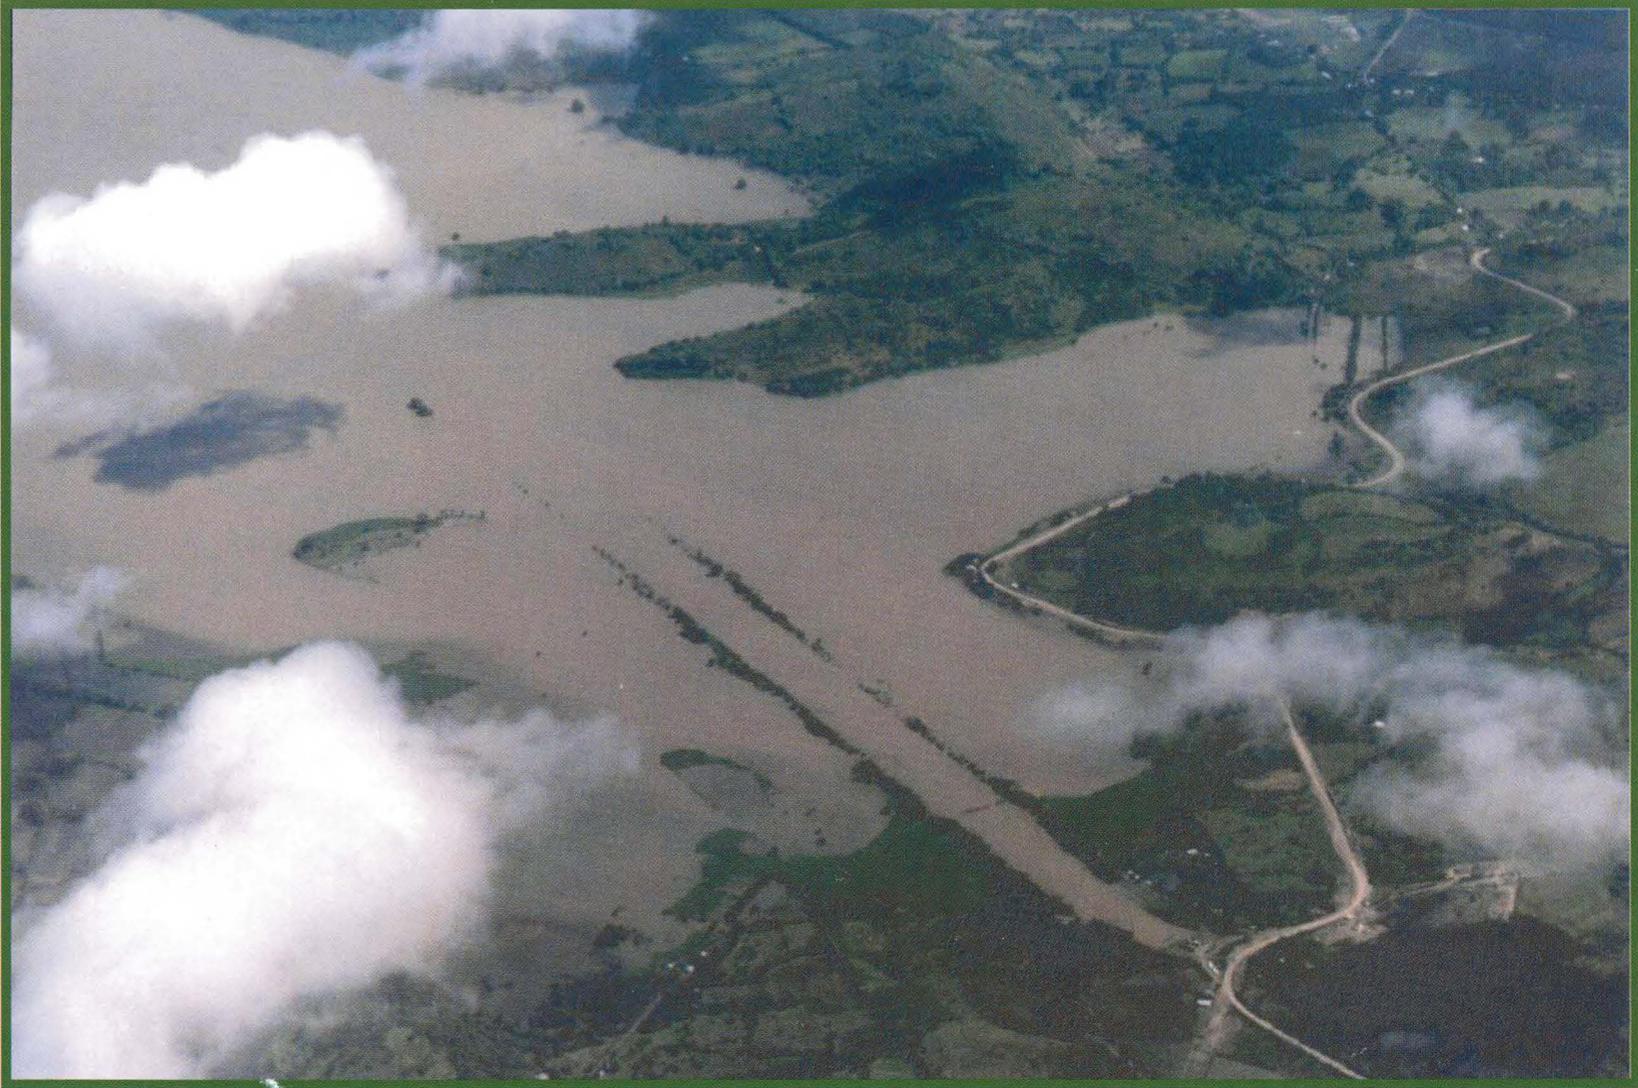
# Lago de Managua, Nicaragua

OS-18. Lago de Managua and other Nicaraguan lakes suffered significant flooding. Here, northwest of Managua, numerous farm buildings and fields are under water. The water level rose as much as 15 feet in some lakes. Compare with Open Skies vertical black-and-white frame 427.

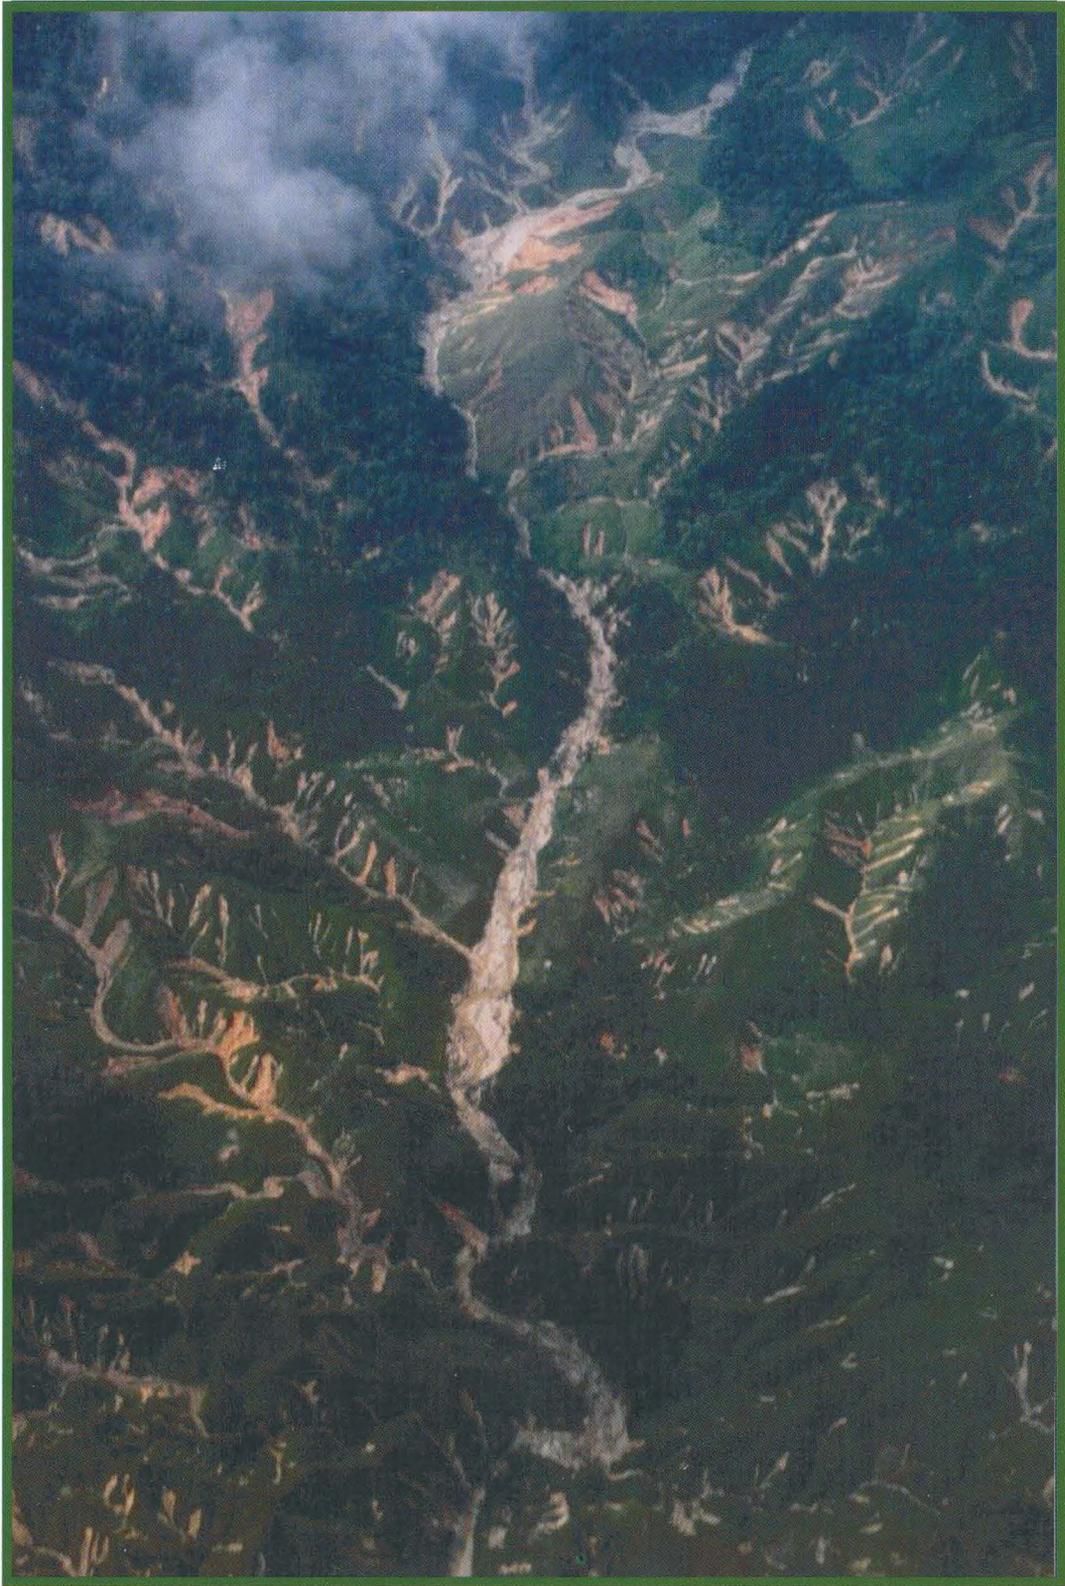
OS-32. The greatest concentration of landslides seen in any of the areas affected by Hurricane Mitch occurred in the mountainous Honduras-Nicaragua border region, northeast of Choluteca. As this region is sparsely populated, little property damage resulted here. Compare with Open Skies vertical black-and-white frames 217, 255, and 420.

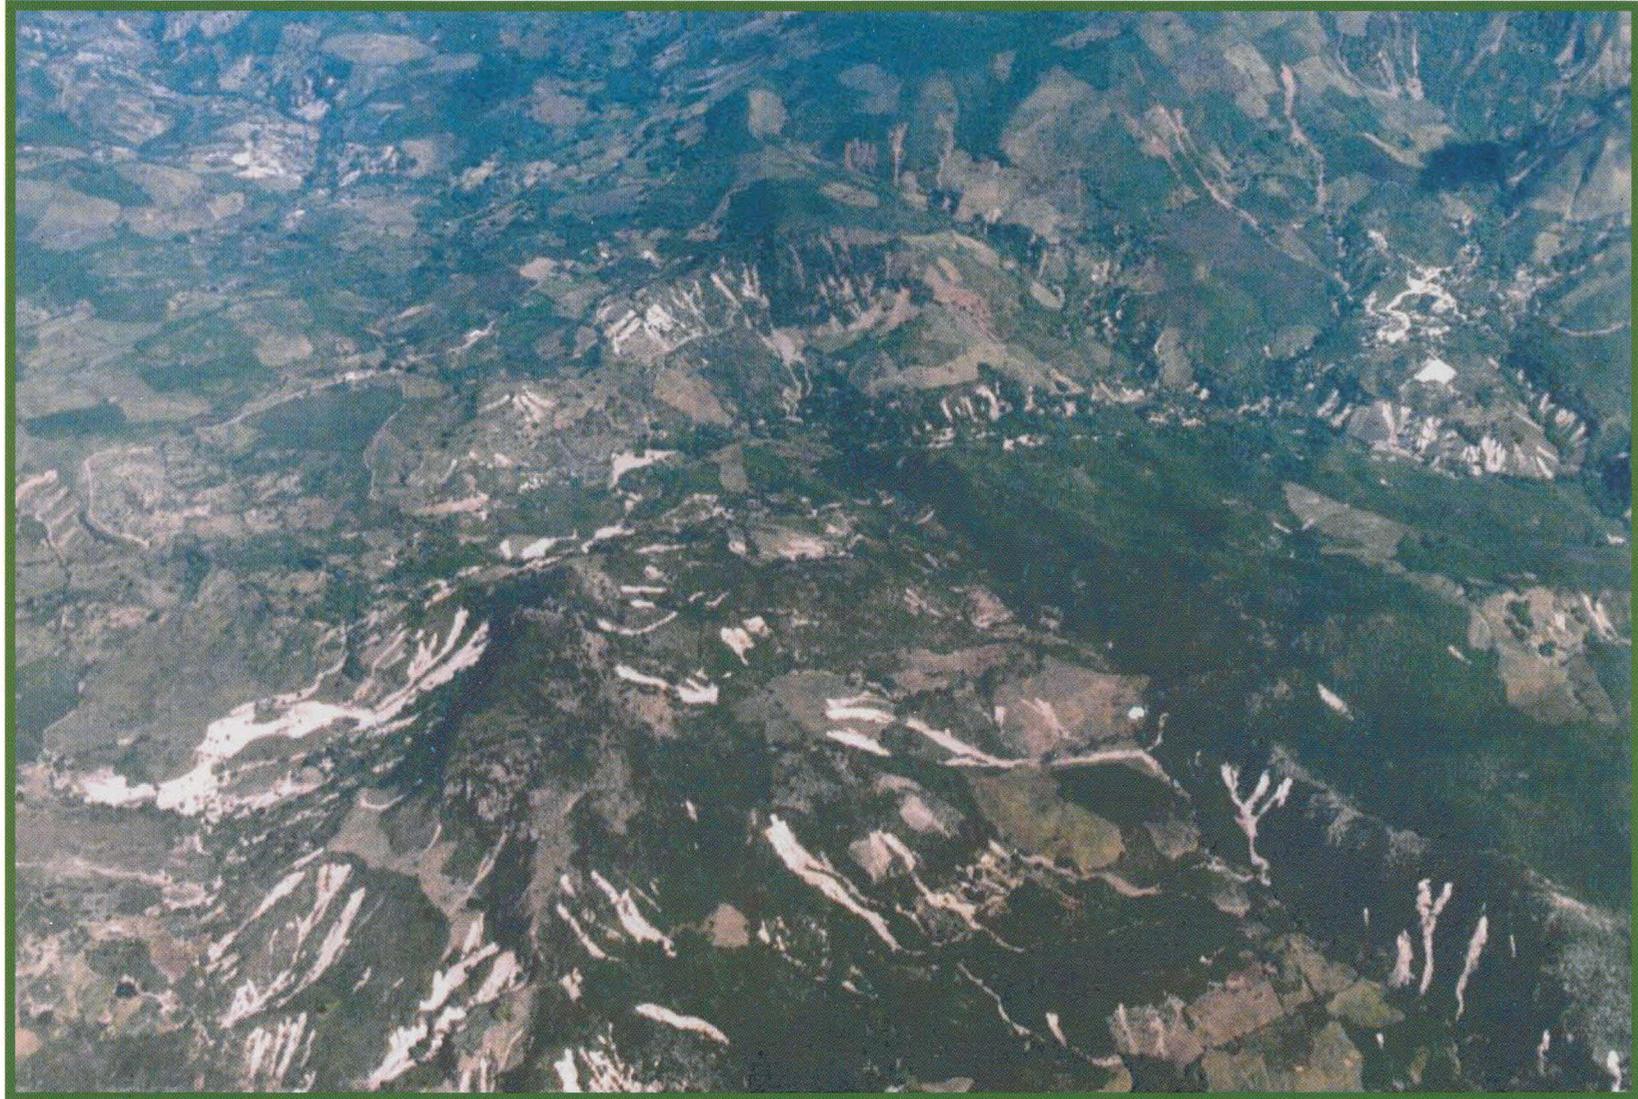
OS-12. Numerous landslides occurred in the mountainous Honduras-Nicaraguan border region, north of Chinandega. As this region is sparsely populated, little property damage resulted here. Compare with Open Skies vertical black-and-white frames 217, 255, and 420.

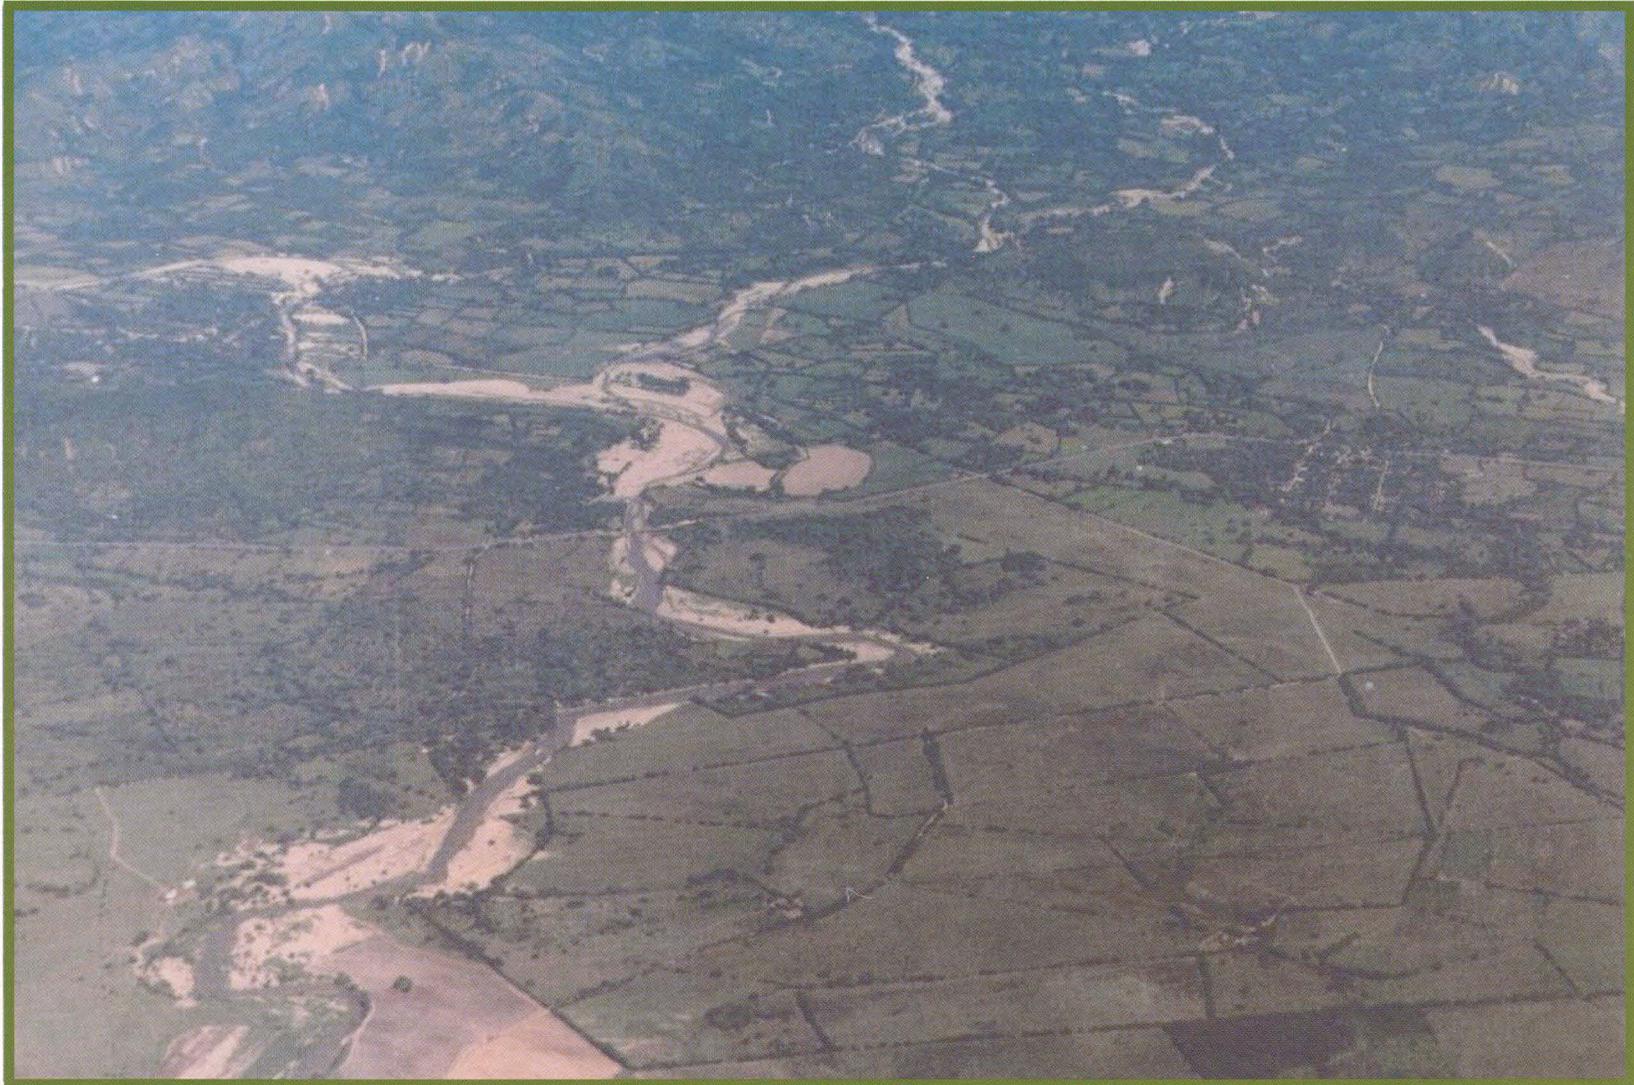
## South-central Honduras

OS-15. This upland area shows significant sediment deposition along the banks and on the floodplain of all of the rivers in this area. Compare with Open Skies vertical black-and-white frames 296 and 316.

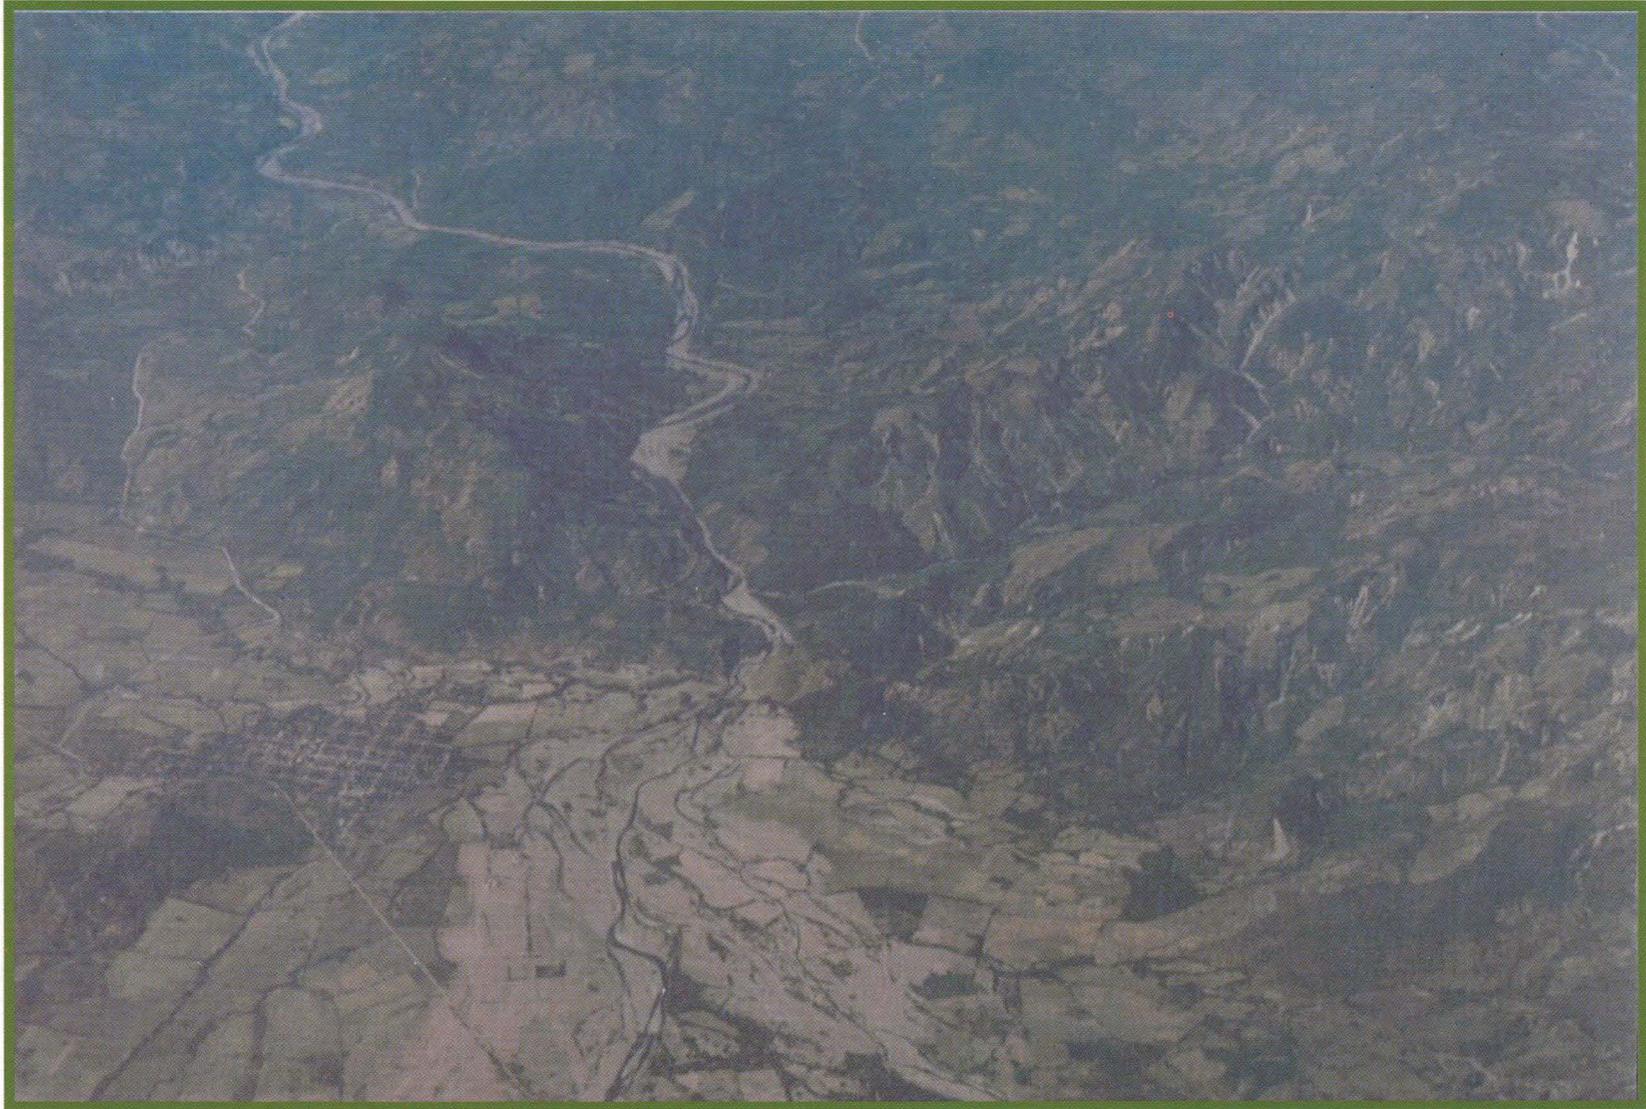
# South-central Honduras

OS-27. When a high-velocity, steep-gradient, sediment-laden river reaches a valley floor, it rapidly deposits its sediment load. Here, at the foot of the mountains, an area larger than a square mile is covered by recently deposited sediment.

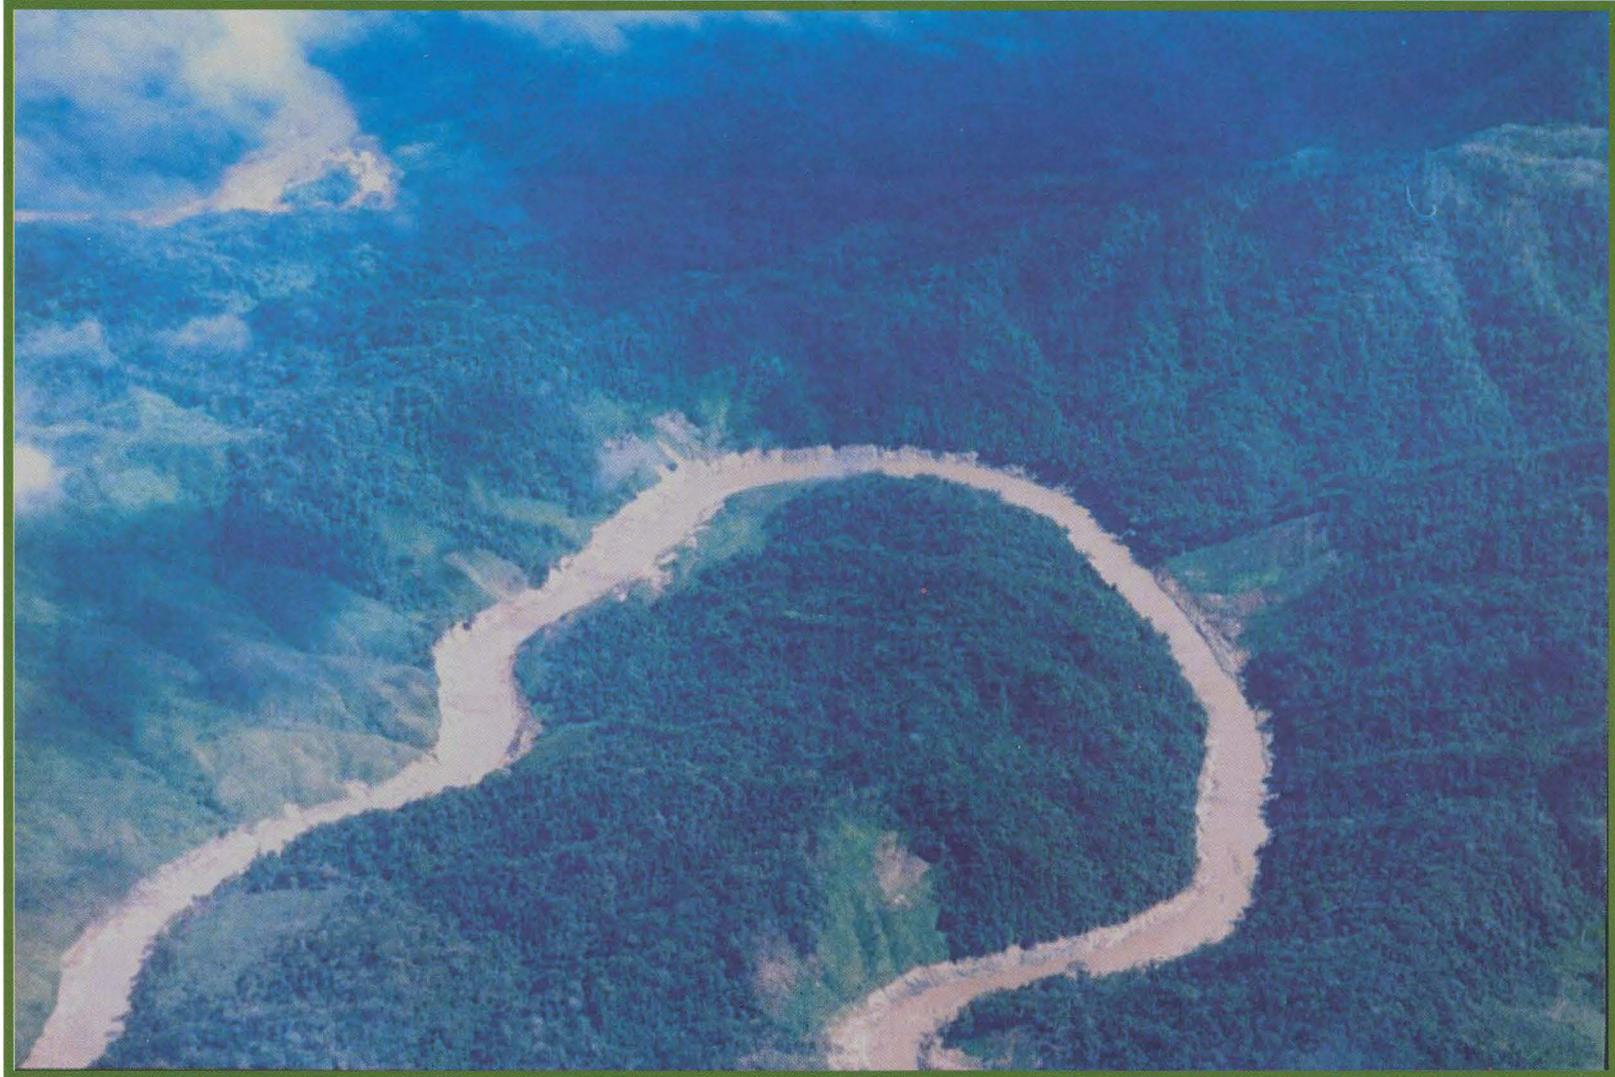
OS-20. Many upland rivers carried so much additional water and sediment during Hurricane Mitch that their banks were scoured many feet above their normal flow level. Here, significant amounts of bank erosion have occurred.

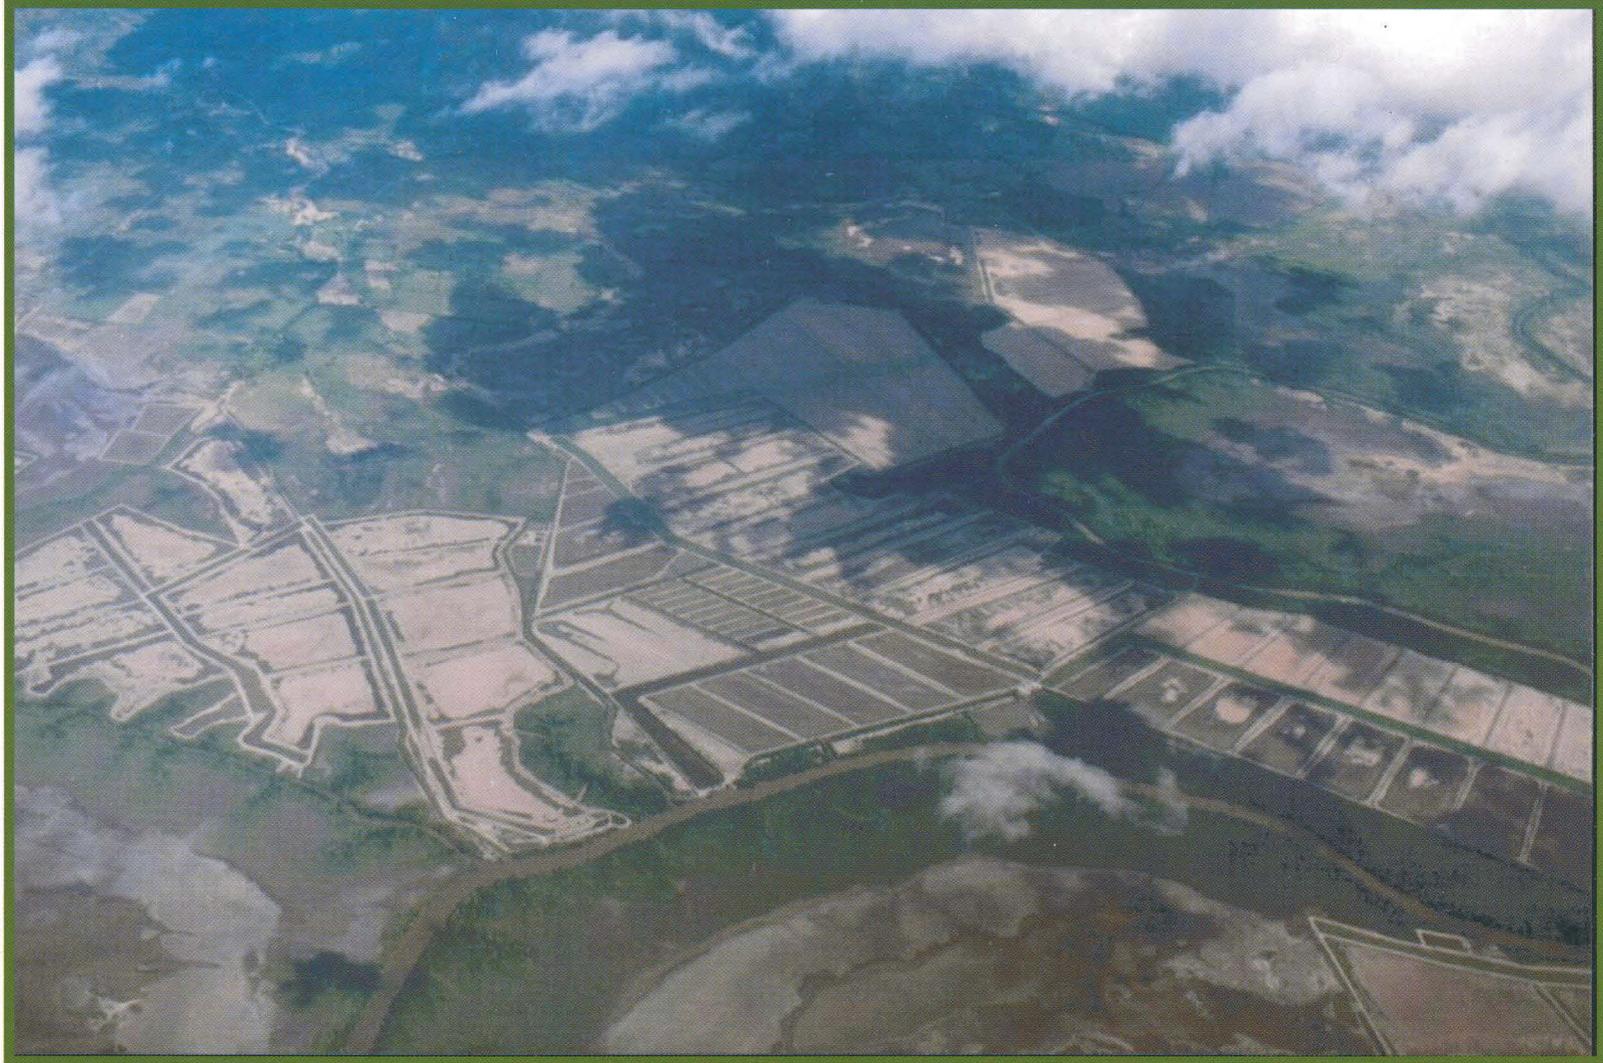
# Southwest of Choluteca, Honduras

OS-5. Sediment deposited by flood waters during Hurricane Mitch filled many of the shrimp ponds in the coastal-plain area southwest of Choluteca, Honduras. Compare with Open Skies vertical black-and-white frames, 72, 94, 125, and 282.
