# Open Skies Aerial Photography of Selected Areas in Central America Affected by Hurricane Mitch

U.S. Geological Survey Circular 1181

**By Bruce F. Molnia and Cheryl A. Hallam**

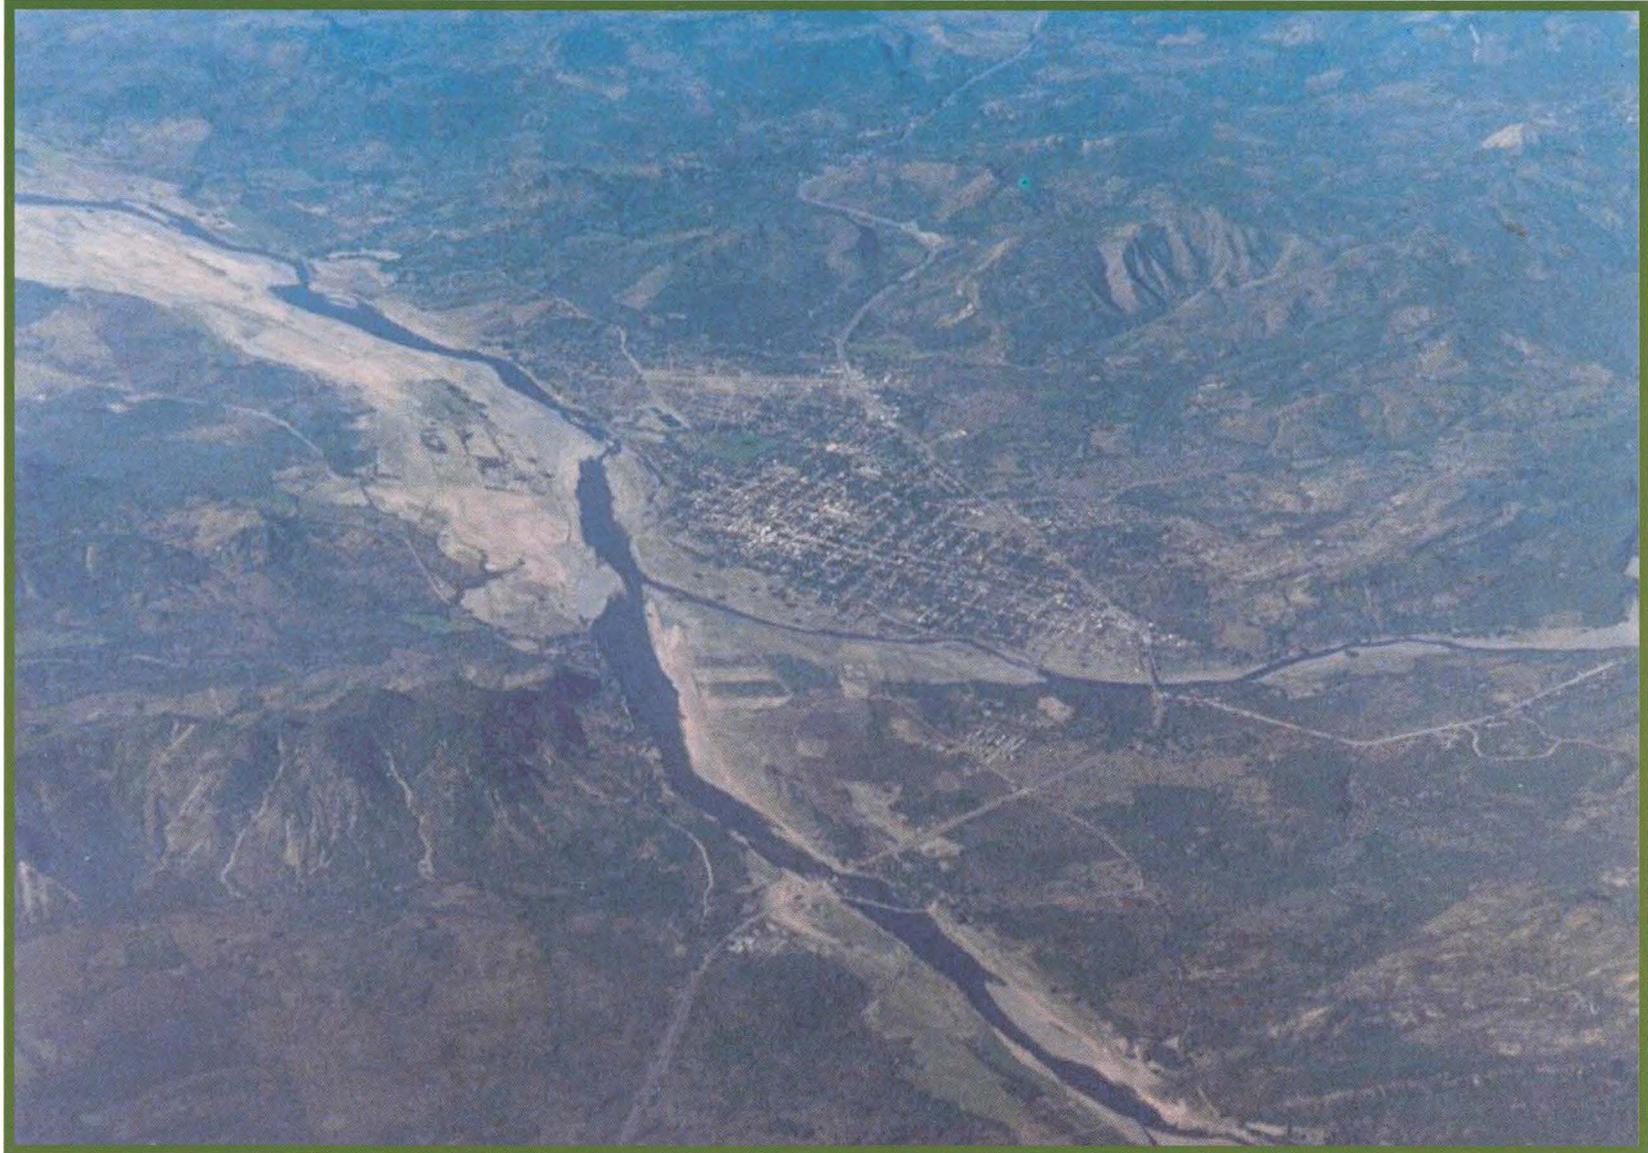
## Nacaome, Honduras

OS-24. Flooding deposited large quantities of sediment along the banks and on the floodplain of the Rio Nacaome near the southern Honduras city of Nacaome. Many manmade structures on the floodplain were destroyed, and parts of the city were flooded. Compare with Open Skies vertical black-and-white frame 96.

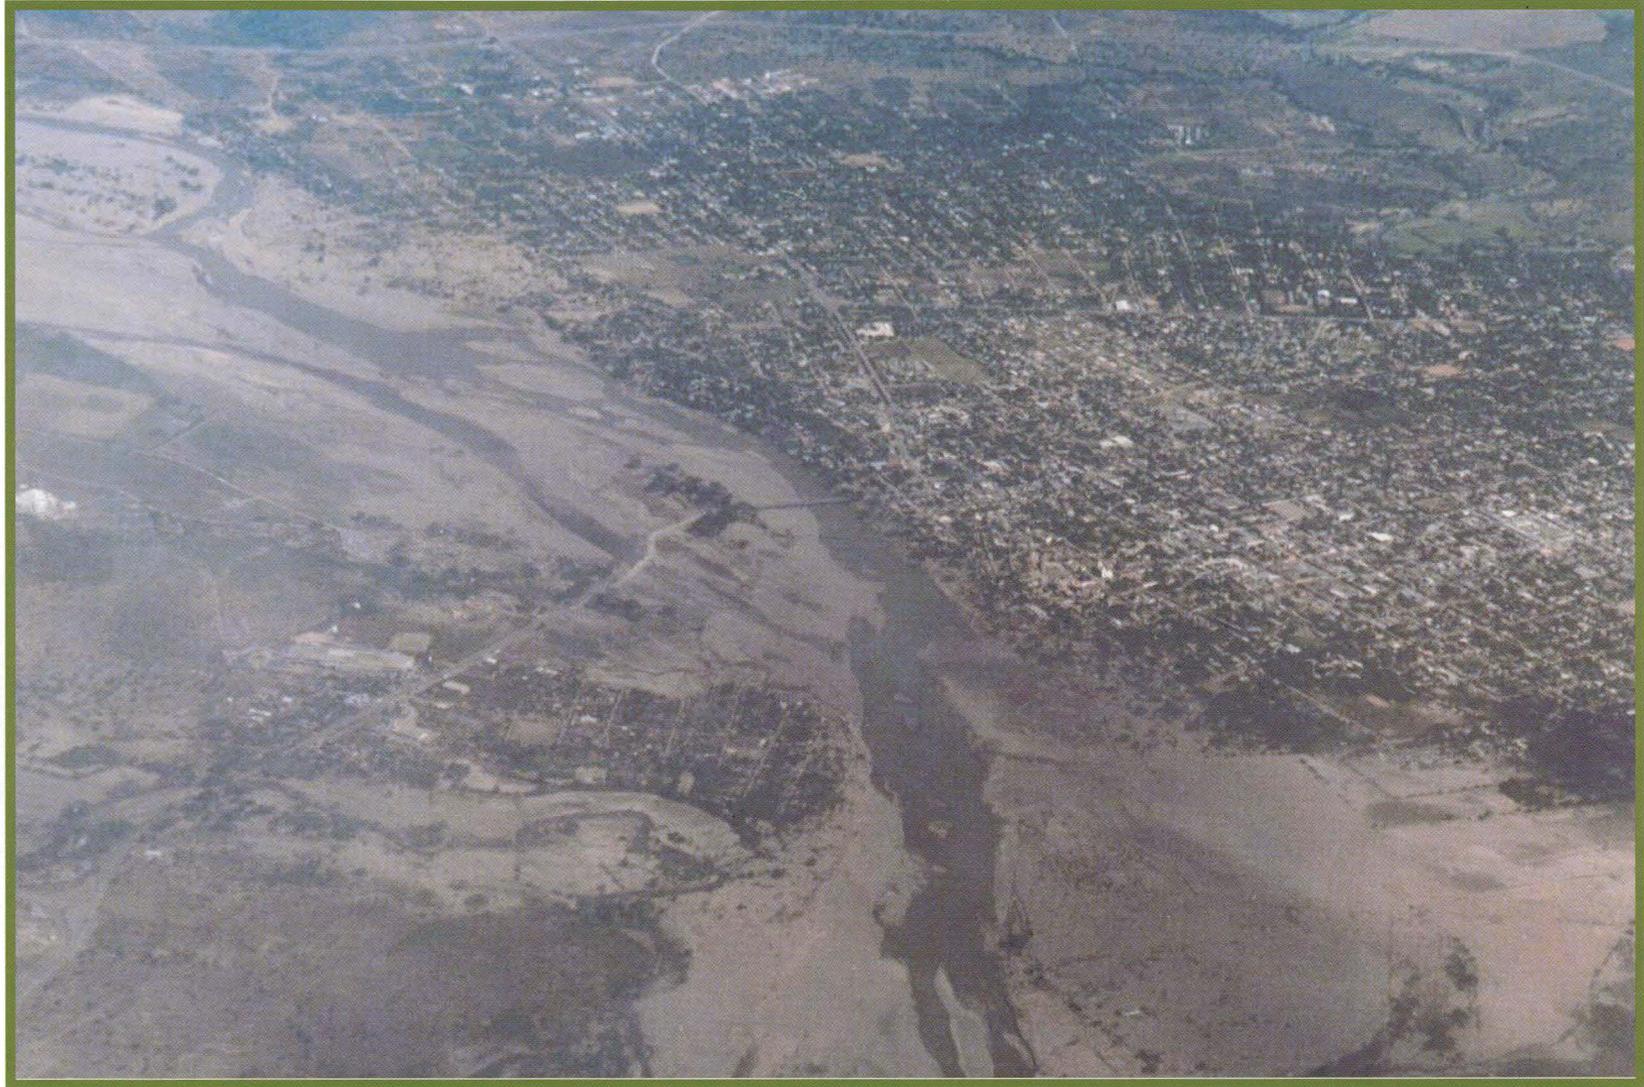
# Choluteca, Honduras

OS-14. Flooding deposited large quantities of sediment on the floodplain of the Choluteca River in the vicinity of the city of Choluteca, southern Honduras. Much of the northern part of the city was flooded. Buildings in some areas were buried by sediment. Compare with Open Skies vertical black-and-white frame 257.

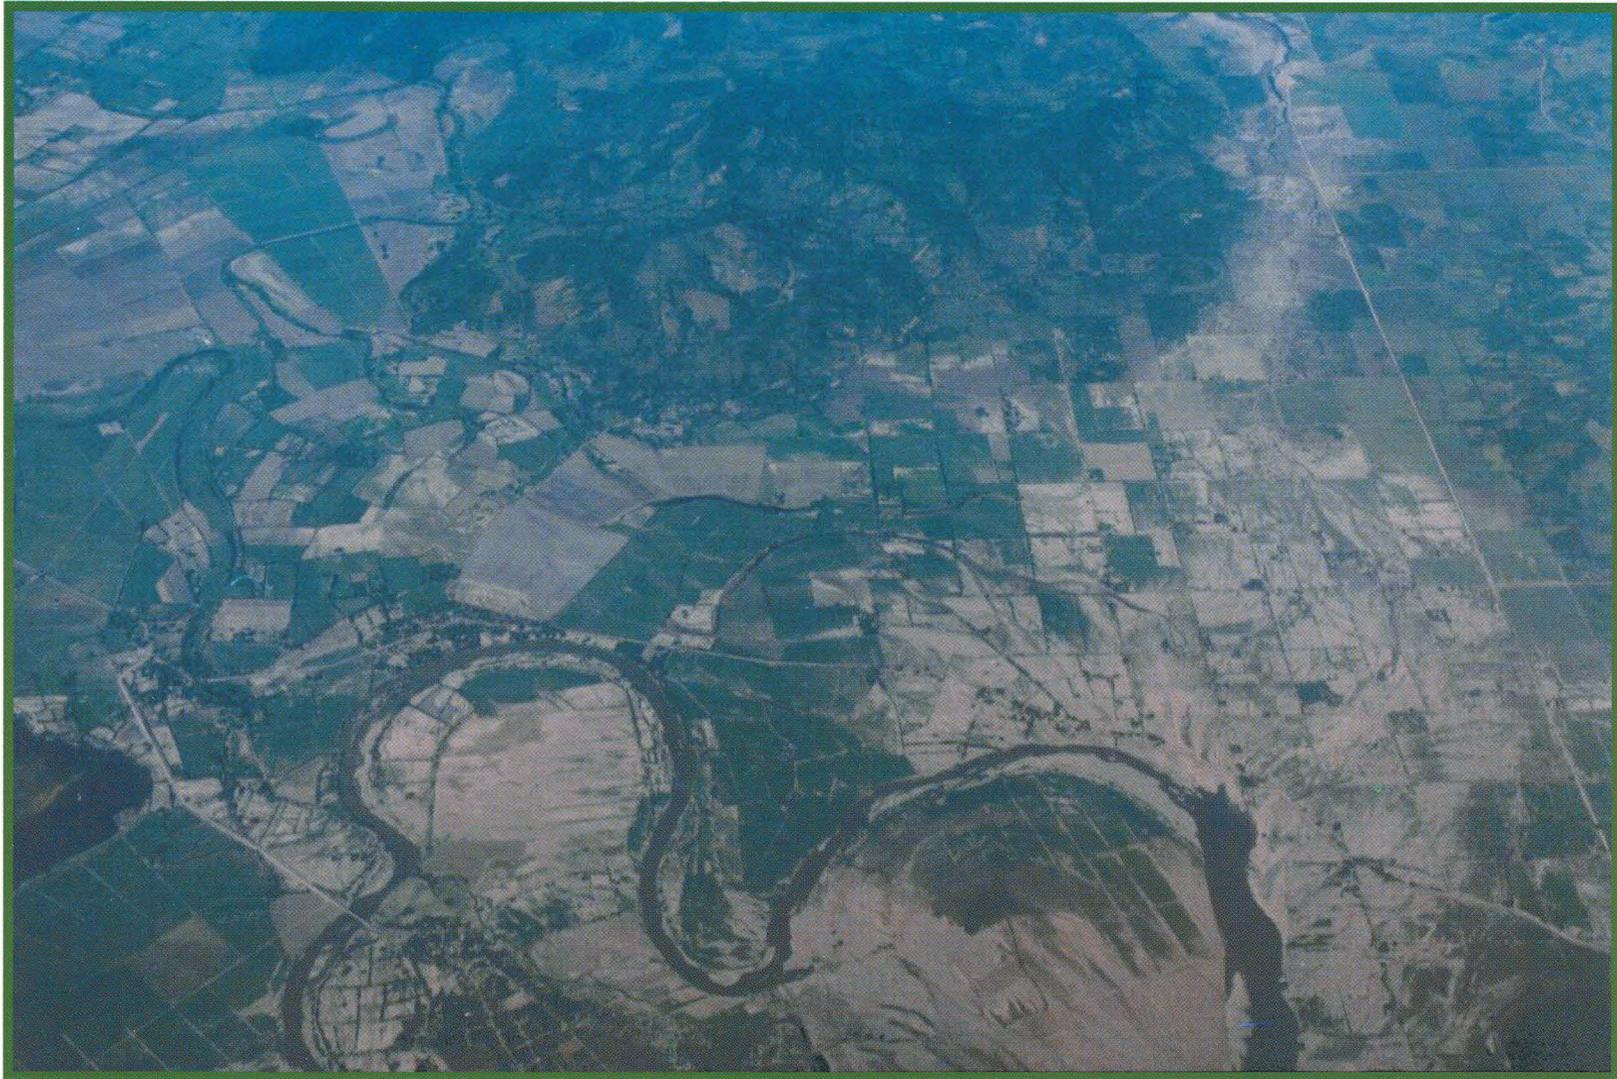
OS-23. Flooding deposited large quantities of sediment on the coastal plain adjacent to the Choluteca River, near Marcovia, Honduras. Here, water from the river cut a new channel to the west (upper right of the photograph), scouring the land surface as it flowed. Compare with oblique color photograph OS-33.

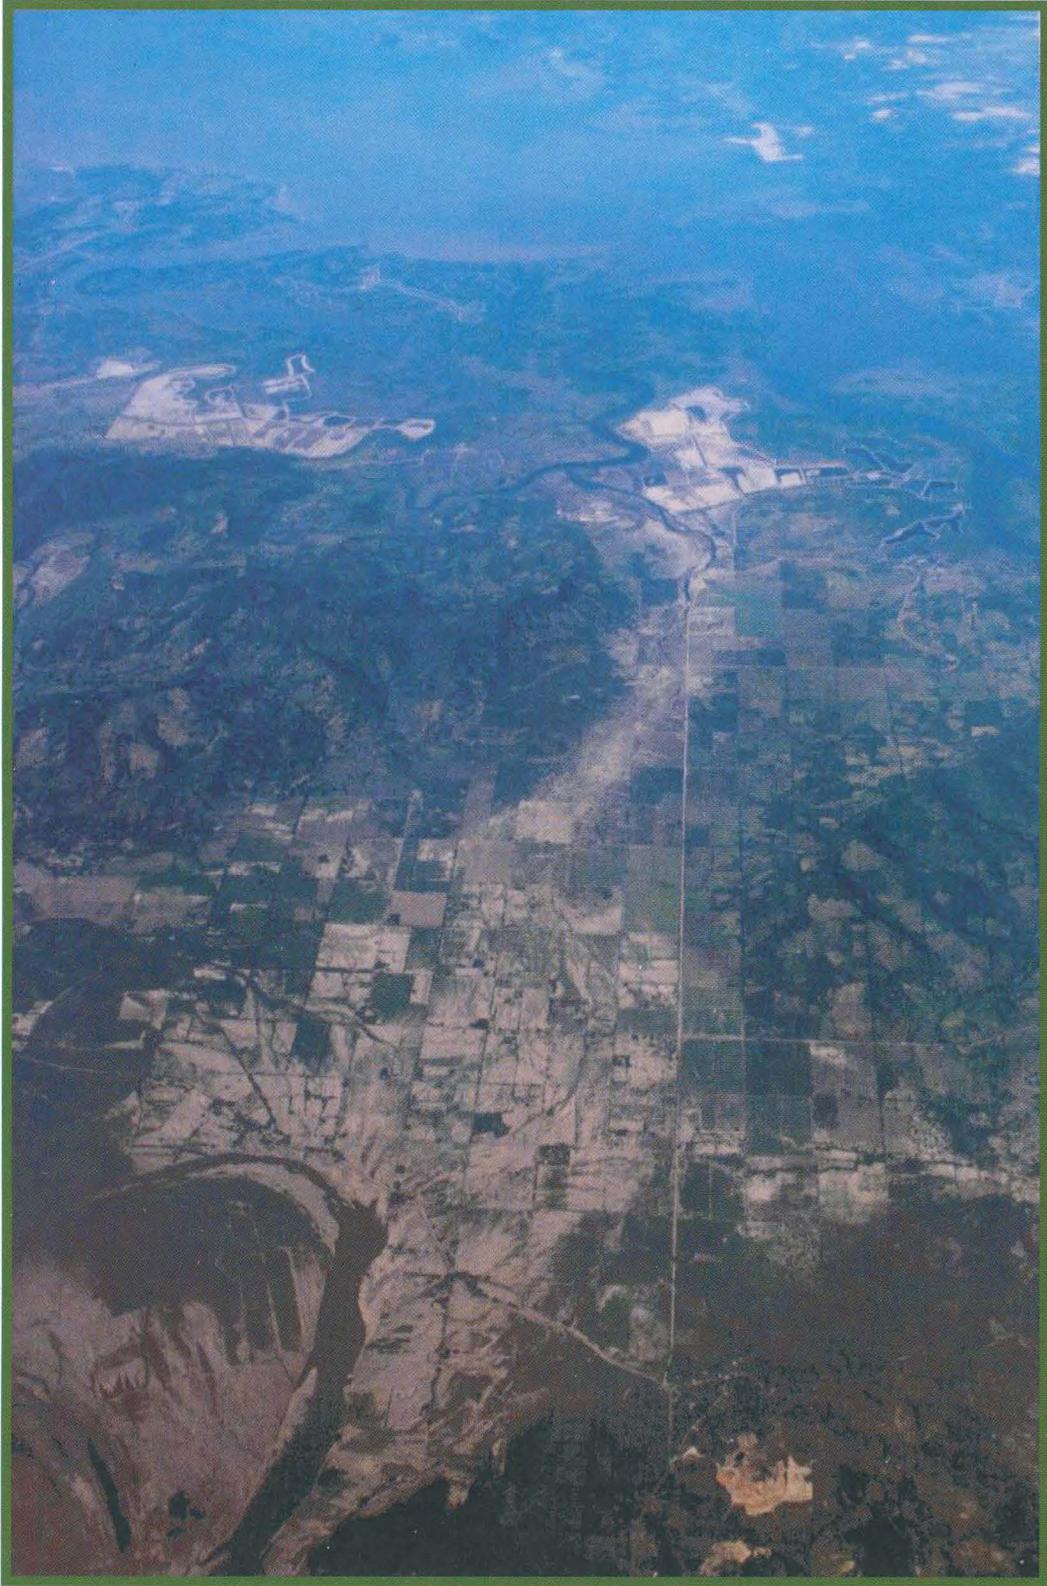
OS-33. Flooding deposited large quantities of sediment on the coastal plain adjacent to the Choluteca River, near Marcovia, Honduras. Here, water from the river formed a new channel, draining to the west toward the Gulf of Fonseca, at the top of the photograph. Compare with oblique photograph OS-23.

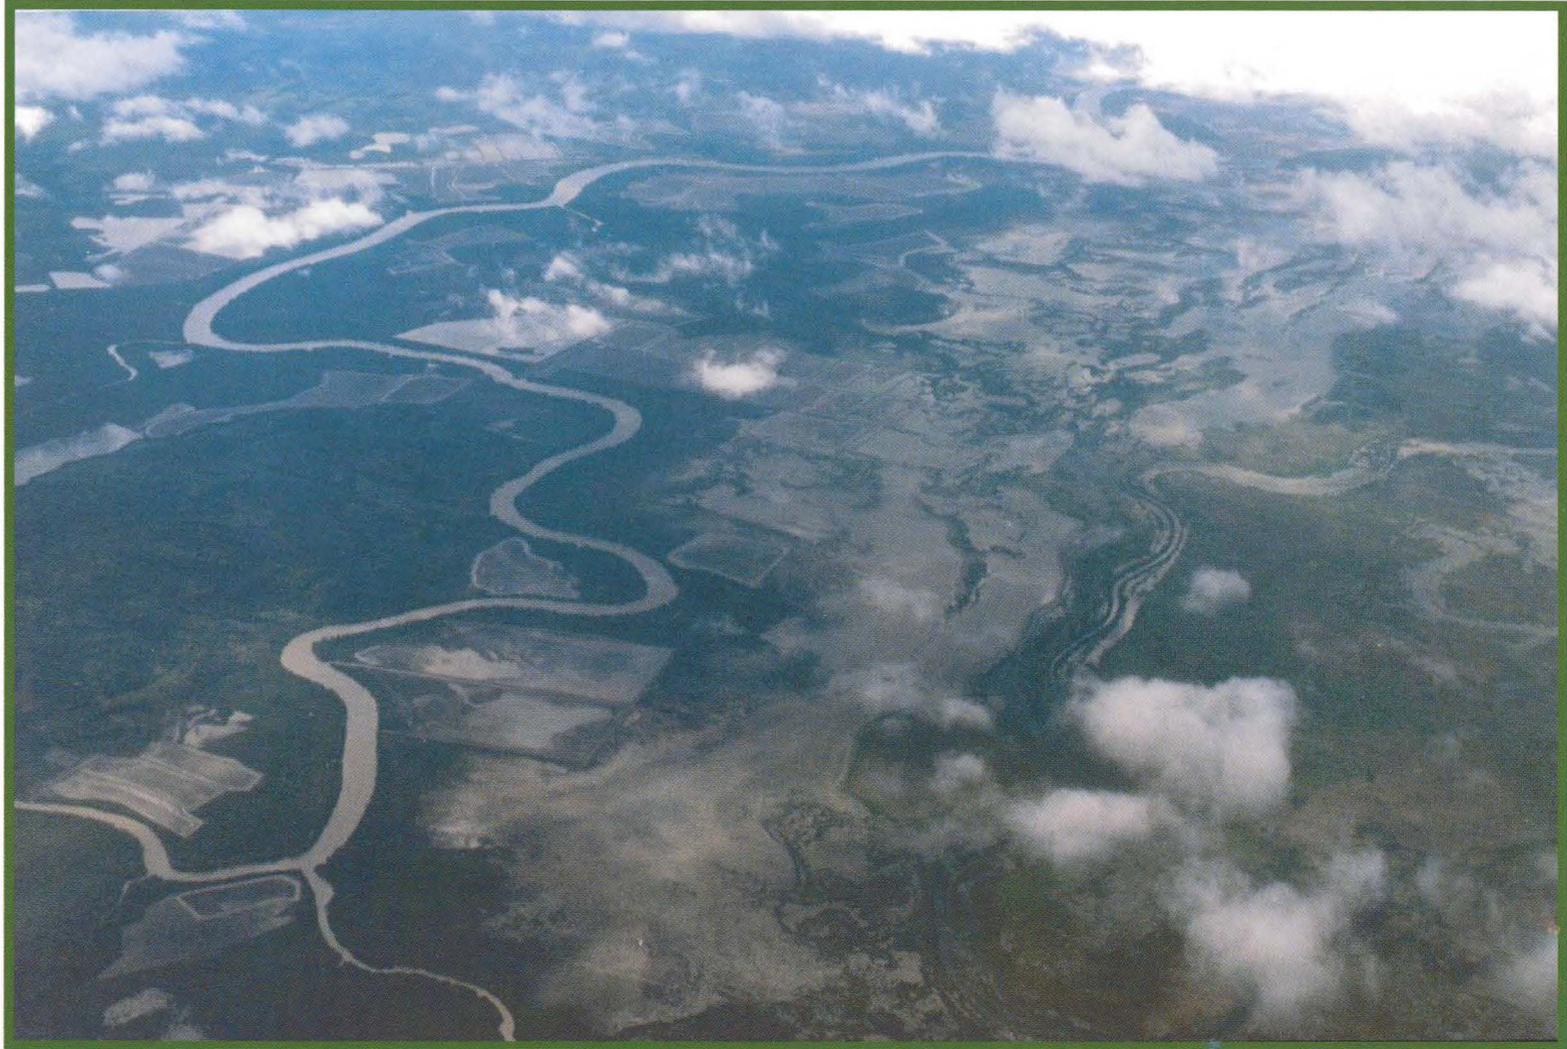
OS-7. More than 6 weeks after the end of Hurricane Mitch, large areas of the Aguan River valley, near Trujillo, Honduras, were still covered by standing water. Many agricultural enterprises suffered significant flood damage.
