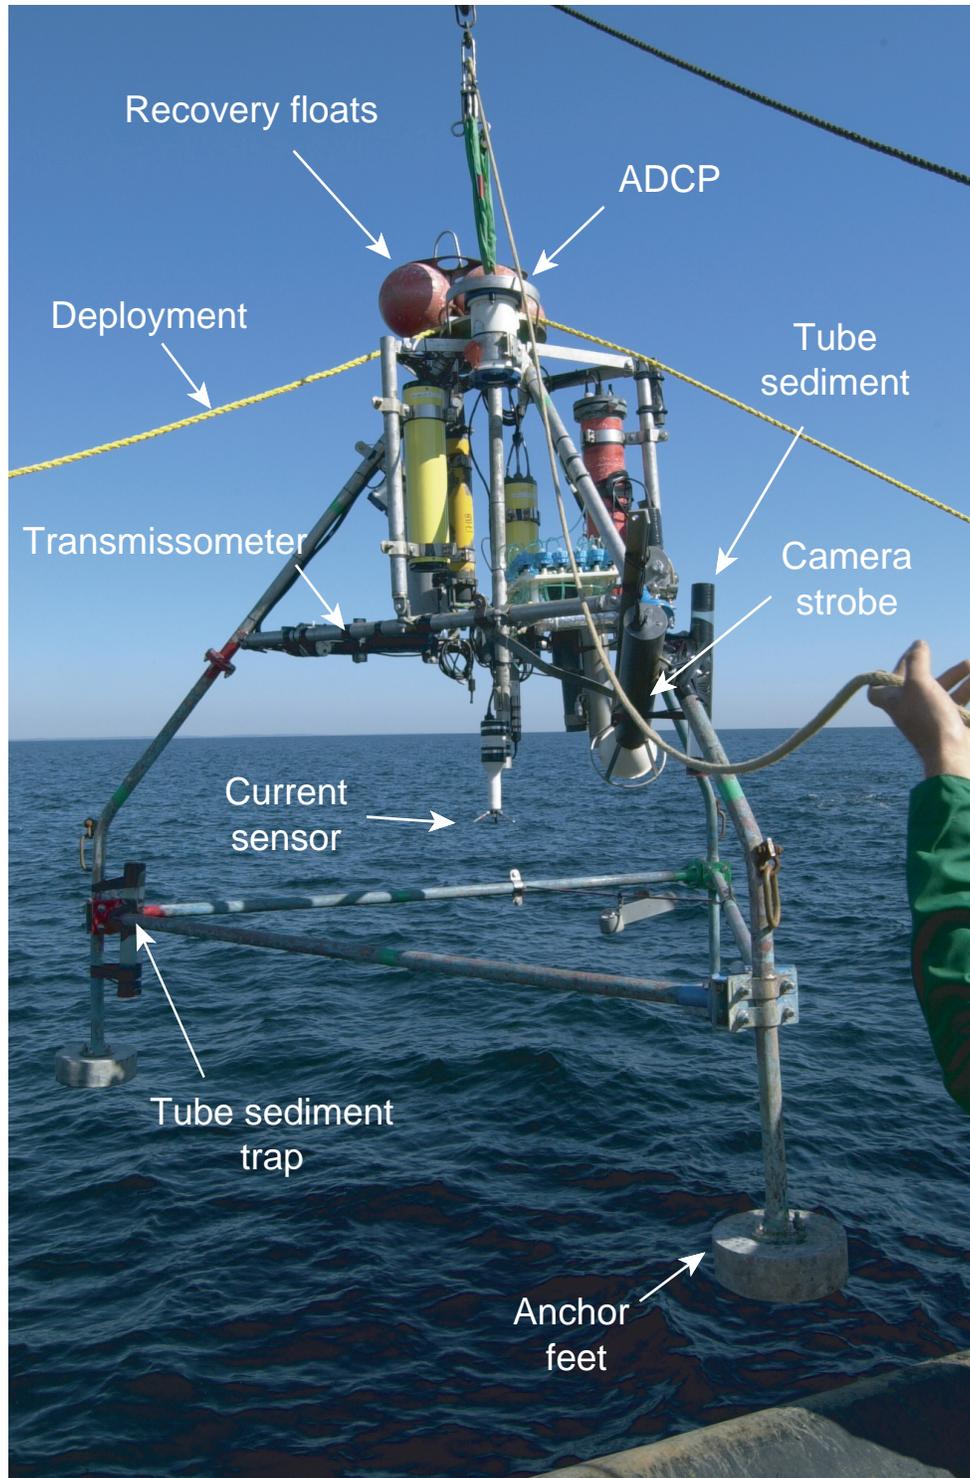
Figure 13A. Photograph of tripod system being deployed from US Coast Guard Cutter *Marcus Hanna* at Site A. The tripod frame is lowered to the sea floor and deployed for about 4 months. The floats on the top of the frame are released by an acoustic release and pull a recovery line to the surface. The current sensor in this image is a Sontek ADV being tested in 2004; a BASS current sensor was used during the period 1991-2002 (see figure 13D for photograph of tripod with BASS current sensors).
