Visualization of Soil-Moisture Change in Response to Precipitation Within Two Rain Gardens in Ohio

Data Series 837

By Denise H. Dumouchelle and Robert A. Darner

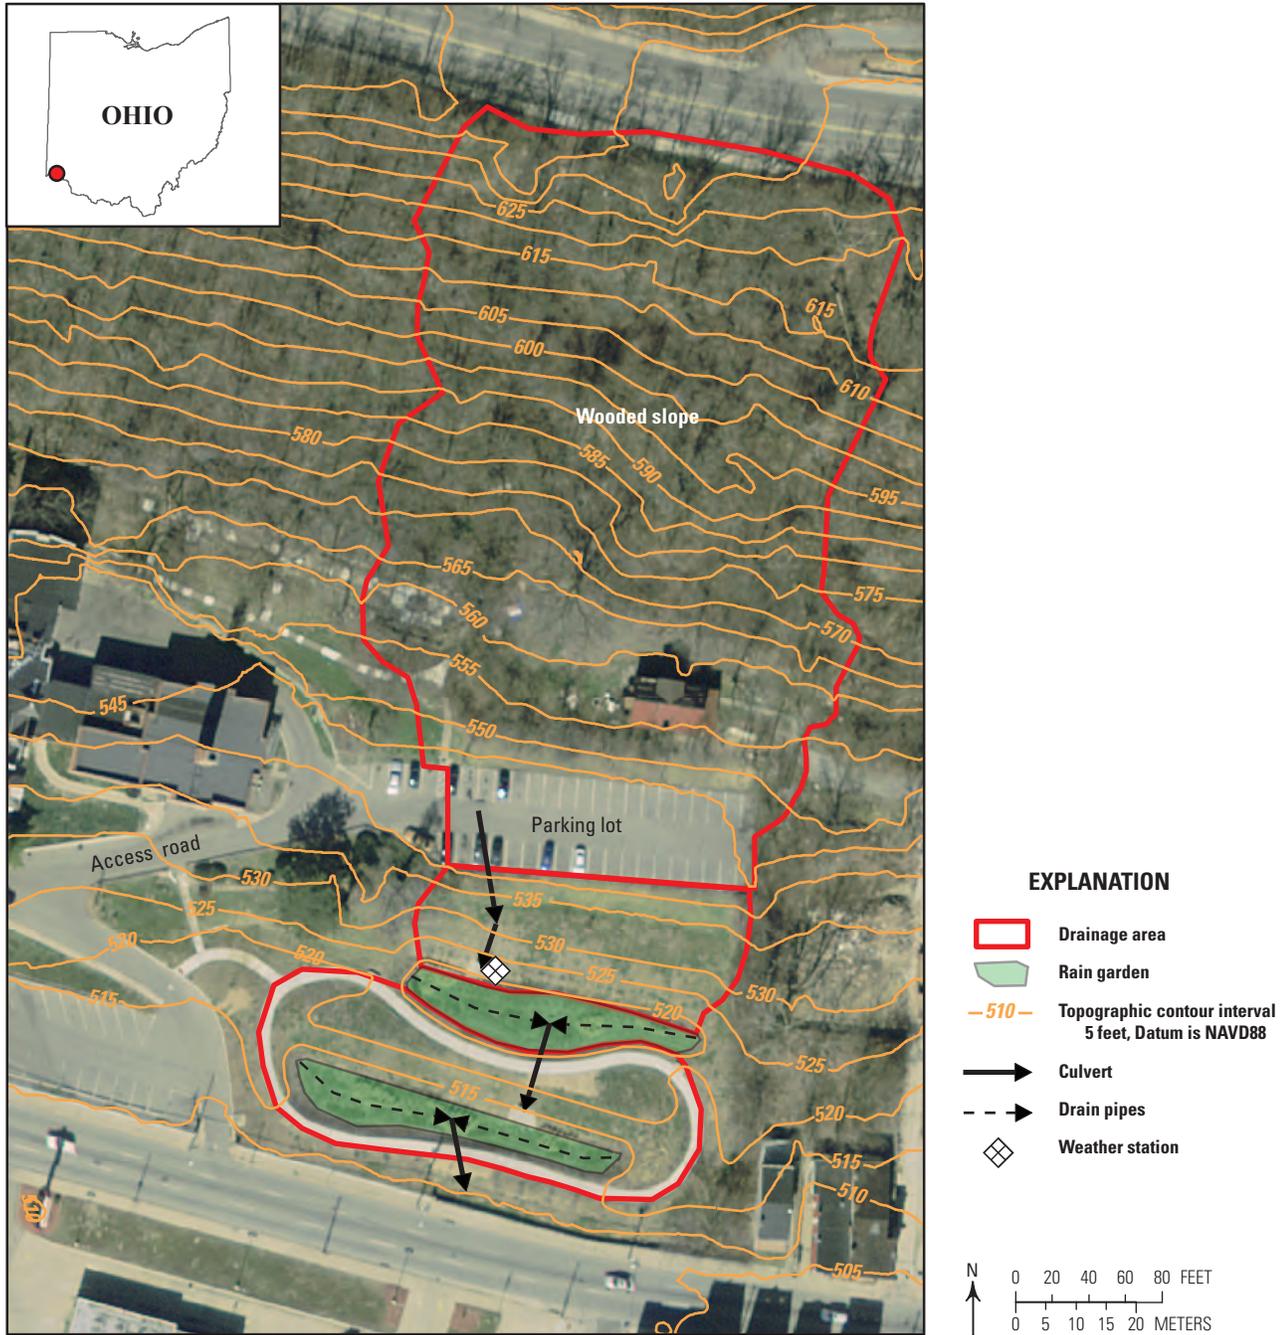
Figure 1. Aerial image of the St. Francis site, Cincinnati, Ohio.

At the St. Francis Apartments along Queen City Avenue in Cincinnati, Ohio, the city contracted for the installation of a two-stage, stepped rain garden as part of the reconstruction of a parking lot. The rain garden was designed to reduce stormwater runoff and provide filtration to improve water quality. The site is sloped; there is a wooded area above a parking lot and a grassed area below the parking lot. The rain garden is at the bottom of the slope (fig. 1) and is divided into two units (figs. 2 and 3), which are hereafter referred to as the “upper” and “lower” rain gardens.

The upper rain garden receives water from precipitation that falls directly on the garden and overland runoff from the wooded slope that drains to the parking lot and from there to the upper rain garden via a 12-inch (in.) culvert. This drainage area is about 94,500 square feet (ft²) (2.2 acres), although an undetermined volume of the overland flow from this area is lost as runoff down the access road. The grassed slope

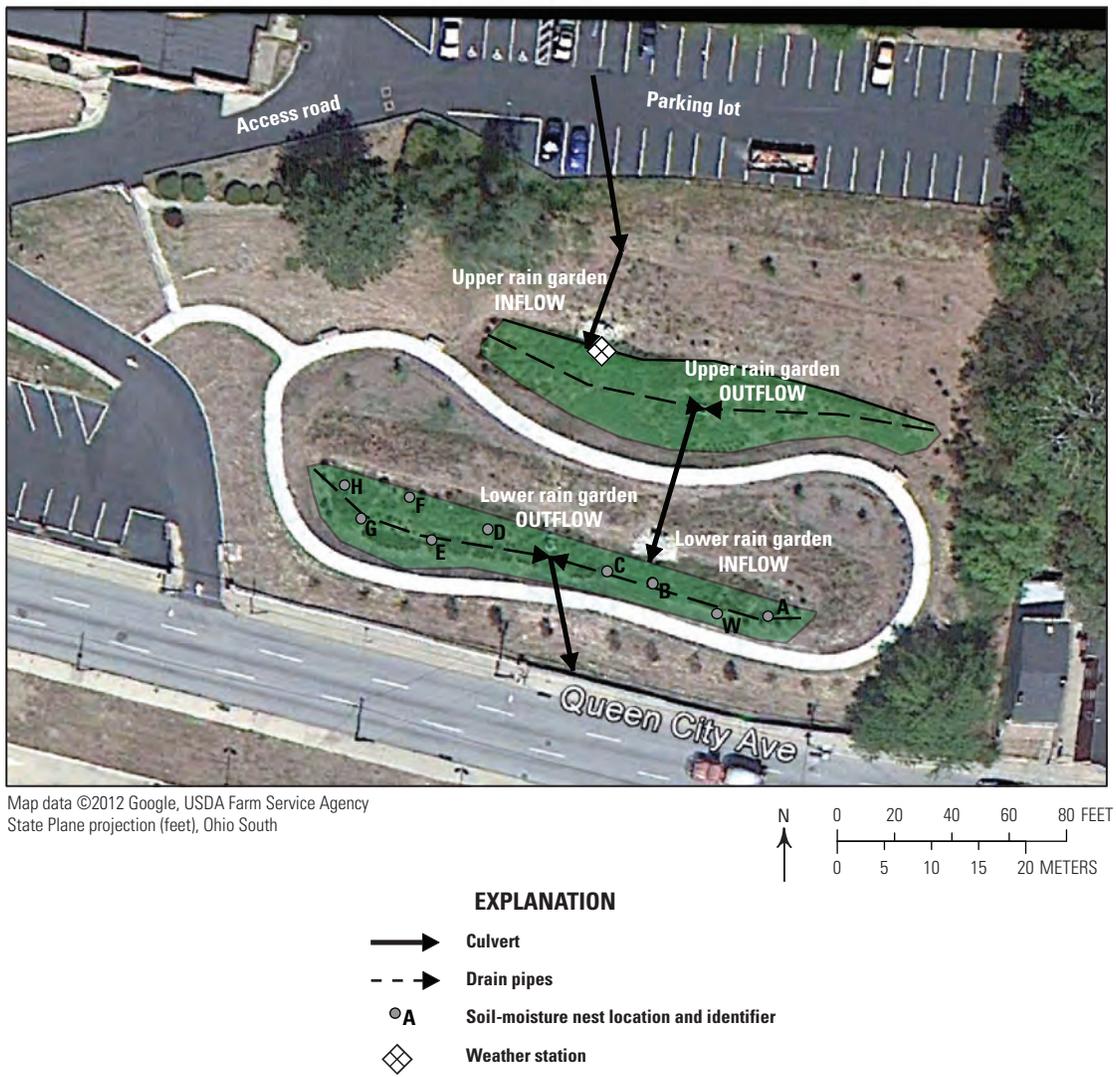
Figure 2. Aerial image of the upper and lower rain gardens, St. Francis site, Cincinnati, Ohio.

At the St. Francis site, nine soil-moisture nests were installed in the lower rain garden. Each nest consists of three sensors with the tines positioned horizontally at about 0.5, 1, and 2 ft below the surface (fig. 5B). The deepest sensor is about 0.2 ft above the geotextile liner. The location of each nest was surveyed (fig. 2). Each sensor was configured to record data hourly.

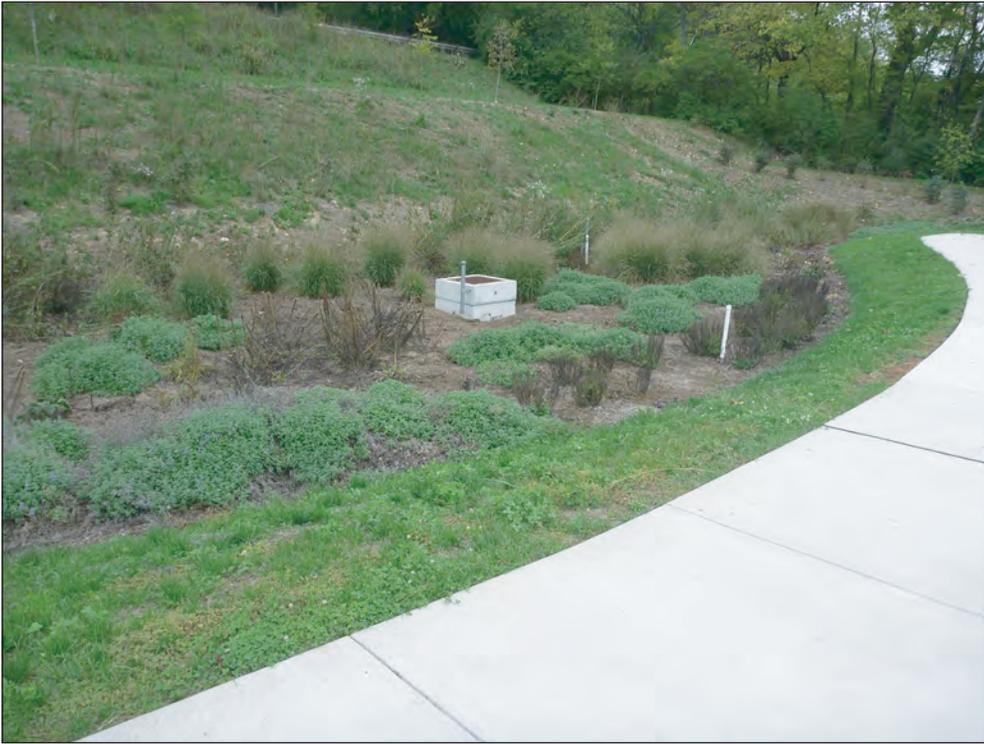
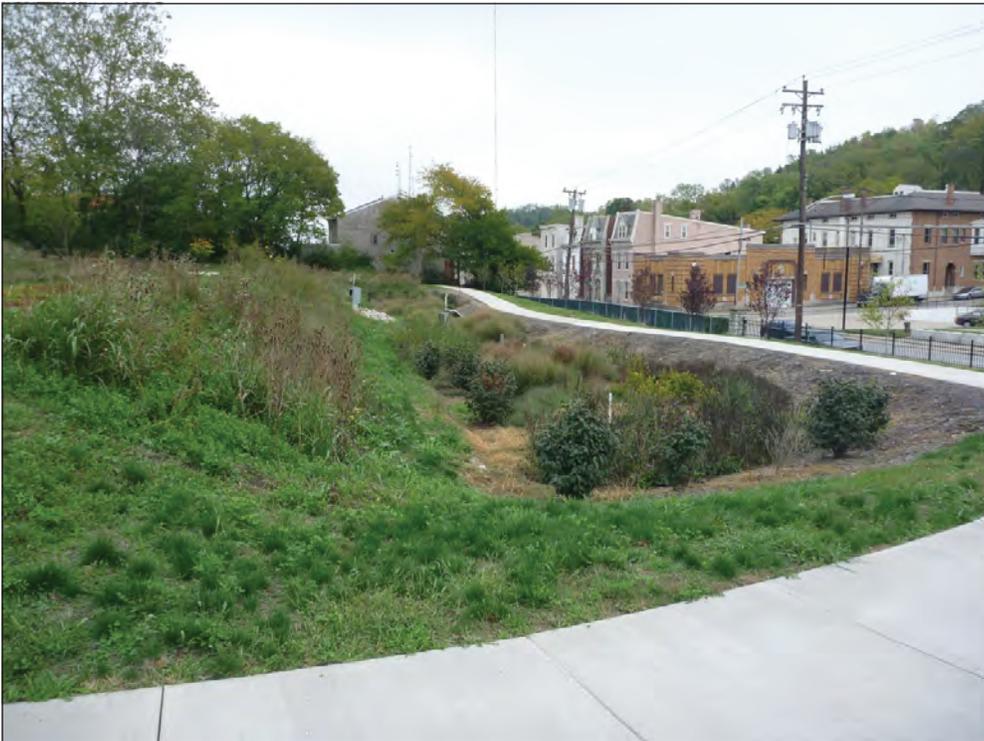
Figure 3. Upper (A) and lower (B) rain gardens at the St. Francis site in Cincinnati, Ohio, October 2012.

The rain gardens were constructed by excavating a bowl-shaped depression into the silty clay loam soil (Lerch and others, 1982). The bottom of the depression was filled with about 1 foot (ft) of gravel, and a geotextile liner was laid over the gravel to reduce the downward migration of fine sediments. Above the liner, about 2 ft of engineered soil (a sand, soil, and compost mixture) was used to fill in the remainder of the excavation. In both gardens, a 6-in.-diameter perforated polyvinyl chloride (PVC) drain pipe was installed in the gravel layer. The drain in the upper rain garden discharges to the surface of the lower garden. The drain in the lower garden discharges to a storm-sewer pipe and, to prevent flooding, there is also an overflow grate raised slightly above the surrounding grade that drains to the same storm-sewer pipe. A crest-stage gage at the overflow grate records maximum surface-water elevations during a rainfall-runoff event (Sauer and Turnipseed, 2010); the elevation of the overflow grate is known, so events that cause surface water to move through the overflow can be determined. Flumes inserted in the culverts are used to measure the inflows and outflows from each garden (Kilpatrick and Schneider, 1983). The upper rain garden has a surface area of about 3,600 ft² and the lower, about 3,300 ft².

The lower rain garden was chosen for the soil-moisture study because the engineered soil mixture contained more

topsoil, and field observations noted more ponded water and faster plant growth compared to the upper rain garden. In addition, because of the transit through the upper rain garden, the inflow to the lower garden is less flashy.

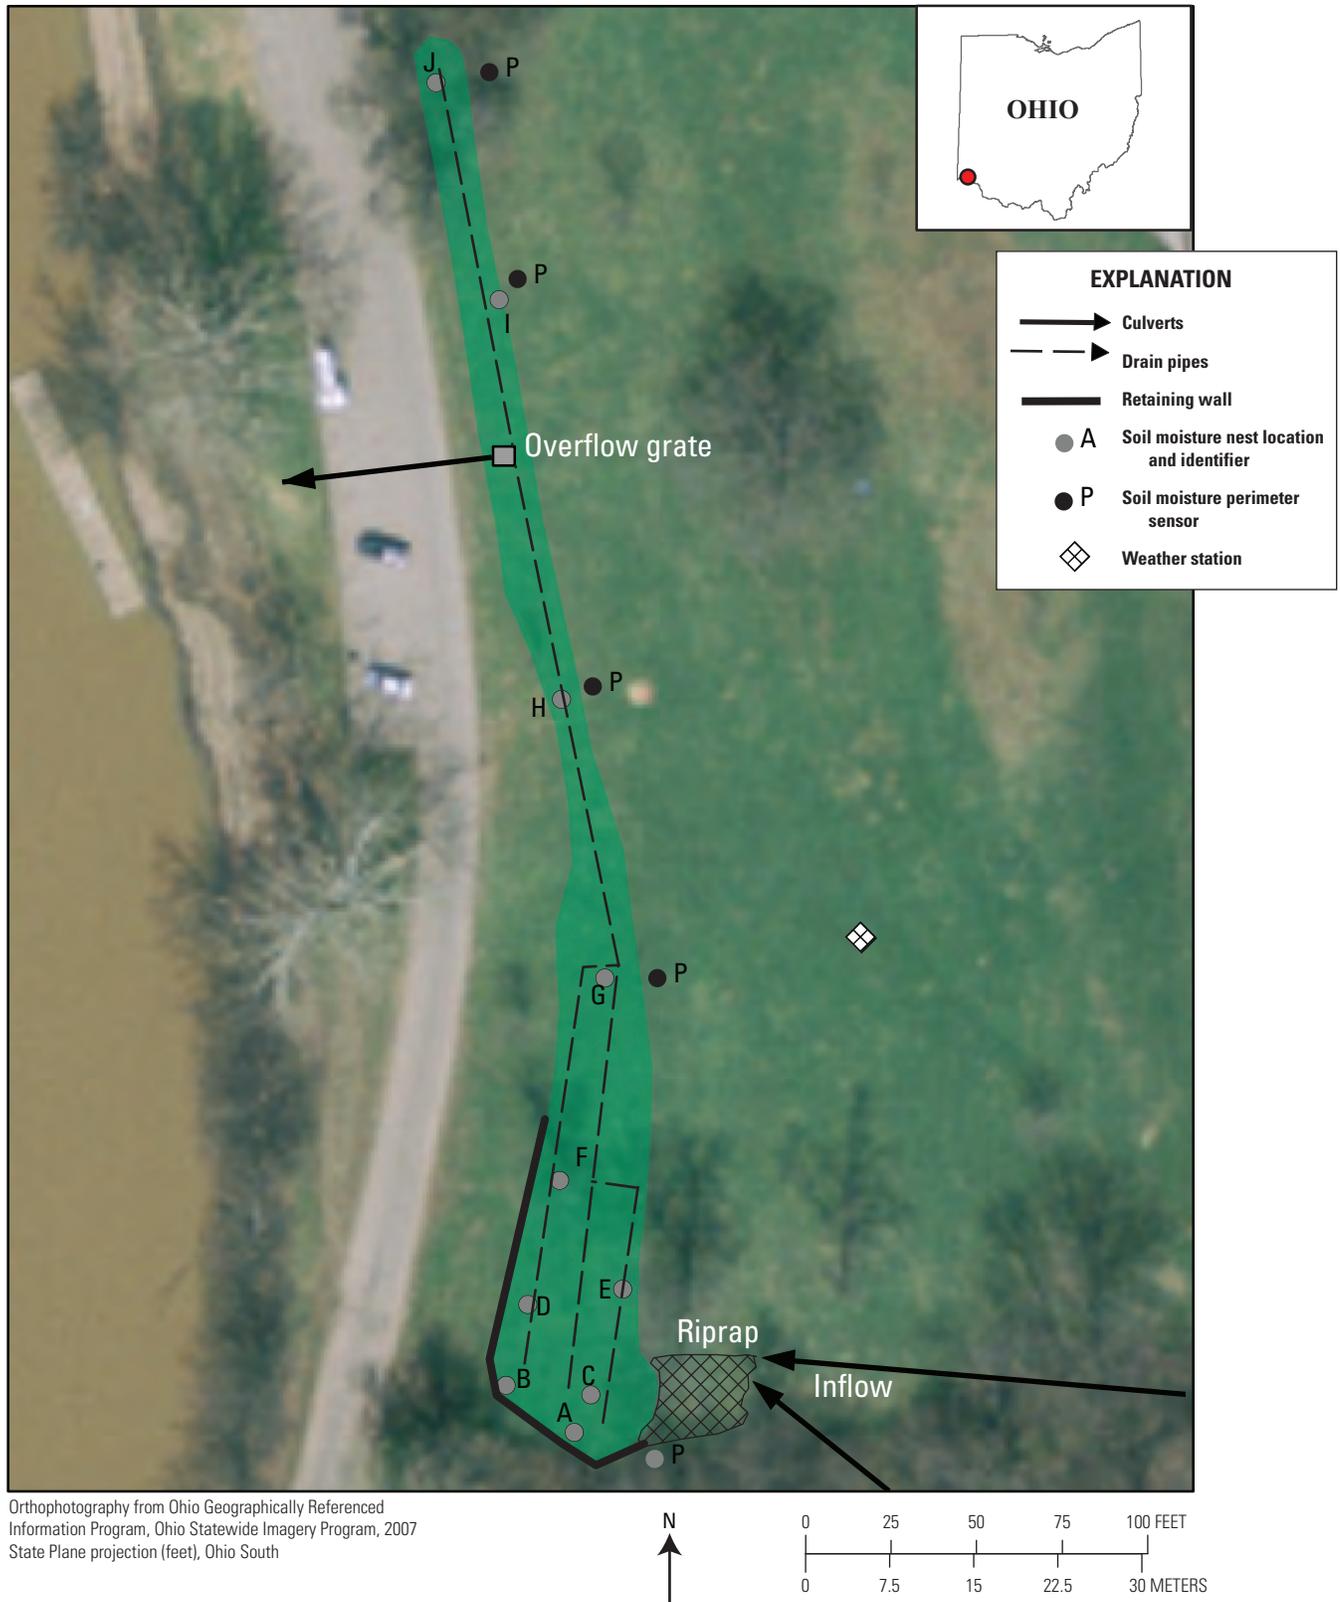
Figure 4. Aerial image of the Griggs Reservoir site, Columbus, Ohio.

Griggs Reservoir in Columbus, Ohio, is one of three water-supply reservoirs serving the City of Columbus. In Griggs Reservoir Park, between Riverside Drive and the edge of the reservoir, the city contracted for the installation of multiple rain gardens to reduce the amount of urban runoff entering the reservoir. The rain garden monitored in this study receives runoff through two culverts that discharge into the garden near its south end (fig. 4). One of the two culverts drains stormwater runoff from a commercial lot of about 204,700 ft² (4.7 acres), and the other drains a residential neighborhood of about 1,302,400 ft² (29.9 acres). The rain garden is similar in design to the one at the St. Francis site, but it is shallower (owing to near-surface, underlying carbonate bedrock), and it contains only 1 to 1 1/2 ft of engineered soil above the geotextile liner. A drainpipe in the gravel base and a raised overflow grate at north end of the rain garden route excess water directly to the reservoir. A crest-stage gage at the overflow grate records maximum surface-water elevations during a rainfall-runoff event; the elevation of the overflow grate is known, so events that cause surface water to move through the overflow can be determined. Because the garden was built on a hillside, a retaining wall was constructed along the edge opposite the inflows. The rain garden is about 8,500 ft² in surface area.

At the Griggs Reservoir site, 10 nests of soil-moisture sensors were installed at depths of 0.5 and 1 ft, with an additional 5 sensors scattered around the perimeter at a depth of 0.5 ft. The location of each sensor was surveyed (fig. 4). Each sensor was configured to record data every 30 minutes.

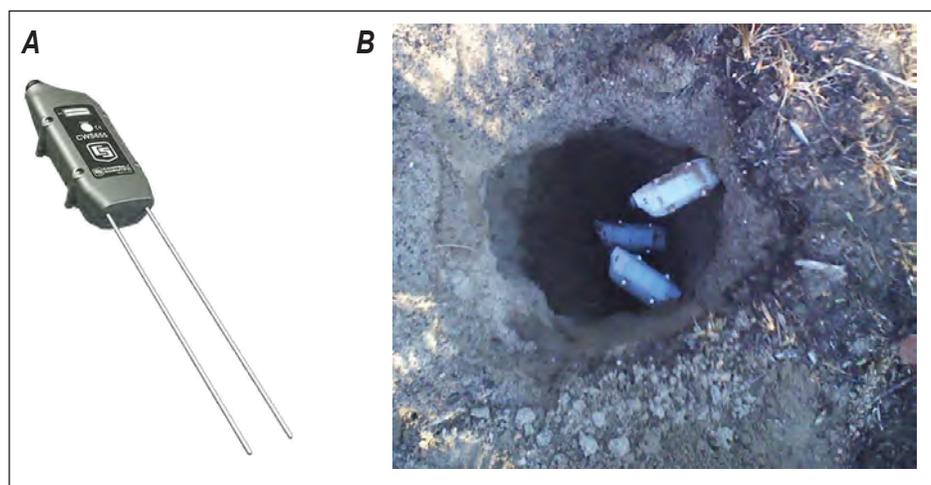
Figure 5. A, Wireless soil-moisture probe. B, a nest of moisture sensors installed at three depths.

The soil-moisture sensors used at both sites (Campbell Scientific models CWS655 (fig. 5A) and CS616; <http://www.campbellsci.com/soil-water-content>) measure volumetric water content from zero percent to saturation. The sensors have two fixed tines that are inserted into the soil; tines on the CWS655 are 15 centimeters (cm; 5.9 in.) long, and those on the CS616 sensor are 30 cm (11.8 in.) long. The CWS655 communicates with a Campbell Scientific CR1000 data logger wirelessly and was observed to lose data during times of communication difficulties, whereas the CS616 sensor is hard wired to a data logger and communication is therefore more reliable.
