Stream Geomorphic and Habitat Data from a Baseline Study of Underwood Creek, Wisconsin, 2012

Data Series 947

By Benjamin M. Young, Faith A. Fitzpatrick, and James D. Blount

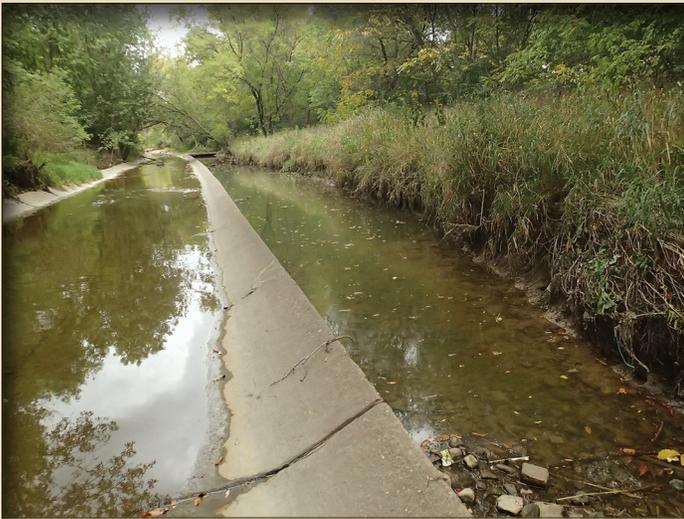
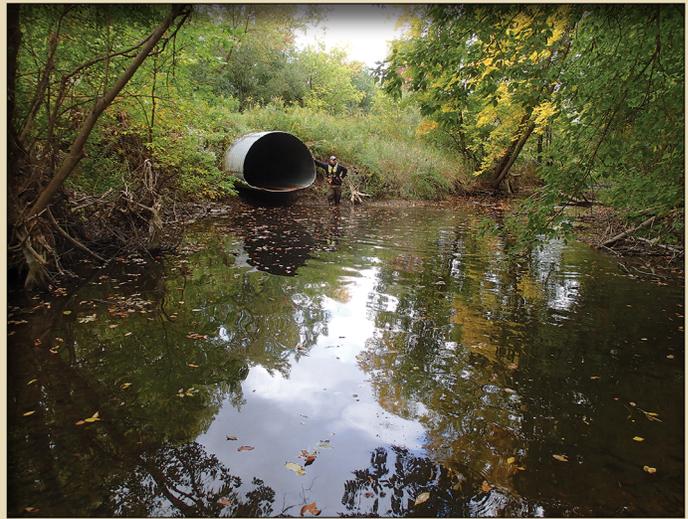
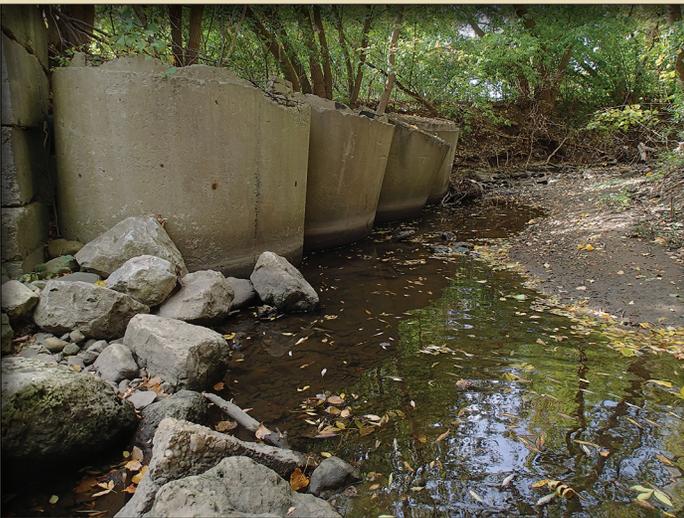
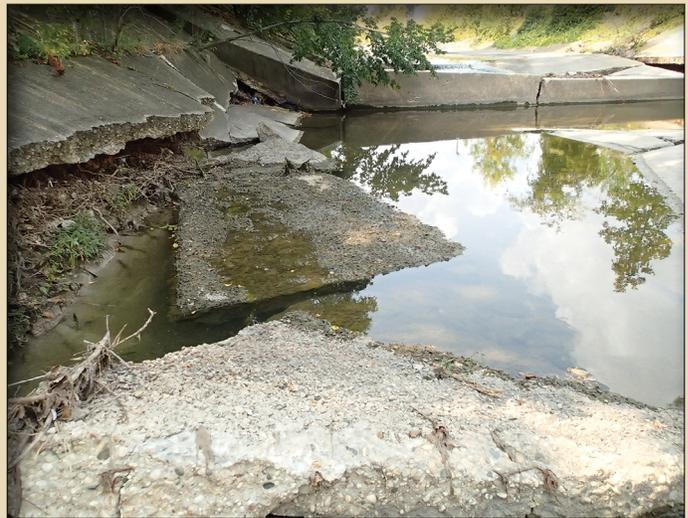
Cover photos (clockwise from top left). Scour and erosion outside of the concrete lined Underwood Creek, September 17, 2012 (photo taken by Nicolas H. Buer); large outfall above scour pool upstream of confluence of Underwood Creek and Menomonee River, September 27, 2012 (photo taken by James D. Blount); concrete bank stabilizers along Underwood Creek, September 27, 2012 (photo taken by James D. Blount); failed concrete bed of Underwood Creek, September 17, 2012 (photo taken by Nicolas H. Buer).

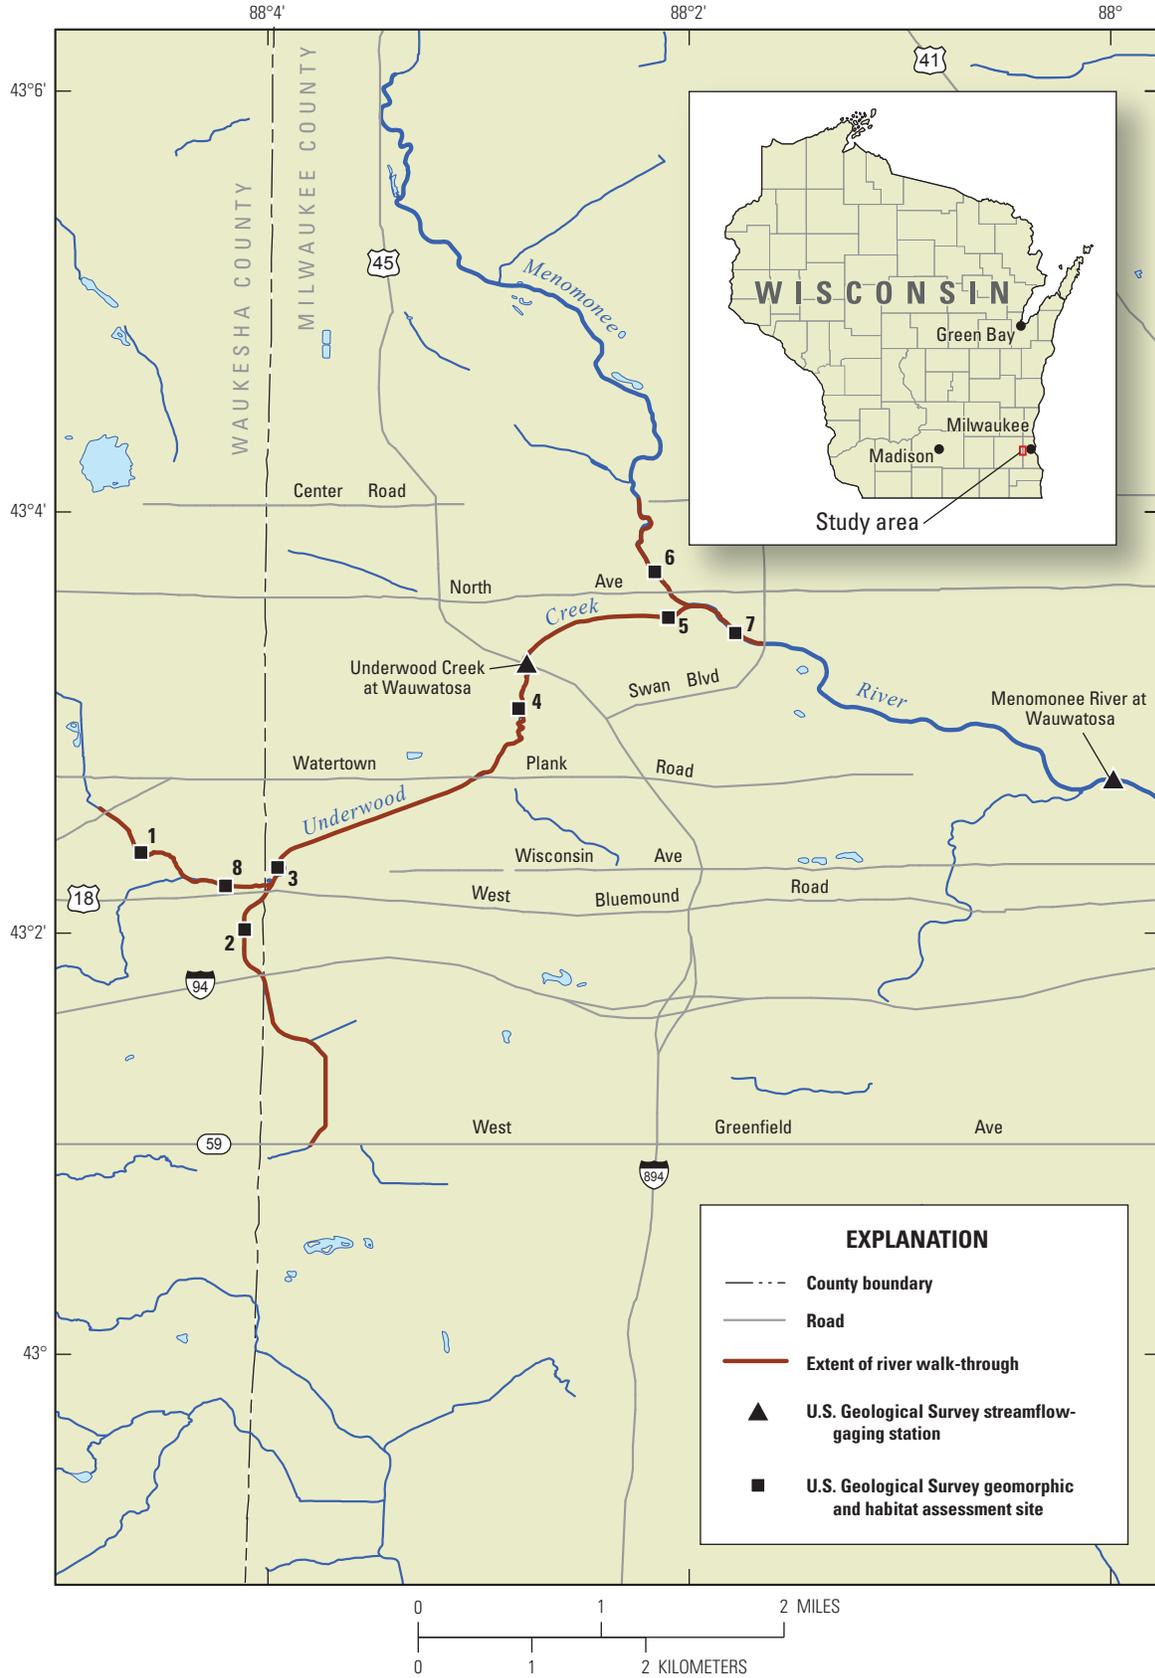
Figure 1. Reach locations included in the Underwood Creek geomorphic and habitat assessments, the Underwood Creek and Menomonee River streamgaging station, and the extent of the river walk-through.

Geomorphic and habitat data were collected at two main spatial scales—at eight representative 150-meter (m) reaches and a reconnaissance river walk-through of approximately 10 km extending between and beyond the reaches (fig. 1, table 1)

An updated version of the USGS National Water-Quality Assessment (NAWQA) habitat protocol was developed for urban streams and evaluating the success of stream restoration activities in the MMSD area (Fitzpatrick and others, 1998). This updated geomorphic and habitat assessment was used at the eight reaches on Underwood Creek and the Menomonee River (fig. 1, table 1). Two reaches are a restored and unrestored pair (sites 4 and 5, respectively) on Underwood Creek that are routinely measured as part of USGS ecological surveys. Site 8 (0408708565) was added after most of the other assessment sites and river walk-through were completed because of the presence of a large culvert with perennial flow entering Underwood Creek between site 1 and the location of the proposed point of return flow found during the river walk-through (fig. 1).

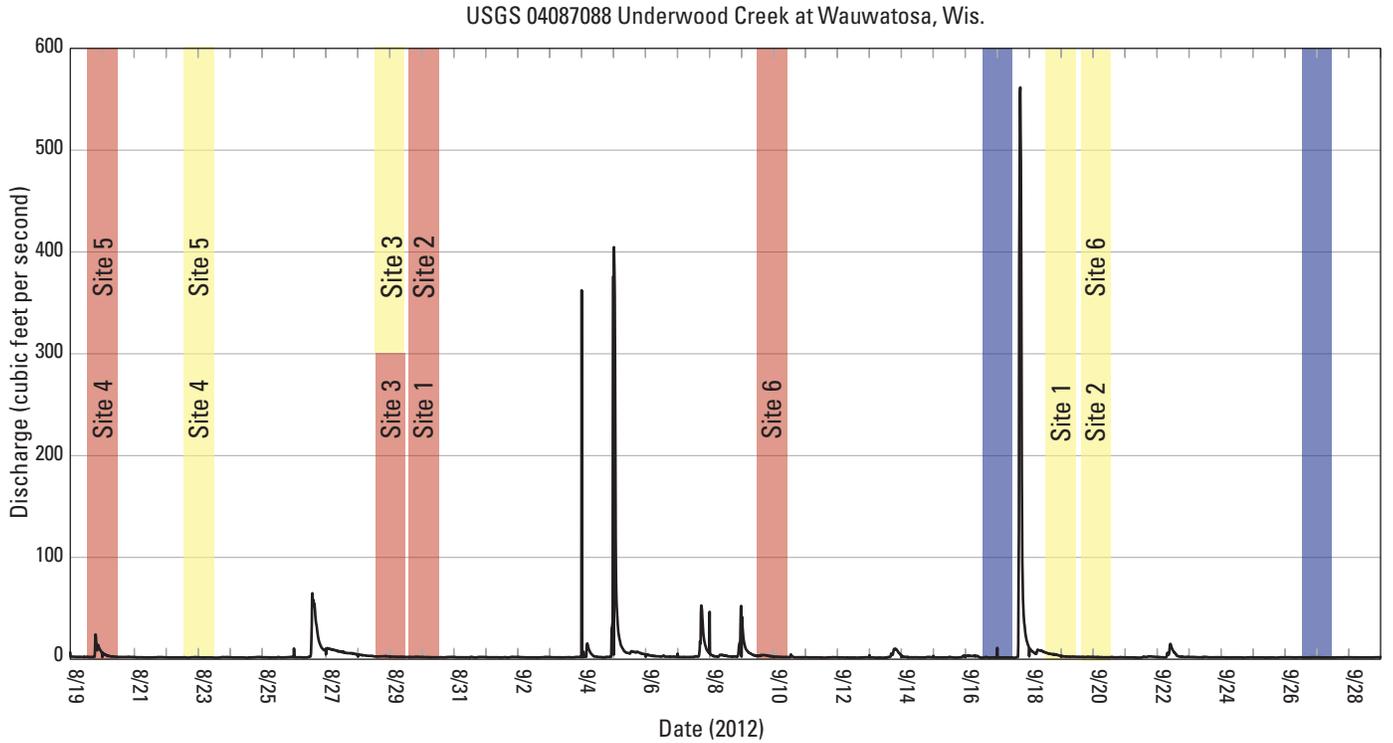
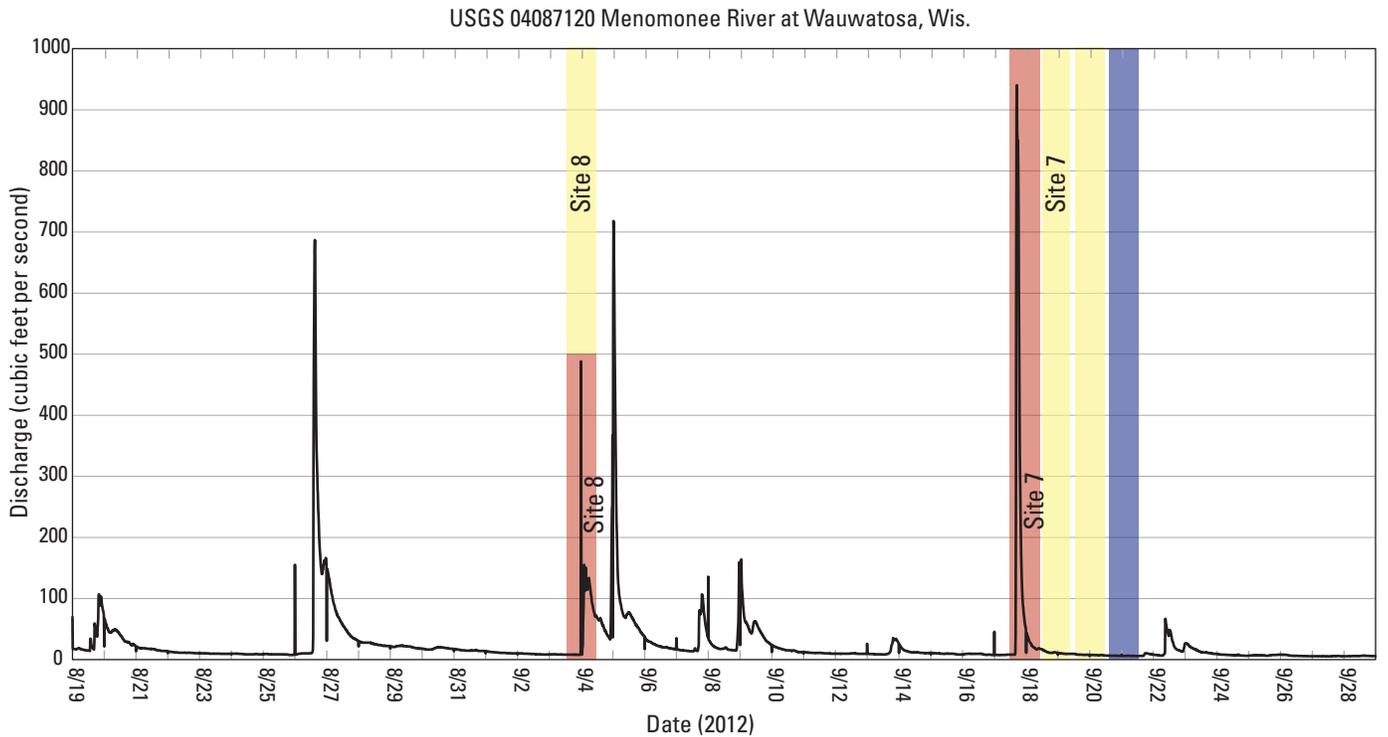
Figure 2. Hydrographs of (A) Underwood Creek and (B) Menomonee River with overlays of time periods when geomorphic and habitat assessments, river walk-through, and channel cross-section surveys and longitudinal profiles were completed.

All data were collected during summer and fall low-flow conditions spanning from late August to late September 2012 (fig. 2). The geomorphic and habitat assessments were completed between late August and mid-September. The topographic surveys of channel cross sections and longitudinal profiles along with the river walk-through continued into late September. Low-flow conditions were preferentially selected, but antecedent conditions (time since last runoff event) affected the amount of water in Underwood Creek. This is evident at site 1 (0408708562), upstream of the possible Waukesha return input point, where on August 30 during the geomorphic and habitat assessment (as well as during the topographic survey) there was standing water in-channel, but a condition of no flow was observed during the river walk-through following a longer time period after the last runoff (fig. 3). Both days had a discharge of approximately $0.05 \text{ m}^3/\text{s}$ at the Underwood Creek streamgage 3.64 km downstream of site 1 (fig. 2).

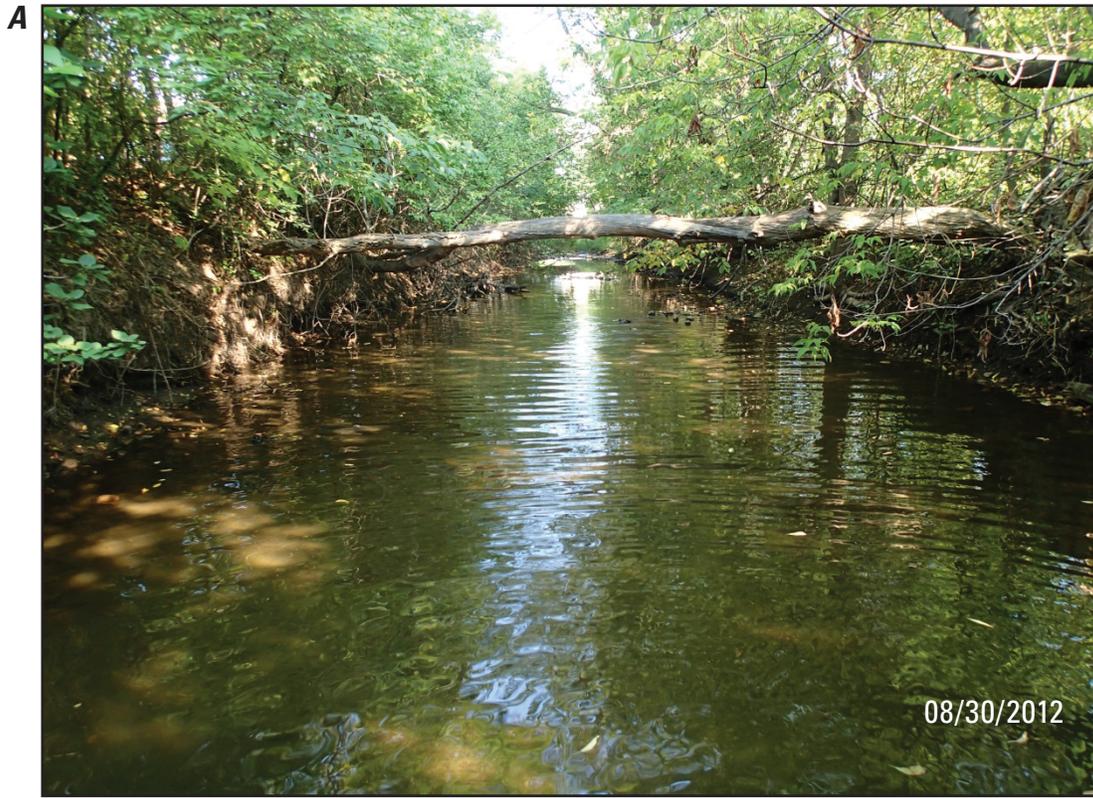
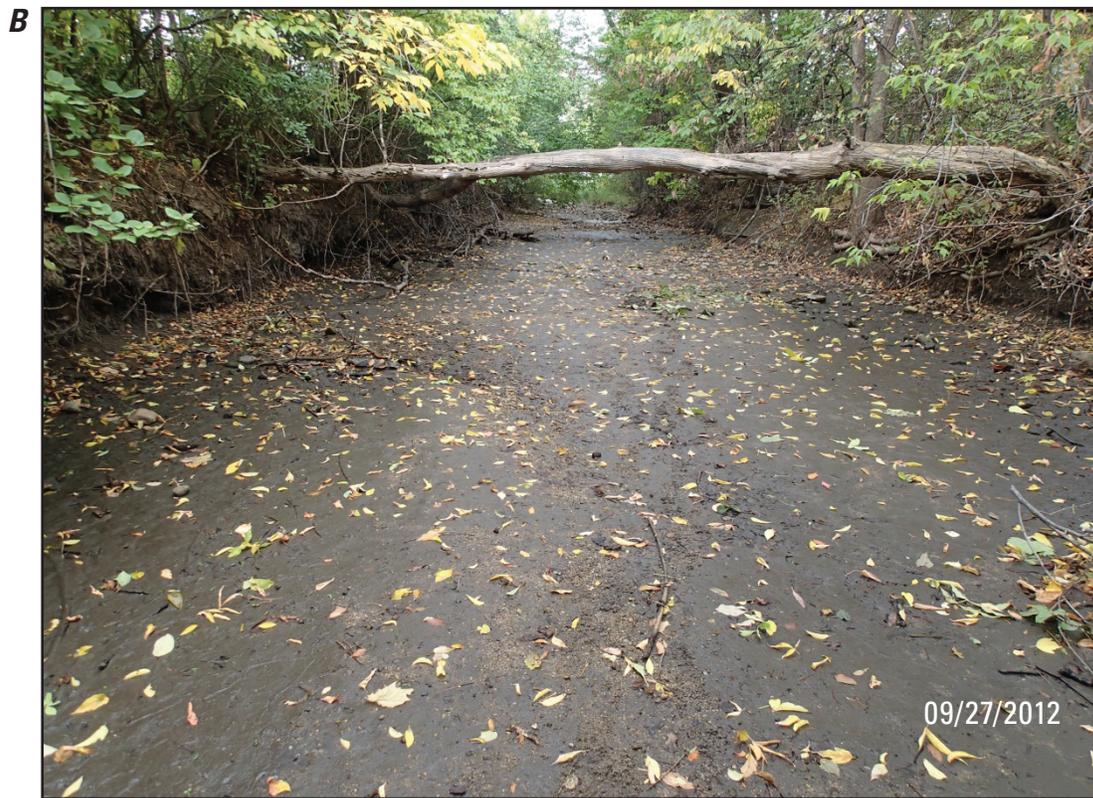
Figure 3. Comparison of flow conditions at Underwood Creek site 1 (0408708562) at time of geomorphic and habitat site assessment (*A*) on August 30, 2012, at time of river walk-through, and (*B*) on September 27, 2012.
