High-Water Marks From Hurricane Sandy for Coastal Areas of Connecticut, Rhode Island, and Massachusetts, October 2012

Data Series 1094

By Lance J. Ostiguy, Timothy C. Sargent, Brittney J. Izbicki, and Gardner C. Bent

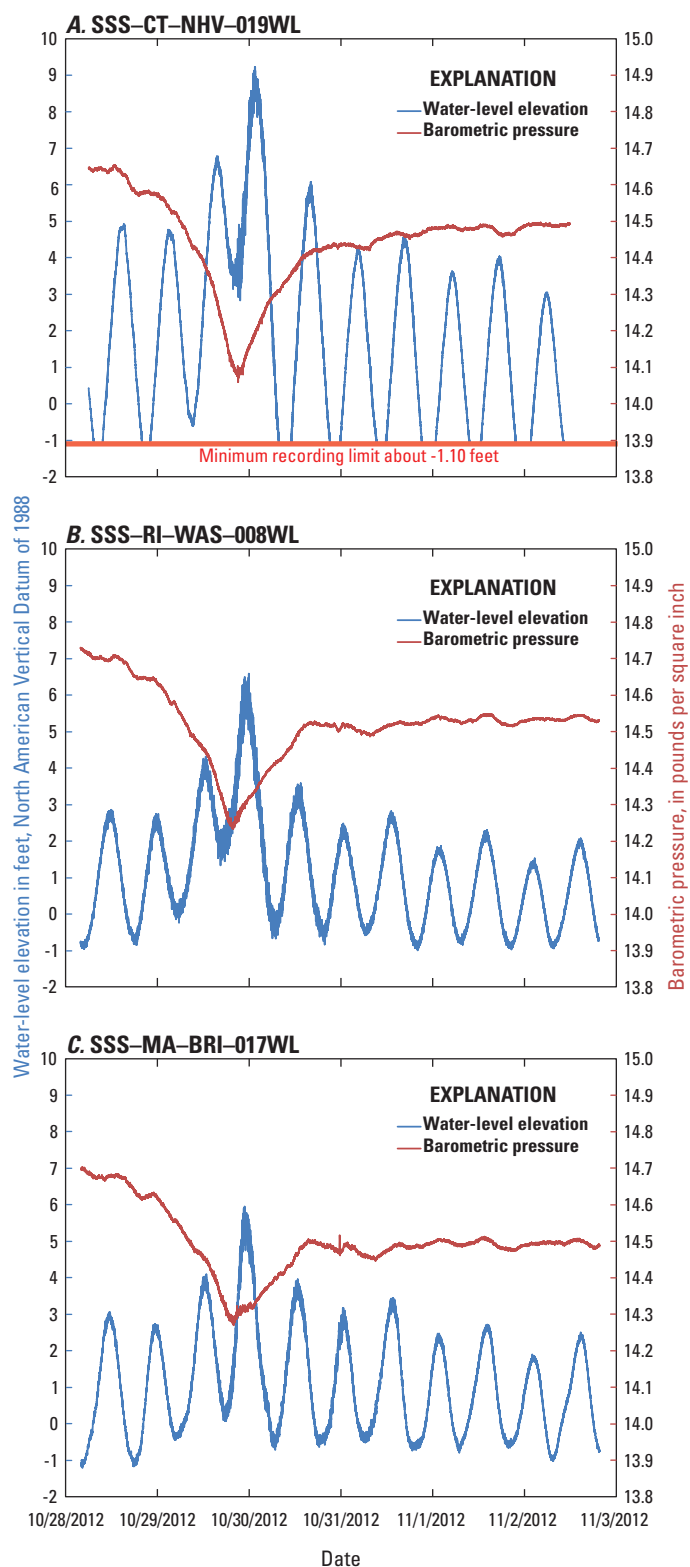
Figure 3. Water-level elevations before, during, and after Hurricane Sandy on October 28–31, 2012, at U.S. Geological Survey temporary storm tide sensors at *A*, the New Haven Coast Guard station dock at New Haven, Conn. (station SSS-CT-NHV-019WL), *B*, Skip's Dock at Point Judith, R.I. (station SSS-RI-WAS-008WL), and *C*, Hoppy's Landing at West Island, Fairhaven, Mass. (station SSS-MA-BRI-017WL).

Astronomical high tides in harmony with the timing of Hurricane Sandy making landfall created the conditions needed for record-setting high tides for the year (National Oceanic and Atmospheric Administration, 2013). Storm surge or the rise in sea level above average heights along the coasts of Connecticut, Rhode Island, and Massachusetts was varied, but there was a clear difference of a few feet between the prestorm high and low tide and the tides affected by Hurricane Sandy. At New Haven, Conn., the high tide during Hurricane Sandy was recorded to be about 3 to 4 ft higher than the prestorm high tides on October 28 at 1:00 p.m. eastern daylight time and on October 29 at about 2:00 a.m. (fig. 3A). This record was approximately 150 mi away from the center of Hurricane Sandy along the southern coast of New England. At Point Judith, R.I., the high tide during Hurricane Sandy was about 3 ft higher than the prestorm high tides recorded around October 28 at 11:00 a.m. and on October 29 at about 12:00 a.m. (fig. 3B). This record was approximately 200 mi away from the center of Hurricane Sandy along the southern coast of New England. In Fairhaven, Mass., 250 mi away from the center of Hurricane Sandy, high tide was about 2 to 2.5 ft higher than the prestorm high tide recorded around October 28 at 11:00 a.m. and on October 29 at about 12:00 a.m. (fig. 3C).

In advance of Hurricane Sandy, the USGS deployed 59 temporary storm tide sensors and 2 real-time rapid deployment gages along the coastline in Connecticut, Rhode Island, and Massachusetts (U.S. Geological Survey, 2018). The 26 temporary storm tide sensors (1 of the 27 sensors could not be found after the storm or was destroyed) along the coastline of Connecticut had peak tide elevations that ranged from about 5.8 to 11.7 ft with an average of 8.3 ft and a median of 8.3 ft. Along the coastline of Rhode Island, the 10 temporary storm tide sensors and 1 rapid deployment gage had peak tide elevations that ranged from about 4.0 to 8.4 ft with an average of 6.3 ft and a median of 6.4 ft. Along the coastline of Massachusetts, the 22 USGS temporary storm tide sensors and 1 rapid deployment gage had peak tide elevations that ranged from about 3.4 to 8.3 ft with an average of 6.2 ft and a median of 6.8 ft.

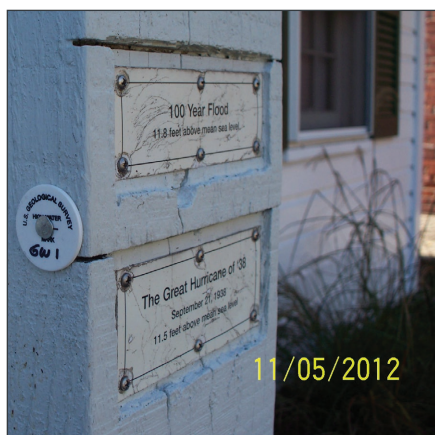
A. HWM-CT-FFD-121

Figure 4. Evidence and field methods for recording high-water marks caused by Hurricane Sandy in Connecticut, Rhode Island, and Massachusetts. *A*, white disc nailed at location of debris line (Greenwich, Conn.); *B*, debris line found along wall siding (Westport, Conn.); *C*, white disc nailed to wooden post at a wrack line (Portsmouth, R.I.); *D*, debris line on foundation of building (Westerly, R.I.); *E*, creating a direct Global Positioning System record at a wrack line found on a cut lawn (Edgartown, Mass.); and *F*, stainless steel stud marking a seed line on a culvert wall (Falmouth, Mass.).
