# Terrestrial Lidar Data of the February 14, 2019, Sausalito Boulevard Landslide, Sausalito, California

**Data Series 1112**

By Brian D. Collins and Skye C. Corbett

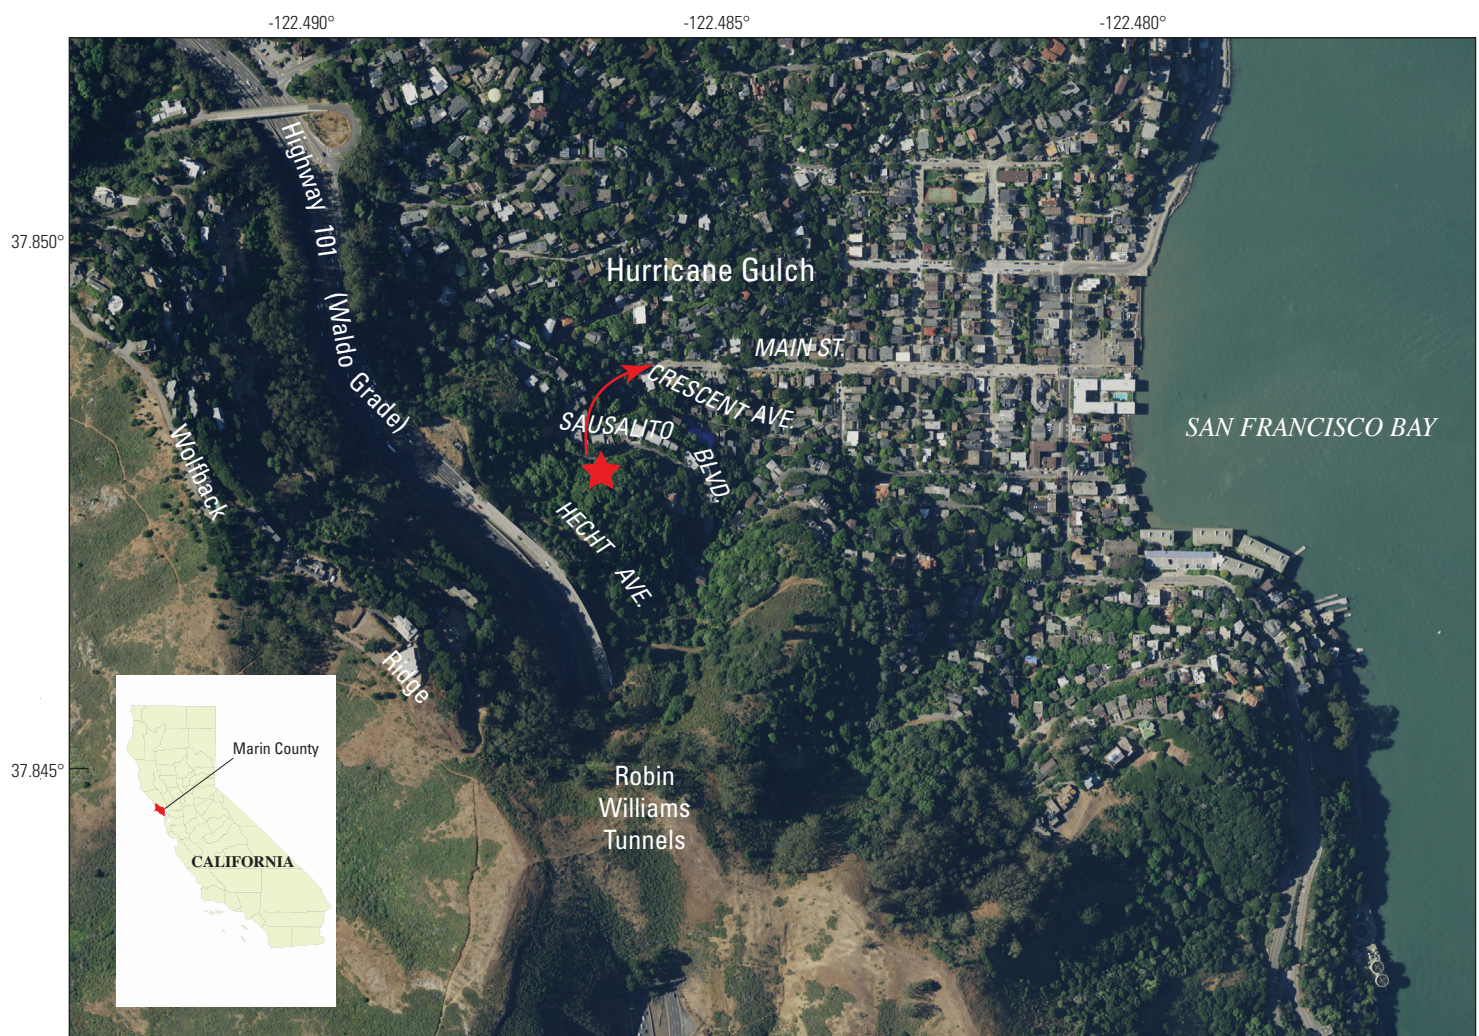
**Figure 1.** Site map of the February 14, 2019, Sausalito Boulevard landslide in Sausalito, Marin County, California. Red star shows approximate location of the landslide. Latitude and longitude tick marks (in World Geodetic Datum of 1984 coordinates, WGS84) are for general reference.

On February 14, 2019, just before 2:56 am local time (Pacific Standard Time), a landslide initiated from the hill-slopes above the Hurricane Gulch section of the City of Sausalito, Marin County, California (fig. 1). The landslide, specifically classified as a debris flow, overran a road (Sausalito

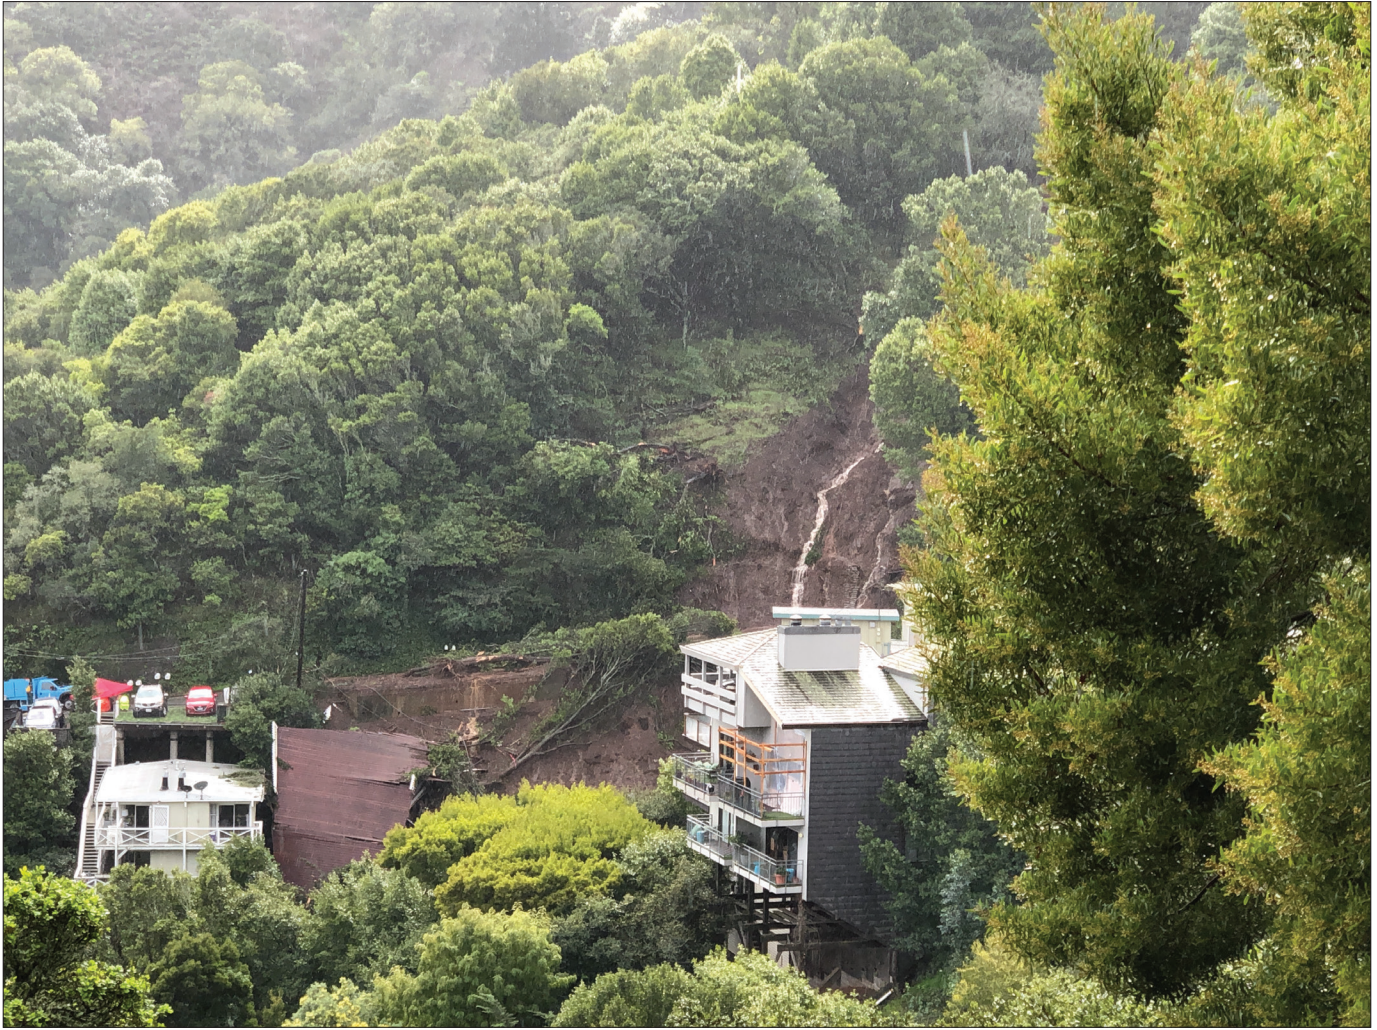
**Figure 2.** Photograph showing partial landslide source area and region of one destroyed residential structure. The landslide traveled from the upper right side of the image, crossed the road (flat area in middle ground), and impacted one residential structure before subsequently carrying debris and vehicles from several partially impacted homes farther down the slope (towards the bottom left of the image). Date of image is February 14, 2019.

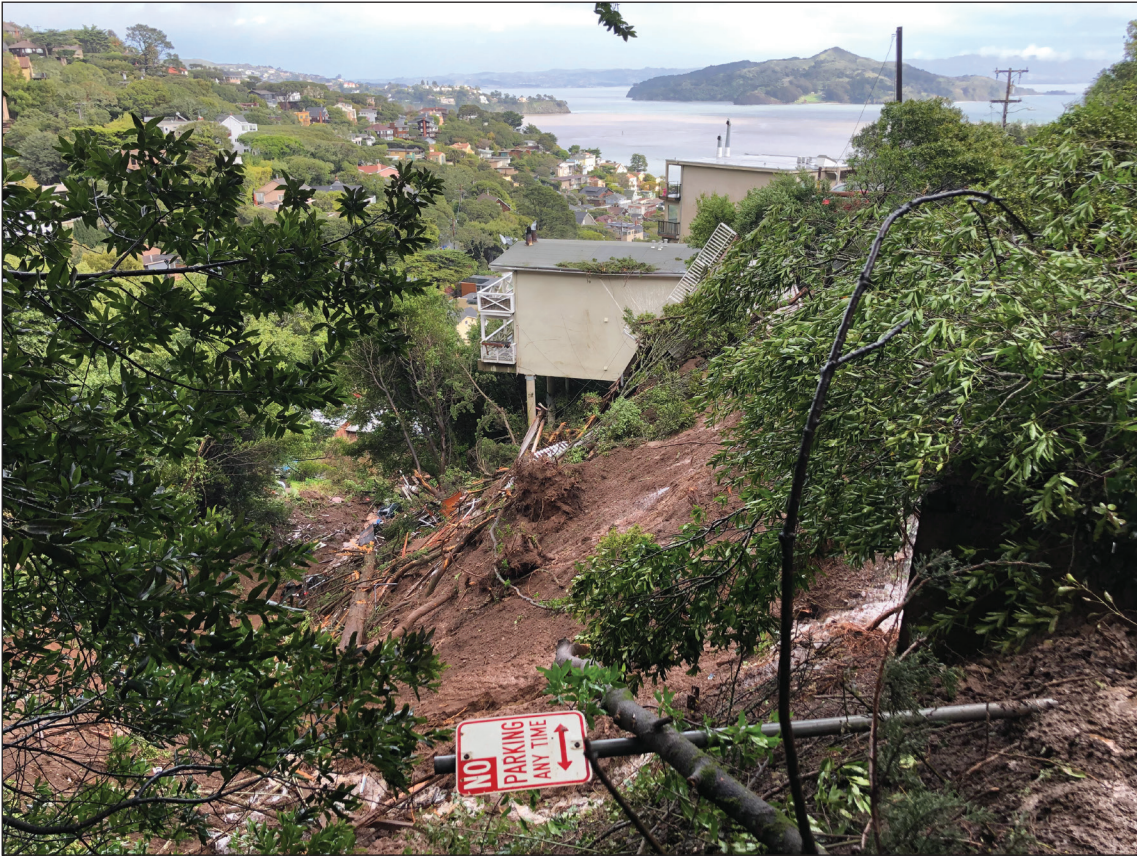
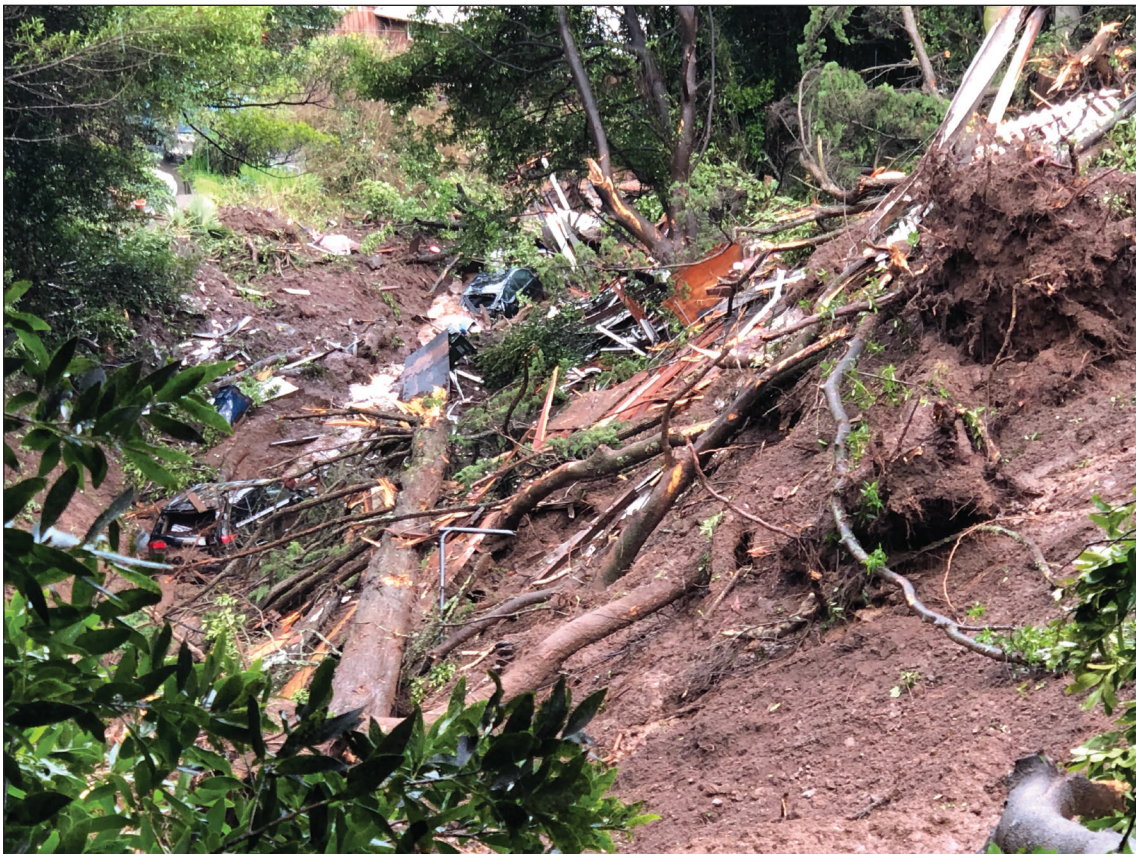
**Figure 3.** Photographs showing damage from the landslide that involved several homes and vehicles. *A*, View looking to the northeast towards Angel Island in San Francisco Bay. The area of one destroyed residential structure is in the foreground. The other destroyed home is located near the center of the image, which is out of site behind trees. *B*, Several vehicles were entrained within the debris amidst soil, trees, and structural debris. Area shown in (*B*) is located in the center left of (*A*). Date of both images is February 14, 2019.

A resident was located in the upper level of the first impacted structure (fig. 3A) and survived the disaster. No residents were located in the second impacted structure. Several other residential structures were damaged as a result of passage of the debris flow below Sausalito Boulevard, and emergency officials evacuated several residents from neighboring partially damaged structures. Overall, 50 residences were evacuated due to the threat posed by potential ongoing instability of the slope and natural gas leaks from broken pipes leading to residential structures. At least seven vehicles were entrained in the debris (fig. 3B), due to the destruction of elevated carports attached to structures impacted just below Sausalito Boulevard.

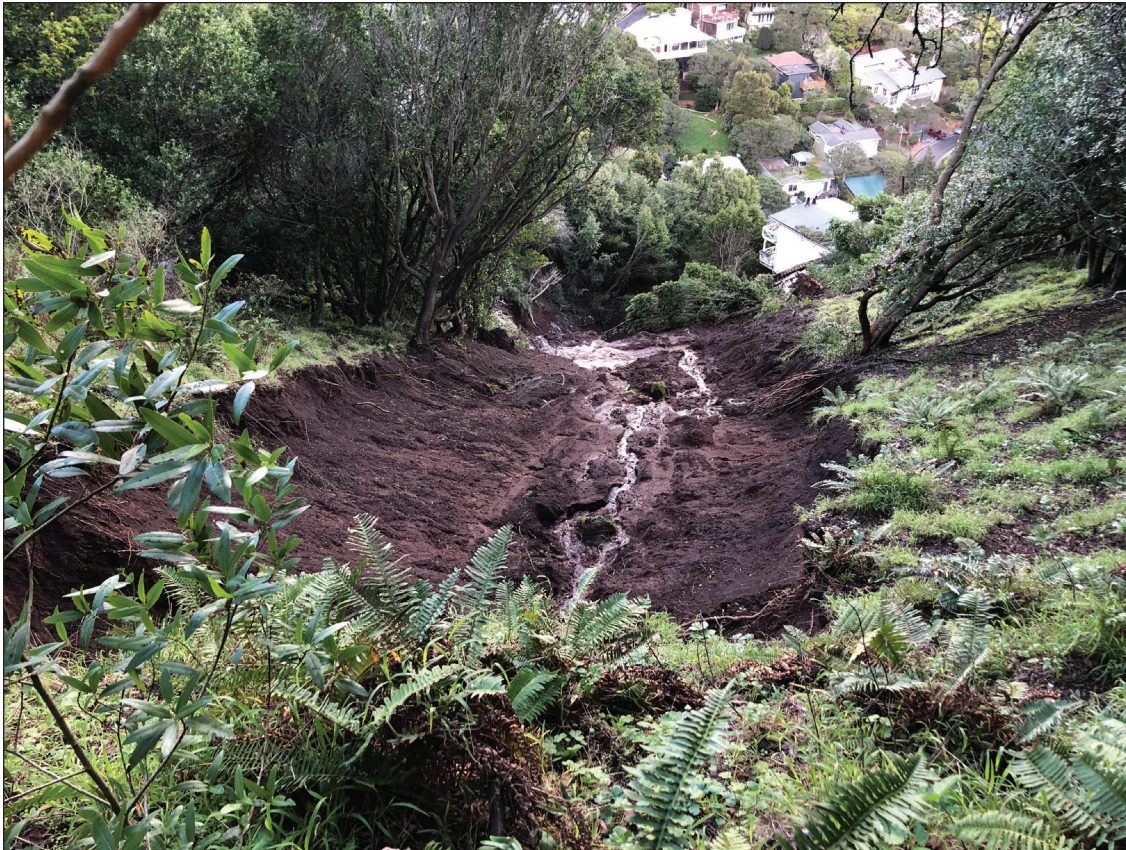
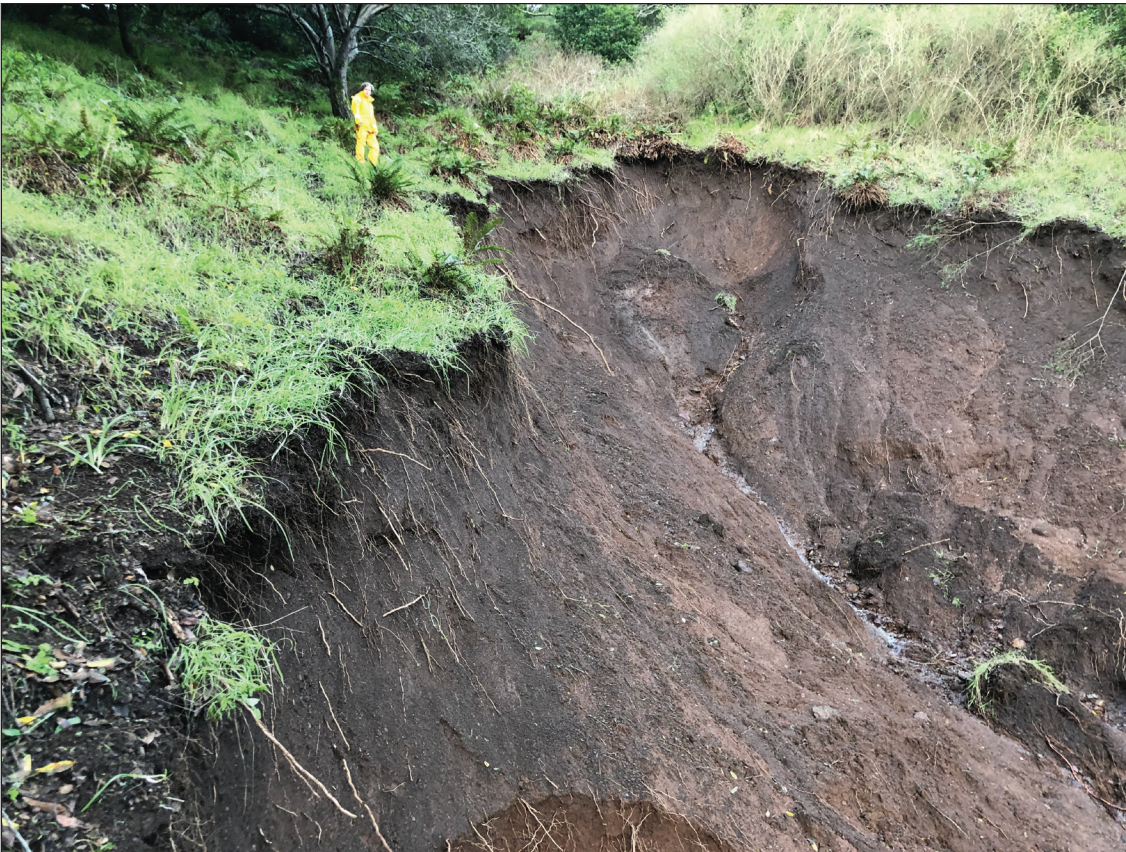
**Figure 4.**

*A*, Photographs showing landslide source area as viewed from the headscarp. A prominent stream of water exited the headscarp and flowed along the landslide axis in the days following the landslide. Sausalito Boulevard is located at the bottom of the slope (middle ground of image). Width of landslide is approximately 12 meters. *B*, The landslide headscarp forms a near-vertical slope approximately 6 meters tall. Photograph (*B*) by Bryant Ho (City of Sausalito)

The landslide source area begins at an elevation of 126 m and extends for a ground distance of approximately 50 m downslope (as measured from the headscarp to just above Sausalito Boulevard) to an elevation of approximately 102 m. The source area is approximately 12 m wide and 2 to 6 meters in thickness (fig. 4A). The landslide occurred on the northwest-facing sideslope of a small (100-m-wide) valley flanked by two small (100-m-wide, 200-m-long) ridges that extend to the northeast from Wolfback Ridge. The northwest-facing slope of the ridge encompassing the landslide source area is composed of several slightly convergent swales (characterized as colluvial-filled hollows; for example, see Dietrich and others, 1986). The landslide initiated from one of these hollows. Following initiation, the landslide dropped over a steep (approximately 49°) 6-m-tall slope, overran Sausalito Boulevard, impacted a residential structure (duplex), and continued downslope. Very little deposition of debris above Sausalito Boulevard was observed (that is, the source area encompasses almost the entire landslide zone above the road and exhibits near complete evacuation of all debris). The landslide deposit zone extends from Sausalito Boulevard (approximate elevation 93 m) 30 m down an approximately 36° slope to the less steep valley floor. The deposit then flowed onto the lower angle (~20°) valley floor and eventually stopped just past Crescent Avenue, where the debris collided with another residential structure. Total ground length of the source and runout zone (as measured from the headscarp to the distal end of the deposit) is approximately 220 m. Total elevation difference over this distance is approximately 75 m.

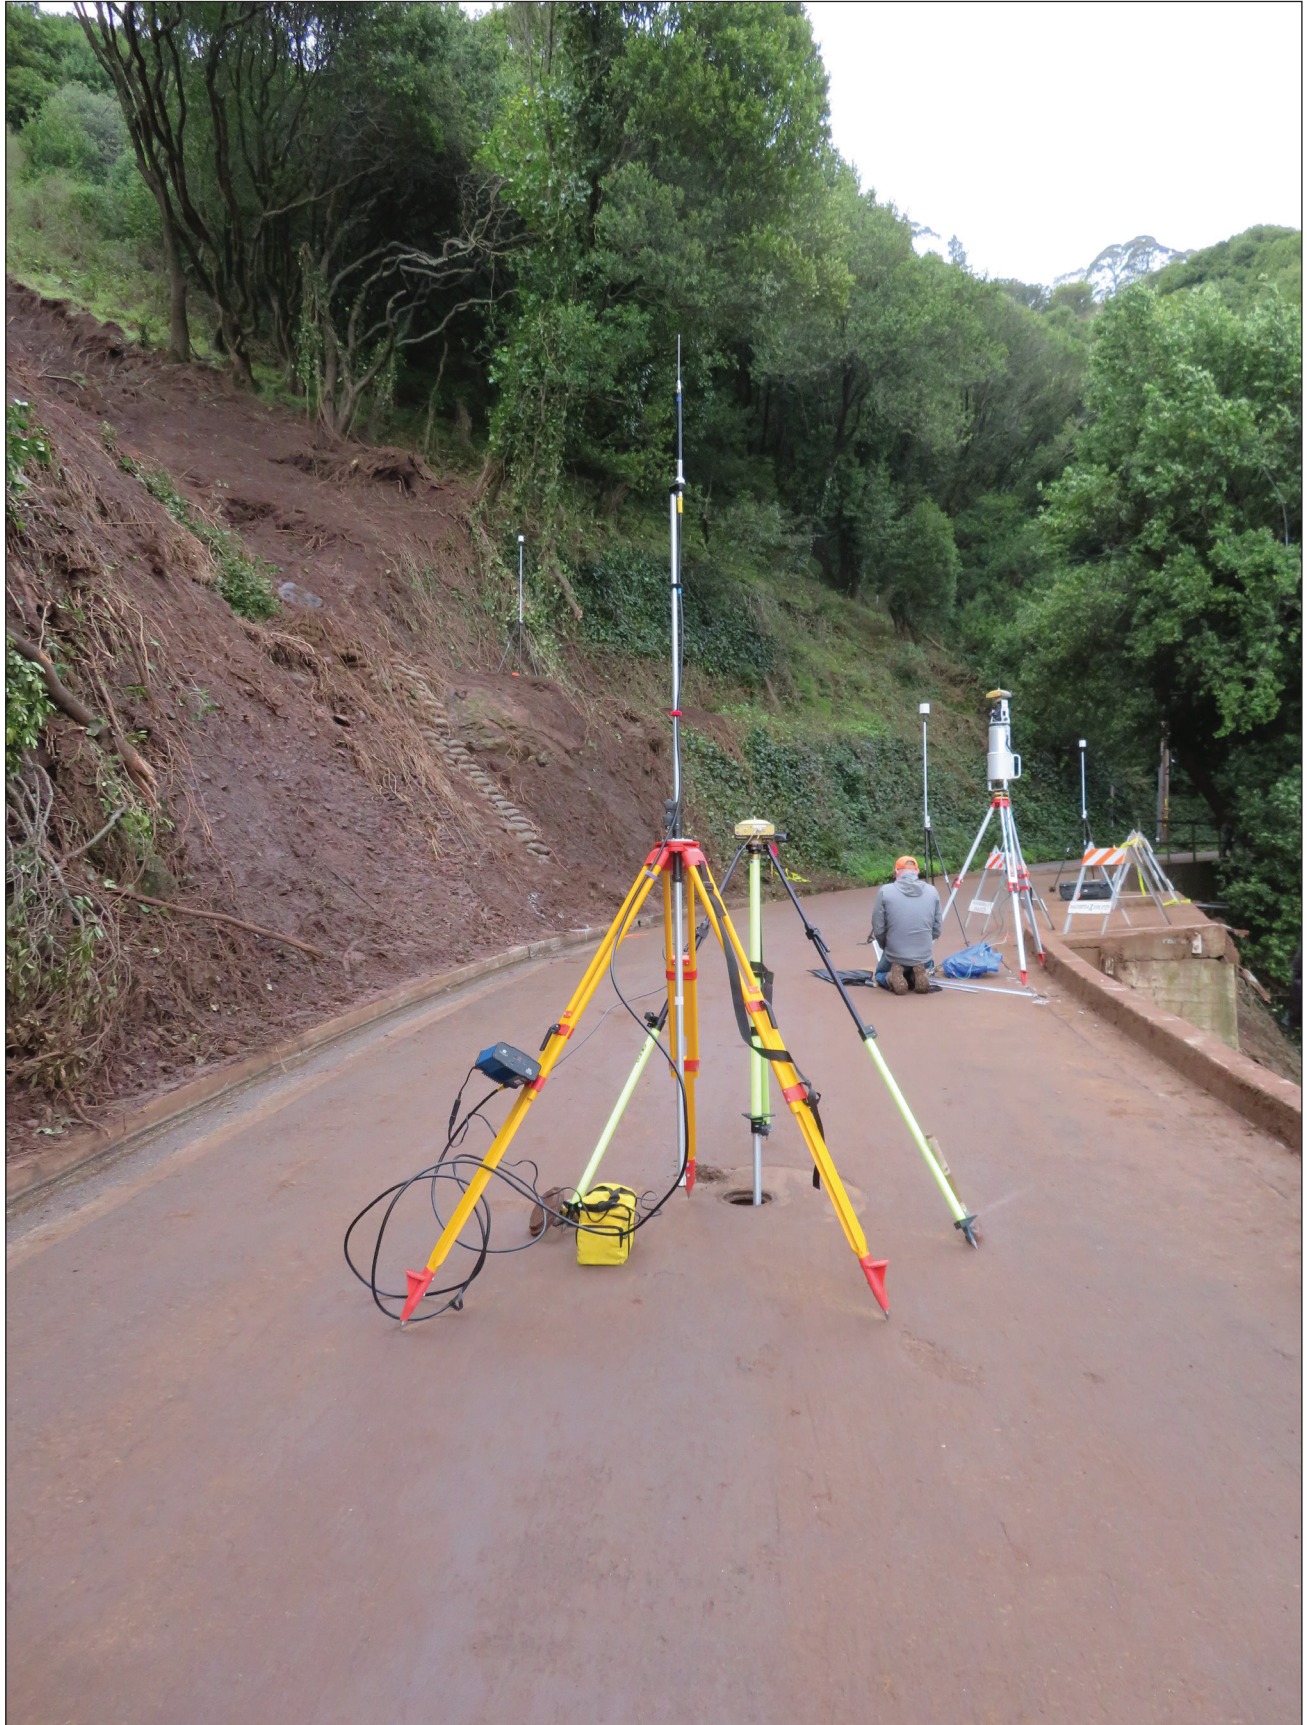
**Figure 7.** Photograph showing GPS base station (neon yellow tripod) with radio mast antenna (yellow and orange tripod) set up over control point M-163 on Sausalito Boulevard. Terrestrial lidar data collection from position LS1 is taking place and several control points (white cylinders on black and silver tripods) are visible in the background.

We located our base station over a City of Sausalito horizontal control point (M-163, fig. 7; NAD27 (North American Datum of 1927) California State Plane Zone 3 horizontal coordinates E1426810.90 ft, N496963.32 ft), but performed a 6-hour static GPS collection to obtain an independent coordinate solution in NAD83(2011) (North American Datum of 1983–National Adjustment of 2011), UTM (Universal Transverse Mercator) Zone 10N coordinates (in meters). The static solution was processed by the National Geodetic Survey’s online positioning user service (OPUS) processing algorithms (<https://www.ngs.noaa.gov/OPUS/>). We used the GEOID12B geoid (<https://www.ngs.noaa.gov/GEOID/GEOID12B/>) output from OPUS to transform the ellipsoid solution for the base station control point to an orthometric height in NAVD88 (North American Vertical Datum of 1988) coordinates (in meters). All laser and control points are thereby referenced to this set of coordinates (NAD83(2011)-UTM Zone 10N and NAVD88). Overall accuracy of the static OPUS solution (that is, the error associated with the global control network,  $E_{control}$ ) is 2.0 cm. Overall three-dimensional accuracy of our internal network RTK solutions (that is, the error associated with the measurement of positions between the base station and rover locations,  $E_{survey}$ ) is 0.8 cm (ignoring one laser scan position, LS4 that we were not able to obtain a fixed GPS solution for). We were able to obtain subcentimeter solutions for all but three points (LS4 – 3.4 cm, LS6 – 1.5 cm, and CP3 – 1.6 cm)—these were located under heavy vegetation on the left lateral margin of the landslide source area with poor visibility to the sky. Applying the georeferenced coordinates from the laser scan (5 of 6 points, excluding LS4) and control points (5 of 5 points) to the point cloud data resulted in a final georeferencing error ( $E_{georef}$ ) of 2.3 cm.
