Bank Topography, Bathymetry, and Current Velocity of the Lower Elwha River, Clallam County, Washington, May 2006

Data Series 363

By Christopher A. Curran, Christopher P. Konrad, Randal L. Dinehart, and
Edward H. Moran

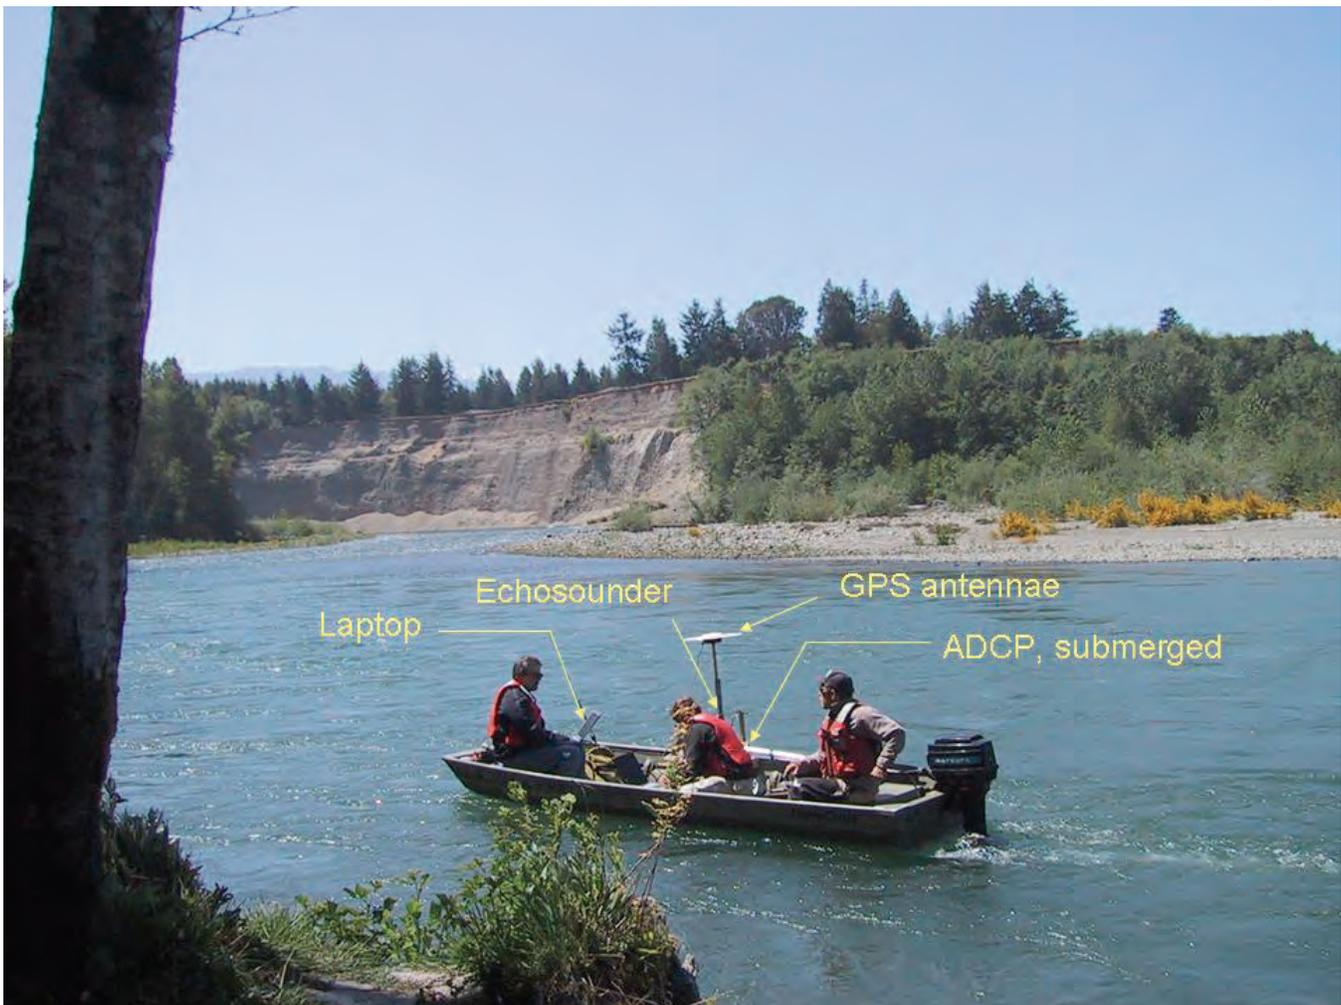
Figure 2. Operation of boat-mounted acoustic Doppler current profiler (ADCP) with Real-Time Kinematic-Global Positioning System (RTK-GPS), looking upstream from RK 0.5 of the Elwha River, Clallam County, Washington. (Photograph taken by Christopher Konrad, May 16, 2006.)

River bathymetry was measured using a single-beam, 200-kHz echosounder, and current velocity was measured with a 1,200-kHz ADCP. The echosounder and ADCP were operated independently, at times concurrently, and were interfaced with RTK-GPS. The ADCP and the echosounder were operated from a 16-ft aluminum Jon boat with a 15-horsepower propeller motor (fig. 2). The echosounder measured water depth at a rate of 1 Hz, and the ADCP measured relative water depth and current velocity (speed and direction of flow) at a single-ping rate of 2 Hz.

The ADCP transect lines were made perpendicular and parallel to the direction of flow, to map a dense data set of velocity magnitudes and directions from which longitudinal (downstream) and lateral (cross-stream) components could be defined. When used simultaneously, the echosounder and ADCP were mounted on the starboard side of the boat, with a 30 cm offset between devices. In this configuration, the RTK-GPS was mounted directly over the echosounder. When only the ADCP was used, a mapping-grade GPS with submeter accuracy (Trimble Navigation Limited, 2003) was mounted directly over the ADCP.
