Terrestrial Lidar Datasets of New Orleans, Louisiana, Levee Failures from Hurricane Katrina, August 29, 2005

Data Series 470

By Brian D. Collins, Robert Kayen, Diane Minasian, and Thomas Reiss

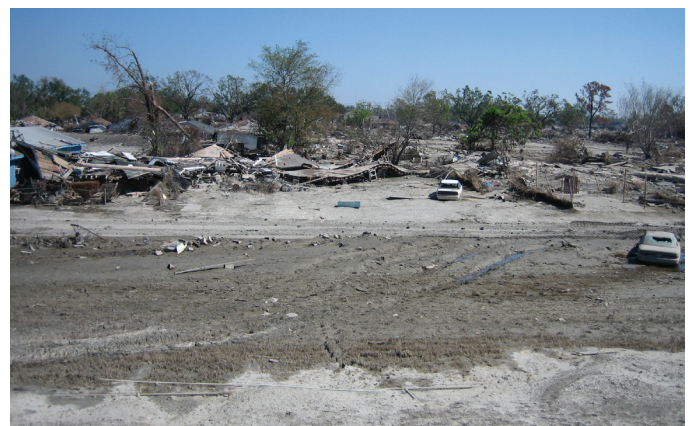
Figure 1. Levee breach damage in the Lower Ninth Ward of New Orleans along the Inner Harbor Navigational Canal (IHNC).

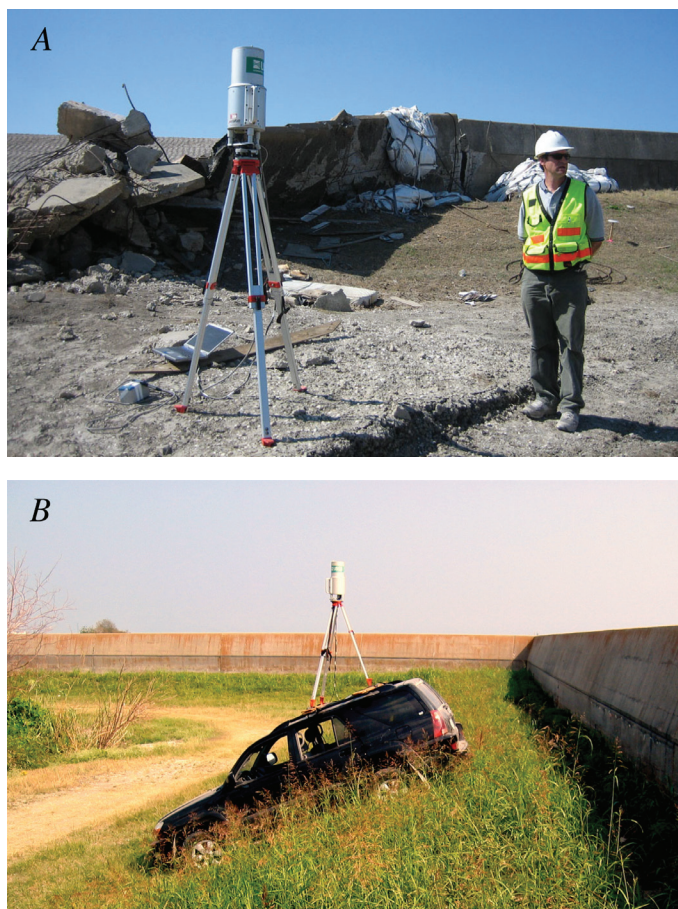
Figure 3. Tripod-mounted (A) and vehicle-mounted (B) terrestrial lidar data collection.

In this study, a Class 1 (eye-safe under normal operating conditions), near infrared (900 nm), pulsed laser diode, Riegl Z210 scanner (Riegl, 2008), with integrated color sensor, was utilized as a tripod-mounted laser scanning instrument (fig. 3A). In some cases, the instrument was elevated on a fixed platform (for example, the vehicle rooftop as shown in fig. 3B) to improve and extend the field of view and to increase the efficient transport of the instrument between individual scan set-up locations (herein referred to as “scans” or “scan locations”). At each scan location, we collected approximately 2.3 million data points in 5 minutes (scan rate of 8,000 points/second) on seven channels (X coordinate, Y coordinate, Z coordinate, red color, green color, blue color, and reflective

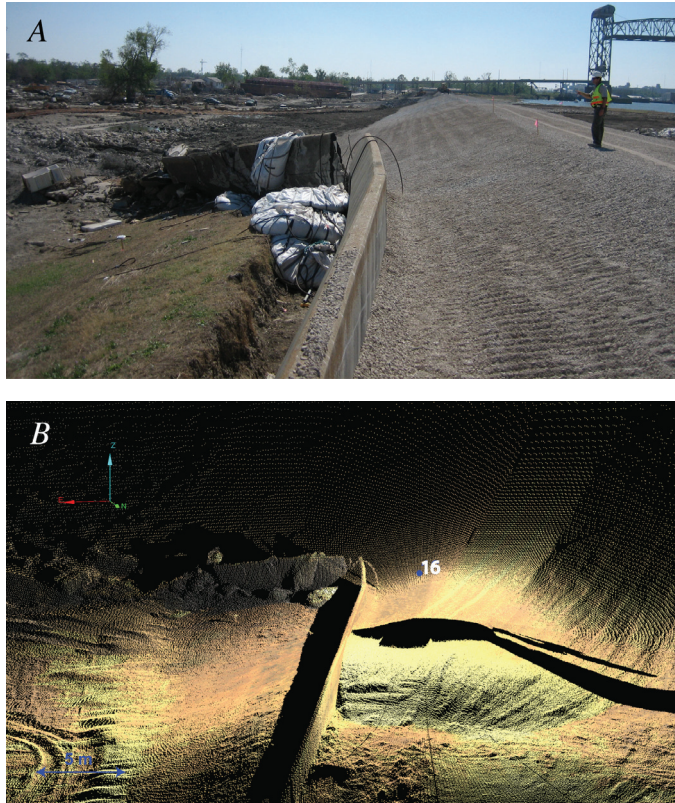
Figure 4. *A*, Lidar data collection at a single scan location (scan location 16) at the Inner Harbor Navigational Canal (IHNC) North Breach, showing how shadow zones are created from objects. *B*, Lidar image of same location. The scour-trench area immediately behind the wall and location of laser scanner (black areas) are not captured in the lidar data from this location.

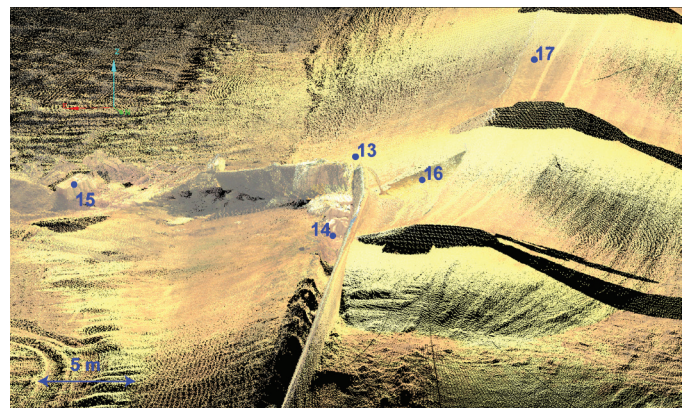
Figure 5. Lidar image oblique view (same site and viewpoint as fig. 4*B*) of multiple scans (scan locations 13-17) at the IHNC North Breach required to fill shadow zones. Scour trench behind floodwall was captured from scan location 14.

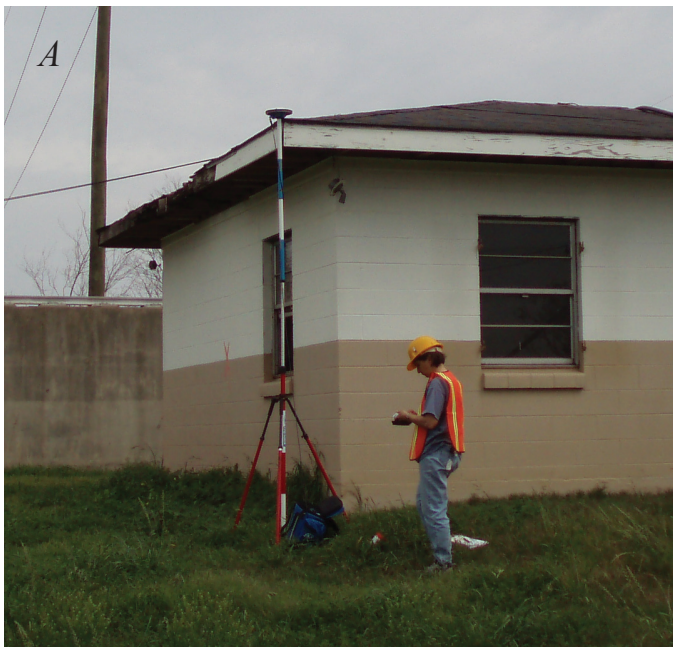
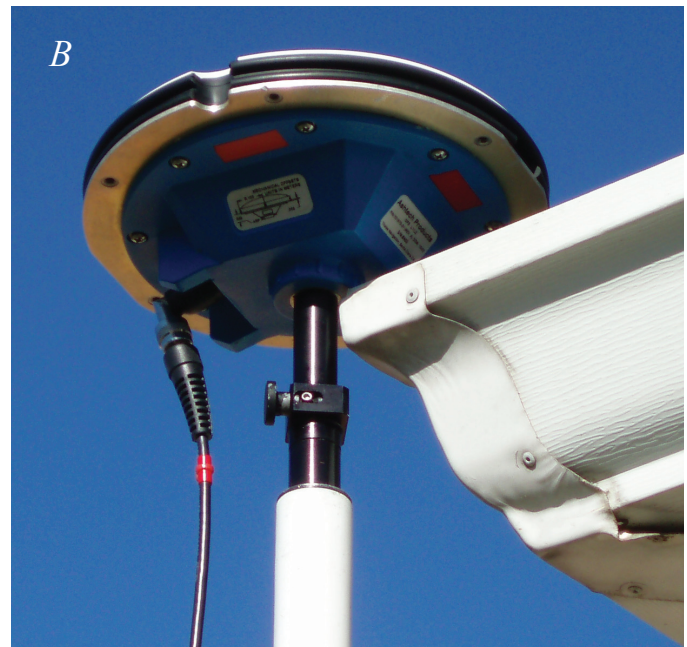
Figure 6. Corners of buildings (A) and gutters (B) provide well-defined global positioning system (GPS) survey points for georeferencing the lidar point-cloud datasets.

For the GPS surveys, we collected high-accuracy survey data on cultural features clearly visible in the scan sets (such as house roof corners, fence posts, concrete foundation corners; fig. 6). We used four dual-frequency GPS receivers (Ashtech Z-Xtreme, Model #800889-C): two acting as static base receivers and two performing kinematic (rover) lidar control-point surveys. All receivers operated simultaneously to obtain the desired geodetic-quality registration points. Because many of the existing control points in the New Orleans area had been subject to long-term subsidence (Shinkle and Dokka, 2004), the static GPS receivers were positioned only over survey control points that had been accurately resurveyed following the hurricane by researchers at the Louisiana State University's Center for GeoInformatics in collaboration with the National Geodetic Survey. This was necessary to ensure that calculated elevations resulting from the survey were of the highest accuracy possible—particularly important with regard to determining actual floodwall elevations at each levee breach. Using this network of base stations for postprocessing of the kinematic GPS data, we collected approximately 15 local control points at each levee site with the two roving GPS receivers. Each point was occupied for approximately 5 to 10 minutes (300 to 600 measurements), providing postprocessed coordinate accuracies on the order of a few centimeters.

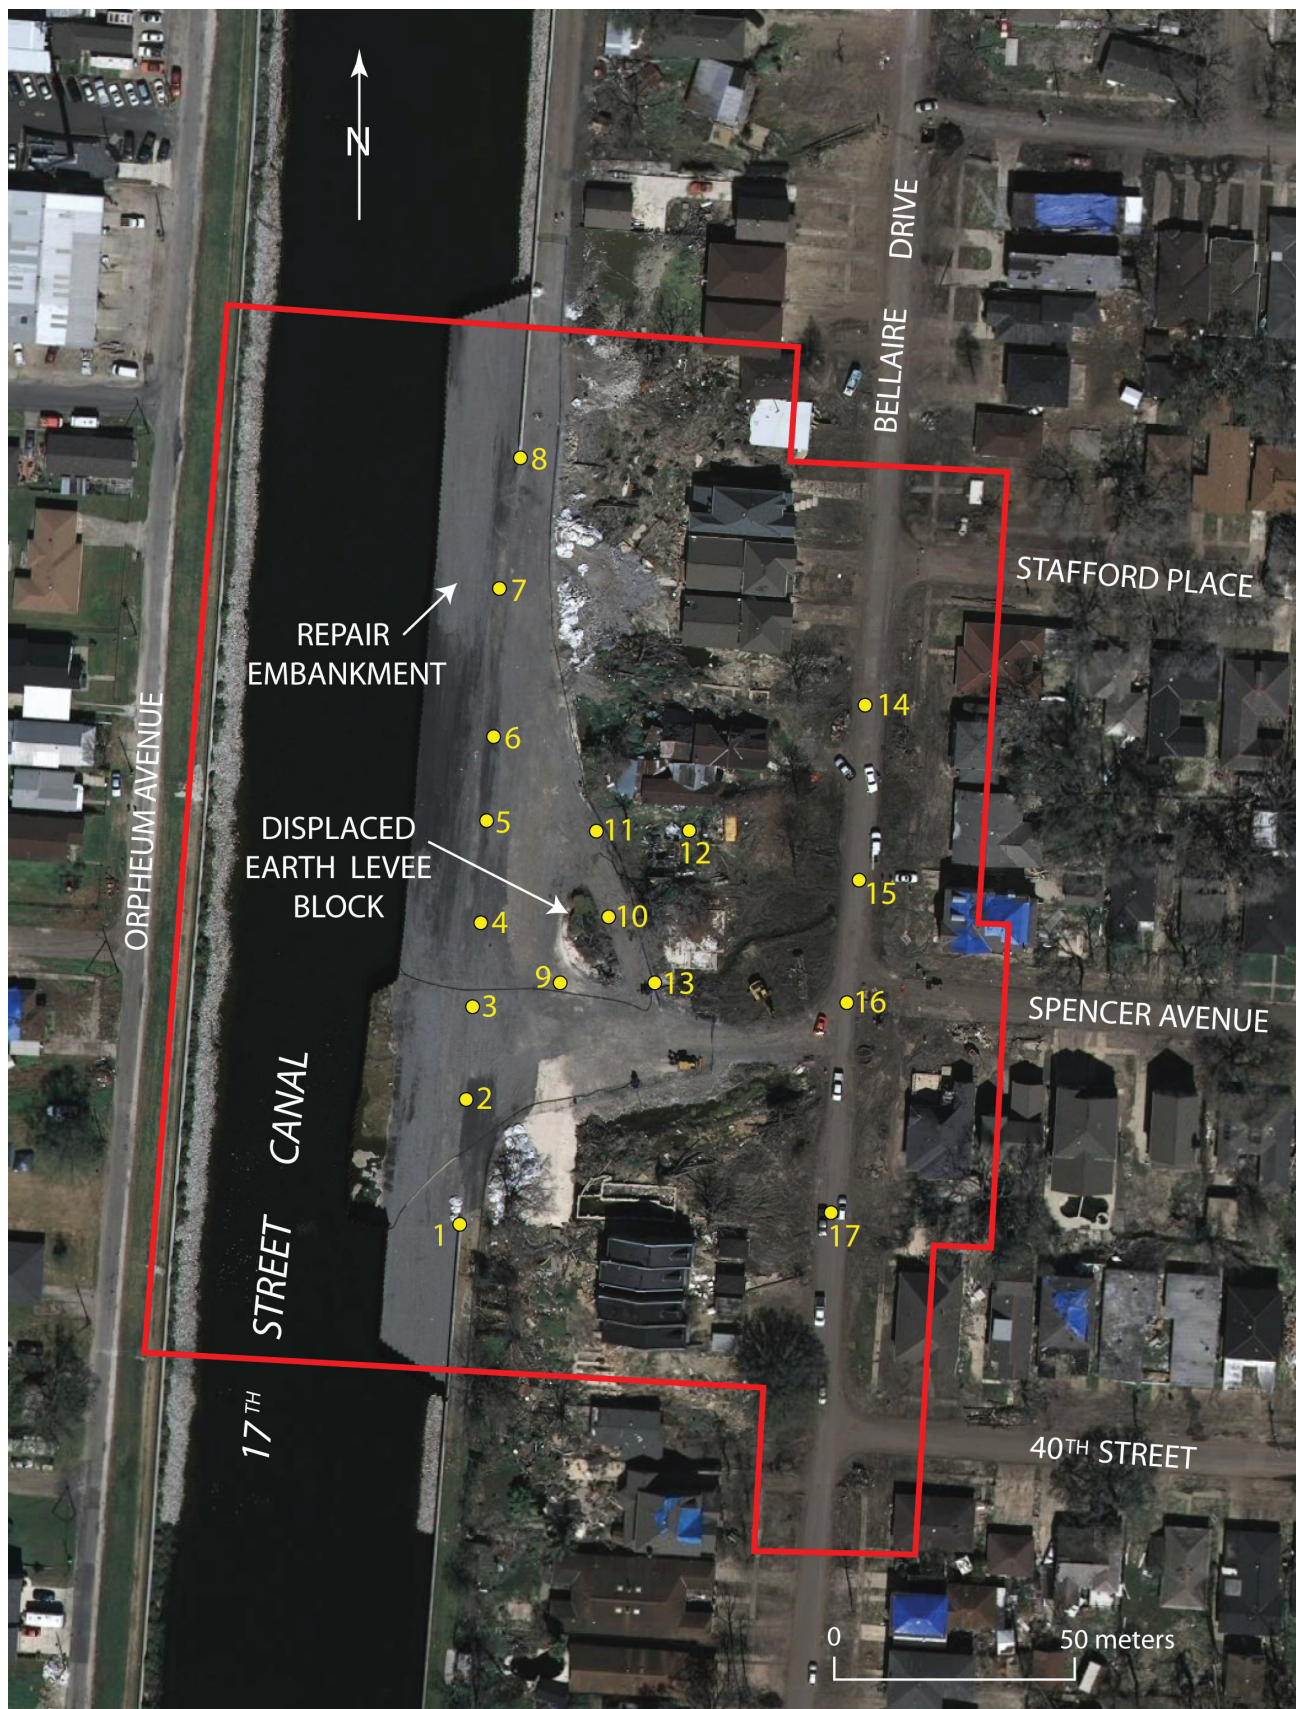
Figure 7. Site 1—17th Street Canal levee breach. Numbered dots indicate locations of scan positions. Red outline indicates area of lidar data coverage. (Photo source: Google Earth–USGS image.)

At the 17th Street Canal levee breach (site 1, fig. 7), we collected data in and around the main levee breach, including documentation of damaged residences approximately 150 m to the east of the breach along Bellaire Drive. Unfortunately, the incipient failure of the west bank of the canal is not documented in great detail by the terrestrial lidar datasets. At the time of data collection, an emergency repair earth embankment was in place to close the breach; however, the

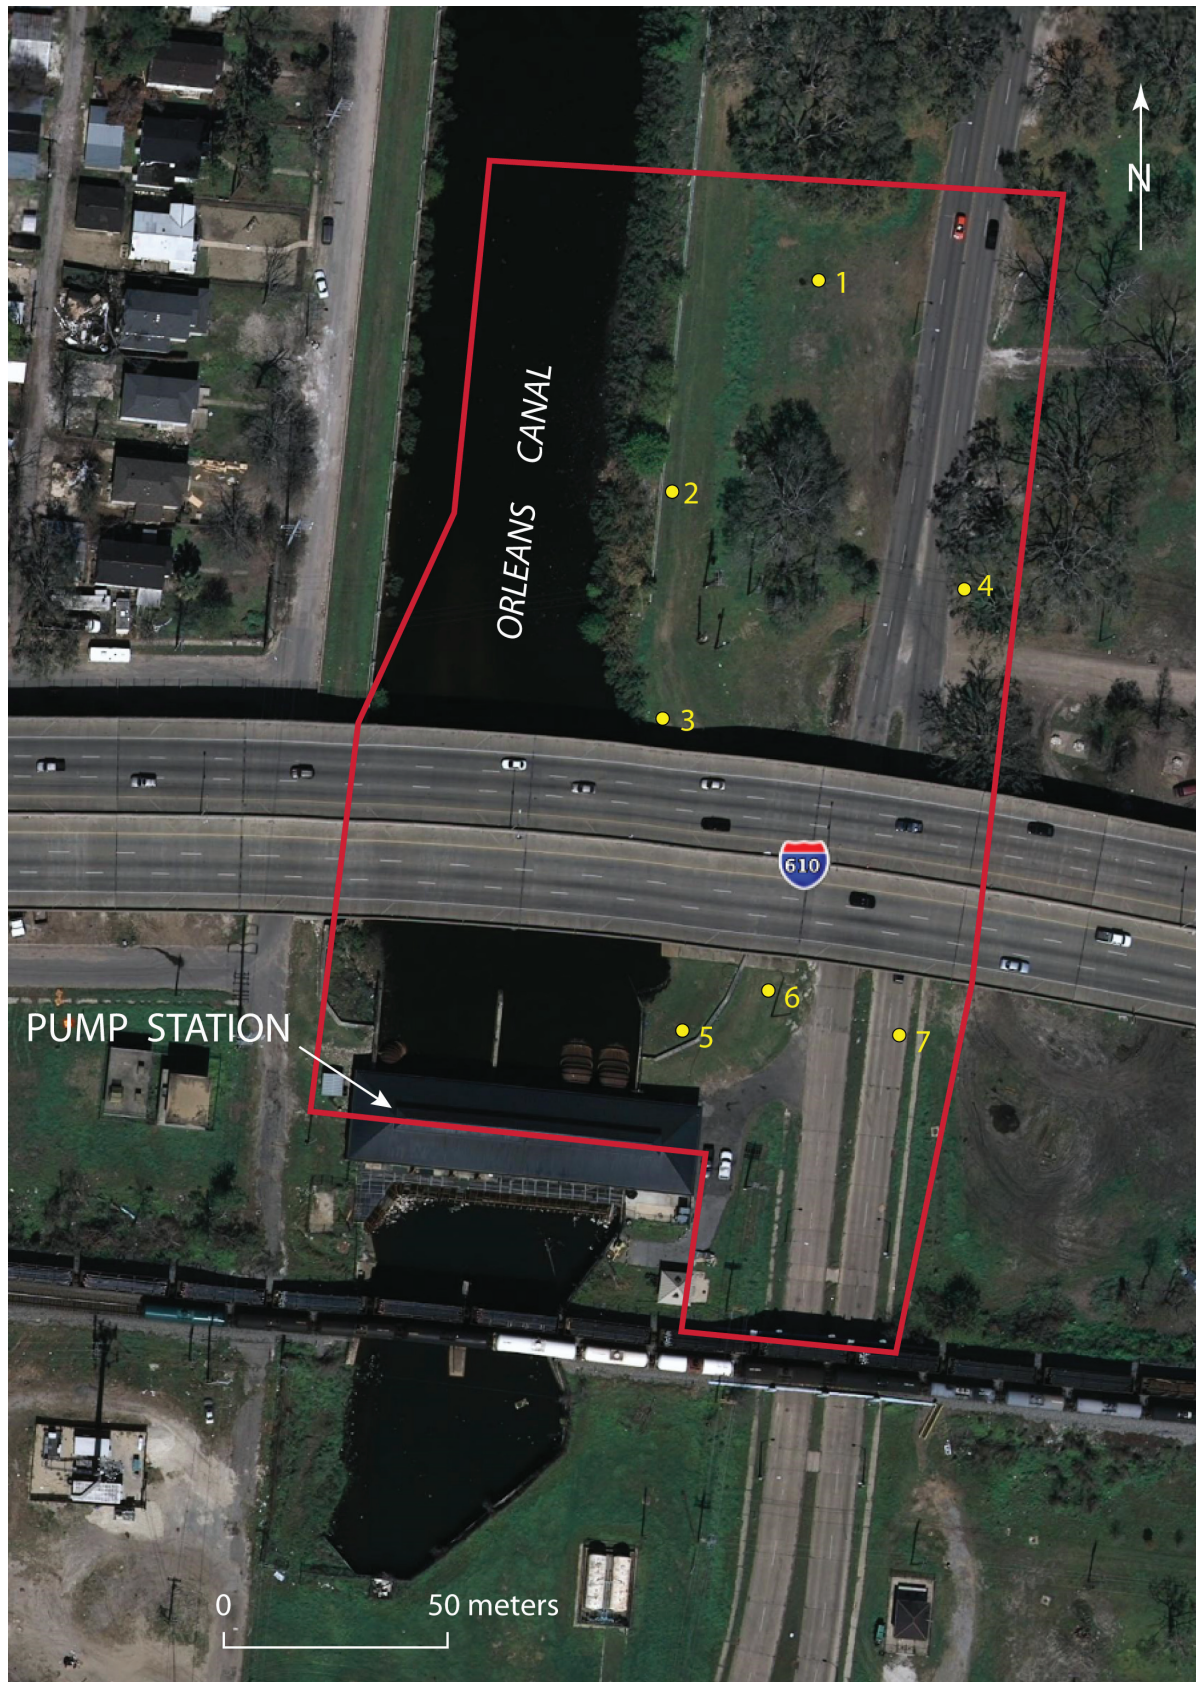
Figure 8. Site 2—Orleans Canal pump station spillway breach. Numbered dots indicate locations of scan positions. Red outline indicates area of lidar data coverage. (Photo source: Google Earth—USGS image.)

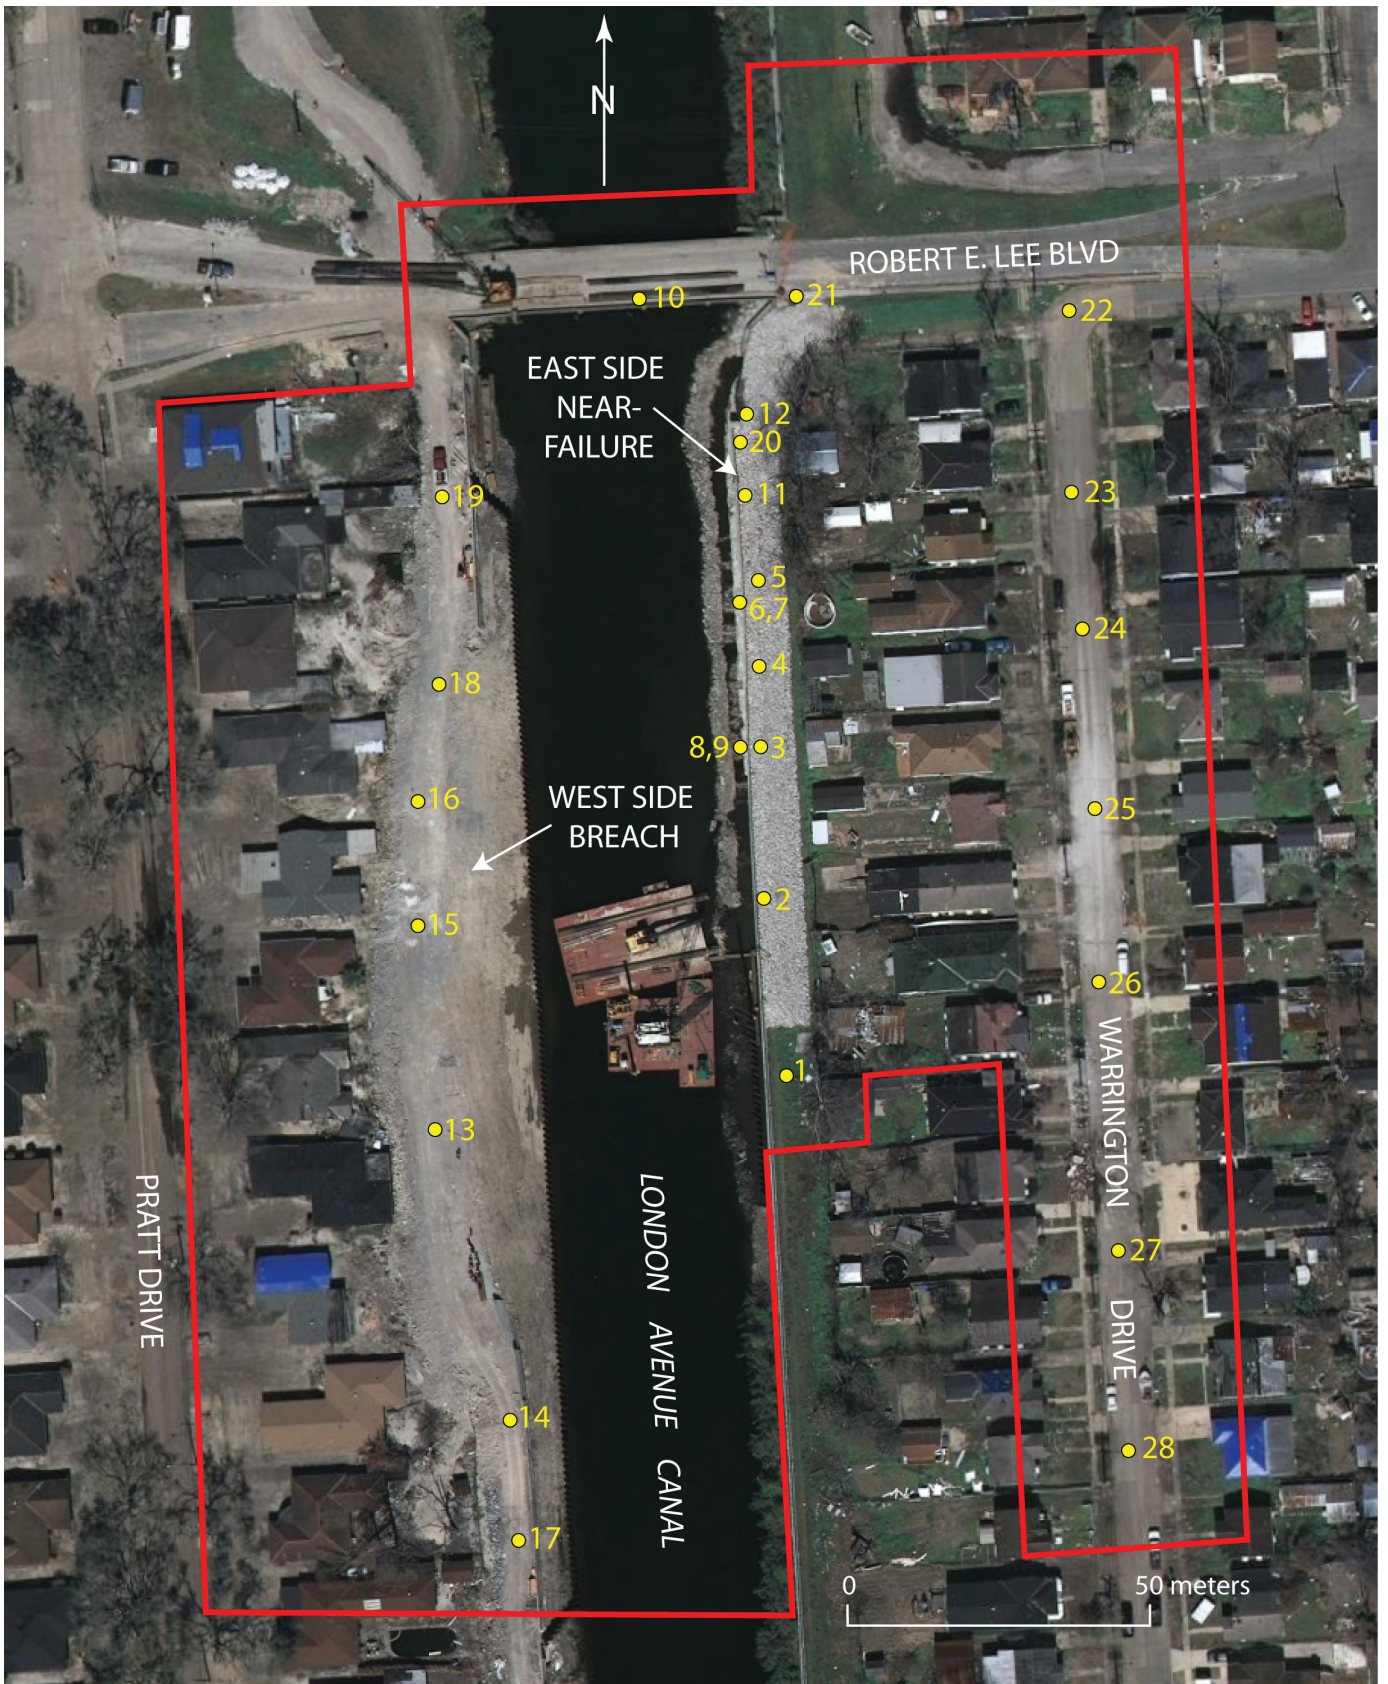
Figure 9. Site 3—North London Avenue Canal levee breach. Numbered dots indicate locations of scan positions. Red outline indicates area of lidar data coverage. (Photo source: Google Earth—USGS image.)

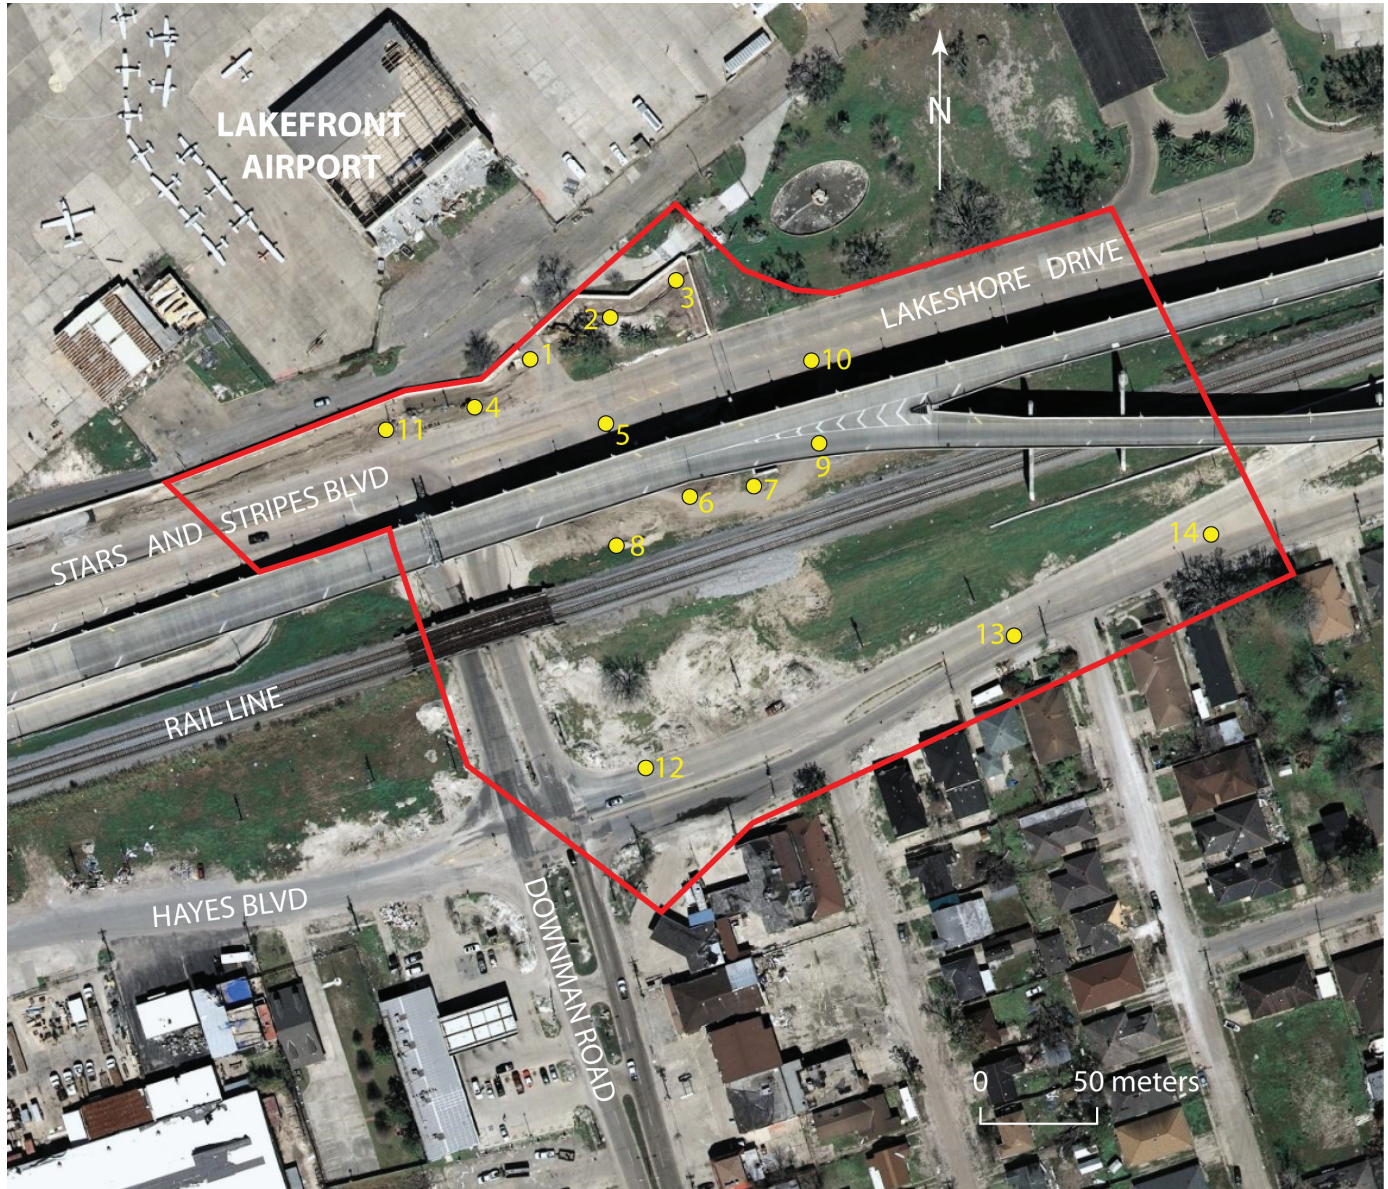
Figure 10. Site 4—Lakefront Airport levee transition breach and floodwall scour. Numbered dots indicate locations of scan positions. Red outline indicates area of lidar data coverage. (Photo source: Google Earth—USGS image.)

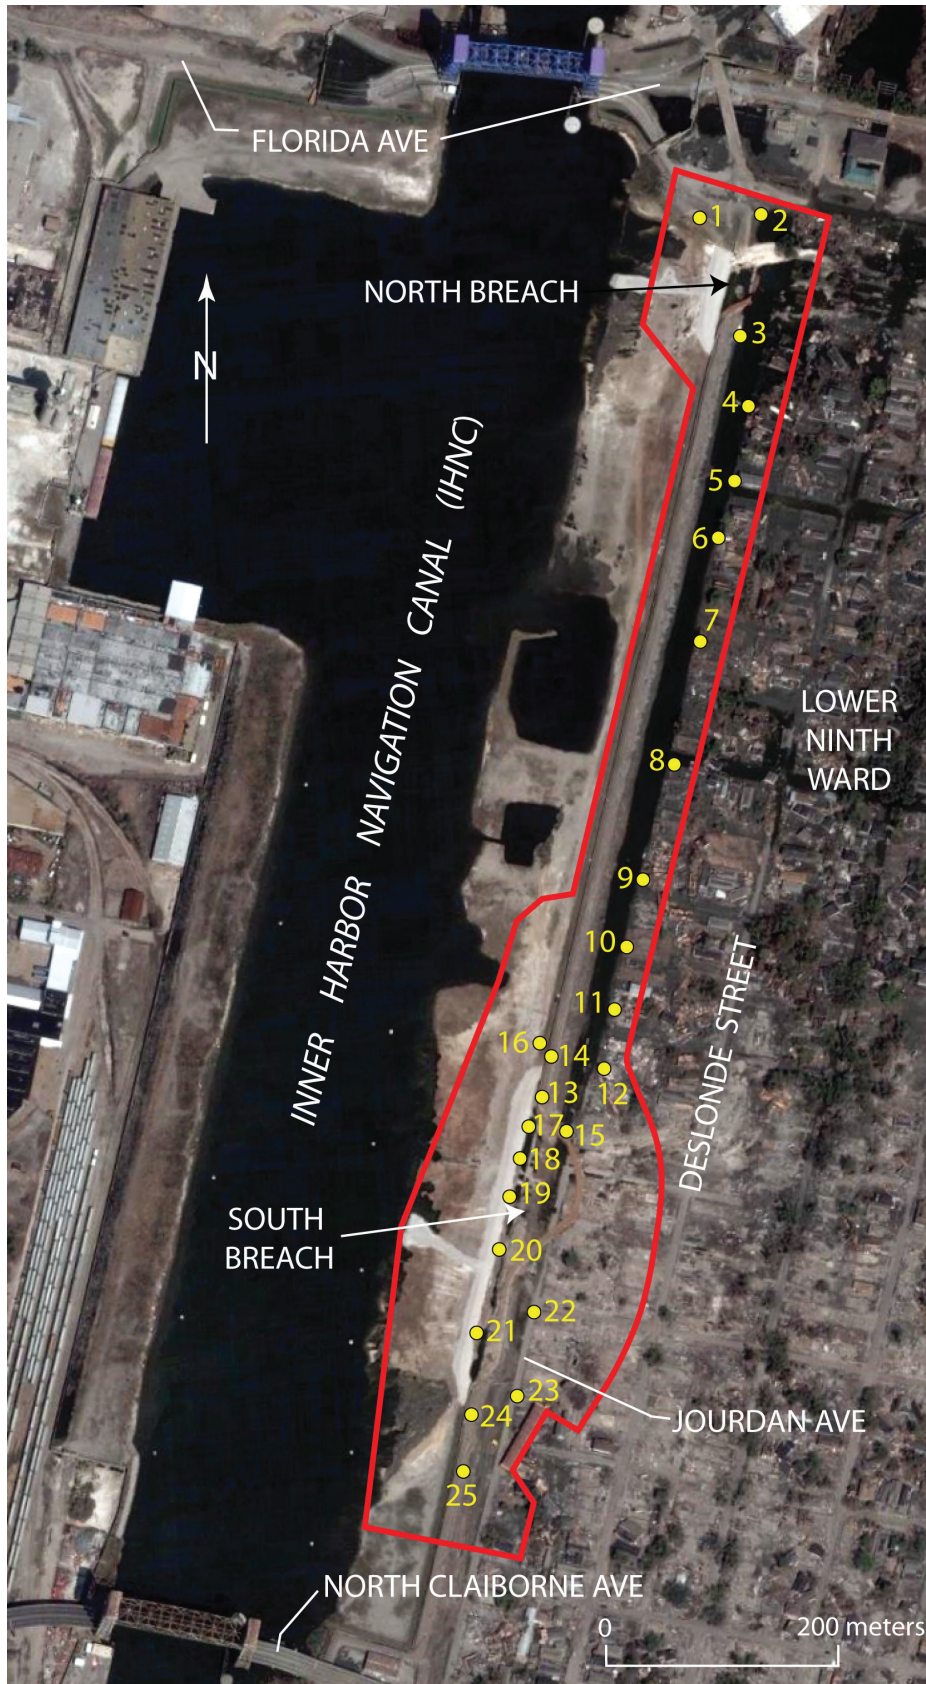
Figure 11. Site 5—Inner Harbor Navigational Canal (IHNC)-East levee breaches. Numbered dots indicate locations of scan positions. Red outline indicates area of lidar data coverage. (Photo source: Google Earth—Digitalglobe image.)

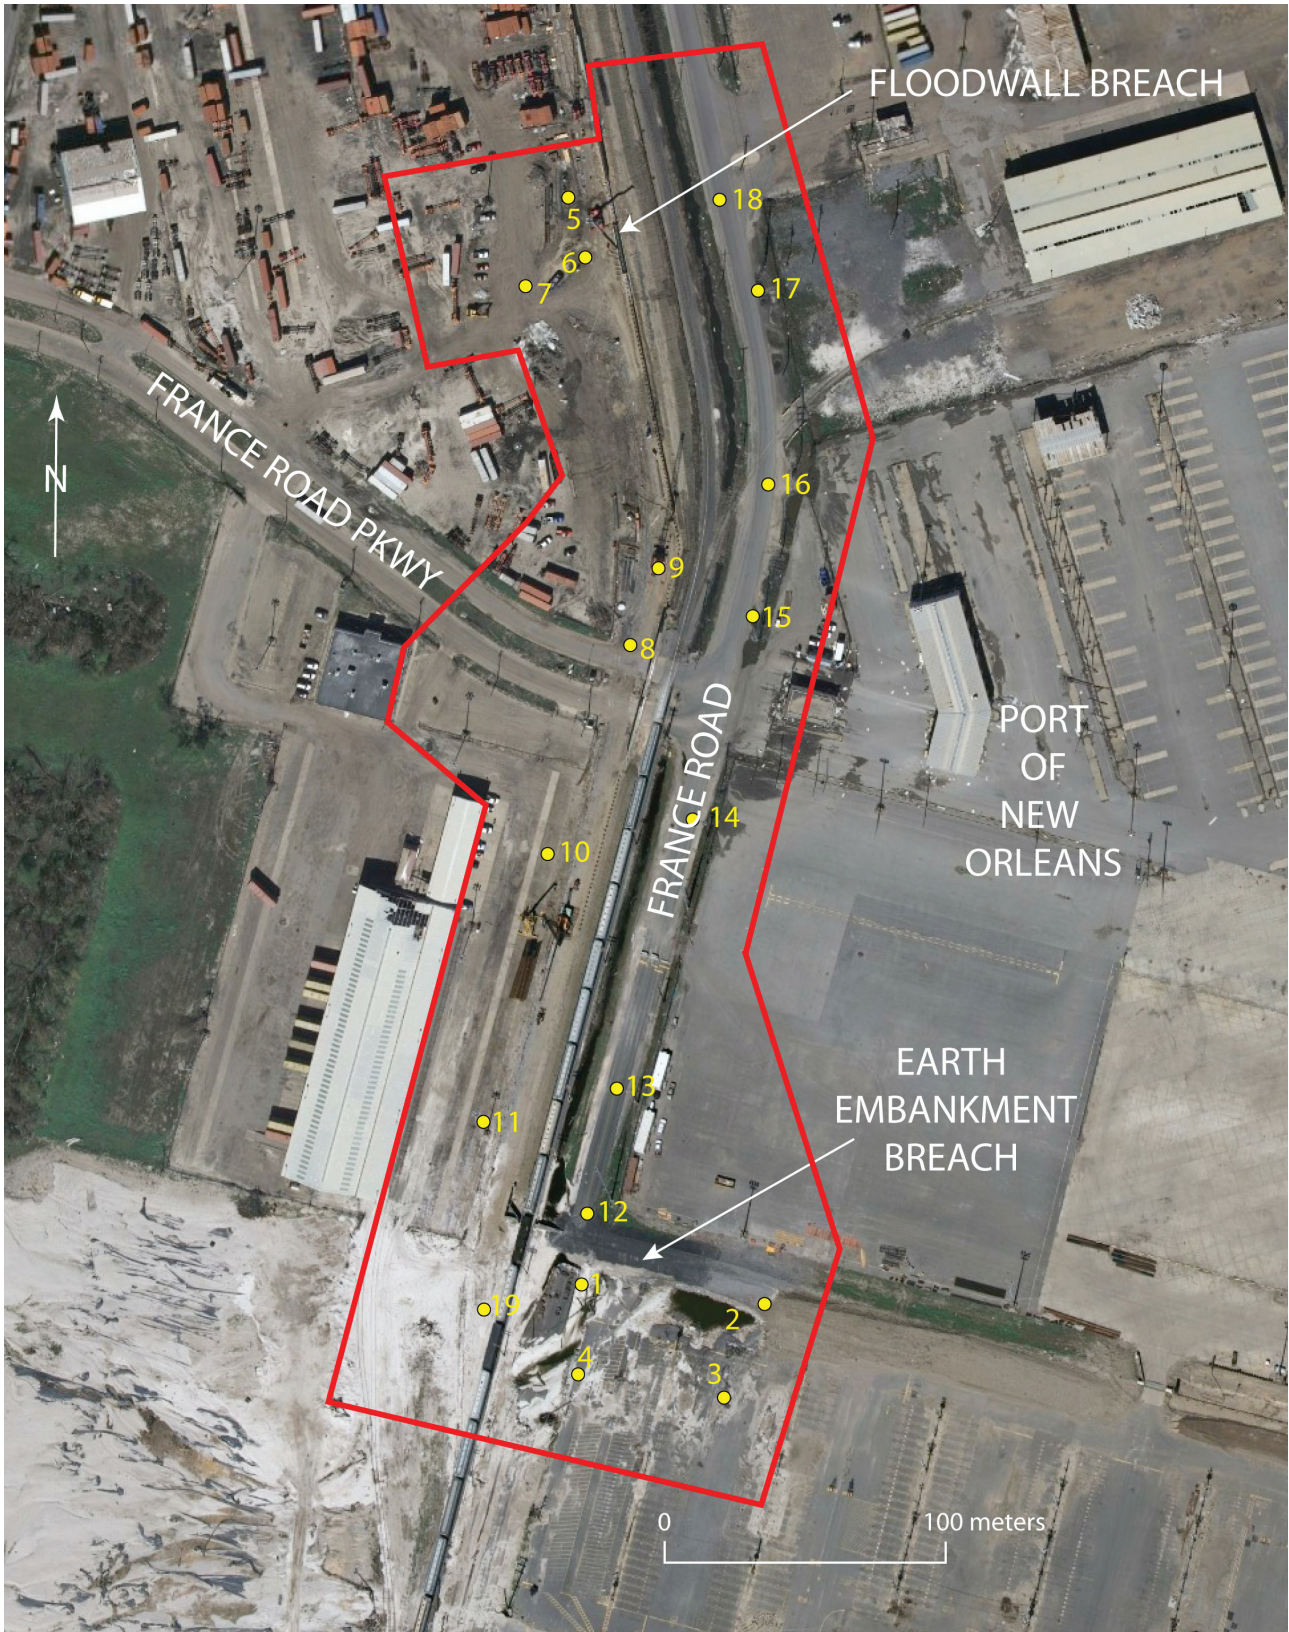
Figure 12. Site 6—Inner Harbor Navigational Canal (IHNC)-West—Port of New Orleans levee breaches. Numbered dots indicate location of scan positions. Red outline indicates area of lidar data coverage. (Photo source: Google Earth—USGS image.)

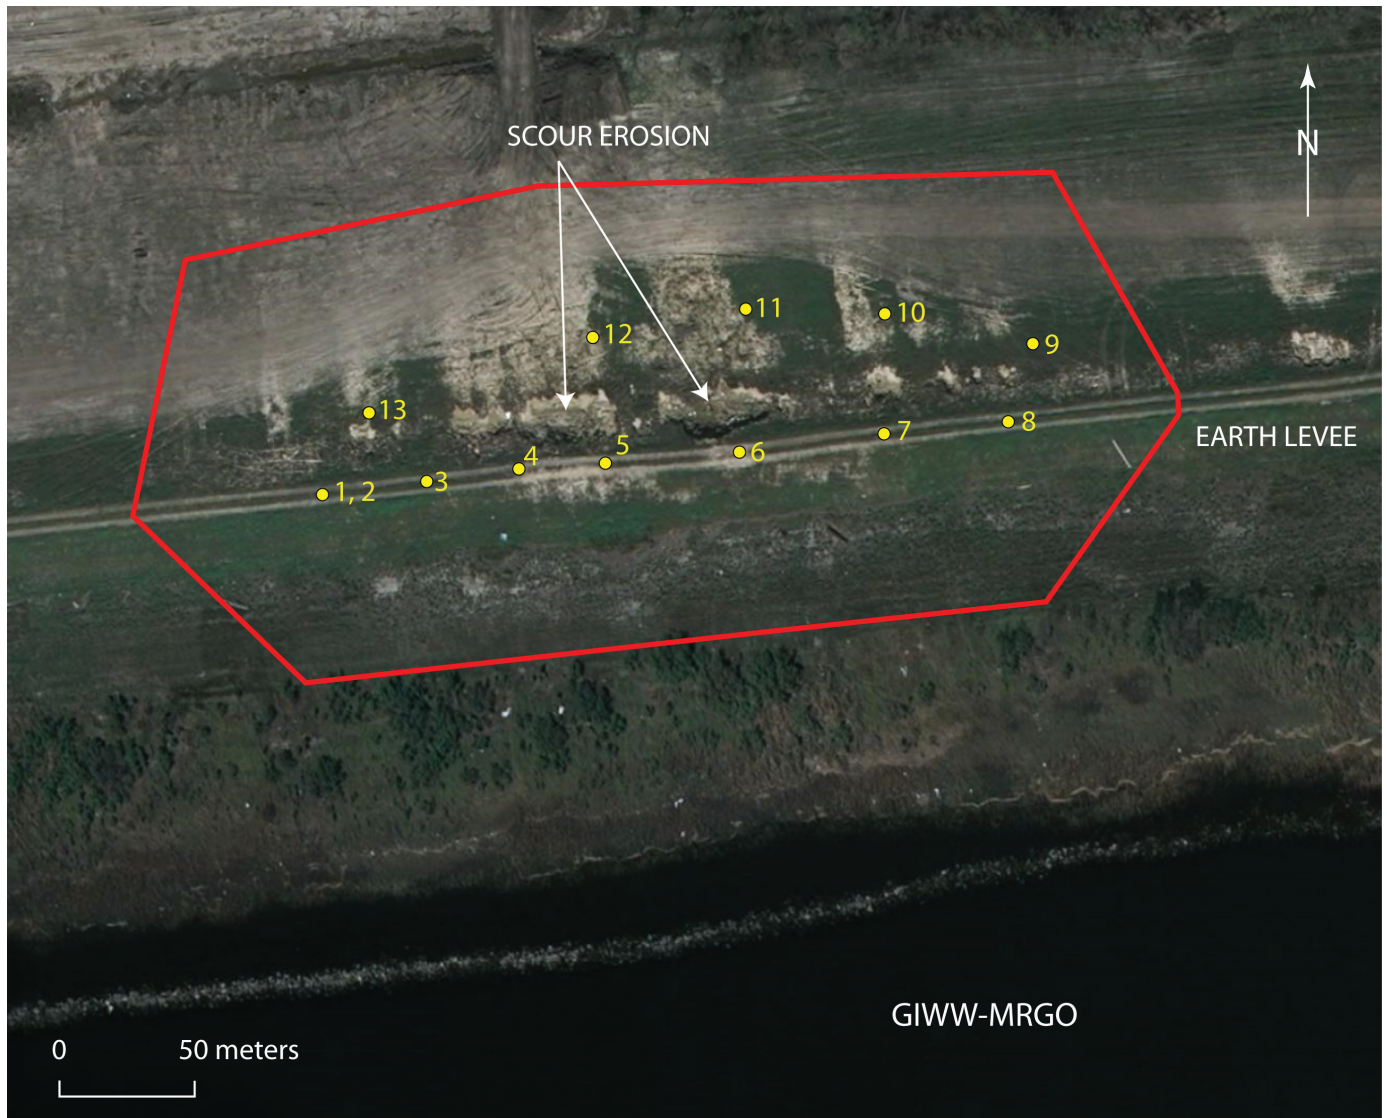
Figure 13. Site 7—Gulf Intracoastal Waterway–Mississippi River Gulf Outlet (GIWW-MRGO) earth levee erosion. Numbered dots indicate locations of scan positions. Red outline indicates area of lidar data coverage. (Photo source: Google Earth–USGS image.)

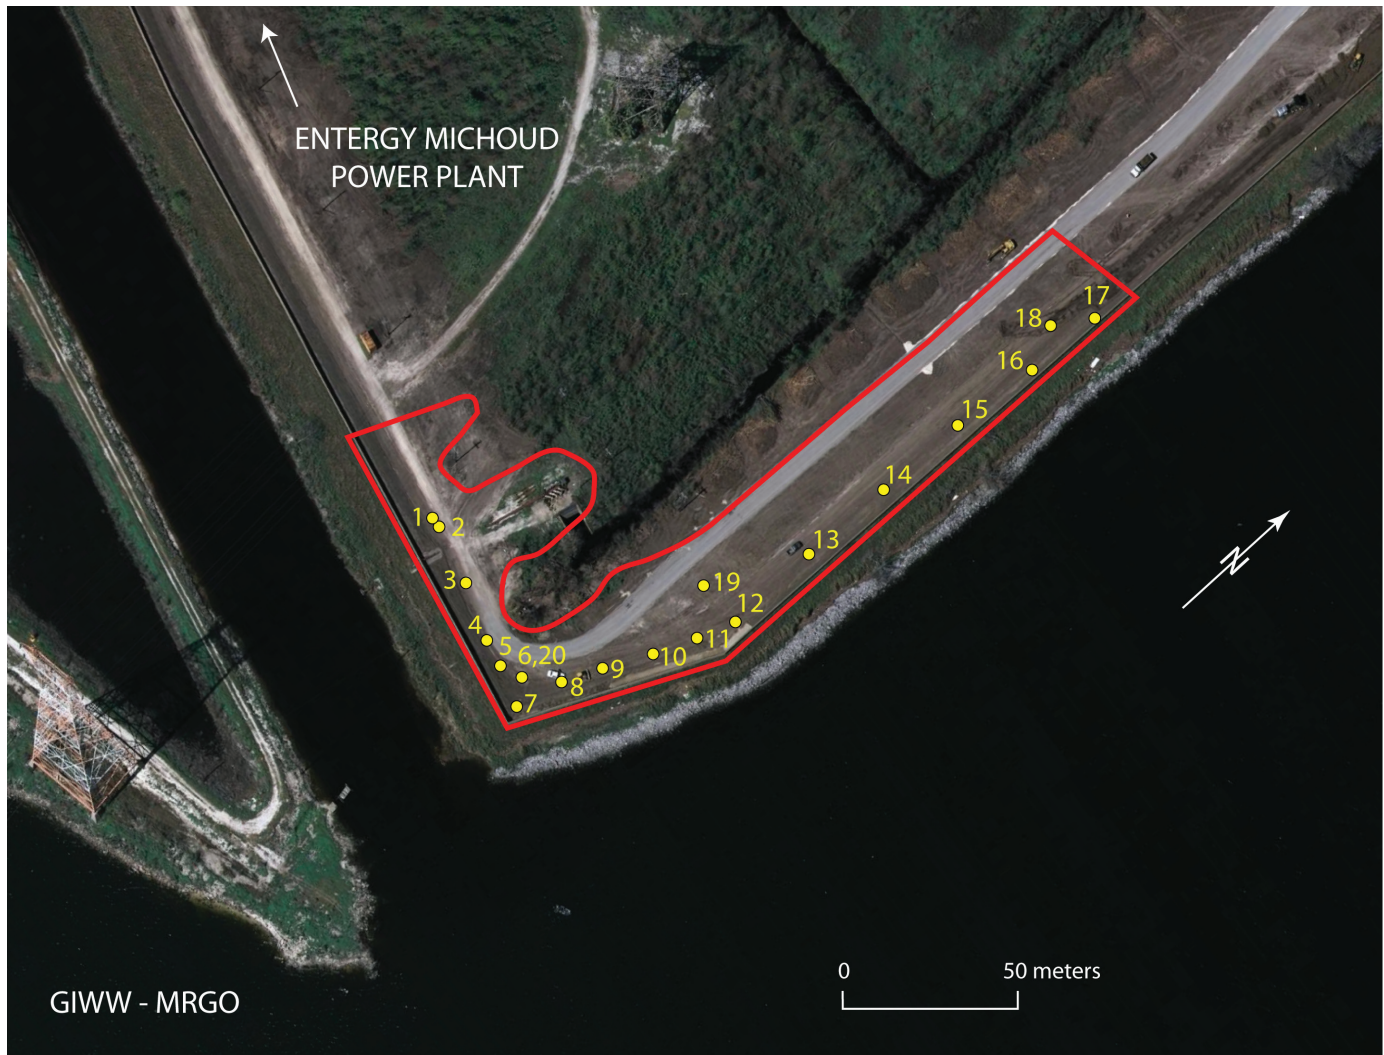
Figure 14. Site 8—Gulf Intracoastal Waterway–Mississippi River Gulf Outlet (GIWW–MRGO) floodwall scour. Numbered dots indicate locations of scan positions. Red outline indicates area of lidar data coverage. (Photo source: Google Earth–USGS image.)

details of approximately 420 m of the floodwall, showing details of scour trench development on the protected side of the wall.

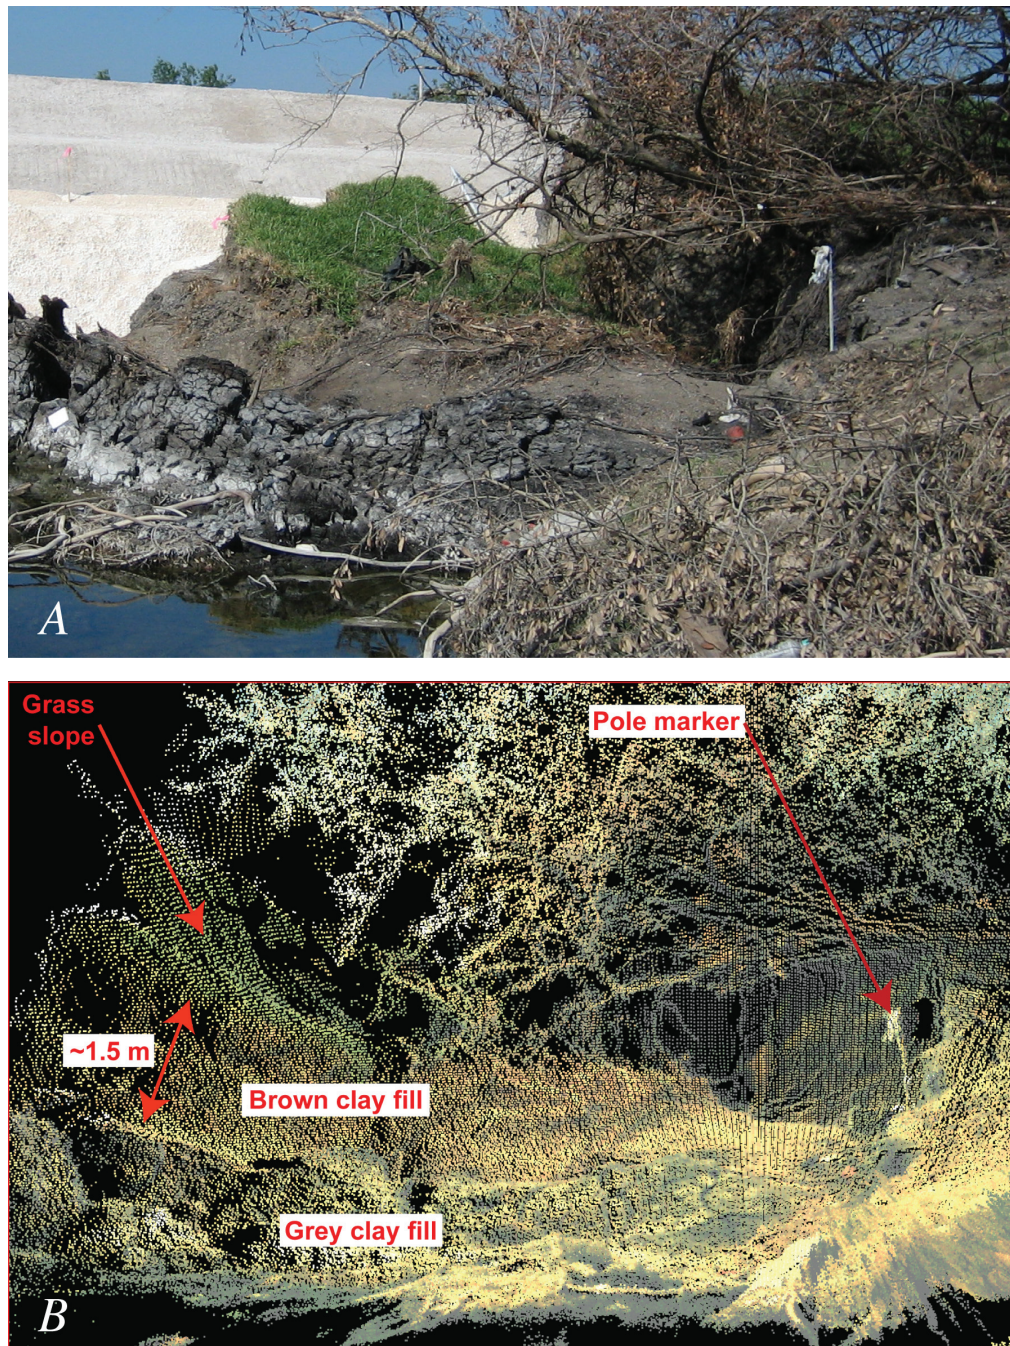
Figure 15. Image (A) and high resolution terrestrial lidar data coverage image (B) of displaced block stratigraphy from the 17th Street Canal levee breach.

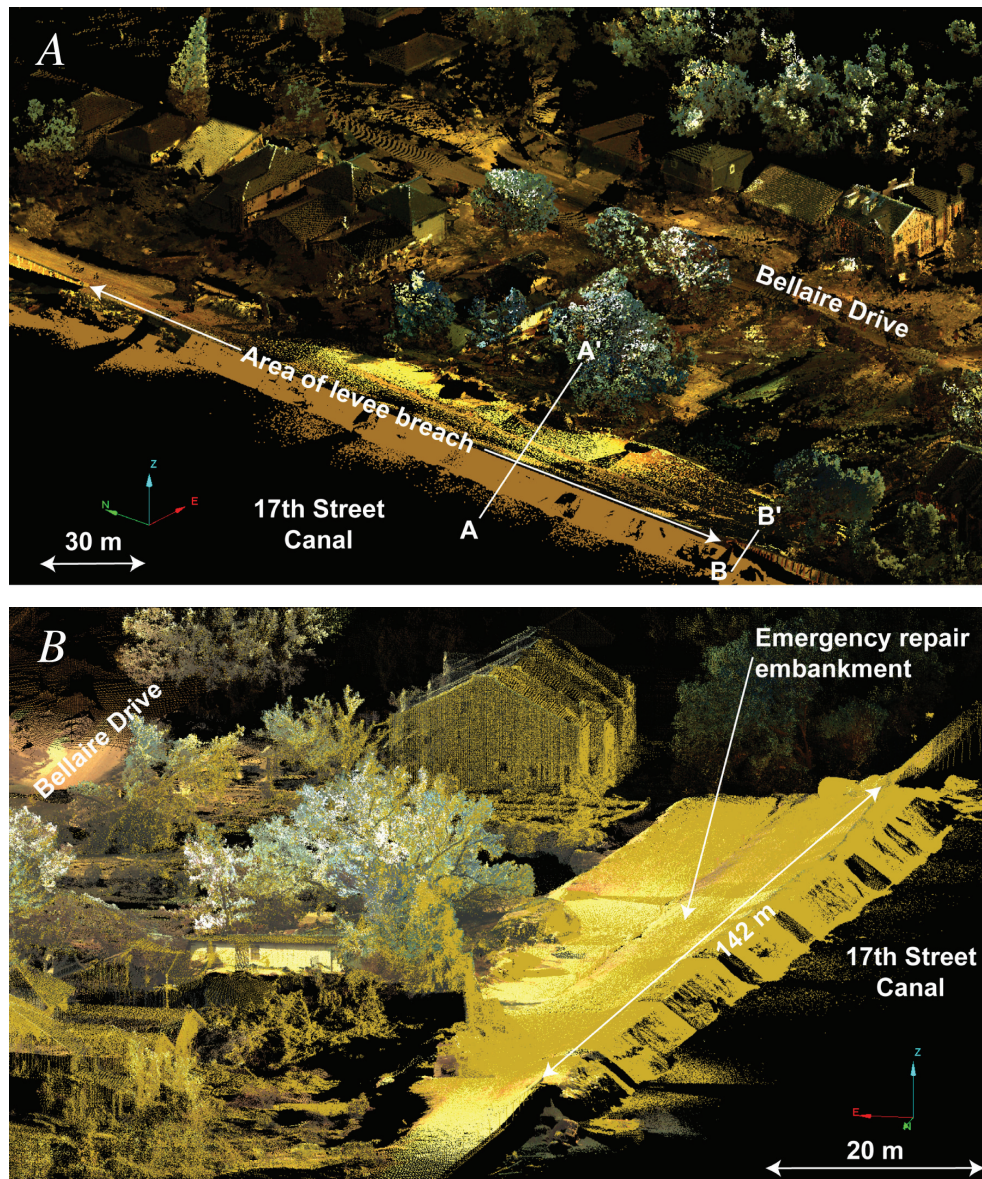
Figure 17. Overview oblique lidar image (A) of the 17th Street Canal area in the vicinity of the breach and close-up view lidar image (B) of the breach area showing key features.

The 17th Street Canal levee breach occurred as a translational failure of the embankment from excessive hydrostatic pressures on the flood side of the water-filled canal (Seed and others, 2008c). Measurement of displacement along the 17th Street Canal breach can be made using the lidar data by

identifying the blocks of ground formerly within the intact levee that slid eastward toward the protected side of the levee. In an overview image of the point cloud dataset (fig. 17A), the dense cluster of points visible in the center of the image highlights the levee breach and surrounding surviving houses. Viewing the data from a different perspective, a total breach width of 142 meters is calculated (fig. 17B). In cross-section view (fig. 18), and close-in to the levee breach, a segment of the remaining I-wall has been aligned with the crest of the replacement structure and a section of the translated earth levee. With this perspective, the geometry of the emergency repair embankment (constructed immediately following the breach and before terrestrial data collection) is clearly visible, as is the magnitude of the displacement (approximately 14 m) of several earth blocks

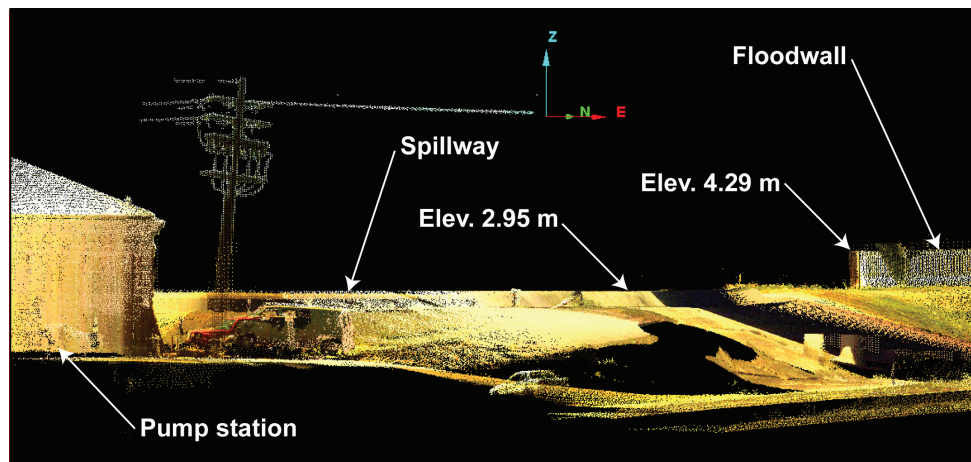
Figure 19. Lidar image of Orleans Canal pump station and floodwalls showing discrepancy between as-built elevations of spillway and adjacent floodwall.

The Orleans Canal pump station spillway breach highlights one of several examples where floodwaters were allowed into the city by a lack of engineering design. Rather than construct either an end-canal floodgate at the canal's northern end, or a closed-system floodwall at the southern end, an approximately 65-meter gap with an elevation 1.3 meters below the surrounding floodwall elevation was constructed. The purpose of the gap was to prevent floodwaters from reaching a height in which the

weak masonry walls of the adjacent pump station could collapse (ILIT, 2006). Instead, the gap allowed flooding of the city, directly contradictory to the intended purpose of the pump station. In the lidar data, this gap is clearly visible (fig. 19).
