Terrestrial Lidar Datasets of New Orleans, Louisiana, Levee Failures from Hurricane Katrina, August 29, 2005

Data Series 470

By Brian D. Collins, Robert Kayen, Diane Minasian, and Thomas Reiss

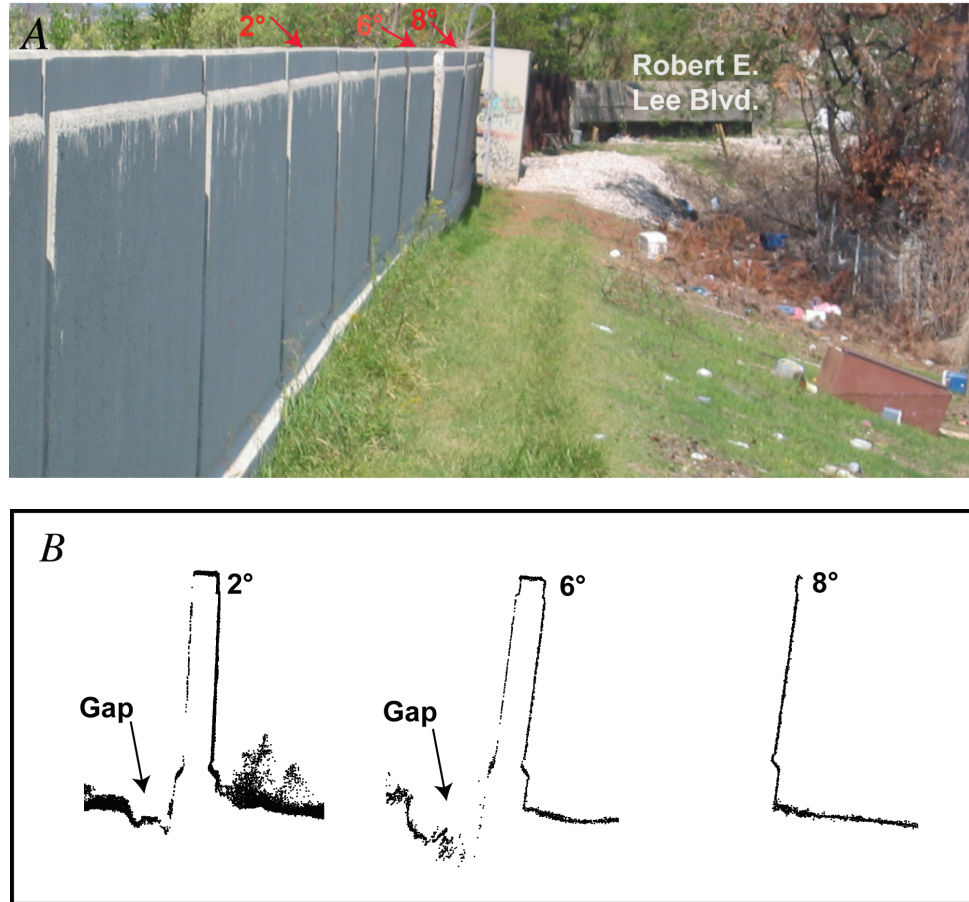
Figure 21. *A*, Leaning floodwall on the east side of the London Avenue Canal (site 3). *B*, Lidar image cross sections through three segments of the floodwall, showing rotational deformation toward the protected side of the levee.

In the area of the incipient failure on the east side of the canal, south of the Robert E. Lee bridge crossing and opposite the main north London Avenue Canal levee breach, the

terrestrial lidar dataset provides additional details of the levee failure mechanisms. Observations and lidar visualizations show that the floodwall suffered rotational displacement and near failure (fig. 21*A*). Because of the precarious nature of the floodwall in this location, it has been shown that if the levee failure located directly across from this area had not occurred, this site might have failed instead (Seed and others, 2008d). Viewed from the south—and preserved in incipient failure by the lidar data (fig. 21*B*),—the distressed wall leans toward the levee maintenance road and the protected side of the levee. Thin slices of the point-cloud data orthogonal to the alignment of the floodwall show the increase in levee rotation from 2° at the south portion of the distressed region to 8° at the position of maximum distress located approximately 50 m to the north. The cross sections also show the geometry of a “gap” on the floodside of the wall, formed from rotation of the wall itself. Seed and others (2008d) show that this gap resulted in the

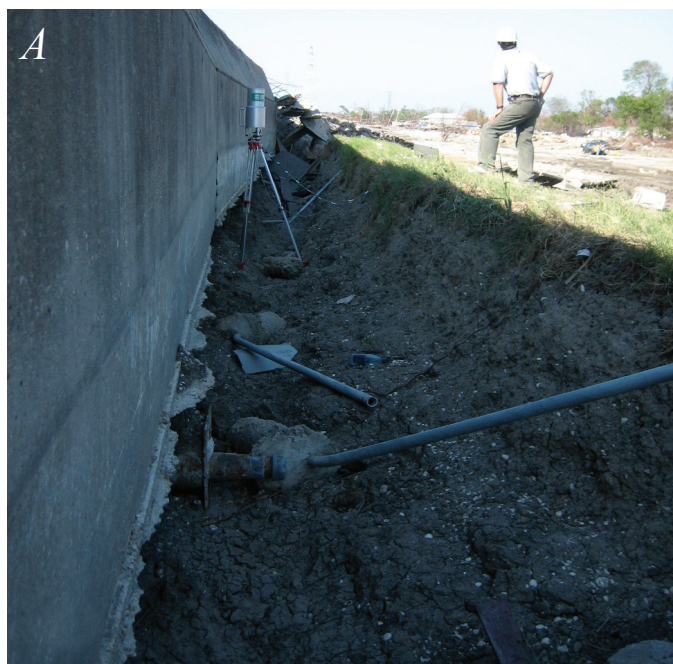
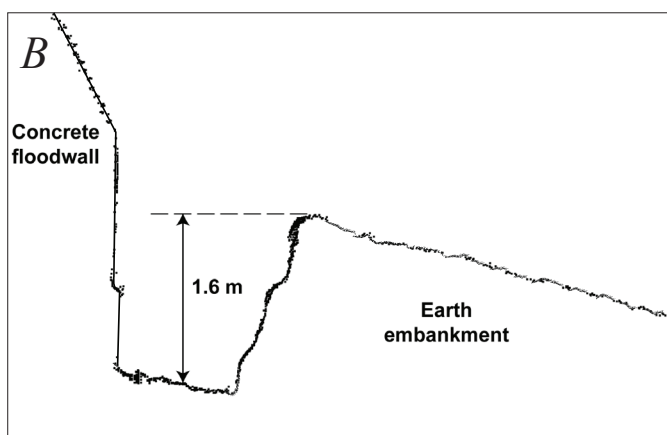
Figure 22. *A*, Scour trench at the south end of Inner Harbor Navigational Canal (IHNC)-East, south breach, looking north. *B*, Measurement of maximum scour-trench dimensions in the point cloud data near the south end of the south breach. The height of the remaining earth embankment is assumed to represent the typical soil height before scour began.

A final example of the use of the lidar data is shown by the analysis of scour trench dimensions at the east side IHNC—south breach (fig. 22). Here the data are viewed in cross section to calculate the depth of scour adjacent to the I-wall and vertically into the embankment so that a direct comparison of the scour depth to sheet-pile embedment can be made. Detailed geotechnical analyses by Seed and others (2008b) have shown that the failure mode at this location was more likely associated with underseepage-induced lateral translation failure of the earth embankment portion of the levee. However, their analyses also indicate that overtopping-caused lateral floodwall toppling related to the formation of a scour

The lidar data (fig. 22*B*) show the maximum scour-trench depth at the south end of the IHNC–south breach. Measurements made at 10-m intervals over a 110-m length of intact floodwall at the south end of the breach indicate an increase in scour from 1.1-m depth over the majority of this length from 110-m to 20-m distance from the breach, to 1.6-m depth within 20 m of the breach. Although not conclusive for determining the failure mode of the breach, these data do indicate that scour-trench depths were higher near to the breach.
