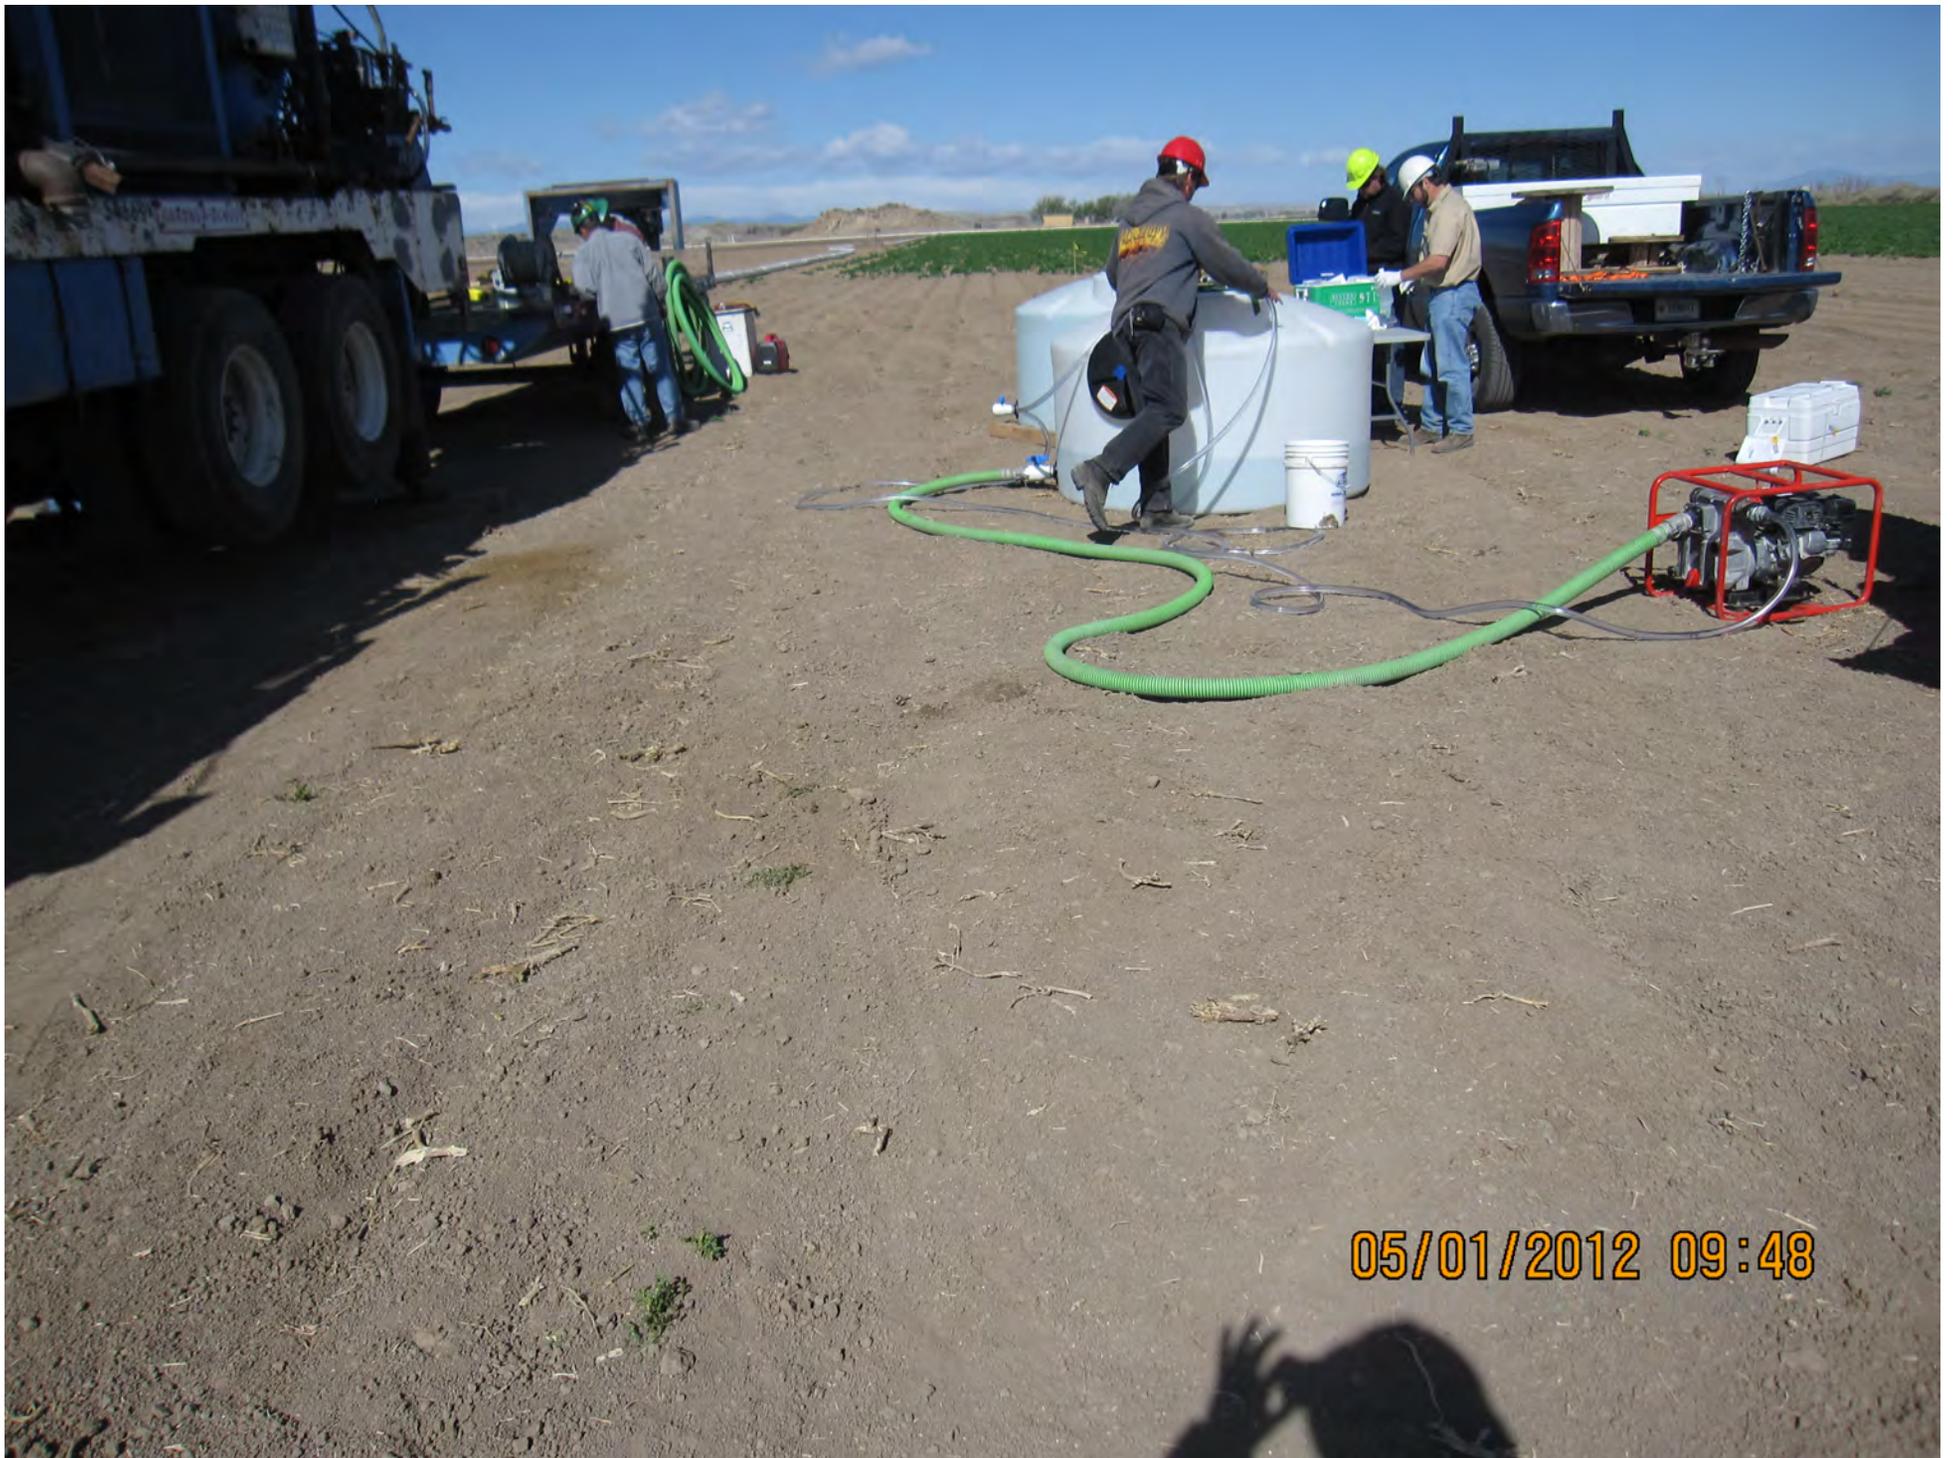
Figure 6.2. Recirculation of Riverton public supply water for sample collection. Photograph by Tom Kropatsch, Wyoming Oil and Gas Conservation Commission, May 1, 2012.
