# High-Water Marks from Tropical Storm Irene for Selected River Reaches in Northwestern Massachusetts, August 2011

Data Series 775

By Gardner C. Bent, Laura Medalie, and Martha G. Nielsen

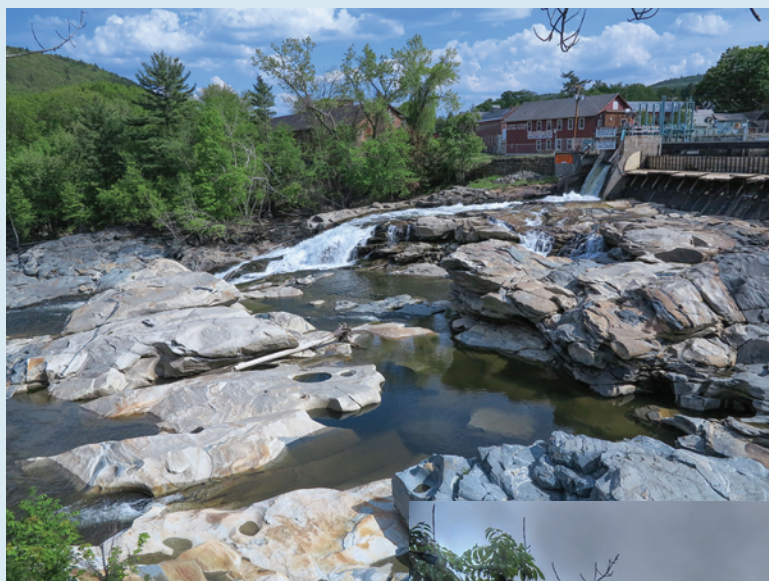
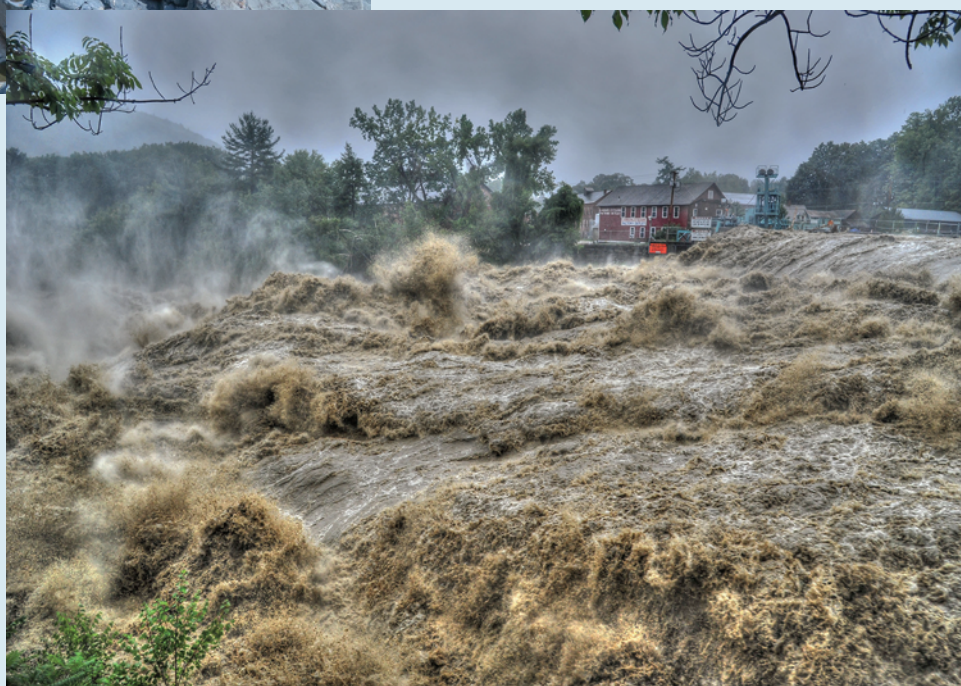
**Front cover.** Photographs of Deerfield River at dam #3 at Shelburne Falls, Massachusetts. Top left photograph was taken on May 14, 2012, during near-normal flows. The rocky area below the dam is called the Glacial Potholes. The bottom right photograph was taken on August 28, 2011, during flood flows from tropical storm Irene. Photographs by John E. Robison, Amherst, Massachusetts.

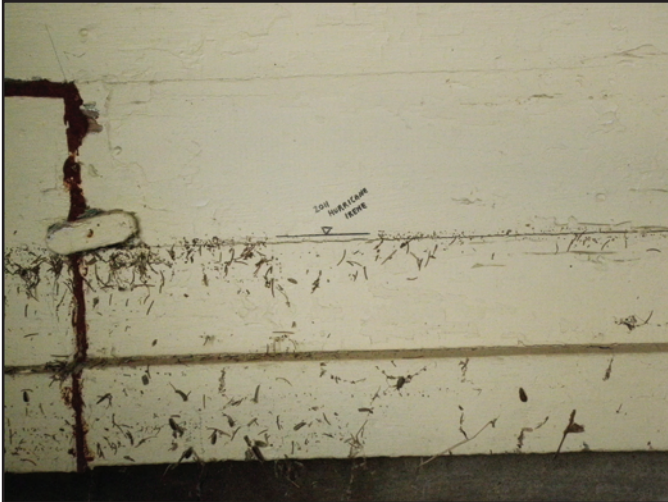
**A.** HWM-MA-EBNORTH-160

**Figure 4.** Examples of high-water marks associated with flooding from tropical storm Irene in the Deerfield and Hudson-Hoosic River Basins in northwestern Massachusetts, August 28–29, 2011: *A, B*, mud and debris line on buildings; *C*, debris on the ground; *D*, wash line on the ground; and *E*, debris on tree.

HWMs are the evidence of the highest water levels during a flood (Benson and Dalrymple, 1967). Bits of material, such as seeds, tree needles, grass, leaves, woody debris, trash, or sediment, that are transported by floodwaters sometimes remain on tree bark, buildings, or fences at the highest water level, leaving a trail to document the height of water (fig. 4). Scour lines in streambanks generally are less accurate and more variable than HWMs from debris or stains. The most useful HWMs tend to result from water that was moving at a low velocity with minimal wave action, usually at some distance from the main river channel or water body. Optimally, HWMs are identified immediately following peak flood levels because over time, rain, wind, and sun can wash, blow, or fade away the HWM material that depict the peak. The general methods used to identify and document HWMs are described by Benson and Dalrymple (1967).

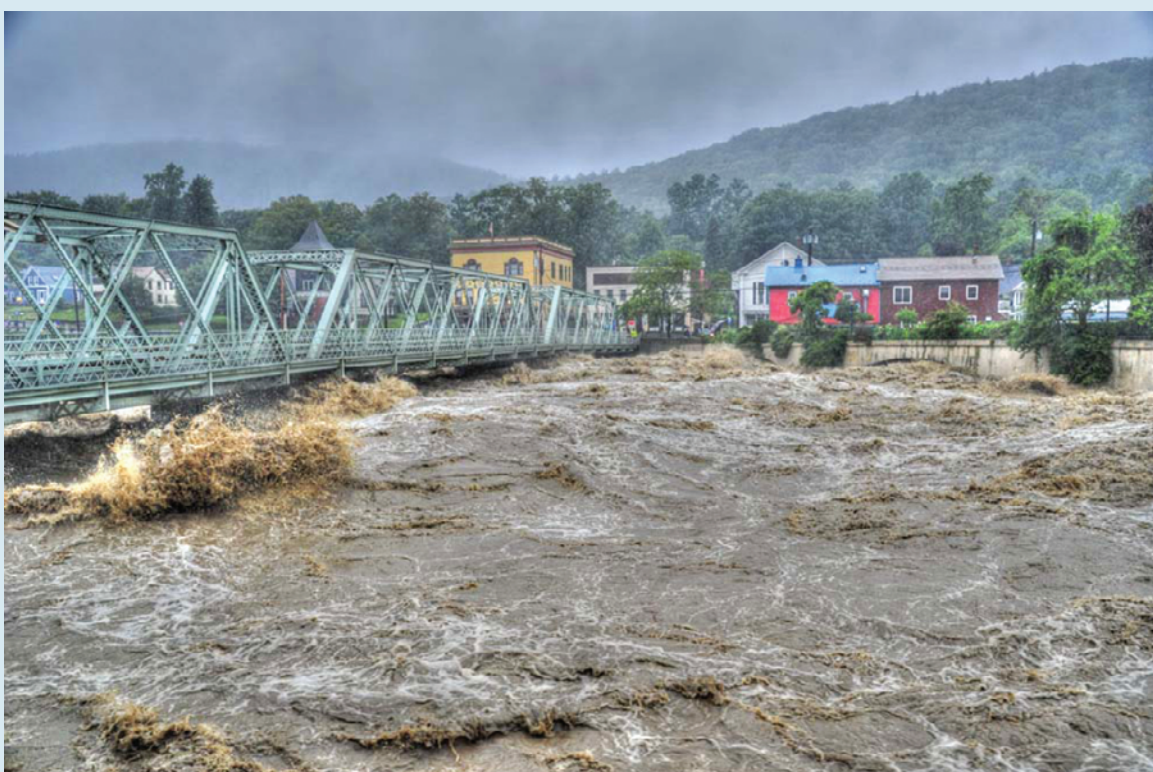
**Back cover.** Photograph of Deerfield River at the Bridge Street bridge (left) and the Bridge of Flowers (right) at Shelburne Falls, Massachusetts, taken on August 28, 2011, during flood flows from tropical storm Irene. Photograph by John E. Robison, Amherst, Massachusetts.
