HURRICANE HORTENSE

Impact on Surface Water in Puerto Rico

U.S. Department of the Interior—U.S. Geological Survey

U.S. Geological Survey
Fact Sheet FS-014-97
Printed October 1997

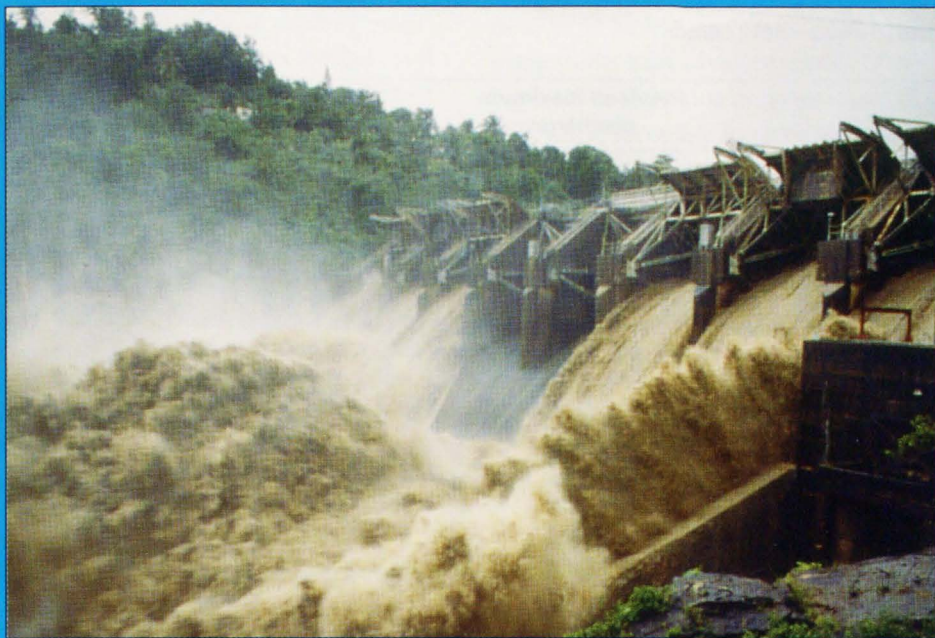
Figure 3. Sediment-laden streamflow over the Carraízo Dam, September 10, 1996, at 2 p.m., during the peak discharge of Hurricane Hortense, in excess of 200,000 cubic feet per second. The narrow, sinuous lake behaves hydraulically like a river during peak flows. Discharge events of this magnitude commonly transport a sediment load equal to the annual yield. Photograph taken by Richard Webb.

occurred in the basins of the Río Grande de Arecibo, the Río Grande de Manatí, the Río Cibuco, the Río de la Plata, the Río de Bayamón, the Río Piedras, the Río Grande de Loíza, the Río Lapa, and the Río Majada (see figs. 3, 4, and 5). Flood stages, discharges, recurrence intervals, and other information pertinent to selected gaging stations within these basins are summarized in table 1. For purposes of comparison, the table also includes the

Peak discharges were exceeded at 34 of 86 gaging stations. The peak discharge ranged from 885 cubic feet per second at the Río Bayamón at Arenas gaging station to more than 200,000 cubic feet per second at the Río Grande de Loíza below Damsite gaging station (fig. 3). Peak discharges in excess of 100,000 cubic feet per second were registered in six sites.

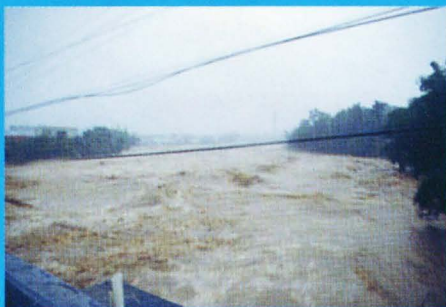
Figure 4. Streamflow on the Río Grande de Loíza, (Station 50055000) September 10, 1996, 12:30 p.m., at peak stage during hurricane. Photograph taken by Matthew Larsen.

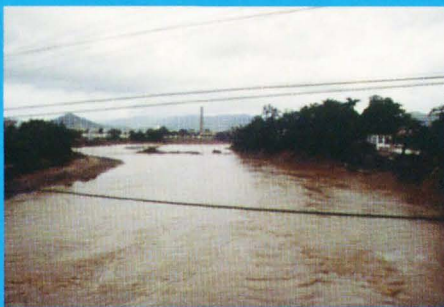
Figure 5. Same location as left photo, 24 hours later. River stage has fallen to near normal flow, leaving evidence of localized bank scour and associated channel widening, as well as deposition of fresh gravel bars. Photograph taken by Matthew Larsen.
