## REDUCING EARTHQUAKE LOSSES THROUGHOUT THE UNITED STATES

# Building Safer Structures

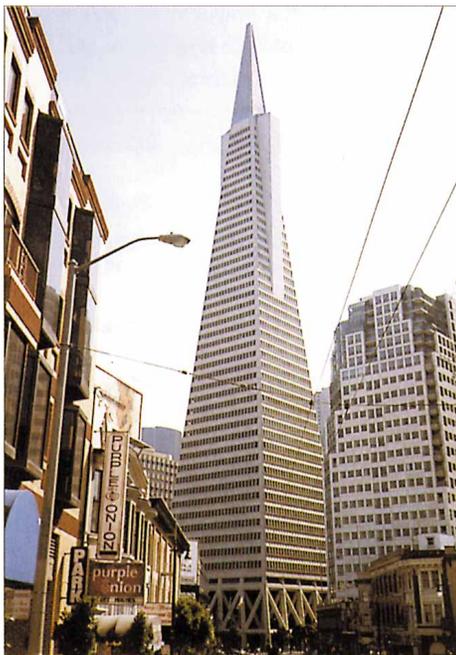
*The Transamerica Pyramid in San Francisco, built to withstand earthquakes, swayed more than 1 foot but was not damaged in the 1989 Loma Prieta, California, earthquake.*

On October 17, 1989, the magnitude 7.1 Loma Prieta earthquake struck the Santa Cruz Mountains in central California. Sixty miles away, in downtown San Francisco, the occupants of the Transamerica Pyramid were unnerved as the 49-story office building shook for more than a minute. U.S. Geological Survey (USGS) instruments, installed years earlier, showed that the top floor swayed more

than 1 foot from side to side. However, no one was seriously injured, and the Transamerica Pyramid was not damaged. This famous San Francisco landmark had been designed to withstand even greater earthquake stresses, and that design worked as planned during the earthquake.

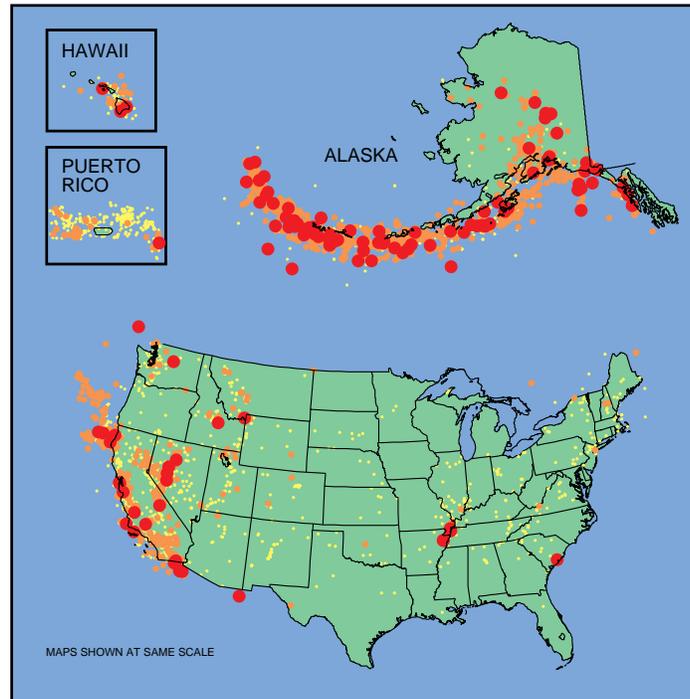
*Earthquakes are a widespread hazard in the United States. Colors show magnitudes of historical earthquakes: red, 7 or greater; orange, 5.5 to 7; yellow, 4.5 to 5.5. The U.S. Geological Survey operates instruments in many structures in the seismically active areas shown. These instruments measure how structures respond to earthquake shaking.*

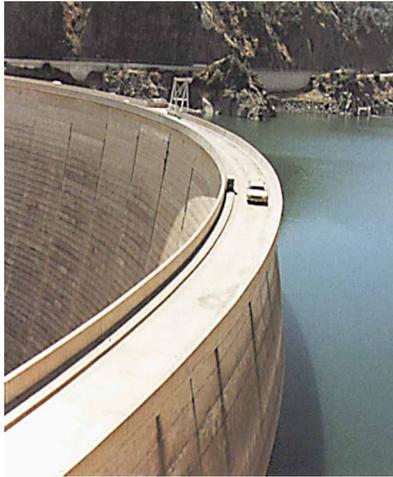
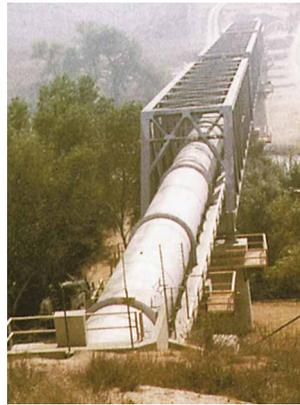
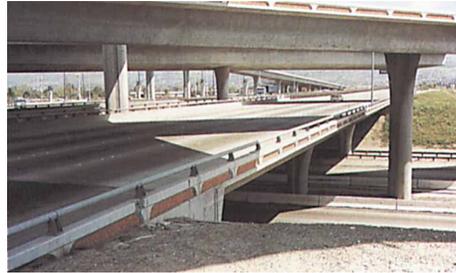
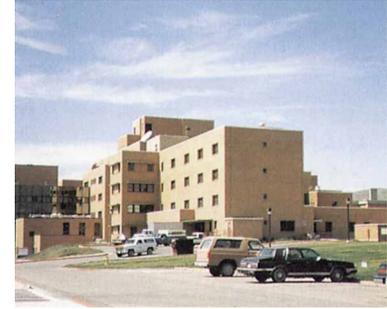
USGS scientists have installed instruments in a variety of structures across the United States to monitor their behavior during earthquakes. Examples shown include a dam, a bridge supporting a large aqueduct, a highway overpass, and a Veterans hospital.

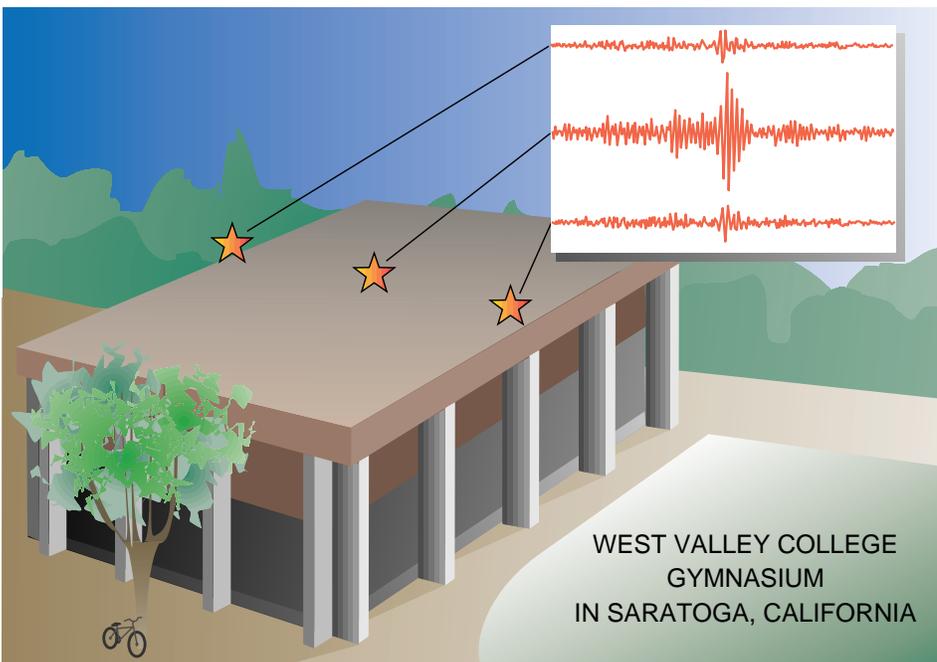
Seismic records (upper right) obtained during the 1984 Morgan Hill, California, earthquake led to an improvement in the Uniform Building Code (a set of standards used in many states). The center of the gym roof shook sideways three to four times as much as the edges. The Code has since been revised to reduce the flexibility of such large-span roof systems and thereby improve their seismic resistance.

ery time a strong earthquake occurs, the new information gathered enables engineers to refine and improve structural designs and building codes. In 1984 the magnitude 6.2 Morgan Hill, California, earthquake shook the West Valley College campus, 20 miles away. Instruments in the college gymnasium showed that its roof was so flexible that in a stronger or closer earthquake the building might be severely damaged, threatening the safety of occupants. At that time, these flexible roof designs were permitted by the Uniform Building Code (a set of standards used in many states). Many industrial facilities nationwide were built with such roofs.

Building codes provide the first line of defense against future earthquake damage and help to ensure public safety. Records of building response to earthquakes, especially those from structures that failed or were damaged, have led to many revisions and improvements in building codes. In 1991, as a direct result of what was learned about the West Valley College gymnasium roof, the Uniform Building Code was revised. It now recommends that such roofs be made less flexible and therefore better able to withstand large nearby earthquakes.
