REDUCING EARTHQUAKE LOSSES THROUGHOUT THE UNITED STATES

# Building Safer Structures

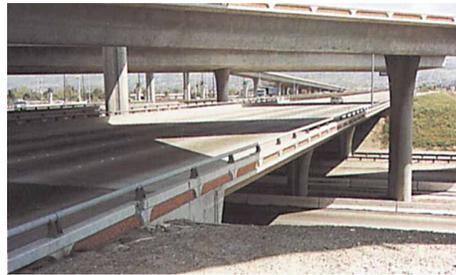
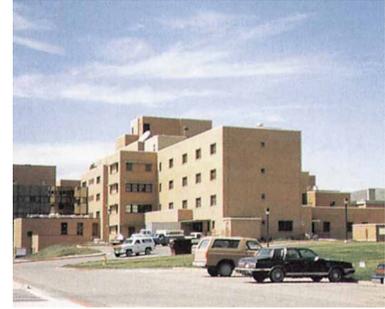
USGS scientists have installed instruments in a variety of structures across the United States to monitor their behavior during earthquakes. Examples shown include a dam, a bridge supporting a large aqueduct, a highway overpass, and a Veterans hospital.
