# History of Landslides at the Base of Bare Mountain, Tully Valley, Onondaga County, New York

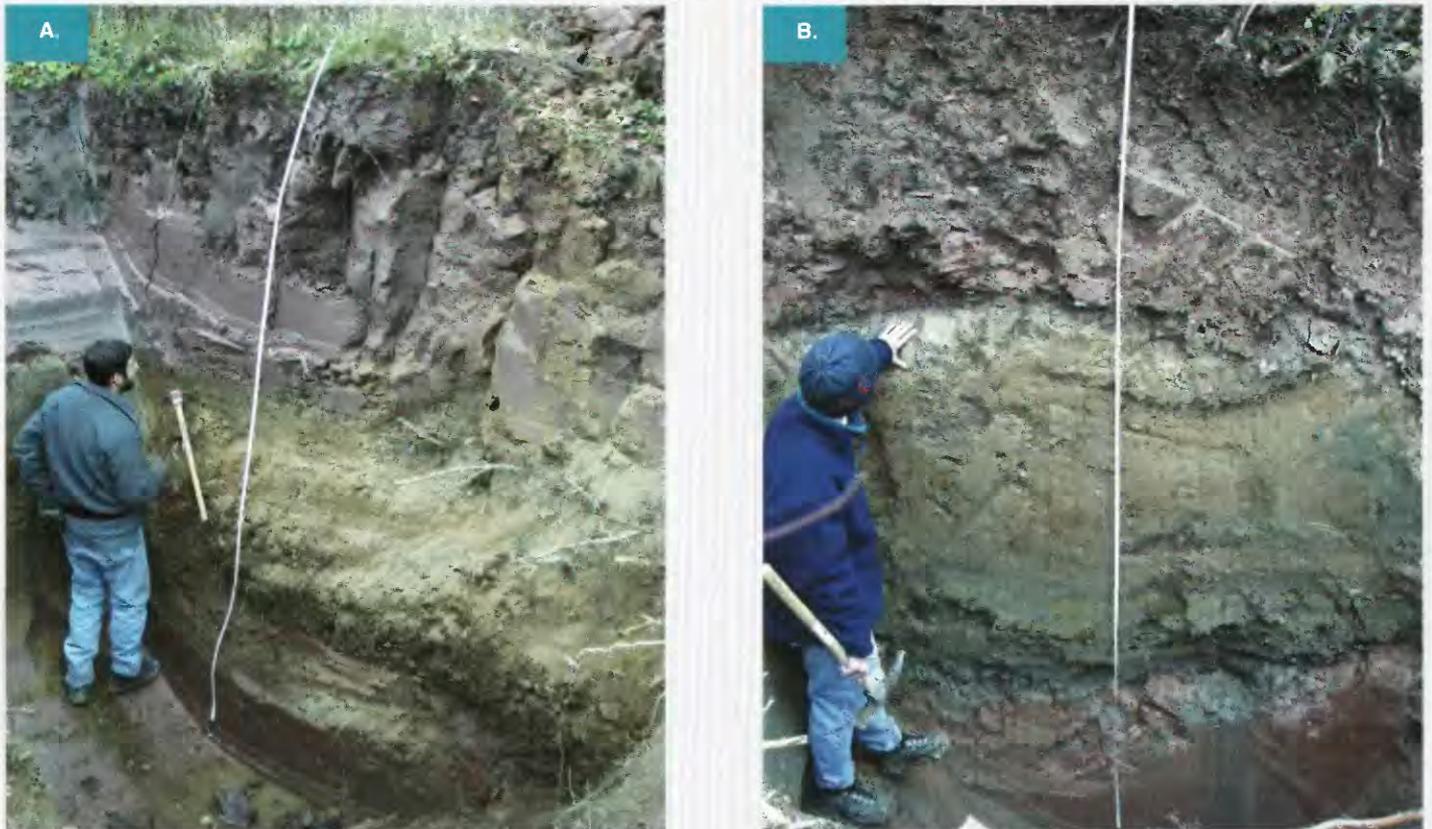
**Figure 4.** Test pit dug in the 2 landslide areas - (A) the Tully Farms Road pit dug just east of Tully Farms Road, just north of a destroyed home and (B) the Webster Road pit dug on the south side of Webster Road, just west of Onondaga Creek. (See fig. 1 for locations.)

A 10-foot-deep test pit was dug into 1993 landslide material along Tully Farms Road (fig. 4A), and a similar pit was dug along Webster Road (fig. 4B) to compare the soil horizons in the two landslide areas. The test pit at Tully Farms Road exposed glacial-lake clay at the bottom, overlain by a postglacial alluvium (silt, sand, and gravel deposited in running water) that was in turn overlain by a well-developed soil horizon containing roots and a mat of compressed vegetation at the buried, former land surface. Overlying this buried surface was the mudflow material deposited by the 1993 landslide.

150 feet south of Webster Road, are both within the toe of the Webster Road landslide, and both reveal a stratigraphy similar to that at the Tully Farms Road test pit (fig. 4A). The glacial and postglacial sediments at the Webster Road landslide and streambank sites are overlain by a soil zone with compressed organic matter (primarily grass and small pieces of wood) capped by a massive clay unit that resembles the mudflow material found in the toe of the Tully Farms Road landslide. Two samples of the peatlike organic and woody material found directly beneath the mudflow at the Onondaga Creek streambank site yielded radiocarbon dates of  $6,160 \pm 40$  years before present (B.P.), and  $6,110 \pm 50$  years B.P. Attempts to find similar buried organic layers at the two northernmost landslide areas (fig. 2) were unsuccessful.

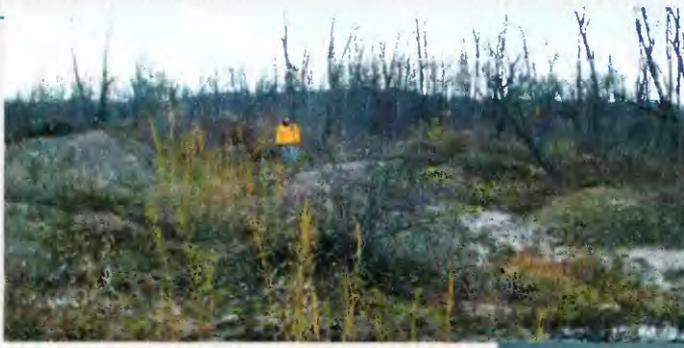
A.

**Figure 3.** Hummocks found in (A) the 1993 Tully Farms Road landslide area and (B) the Webster Road landslide area (See fig. 1 for locations)

the slope at the Tully Farms Road site and within the toe of the landslide (fig. 3A). These blocks have weathered since 1993, such that the topography now resembles an area of hummocky ground at the toe of the Webster Road landslide (fig. 3B). Thus, the Tully Farms Road and the Webster Road landslide areas are about the same size, and the two landslides seem to have displaced similar volumes of material from the lower slope of Bare Mountain.

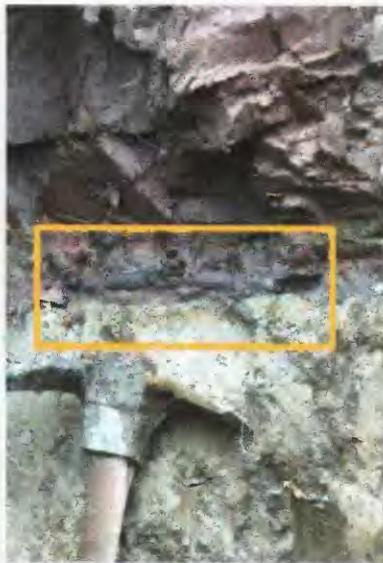
**Figure 5.** Onondaga Creek streambank exposure south of Webster Road showing the interface between the old land surface and the overlying mudflow materials. Wood fragment (within box) at the interface was dated at 6,160 years before present.

The test pit at Webster Road (fig. 4B) and a natural exposure along the west bank of Onondaga Creek (fig. 5),
