Floods of July and September 1998 in Clark County, Nevada

Background

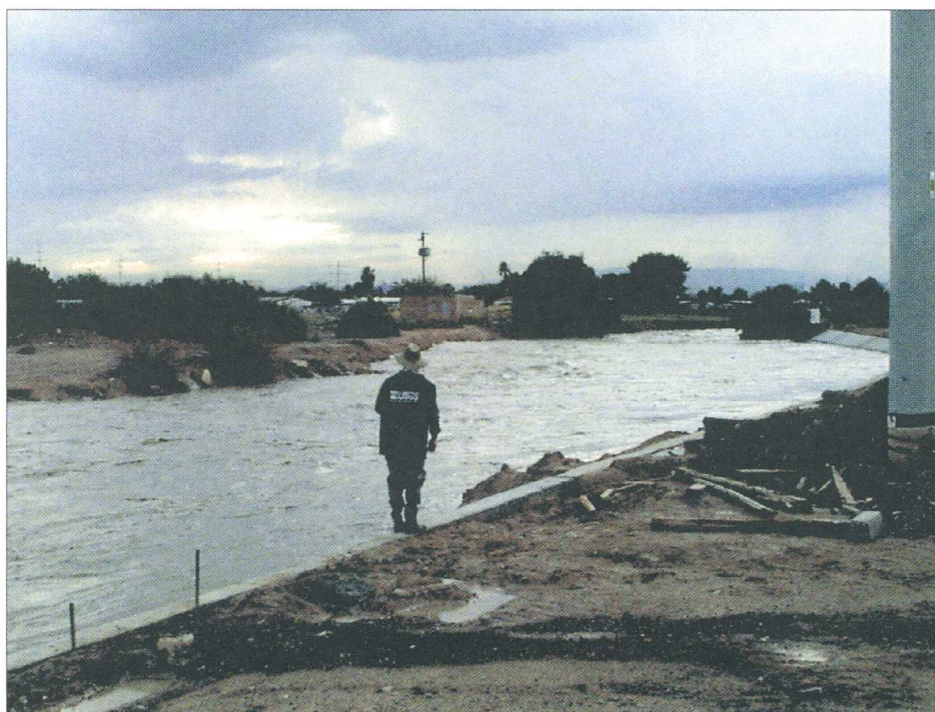
Figure 2. View upstream of flow at peak discharge (6,100 ft^3/s) in Las Vegas Wash below Flamingo Wash confluence (site 18, Fig. 1 and table on facing page) during September 11, 1998, storm.

Runoff from the September 11, 1998, storm occurred in most of the main drainage basins in Las Vegas Valley. Peak flows for the period of record occurred in Pittman wash (site 21, Fig. 1), Sloan channel (site 13), and other tributaries to Las Vegas Wash in Las Vegas Valley (sites 10 and 12). Peak flows were recorded at Las Vegas Wash near Sahara Avenue (site 9), below Flamingo Wash confluence (site 18, Fig. 2), above Three Kids wash (site 23), and at the overflow at Lake Las Vegas¹ inlet (site 24).

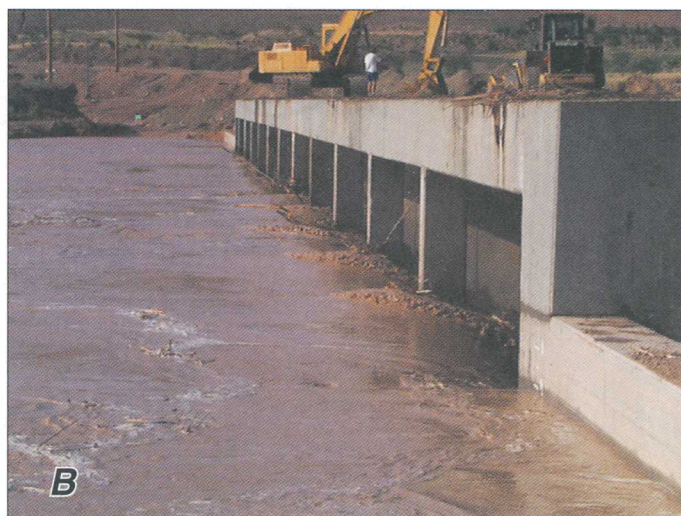
Figure 3. Views of Las Vegas Wash overflow at Lake Las Vegas inlet (site 24, Fig. 1 and table) and culvert structure. A, View when wash is dry. B, View during flood of September 11, 1998, showing floodwater discharging into Lake Las Vegas through culvert. Culvert openings are 8 ft high; total width of structure is 240 ft. Photographs taken by G.C. Gortsema, U.S. Geological Survey.

Because the bypass conduit was closed for repairs, floodwaters (Fig. 3) passed into Lake Las Vegas¹. The peak discharge of 9,600 ft^3/s at Las Vegas Wash above Three Kids wash was the highest recorded since 1957 (period of record) for this section of Las Vegas Wash. A peak flow of 6,550 ft^3/s (Steven Weber, Lake Las Vegas Resort¹, oral commun., 1998) was released from Lake Las Vegas through a series of spillways back into Las Vegas Wash (Fig. 4).

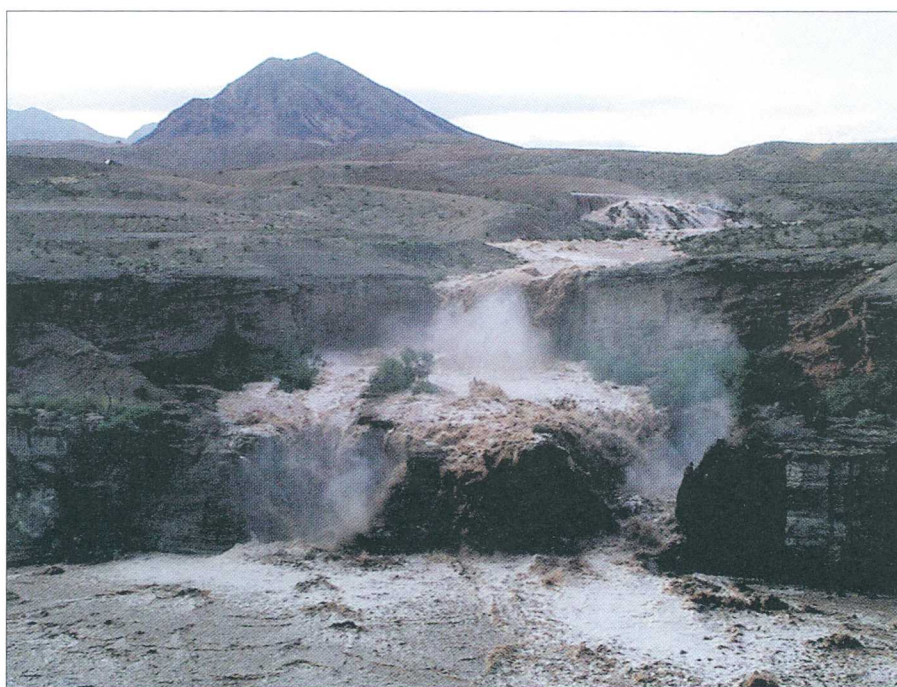
Figure 4. Floodwaters released from one of three overflow spillways at Lake Las Vegas during flood of September 11, 1998, into Las Vegas Wash (below site 24; see Fig. 1 and table). Flow was estimated to be 6,000 ft³/s at time photograph was taken.
