Flood of June 2003 in Southwest-Central Florida

Background

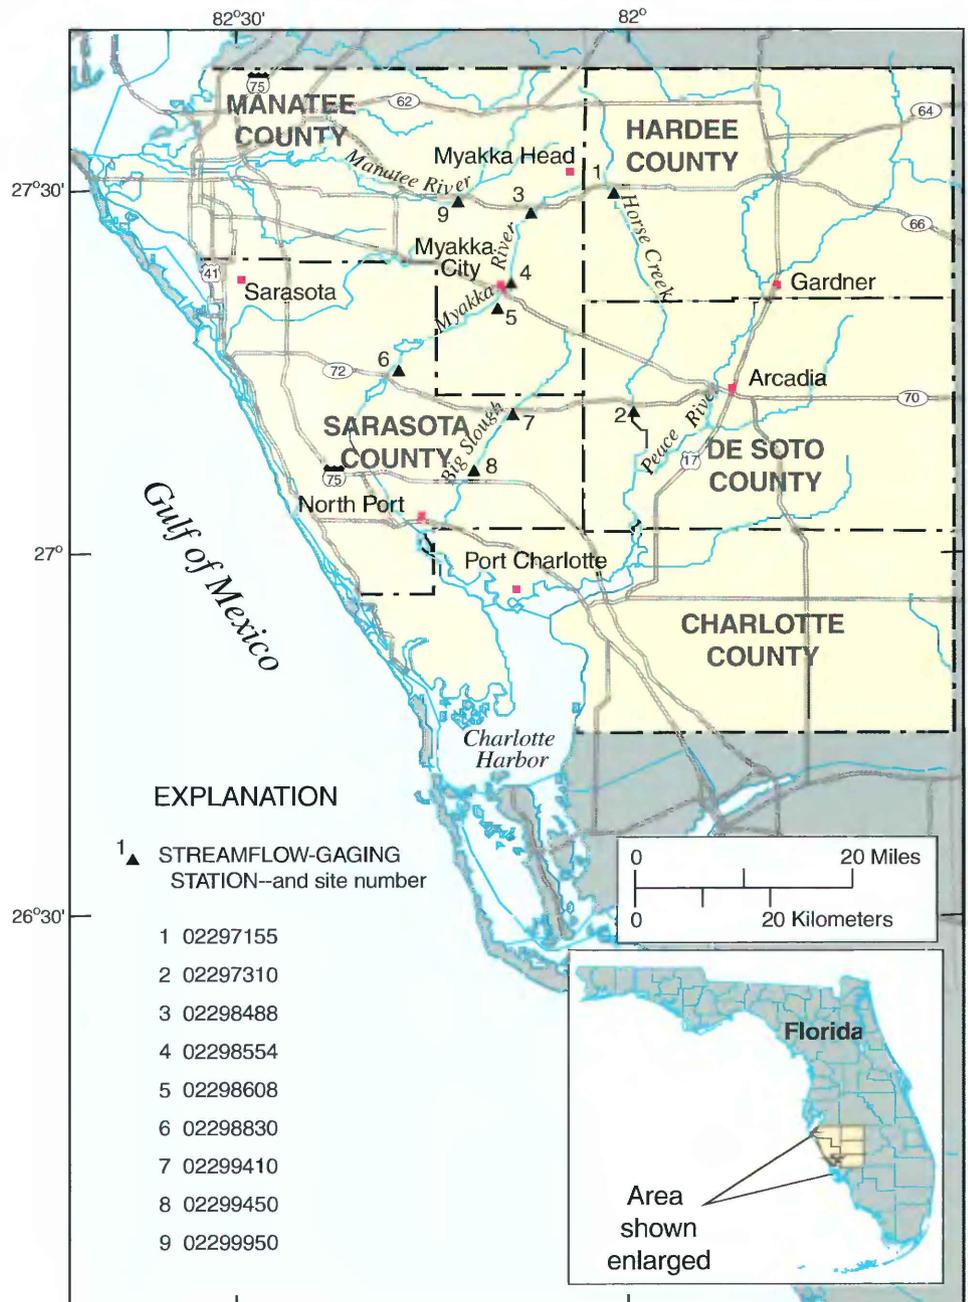
Figure 1—Geographic and hydrologic features in southwest-central Florida. Triangles locate U.S. Geological Survey streamflow-gaging stations.

Western De Soto, western Hardee, Manatee, and Sarasota Counties are drained by the Horse Creek, Manatee River, and Myakka River systems. Water in these watersheds flows southwestward to Charlotte Harbor and the Gulf of Mexico (fig. 1).

Information on peak discharges for selected gaging stations (fig. 1) in southwest-central Florida is shown in table 1. The data include peak discharge, peak stage, recurrence interval, gaging-station period of record, and date and magnitude of the largest historical peak discharge recorded prior to June 2003.

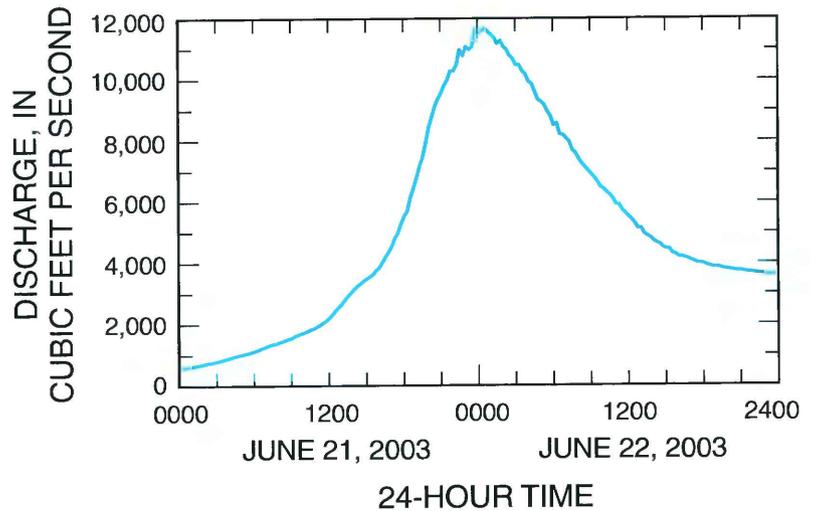
Figure 2—Manatee River near Myakka Head, Florida (02299950, site 9, fig. 1, table 1). Computed discharge, in cubic feet per second. These data are provisional and subject to revision.

The June flooding caused by localized runoff was most severe in the Myakka and Manatee River Basins. Peak discharges for the period of record were 7,800 cubic feet per second (ft³/s) at Myakka River upstream from Youngs Creek near Myakka City (site 3, fig. 1, table 1) and 9,270 ft³/s at Myakka River near Myakka City (site 4, fig. 1, table 1). Discharge peaked at Myakka River at Myakka City (site 5, fig. 1, table 1) at 10,800 ft³/s, the second highest flow on record and the highest since 1992. The flood wave continued downstream to Myakka River near Sarasota (site 6, fig. 1, table 1) where 11,100 ft³/s was recorded. This discharge was also the highest for the period of record, which began in 1936. USGS field crews observed discharge at this site flowing over State Highway 72 near Myakka River State Park. The highest discharge ever recorded on Manatee River (11,700 ft³/s) occurred near Myakka Head (site 9, fig. 1, table 1). Discharge at this site increased more than 11,000 ft³/s in 24 hours on June 21-22, after more than 10 inches of precipitation fell in 48 hours (fig. 2).

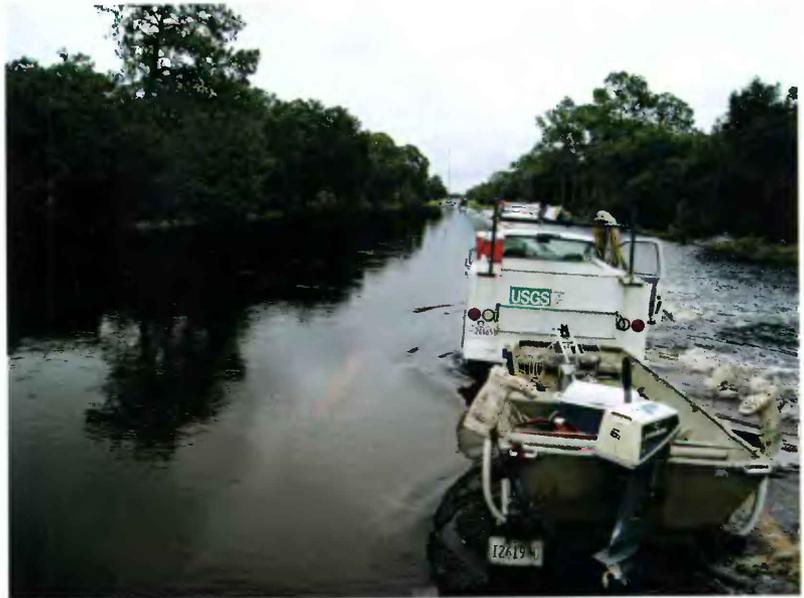
Figure 3—View of road overflow at discharge of 9,900 ft³/s in Horse Creek near Arcadia (site 2, fig. 1, table 1) on June 23, 2003.

discharge for Horse Creek near Arcadia (site 2, fig. 1, table 1) was observed overflowing the road by USGS field crews (fig. 3). The peak discharge of 11,000 ft³/s was the second highest flow recorded since 1950 and the highest since Hurricane Donna in 1960.

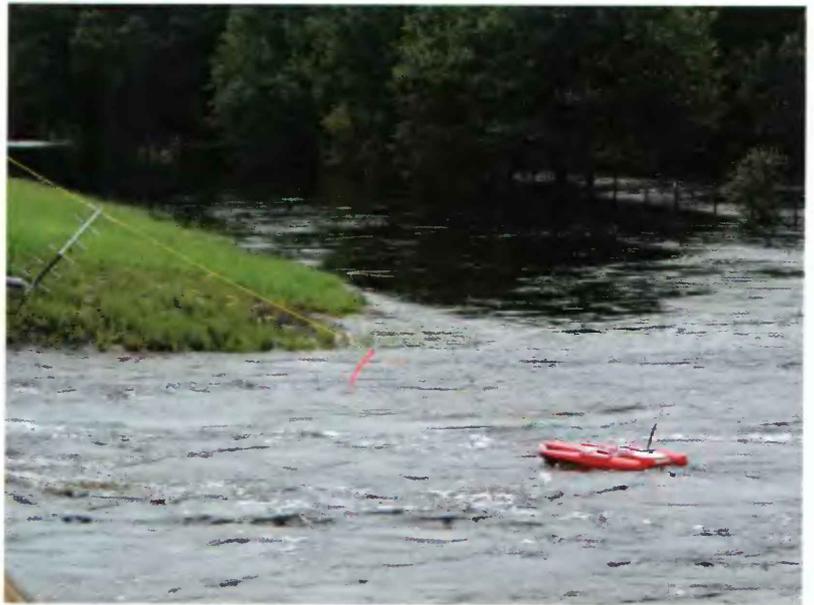
Figure 4—View of Big Slough Canal near Myakka City (site 7, fig. 1, table 1). Discharge measurement being made using a tethered boat and acoustic doppler current profiler.

At Big Slough Canal near Myakka City (site 7, fig. 1, table 1), a discharge of 7,180 ft³/s was the highest recorded since 1992 and second highest for the period of record. Flow measurements at site 7 were made using an acoustic doppler current profiler on a tethered

boat (fig. 4). Flooding continued downstream and was most severe in the City of North Port, where the Big Slough Canal overflowed its banks at Tropicaire Boulevard (fig. 5; site 8, fig. 1, table 1). The peak discharge of 4,950 ft³/s was the highest recorded for the period of record at site 8.

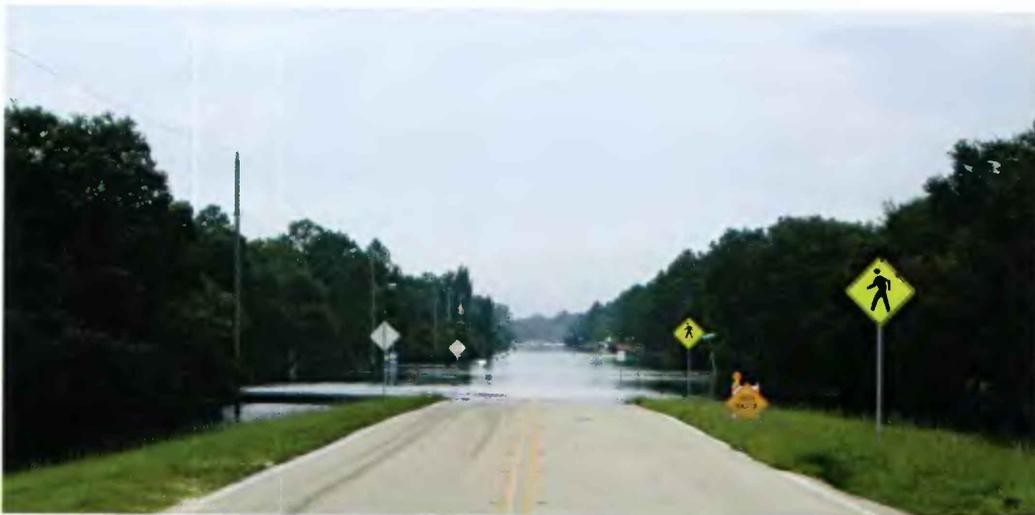
Figure 5—View of road overflow at discharge of 4,450 ft³/s, Big Slough Canal at Tropicaire Boulevard near North Port (site 8, fig. 1, table 1) on June 24, 2003.
