**Table 1.** Pasture characteristics and monitoring information for rotational-deferred paddocks at Pioneer Farm, Wisconsin, 2004.

The major goal of this study is to measure bank erosion, channel shape, location, and stream-substrate changes caused by rotational-deferred grazing practices. There is no control reach along the Fever River with standard grazing practices; measured decreases in bank erosion and increases in bank stability and vegetation along the reach with rotational-deferred grazing are assumed to be the result of the change in grazing management. The purpose of this Fact Sheet is to describe the ongoing methods used to monitor long-term bank erosion in the pastures. Example data are presented for each method of observing the bank erosion.

Authors: Marie C. Peppler and Faith A. Fitzpatrick

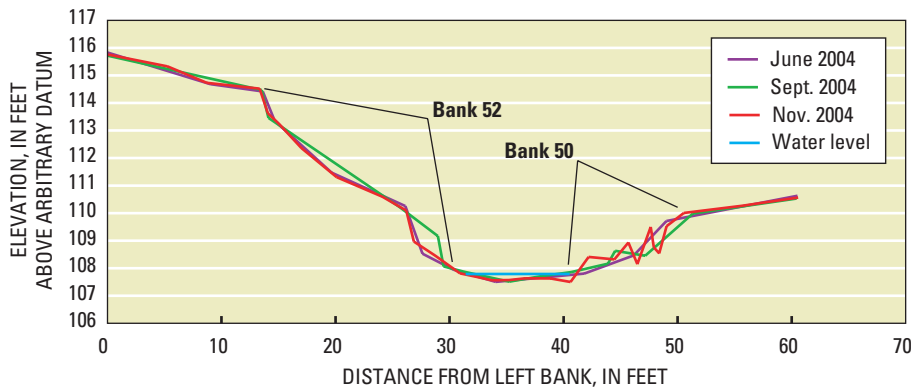
**Figure 2.** Cross section 33 in paddock 7 showing the development of a cattle crossing at the edge of bank 50. The steep scratching area of bank 52 is shown in figure 4.

Thirty-five channel cross sections (fig. 1, table 1) were established to measure channel movement, incision or aggradation, and bank failures by the methods of Harrelson and others (1994). Two cross sections are in two enclosure areas (cross-sections 2 and 7), and a third cross-section is located south of College Farm Road at the USGS long-term stream-flow-gaging station (05414850) (cross-section 1, fig. 1). The cross sections were spaced roughly evenly along the length of the river and represent channel conditions in meander bends and straight stretches. Steel reinforcement bars with numbered plates welded to the top were pounded flush to the ground surface to mark the cross-section endpoints permanently yet prevent cattle injury. Cross-section 33 shows an

example of the development of a cattle crossing in the Fever River channel since late June 2004 (fig. 2). The irregular surface on bank 50 in the November 2004 survey represents numerous newly developed individual paths that typically make up a stream crossing made by cattle.

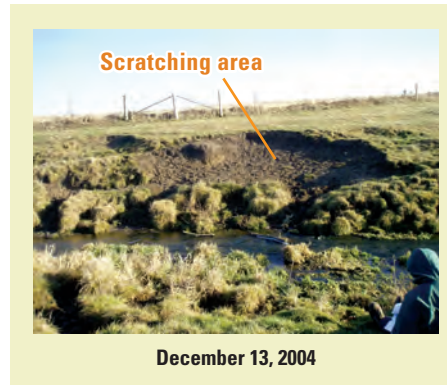
**Figure 4.** Pronounced scratching area in bank 52, paddock 7, with visible cattle paths to the stream. Dimensions are shown in figure 2.

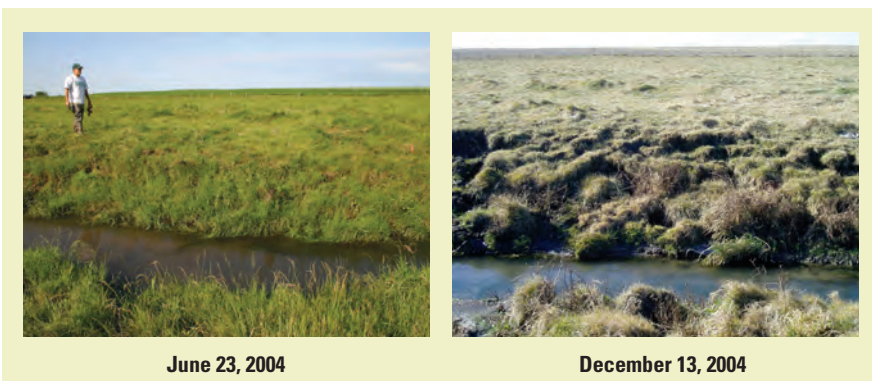
**Figure 5.** Development of bank slumps from cattle trampling, bank 36, paddock 6. (Photo at left taken by Randy Mentz.)

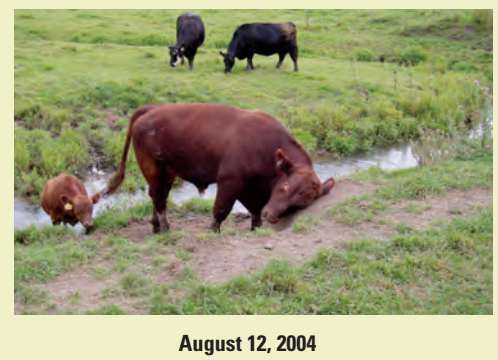
**Figure 6.** Bull scratching on bank 52, paddock 7. A calf is using a trail leading from the stream to the scratching area. Bank 50 is in the background.

Eroding-terrace cuts are often enhanced by repeated cattle scratching (fig. 6). The bare spot may be formed initially by hydraulic erosion which can lead to mass wasting at the outsides of bends, or cow trampling. The bare area can then be expanded by scratching. The areas used for scratching typically have a scallop shape,
