In cooperation with the University of Wisconsin-Platteville, Pioneer Farm

Methods for Monitoring the Effects of Grazing Management on Bank Erosion and Channel Morphology, Fever River, Pioneer Farm, Wisconsin, 2004

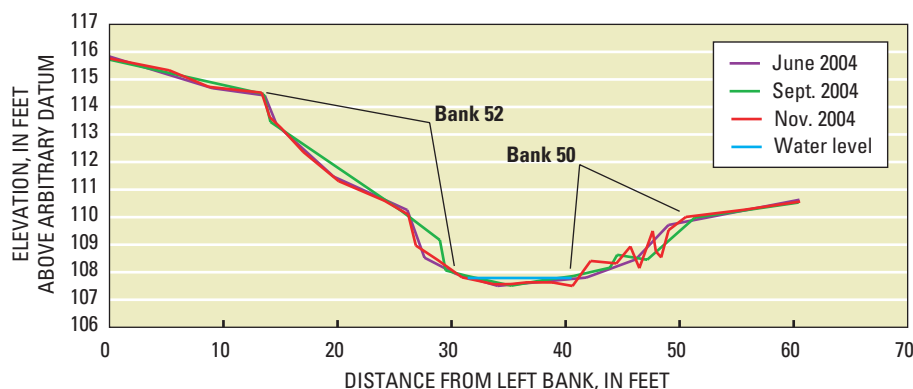
Figure 2. Cross section 33 in paddock 7 showing the development of a cattle crossing at the edge of bank 50. The steep scratching area of bank 52 is shown in figure 4.

example of the development of a cattle crossing in the Fever River channel since late June 2004 (fig. 2). The irregular surface on bank 50 in the November 2004 survey represents numerous newly developed individual paths that typically make up a stream crossing made by cattle.

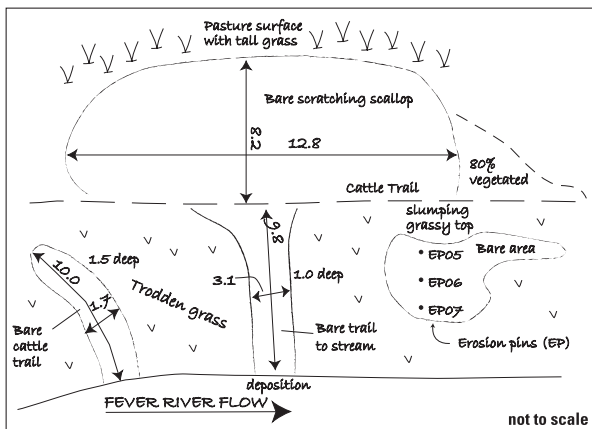
Figure 3. Example sketch of bank measurements and features. Angular view sketches are made of all eroding banks twice a year.

and causes for erosion, drawings or sketches, and photos were made (fig. 3). Possible causes for erosion include hydraulic or freezing and thawing forces acting against the base or toe of a bank, mass wasting along upper banks on the outside of bends where the stream intersects a terrace, cattle trampling (crossing the stream or walking along the bank), and cattle scratching (fig. 6) on the bank, or a combination of causes. Sketches of the eroding banks included locations of cross sections and erosion pins. A photo point was established for each bank and photos were taken approximately every 2 months. A photograph of bank 52 in December 2004 shows the decreased vegetation and a scratching corner (fig. 4). Photographs of bank 36 show the development of slumping caused by cattle trampling along the top edge of the bank (fig. 5). The photos illustrate how the height of the vegetation along the bank (related to the length of the rest period) may affect interpretations of bank stability.

formed by repeated head movement and hoof scraping (fig. 3). Most, but not all, scratching areas have a direct hydraulic effect on the channel because cattle paths connect the scratching areas to the stream at a non-constructed cattle crossing. Eroding areas enhanced by scratching are recorded in the bank-measurement notes.

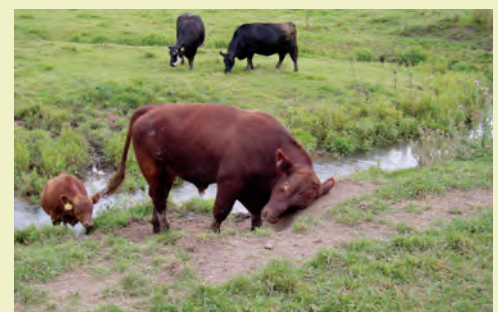
Figure 6. Bull scratching on bank 52, paddock 7. A calf is using a trail leading from the stream to the scratching area. Bank 50 is in the background.

Eroding-terrace cuts are often enhanced by repeated cattle scratching (fig. 6). The bare spot may be formed initially by hydraulic erosion which can lead to mass wasting at the outsides of bends, or cow trampling. The bare area can then be expanded by scratching. The areas used for scratching typically have a scallop shape,

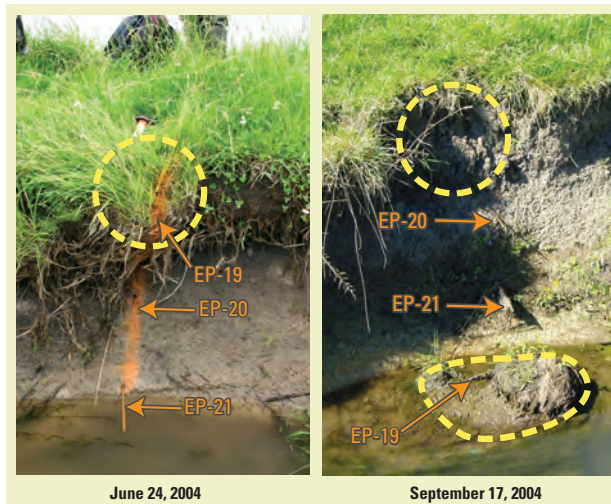
Figure 7. Erosion pins (EP) in bank 21, paddock 4, record a bank failure. The yellow dashes mark the block that failed.

Steel erosion pins were set in 12 eroding banks in vertical arrays of two or three pins inserted parallel to the water surface with a known amount of pin left exposed. Each ¼-inch-diameter pin is 2 ft long. The original design included installation of 150 pins; only 59 were installed because only a limited number of locations were available where pins would not potentially injure cattle. Pins were installed only in locations where the bank appeared to be eroding exclusively due to fluvial processes. Two pins were set when the bank was too low to accommodate a three-pin array. The array of three erosion pins was designed to facilitate the monitoring of mass wasting at the top of the banks, short-term deposition at the water level, and overall erosion as the bank recedes. The typical failure mechanism for the banks is rotational block failure (fig. 7, bank 21). After the block failure at bank 21 that occurred between June 24, 2004, and September 17, 2004, the top erosion pin (EP-19) was ripped out and found in the stream in the remaining clump of slumped vegetation and roots. Depending on the amount of rotation and bank angle, sometimes the failed block covers the bottom erosion pin.
