Author: Karen L. M. Morgan, USGS [kmorgan@usgs.gov](mailto:kmorgan@usgs.gov) 727-803-8747 x 3037  
 Project Contact: Asbury (Abby) Sallenger, USGS [asallenger@usgs.gov](mailto:asallenger@usgs.gov) 727-803-8747 x 3015  
<http://coastal.er.usgs.gov/hurricanes/>

## Coastal Change During Hurricane Ivan 2004

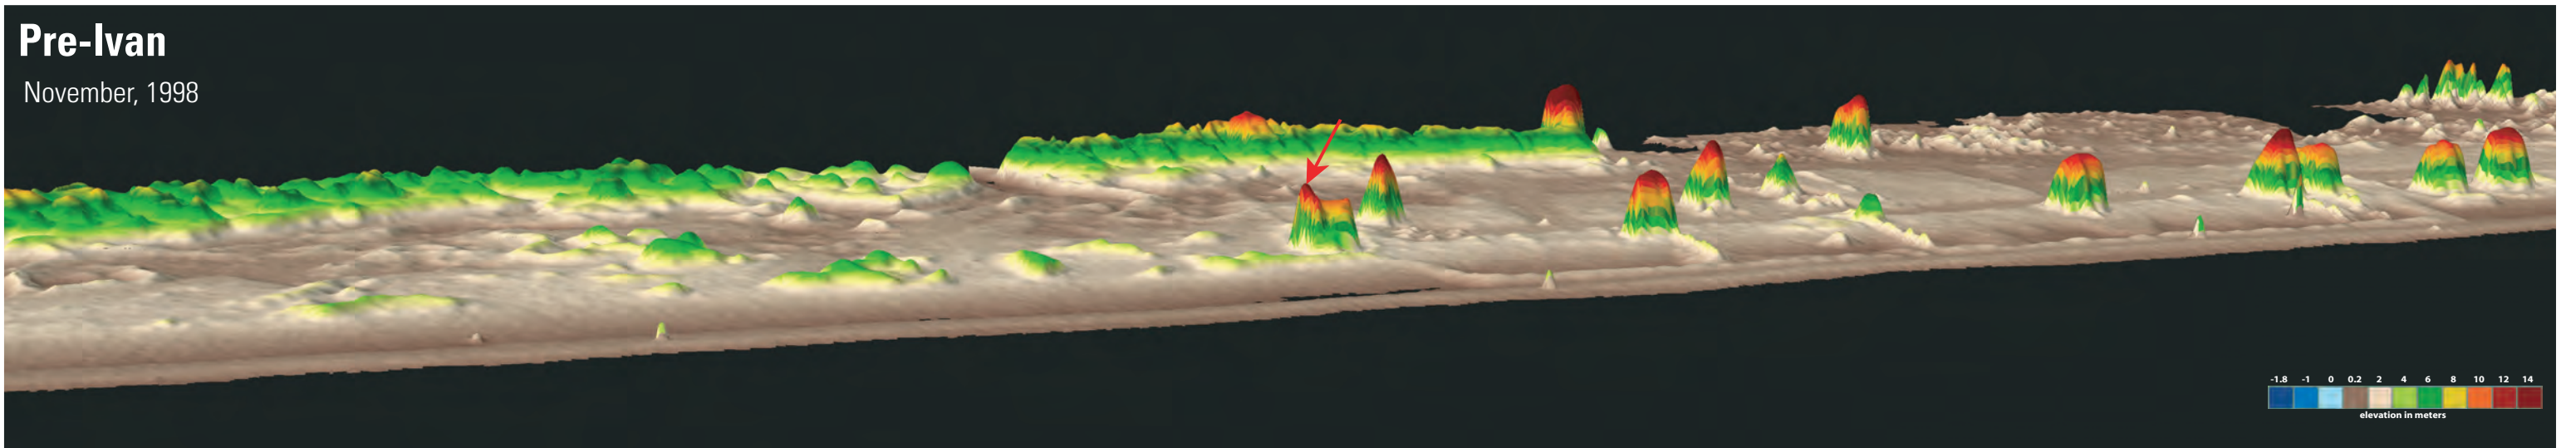
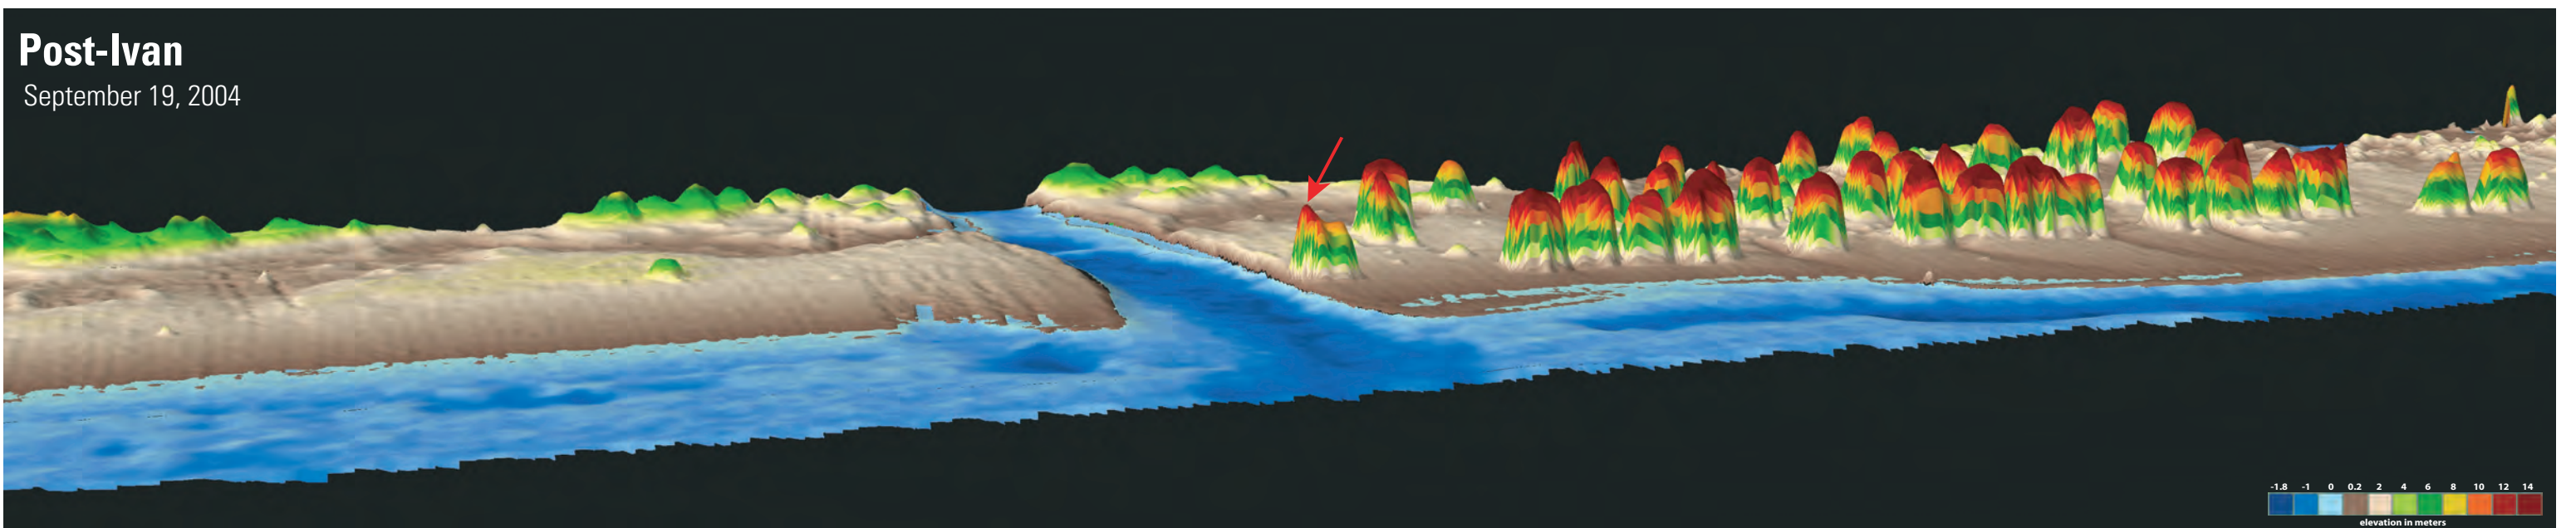
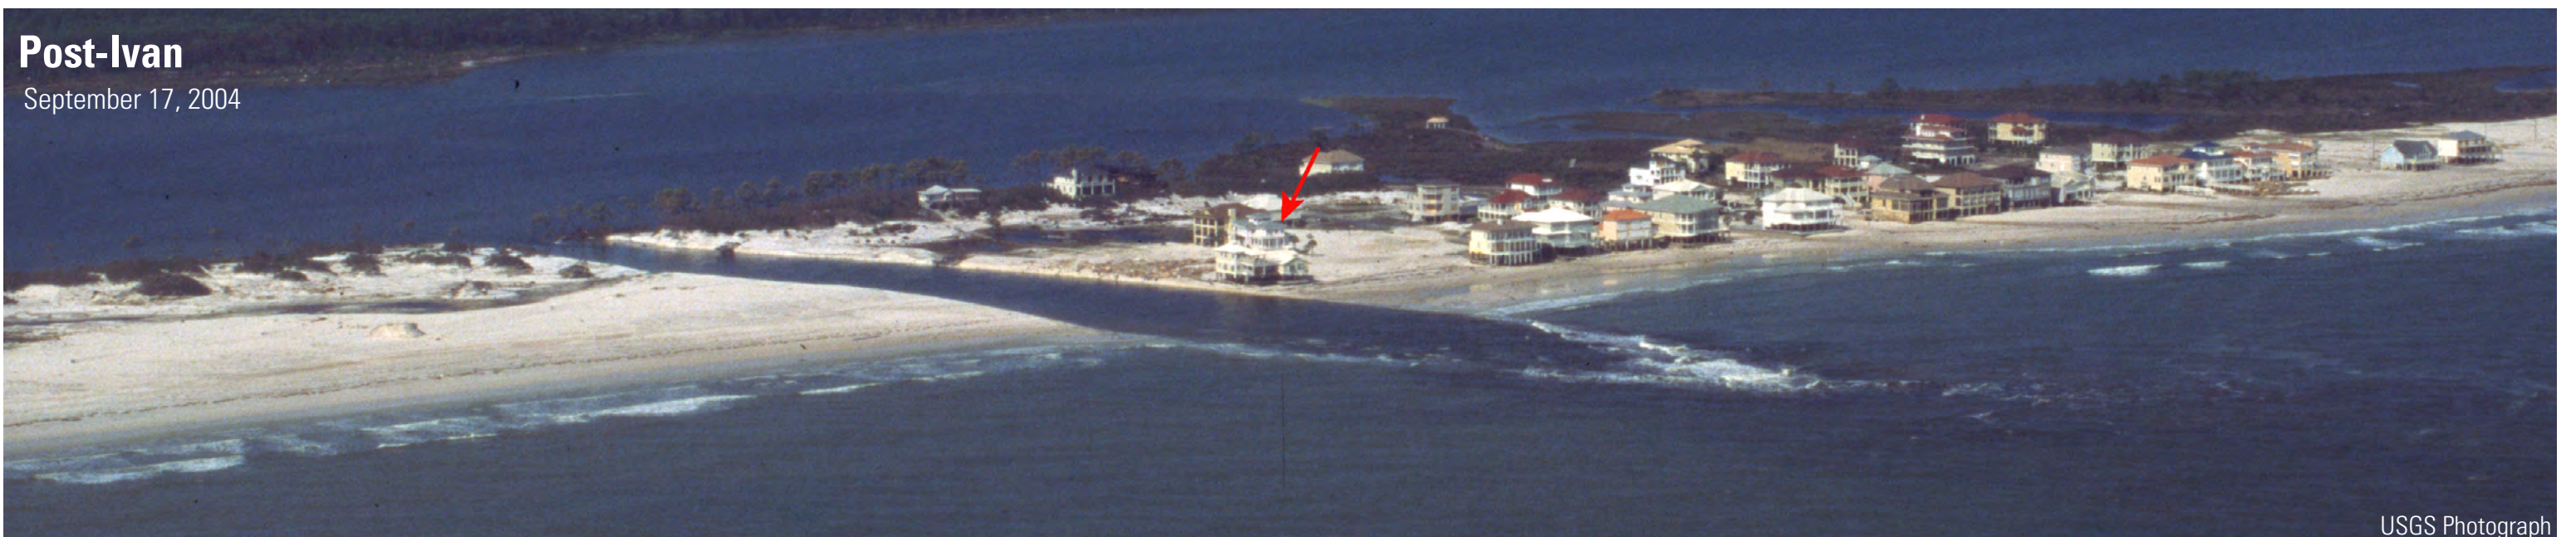
**Figure 3.** Pine Beach, Alabama. Top and Center: Topography/bathymetry measured with lidar before and after the impact of Hurricane Ivan showing a new breach that severed the island. (Note the new houses that were built between the surveys. Houses appear in the topography as rectangular mounds. Their warmer colors indicate higher elevations.) Bottom image: A USGS aerial photograph shows the new breach following landfall. (Arrows in all images point to the same features.)

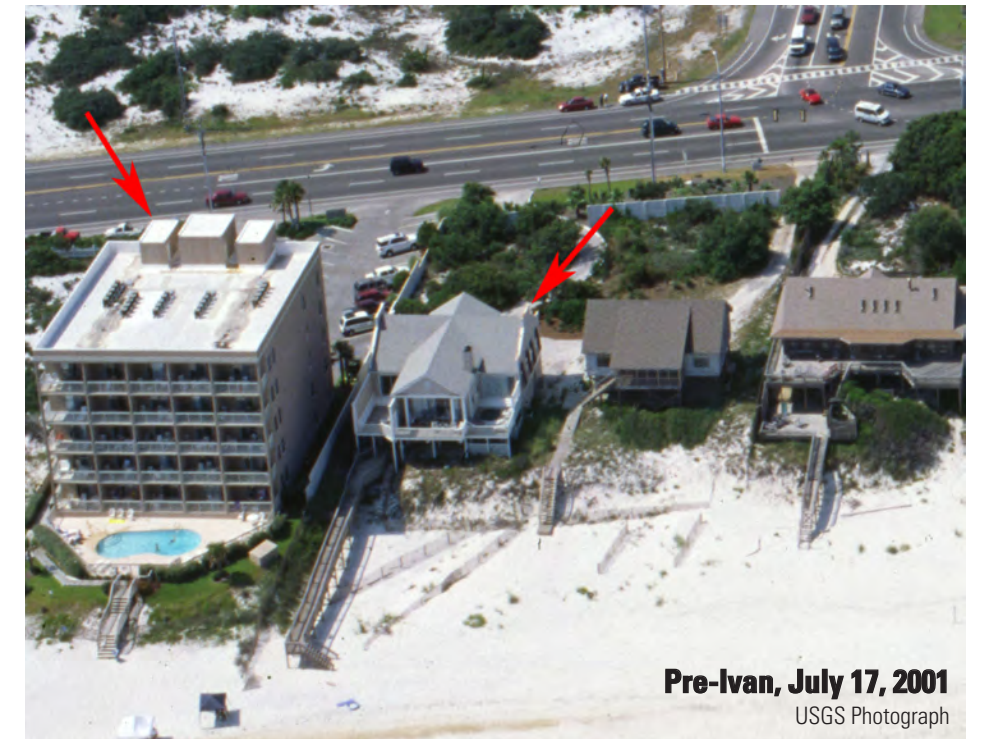
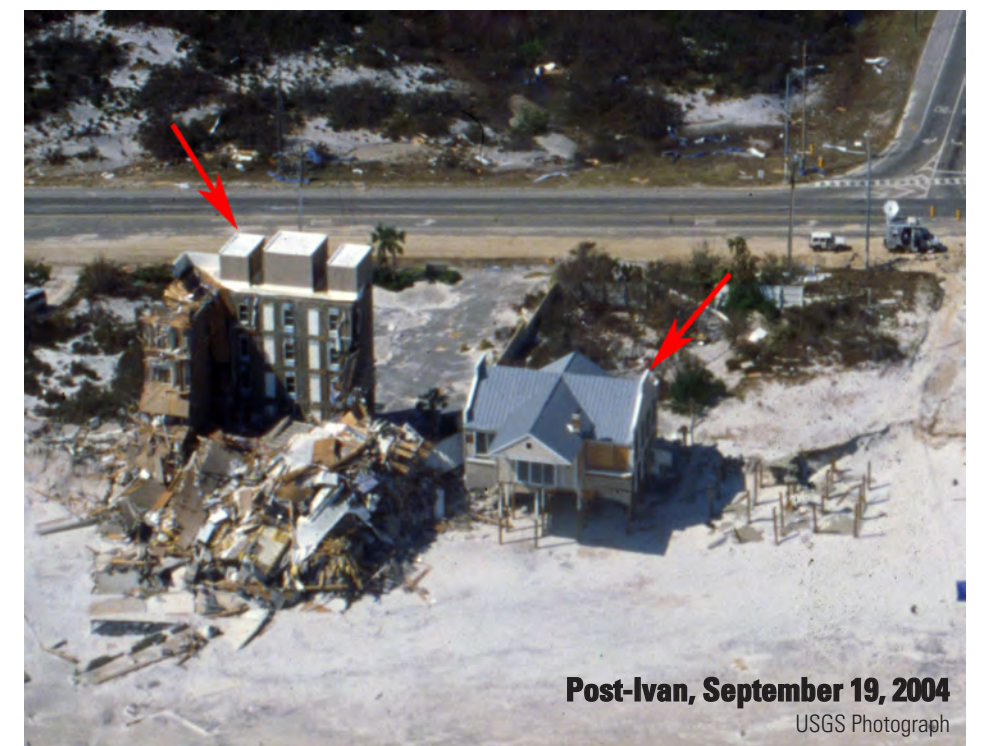
**Figure 2.** Orange Beach, Alabama. USGS aerial photographs taken before and after the landfall of Hurricane Ivan show the failure of a five-story condominium tower. The only parts of the structure that remain standing after Hurricane Ivan are the elevator and stairwell shafts. Airborne laser mapping data showed that the sand dune on which this building was constructed was subjected to about 3 m of vertical erosion during the storm. (Arrows in all images point to the same feature.)
