In cooperation with the Texas Water Development Board

# An Overview of Historical Channel Adjustment and Selected Hydraulic Values in the Lower Sabine and Lower Brazos River Basins, Texas and Louisiana

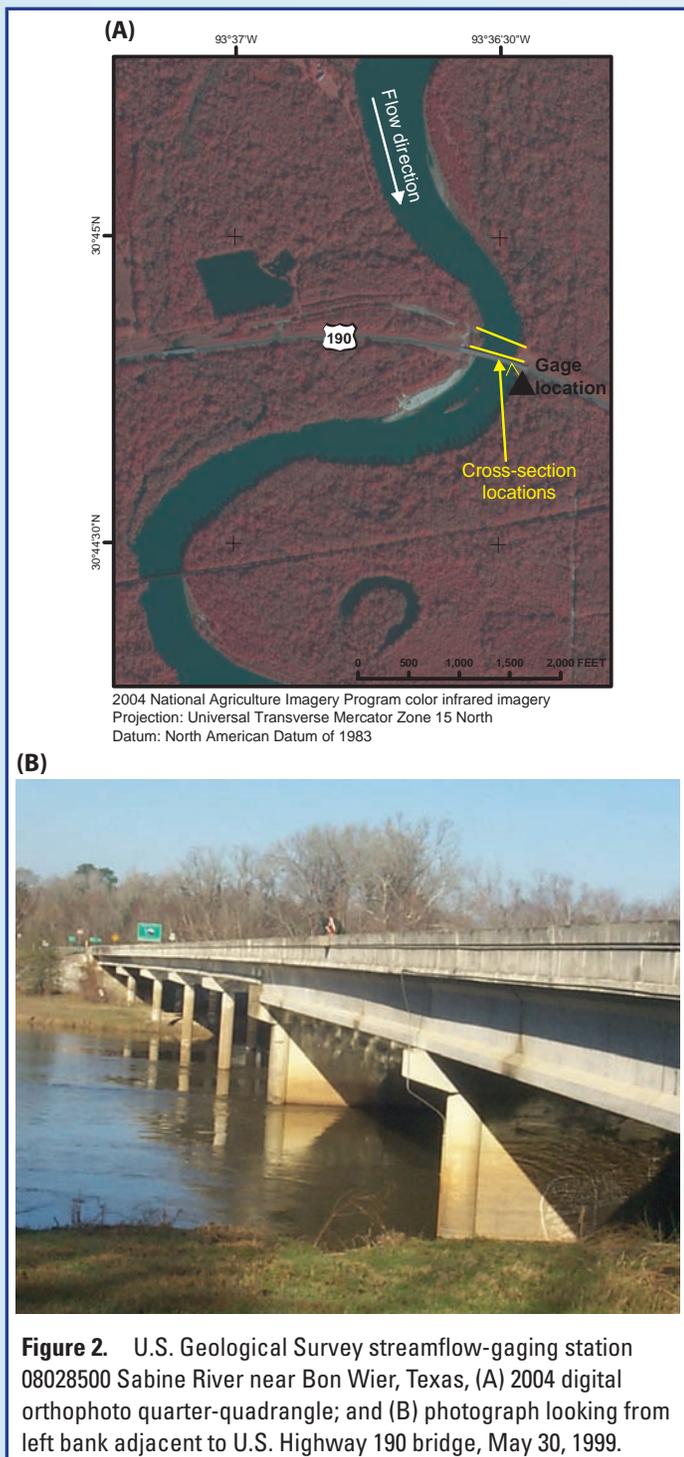
**Figure 2.** U.S. Geological Survey streamflow-gaging station 08028500 Sabine River near Bon Wier, Texas, (A) 2004 digital orthophoto quarter-quadrangle; and (B) photograph looking from left bank adjacent to U.S. Highway 190 bridge, May 30, 1999.

190 downstream from Toledo Bend Reservoir, and the sand-bed river forms the boundary between Texas and Louisiana (figs. 1, 2). Streamflow measurements at the site began in October 1923 and continue to present (2009); 17 stage-discharge rating curves have been used for the period of record. Rating curves were most frequently updated between 1950 and 1953. Stage-discharge relations determined from field measurements for the period of record indicate progressive channel degradation since the 1930s (fig. 3). The bridge at this site was replaced in 1981, thus two sequences of historical cross sections are provided because: (1) the bridge and discharge-measurement site were relocated about 200 feet downstream; (2) USGS measurement cross-section distances were changed; and (3) construction activity might have altered channel geometry.

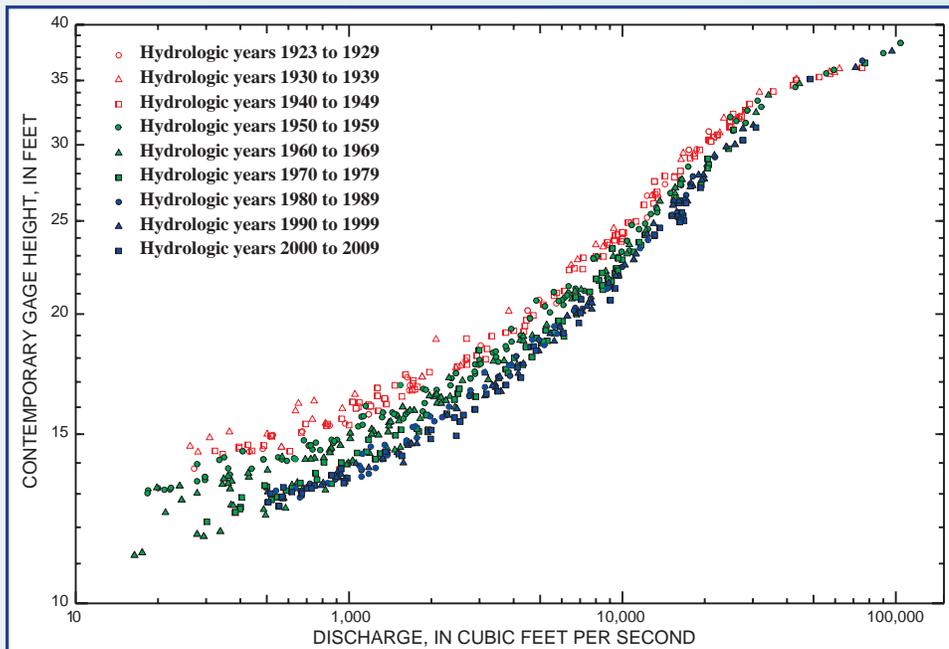
**Figure 3.** Stage-discharge relations of field measurements for U.S. Geological Survey streamflow-gaging station 08028500 Sabine River near Bon Wier, Texas, 1923–2009.

As part of maintaining a USGS streamflow-gaging station, field measurements of discharge are summarized using USGS Form 9-207, which includes the discharge, gage height, width, cross-sectional area, mean velocity, and other data for all measurements made at one station. For the gaging stations investigated in this study, relations of measured gage height to measured discharge were analyzed for all digitally available measurements for the period of record. Analyses of stage-discharge relations of field measurements were done to complement and reinforce interpretations of channel adjustment made from historical cross sections.

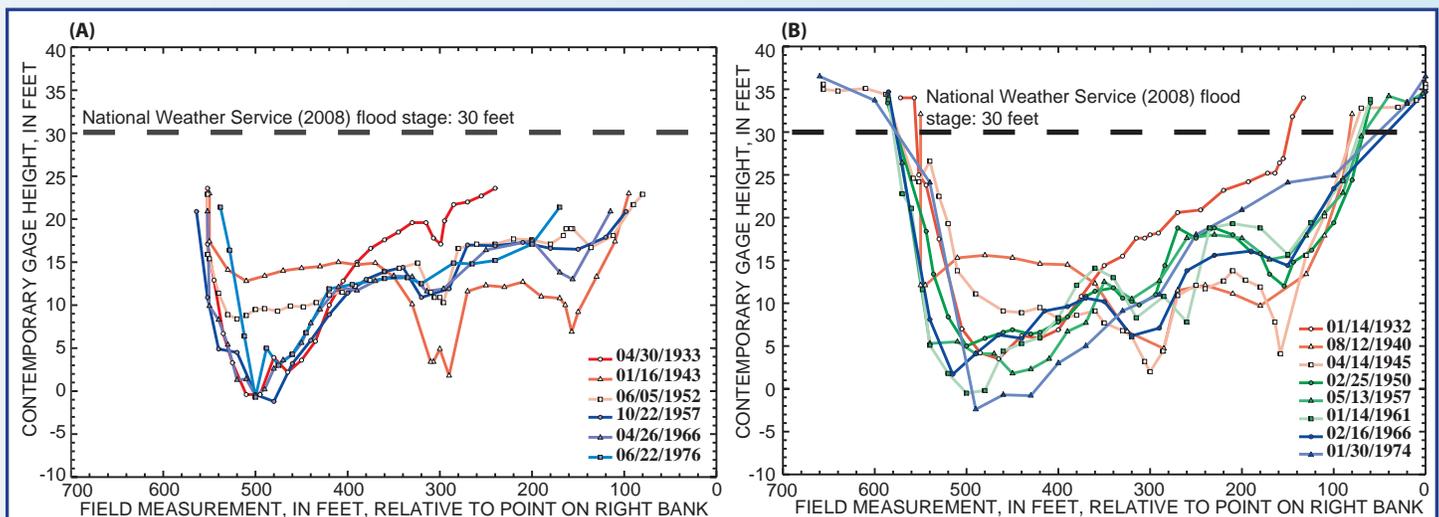
**Figure 4.** Historical cross-sectional channel geometry for U.S. Geological Survey streamflow-gaging station 08028500 Sabine River near Bon Wier, Texas, (A) at moderate-flow conditions (greater than 5,000 cubic feet per second and less than 10,000 cubic feet per second), 1933–76; (B) at high-flow conditions (greater than 10,000 cubic feet per second), 1932–74; (C) at moderate-flow conditions, 1986–2005; and (D) at high-flow conditions, 1984–2003.

flows between 1932 and 1966 (fig. 4B) and amounts to approximately 30 feet, or an average of 0.88 foot per year.

Since 1981, the cross-sectional geometry at the new bridge location is narrower and has a steeper right bank (fig. 4C, D) than the former bridge location. Since the mid-1980s, minor adjustment of the channel-bed elevation has occurred several times, which is common for sand-bed rivers. More distinctive, however, is the apparent migration of the channel thalweg to the right. Between 1984 and 2005, the thalweg has moved approximately 30 feet to the right, or an average of 1.43 feet per year, and the left channel bank has moved approximately 15 feet to the right, or an average of 0.71 foot per year. A number of large floods have occurred along the lower Sabine River during this time, including a peak of 98,200 cubic feet per second in July

The measurement site is at a meander bend and the asymmetrical cross-sectional geometry shows the gradual right point bar descending to the thalweg near the left cutbank side of the channel (fig. 4). Between 1933 and 1940, an aggradational episode at the site filled the thalweg near the cutbank with nearly 13 feet of sediment and incised a new elevated thalweg across the point bar; and the channel cross section dramatically changed its geometry (fig. 4A, B). Between 1940 and 1980, the channel gradually reestablished asymmetry at the site with the thalweg on the left, or outside the meander bend. The elevation and uniform transverse slope of the early 1930s point-bar surface, however, was not fully restored by the late 1970s. A progressive pattern of channel incision is not detected, either in moderate-flow or high-flow cross sections. Cutbank migration is not detected for moderate flows (fig. 4A) but is detected for high

The morphological results generally support observations of channel shape and interpretations of adjustment at this site made by other investigators, including a steep left bank and a gradually sloping bar surface on the right side. Historical cross sections (fig. 4) confirm the steep left bank, but the gradually sloping bar is steeper on the right side of the channel at the USGS cross-section location. Further, the downstream migration of the right point-bar deposit between 1994 and 2000 is confirmed by historical cross sections, indicating that the bar fully migrated downstream between 1994 and 1997.
