Prepared in cooperation with the Hood Canal Dissolved Oxygen Program and University of Washington Advanced Physics Laboratory

Locating Inputs of Freshwater to Lynch Cove, Hood Canal, Washington, Using Aerial Infrared Photography

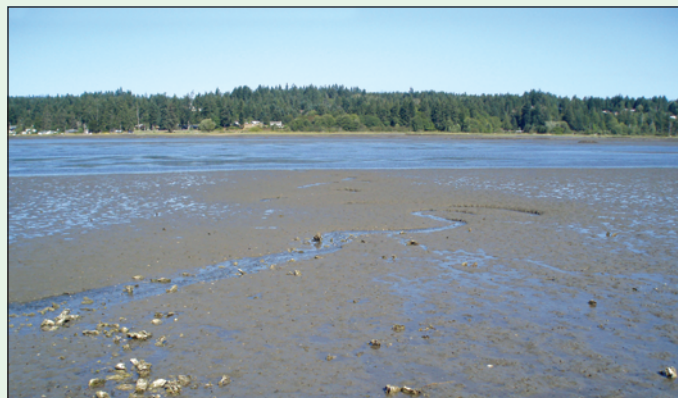
An area of Lynch Cove during low tide showing diffuse nature of freshwater inputs as small rivulets and dispersed seepage.

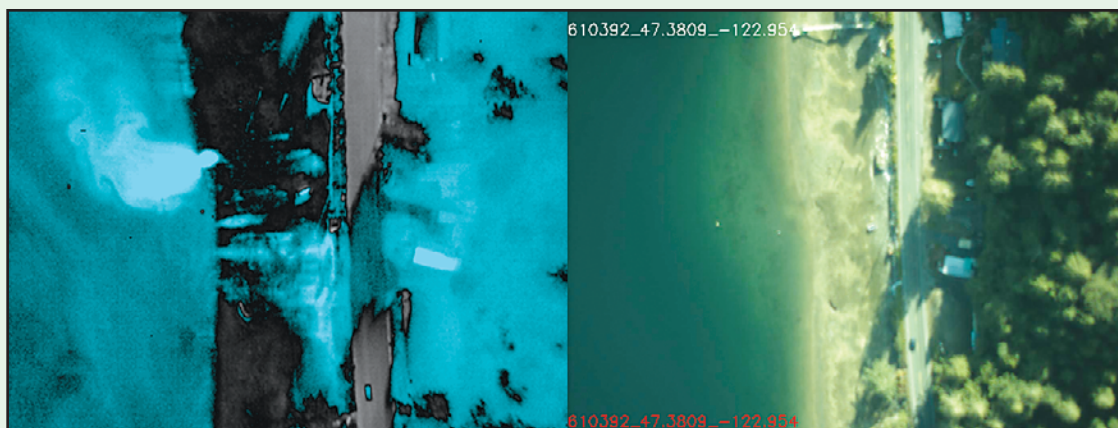
Figure 3. A point source of groundwater creates a plume in the nearshore (image 610392, acquired August 18, 2009).

The sample images that follow illustrate some of the phenomena seen in the imagery. The red and white numbers on each image are the image identifier, and the latitude and the longitude of the image pair, respectively.

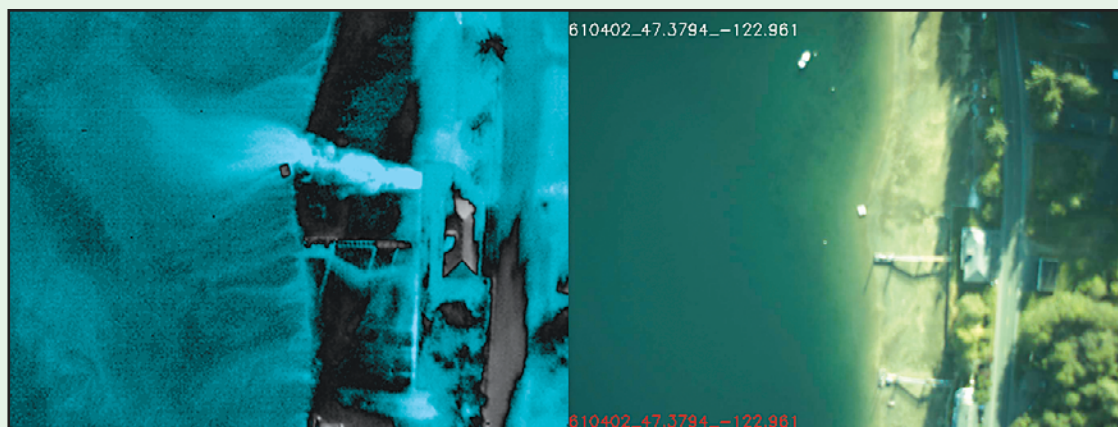
Figure 4. Water emanates from a bulkhead and flows across the intertidal zone (image 610402, acquired August 18, 2009).

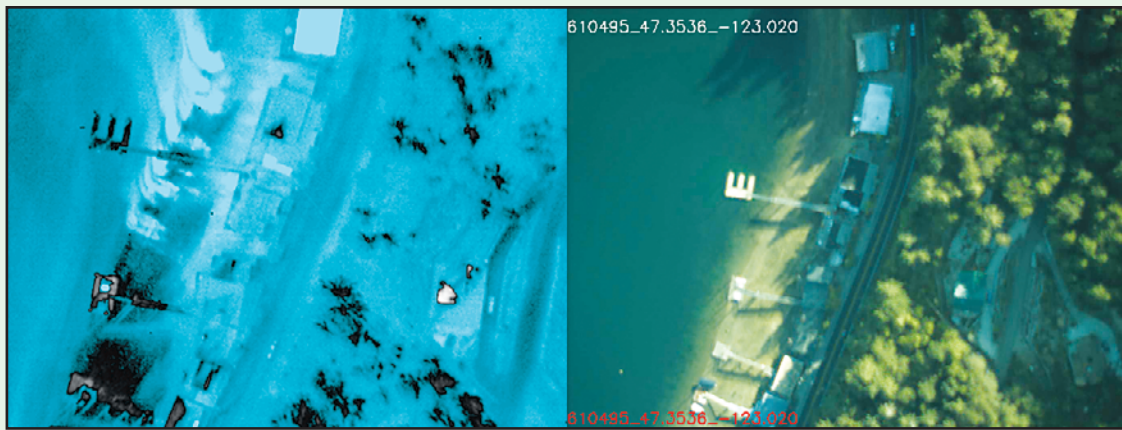
Figure 5. Multiple groundwater point sources in the intertidal zone (image 610495: acquired August 18, 2009).

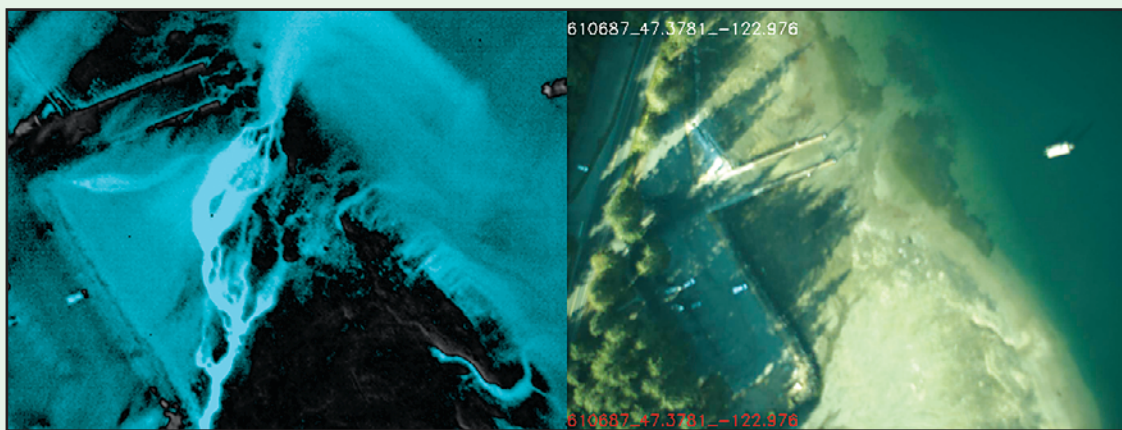
Figure 6. A stream flows across an alluvial fan at Twanoh State Park, Washington (image 610687, acquired August 18, 2009).

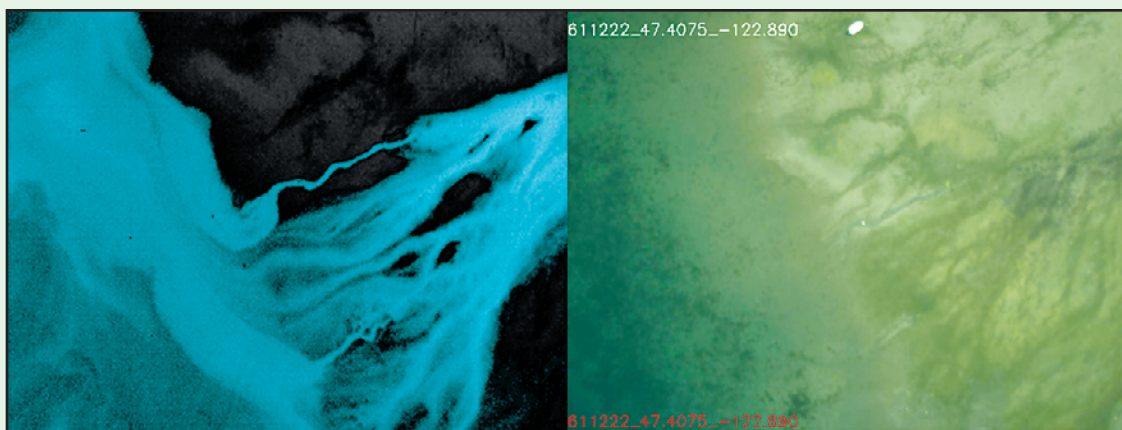
Figure 7. Braided (unnamed) streamflow on a mud flat just west of Sunset Beach, Washington (image 611222, acquired August 18, 2009).

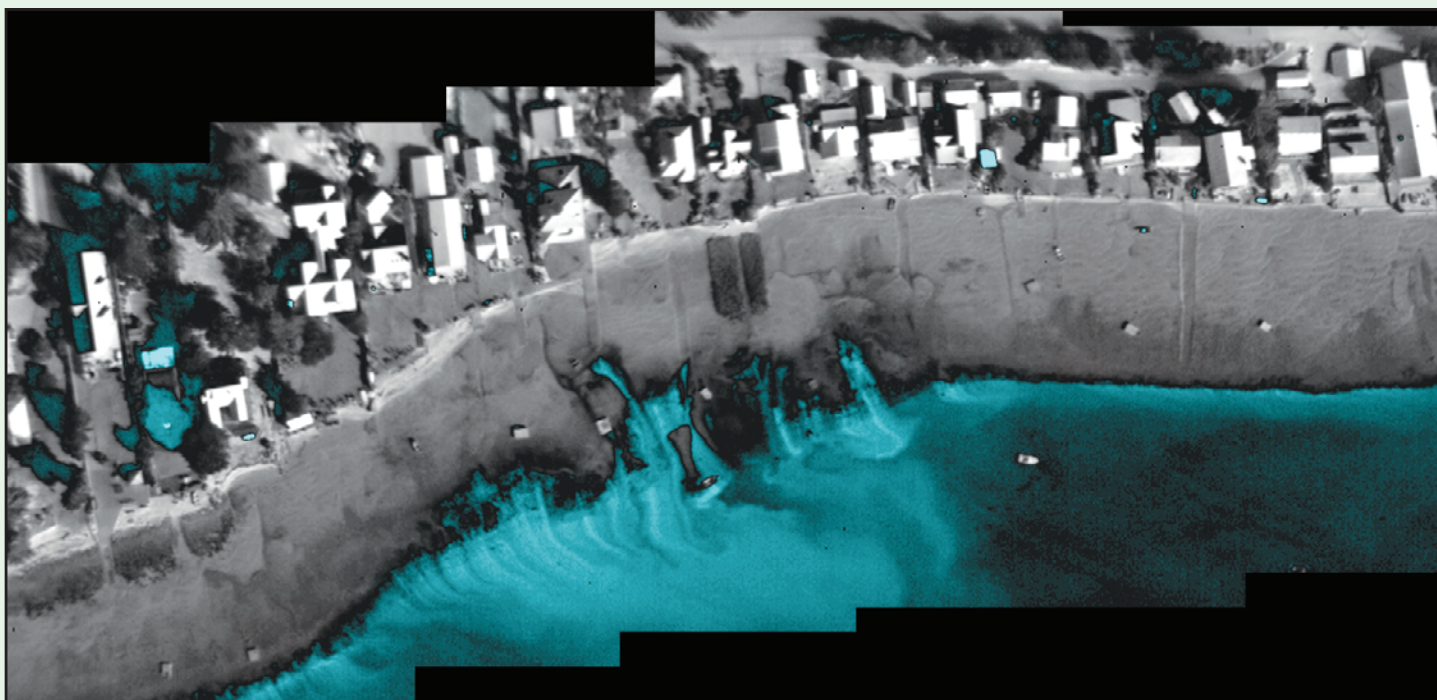
Figure 8. A mosaic of several adjacent images from the north shore near Landon Road, Belfair, Washington, showing the extent of diffuse groundwater discharge (images, Landon mosaic, acquired August 18, 2009).
