# A Dryland River Transformed—The Little Colorado, 1936–2010

**T**he Little Colorado River, in northeastern Arizona, is a major tributary of the Colorado River. Over a span of 74 years, the U.S. Geological Survey (USGS) has mapped substantial migration of the river channel between the City of Winslow and the Navajo Nation community of Leupp (Tólchíí koooh). In a human lifetime, the river has moved more than 1 mile across its valley floor. Channel migration and flooding pose a considerable risk to the life and property of people living near the river. USGS scientists are working to better understand the potential for further channel adjustments and flooding to help provide communities at risk with the information they need to address these threats and make future development decisions.

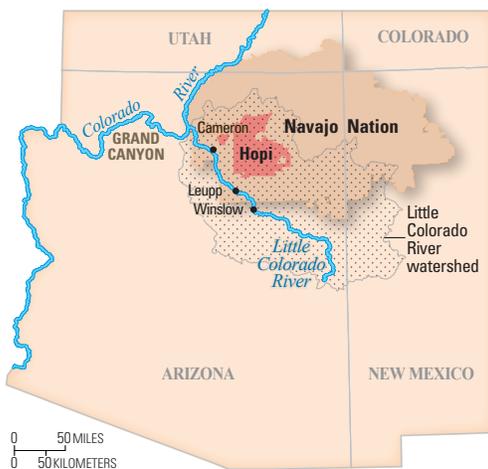
Map showing the Little Colorado River watershed in Arizona.

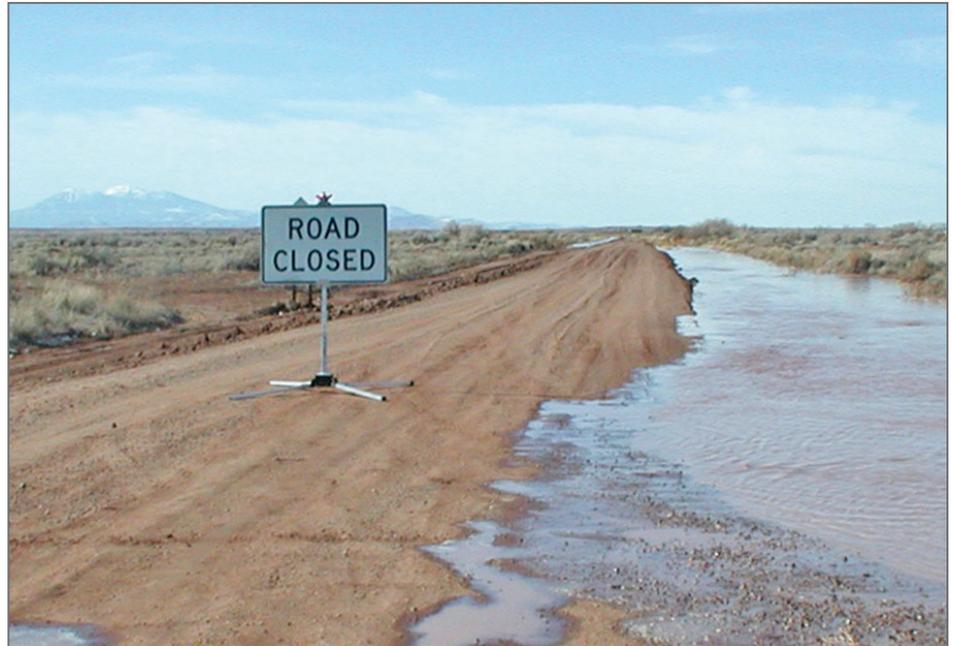
Flooding along the Little Colorado River poses a serious threat to communities between Winslow and Leupp, Arizona. This photograph shows the intersection of Indian Routes 2 and 71 in the Navajo Nation, which was closed by flooding along the Little Colorado River in January 2008. Because there are few main roads and bridges in the region, such closures can have serious consequences. Nearby homes were also threatened by the flooding. (USGS photo by Lee Amoroso.)

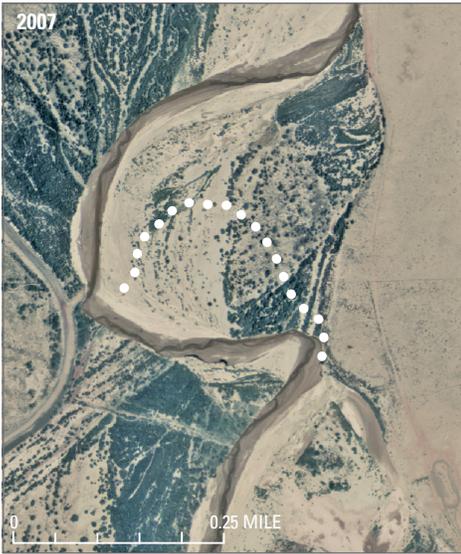
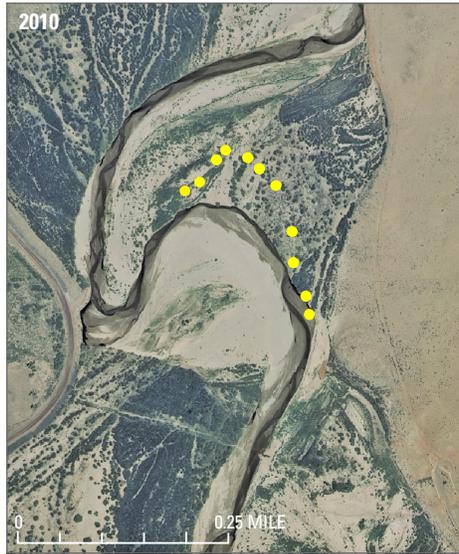
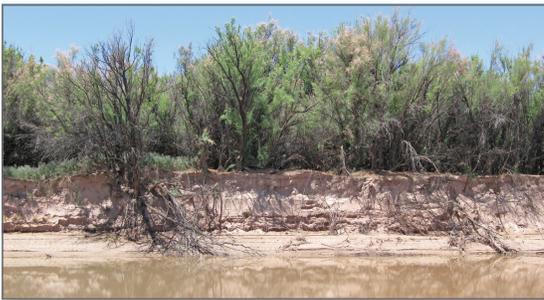
These aerial photographs taken in 2007 and 2010 show the migration of a meander bend on the Little Colorado River in northeastern Arizona (USDA National Agriculture Imagery Program). White dots in the 2007 image show the location of the channel bank in 2010. Yellow dots in the 2010 image show the location of the bank in June 2011. From June 2010 to June 2011, the axis of the meander bend migrated at least 325 feet. The inset photo shows channel bank erosion despite dense tamarisk (*Tamarisk* spp.) growth. (USGS photo by Debra Block.)

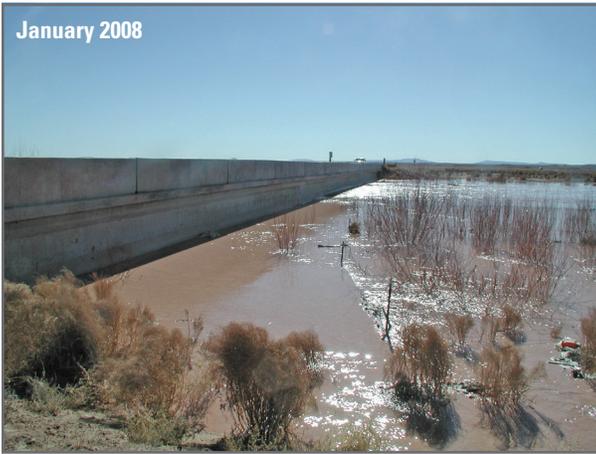
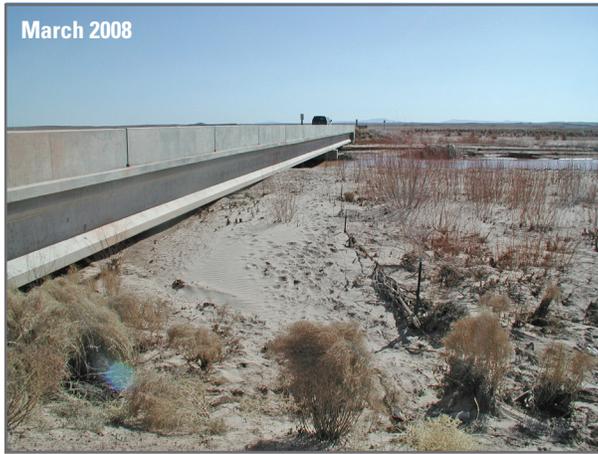
Flooding along the Little Colorado River in northeastern Arizona in January 2008 reached the decking of the Birdsprings Bridge in the Navajo Nation (photo at left). The photo at right taken in March 2008 shows the large amount of sediment deposited against the bridge by the flood. (USGS photos by Lee Amoroso.)

the decrease in channel width there. On January 29, 2008, peak discharge recorded at Winslow was 11,200 cfs and the stage, or elevation of the water surface, was 17.46 feet. Flood stage is considered to be 19 feet for the Little Colorado River at Winslow by the Advanced Hydrologic Prediction Service (<http://www.weather.gov/oh/ahps/>). However, about 22 miles downstream, where two bridges provide access for the Navajo community of Birdsprings, the river crested at or near the decking beneath the bridges and spread for nearly 2 miles across the flood plain. As the flood water receded, sediment was left piled against the bridge piers and abutments, requiring dredging.
