Landslides in the Northern Colorado Front Range Caused by Rainfall, September 11–13, 2013

Jonathan W. Godt, Jeffrey A. Coe, Jason W. Kean, Rex L. Baum, Eric S. Jones, Edwin L. Harp, Dennis M. Staley, and William D. Barnhart

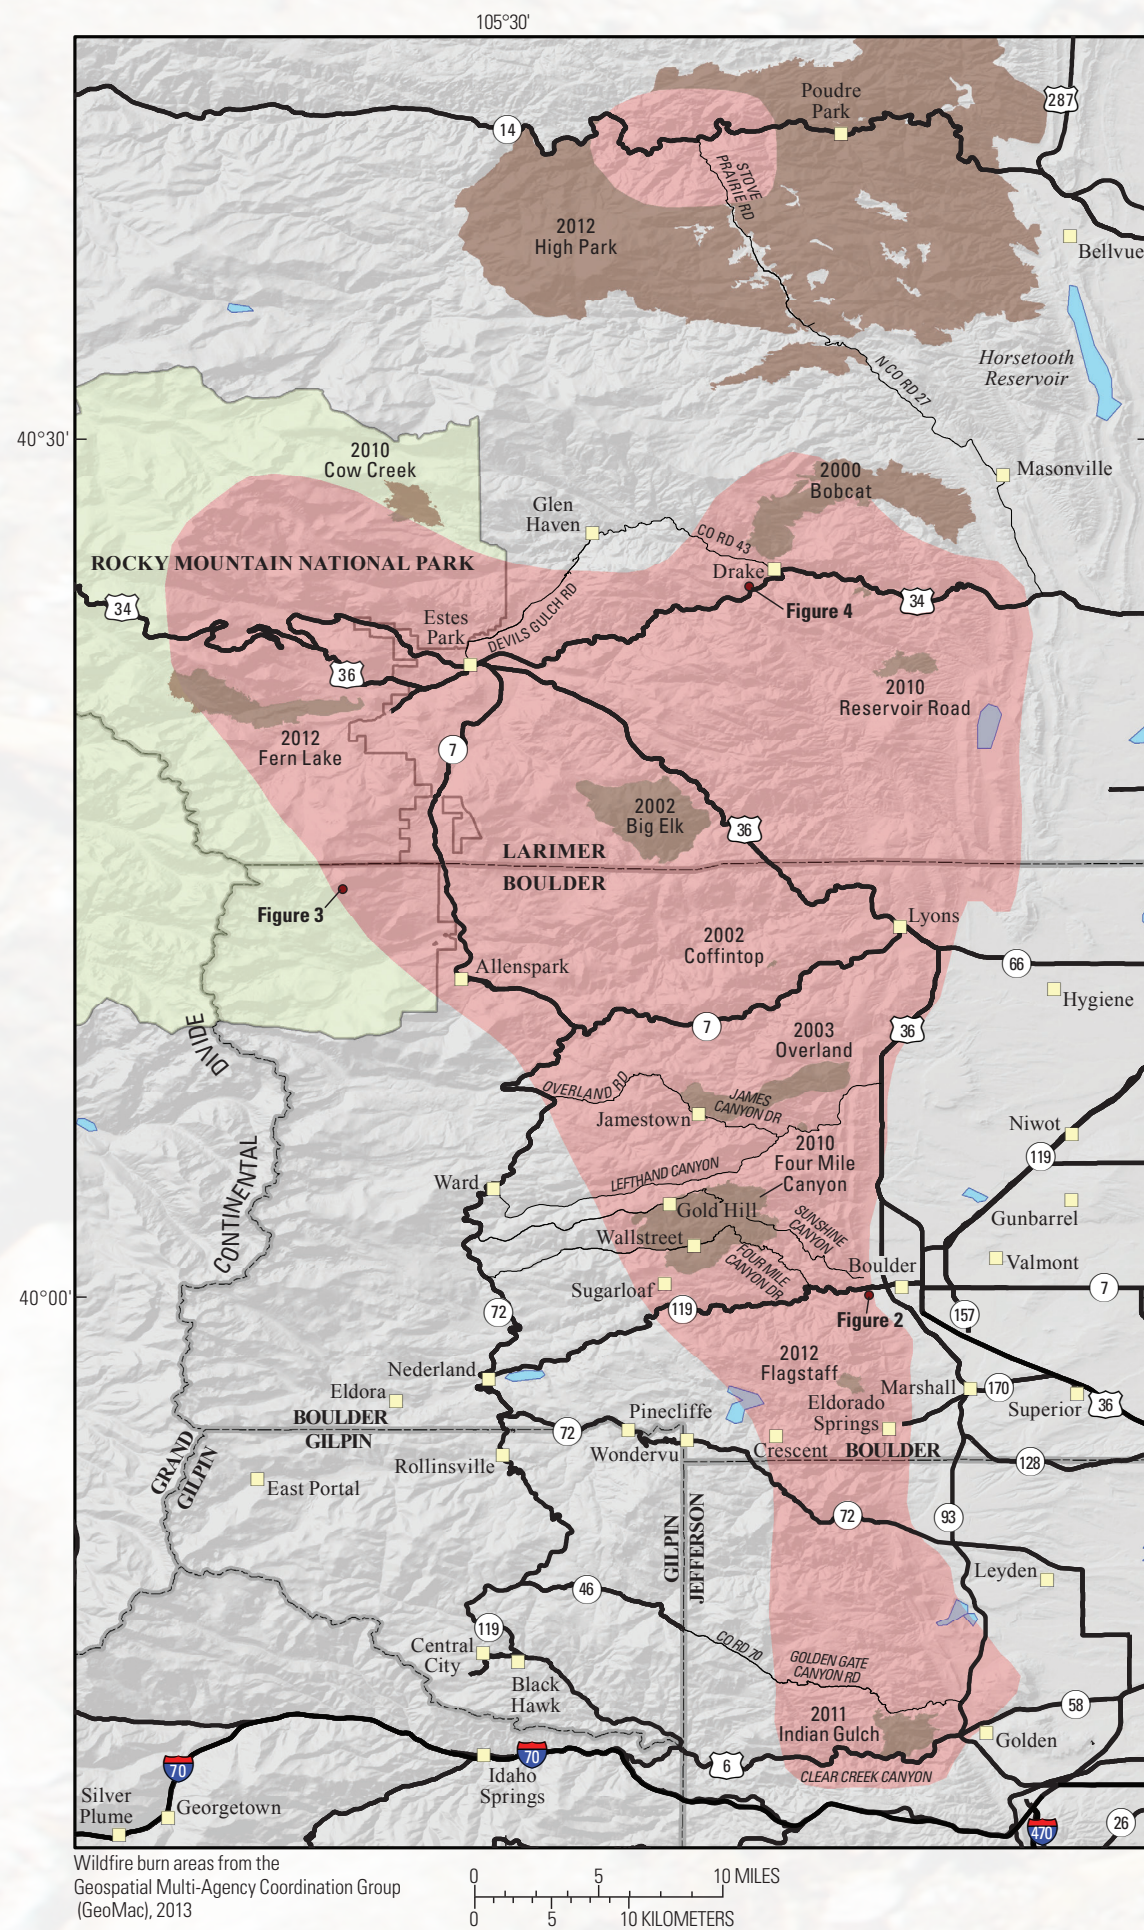
Figure 1. Extent of landslides in the northern Colorado Front Range. Areas burned by wildfires between 2000 and 2012 are shown with fire names and dates.

USGS field observations indicated that the area having the greatest density of landslides was roughly the shape of an inverted triangle with the southern apex near Golden and widening north of Boulder (fig. 1). Debris flows were the most common type of landslide observed. These debris flows occurred across a large elevation and climatic gradient extending from the high plains to the alpine environment. Debris flows occurred in soils formed on a wide range of geologic units from the Pennsylvanian through Cretaceous sedimentary sequence of folded sandstones and shales at the range front to Precambrian gneissic and granitic rocks to the west. The types of vegetation where debris flows occurred also were diverse. Some debris flows occurred above tree line and in recent burn areas having little to no vegetation (fig. 3). Other debris flows occurred on grass-covered slopes, and still others occurred on slopes covered by thick, mature conifer trees. The common link between nearly all debris flows observed was that they began as discrete sliding masses that moved downslope as a fluidized mixture of sediment and water. Thicknesses of these initial slides ranged from about 30 centimeters to more than 5 meters. Travel distances of resulting debris flows ranged from tens of meters to about five kilometers (fig. 3). In general, debris flows that entered drainages having flowing water had the longest travel distances and those that occurred on open grass-covered slopes had the shortest travel distances. Part of the reason for this difference in travel distances was that debris flows that entered drainages increased their size by eroding and incorporating additional material into the flow, whereas debris flows on open slopes were limited in size to the volume of the initial landslide.

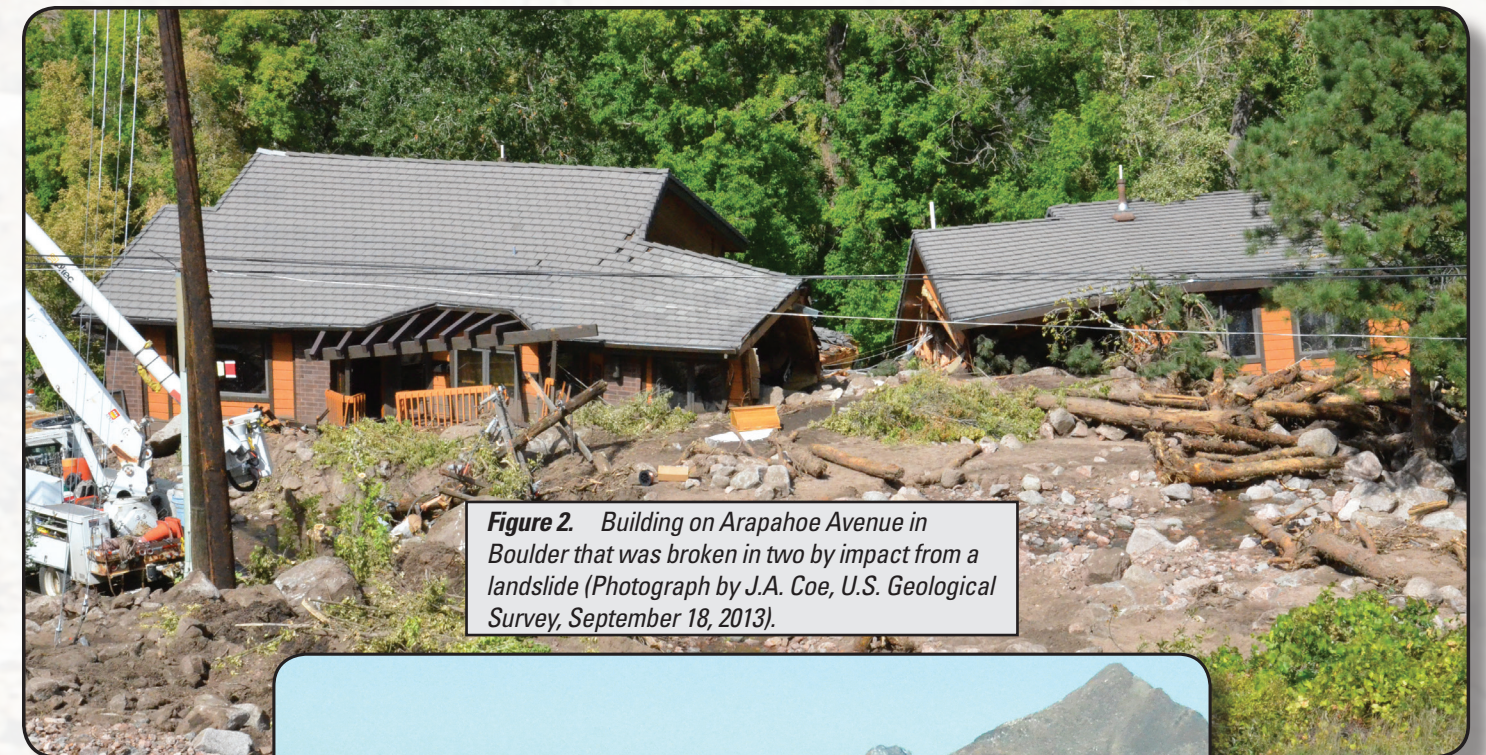
Figure 2. Building on Arapahoe Avenue in Boulder that was broken in two by impact from a landslide (Photograph by J.A. Coe, U.S. Geological Survey, September 18, 2013).

During the second week of September 2013, nearly continuous rainfall caused widespread landslides and flooding in the northern Colorado Front Range (fig. 1). The combination of landslides and flooding was responsible for eight fatalities and caused extensive damage to buildings, highways, and infrastructure (fig. 2). Three fatalities were attributed to a fast moving type of landslide called debris flow (fig. 3). One fatality occurred in Jamestown, and two occurred in the community of Pinebrook Hills immediately west of the City of Boulder. All major canyon roads in the northern Front Range were periodically closed between September 11 and 13, 2013. Some canyon closures were caused by undercutting of roads by landslides and flooding, and some were caused by debris flows and rock slides that deposited material on road surfaces (fig. 4). Most of the canyon roads, with the exceptions of U.S. Highway 6 (Clear Creek Canyon), State Highway 46/Jefferson Co. Rd. 70 (Golden Gate Canyon), and Sunshine Canyon in Boulder County, remained closed at the end of September 2013. A review of historical records in Colorado indicates that this type of event, with widespread landslides and flooding occurring over a very large region, in such a short period of time, is rare.

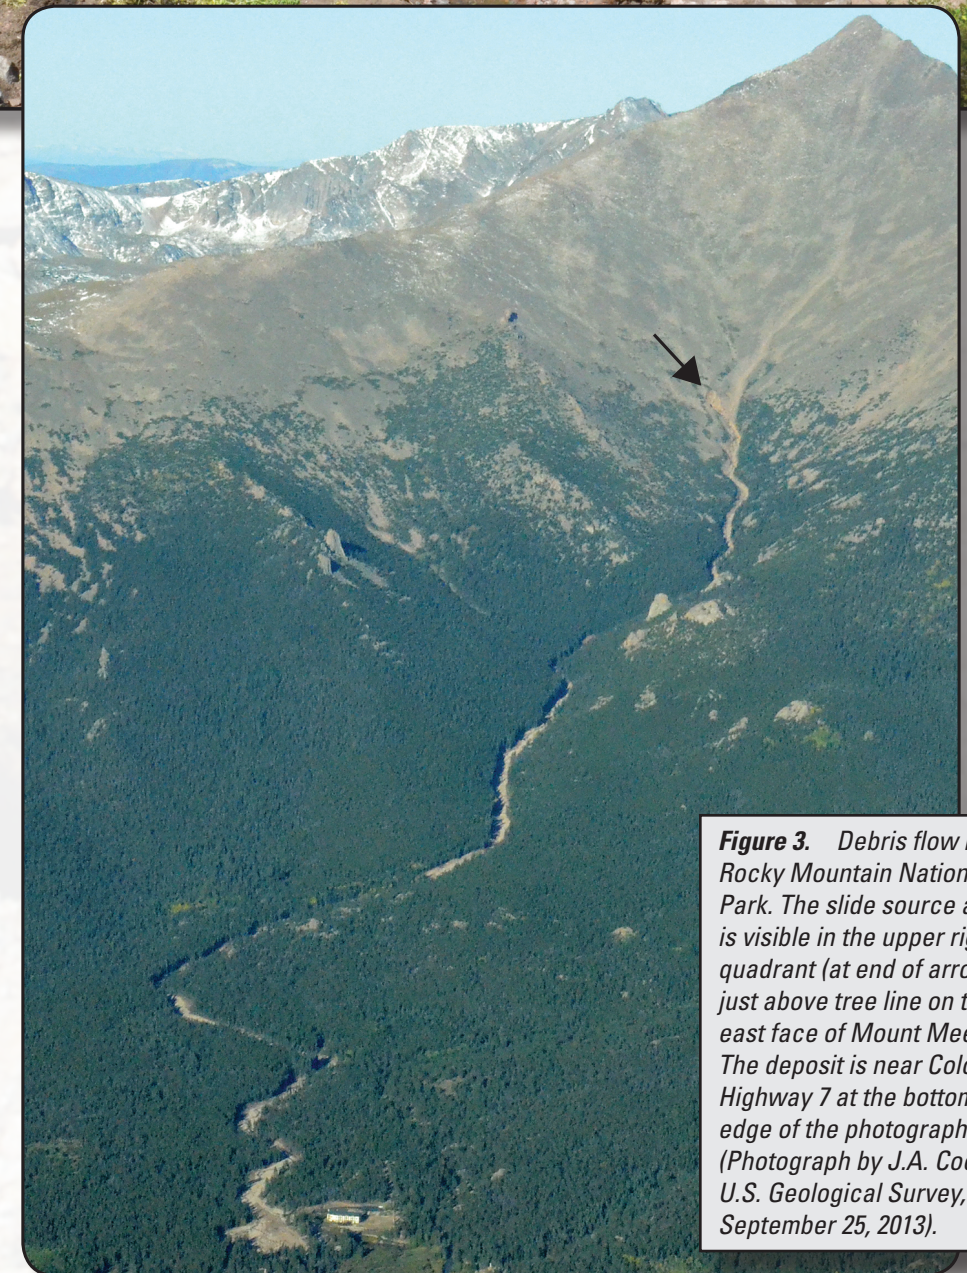
Figure 3. Debris flow in Rocky Mountain National Park. The slide source area is visible in the upper right quadrant (at end of arrow), just above tree line on the east face of Mount Meeker. The deposit is near Colorado Highway 7 at the bottom edge of the photograph (Photograph by J.A. Coe, U.S. Geological Survey, September 25, 2013).

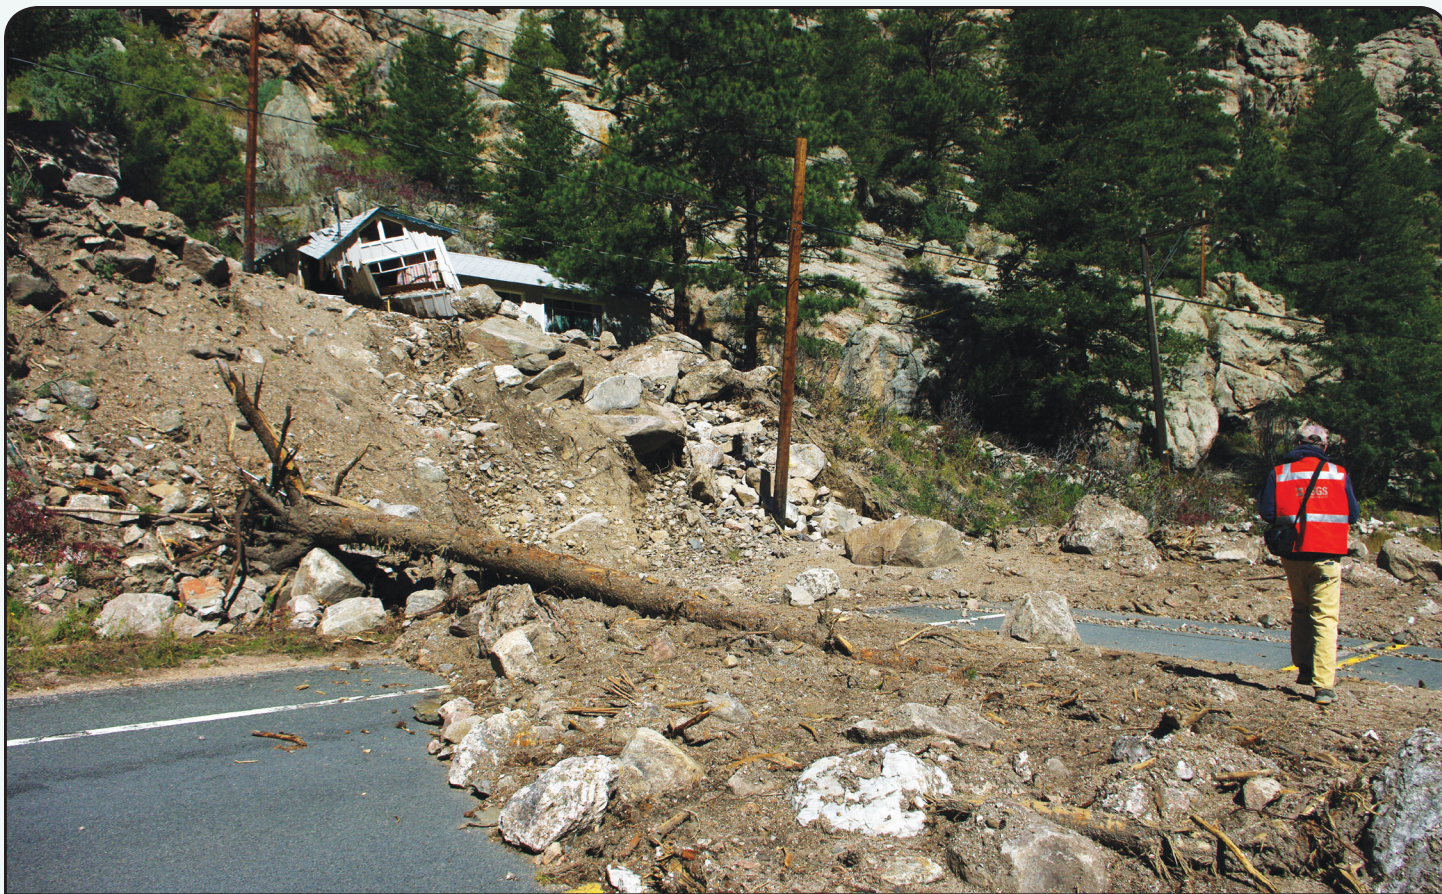
Figure 4. House damaged by debris flow in Big Thompson Canyon; deposit (foreground) covers U.S. Highway 34 (Photograph by J.W. Godt, U.S. Geological Survey, September 20, 2013).
