Science Partnership Between U.S. Geological Survey and the Lower Elwha Klallam Tribe: Understanding the Elwha River Dam Removal Project

The Elwha River Dam Removal and Ecosystem Restoration Project

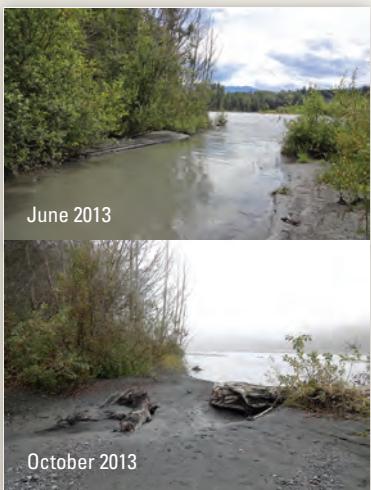
Figure 2. Water-quality samples collected from the east and west sides of the Elwha River estuary during dam removal. An increase in turbidity (bottom) and decrease in salinity (top) began when sediment load increased beginning in 2013. Images (left) and graphic from Foley and others (2015).

The Elwha River efficiently transported more than 90 percent of the eroded sediment from the reservoirs to the coastal zone (Warrick and others, 2015). Accumulation of sediment at the mouth of the river led to rapid and persistent changes to the estuary, as measured by water-quality instruments installed by USGS and Tribal scientists (fig. 2). Before dam removal, the river mouth routinely fluctuated as tidal and river flow conditions mixed fresh and salt water in the estuary. After dam removal, large sediment deposits formed, eliminating the tidal influence and turning most of the “old estuary” into freshwater-dominated habitat (Foley and others, 2015).

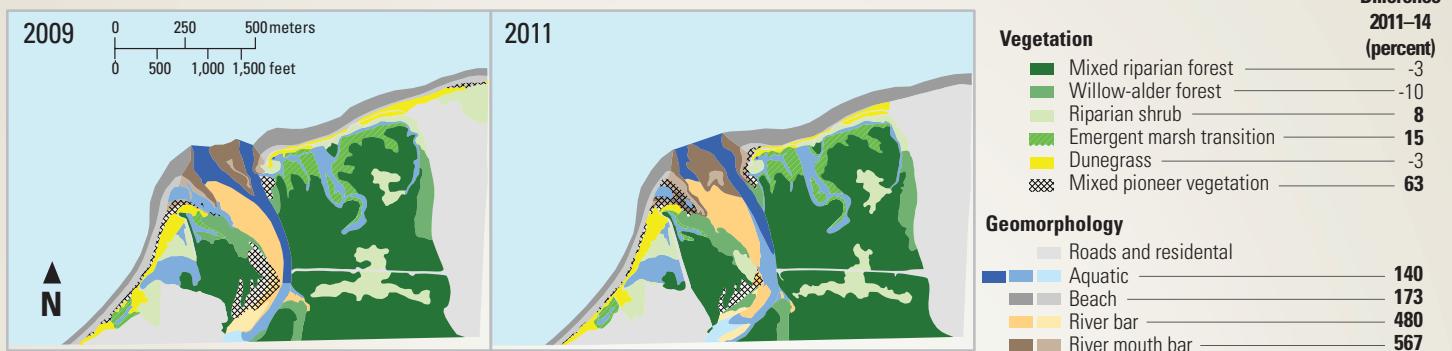
Before dam removal

Figure 3. Time series of coastal habitat change of the Elwha River estuary during dam removal. Modified from Foley and others (2017).

New habitat and landforms were created in the estuary, reversing decades of erosion and habitat loss (fig. 3). This shifting habitat mosaic, caused by the changing landforms and a new water regime, has prompted responses in estuarine plant and animal species. Although total plant species richness and relative density was stable, the amount of pioneer vegetation

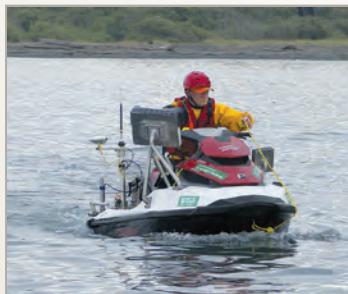
Seafloor mapping.

Figure 4. Time series of beach and seafloor mapping of the Elwha River mouth before, during, and after dam removal. For detailed methods, see Gelfenbaum and others (2015). Image courtesy of Andrew Stevens, U.S. Geological Survey.

Before the dam removal project, the beaches around the Elwha River mouth—including those fronting the Lower Elwha Klallam Tribal Reservation—had been eroding at more than 1 foot per year, a rate that was increasing with time (Warrick and others, 2009). This coastal erosion resulted in the loss of Reservation lands, including coastal wetlands. Dam removal changed this erosional trend and resulted in the creation of broad, new beaches and a new estuary complex near the river mouth (fig. 4; Gelfenbaum and others, 2015). Although the coastal waters remained turbid, or cloudy with sediment, during the dam removal project, this condition has improved considerably in the years following dam removal.
