UNDERSTANDING EARTHQUAKE HAZARDS IN THE SAN FRANCISCO BAY REGION

Santa Rosa's Past and Future Earthquakes

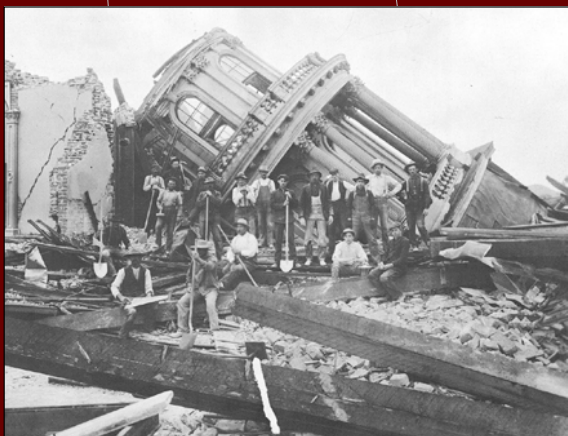
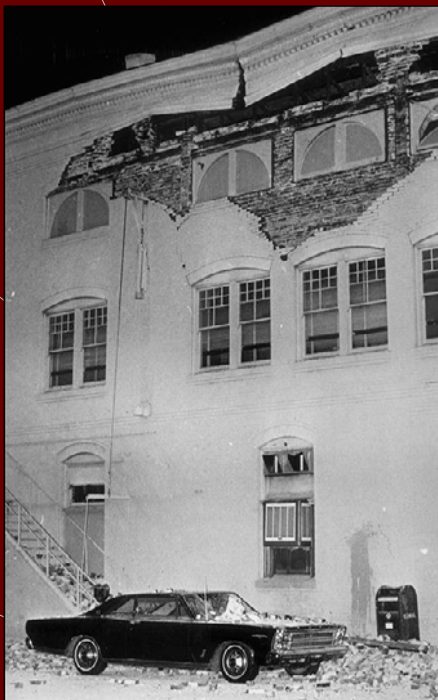
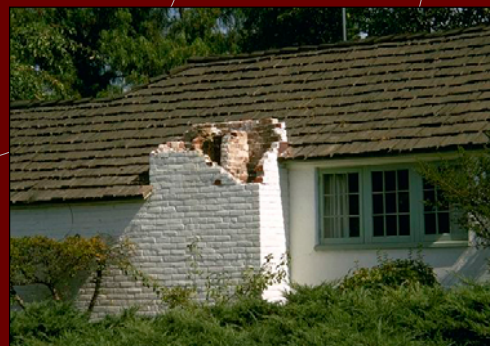
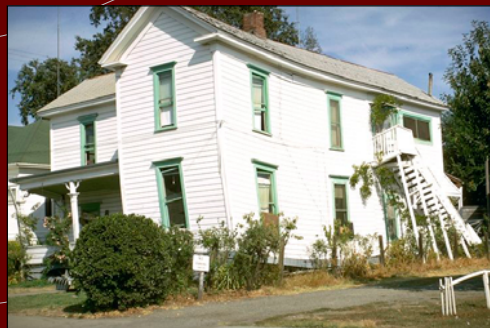
Photos of earthquake damage in Santa Rosa from the 1906 and 1969 earthquakes. Clockwise from upper left: collapsed Sonoma County Courthouse, 1906; partial collapse of brick facade onto car below in Old Courthouse Square, 1969; toppled brick chimney, 1969; and a two-story wood-frame house shaken off its foundation, 1969. Photos courtesy of NISEE-PEER, University of California Berkeley; photos of 1969 damage are from the Karl V. Steinbrugge collection.

repair, although none collapsed. Total damage, including to building contents, exceeded \$7 million (\$50 million in 2019 dollars). The shaking toppled brick chimneys and broke windows over a wide area and locally ruptured water mains and buckled sidewalks and curbs. Fortunately, no one died in the earthquakes, owing in part to the late hour and quiet downtown nightlife.

Santa Rosa had fared far worse six decades earlier in the magnitude 7.9 San Francisco earthquake of 1906, which destroyed much of downtown Santa Rosa and killed at least 85 people in a town of approximately 7,000. Even though the earthquake was on the San Andreas Fault 20 miles away, Santa Rosa suffered more damage in proportion to its size than any other city except San Francisco.

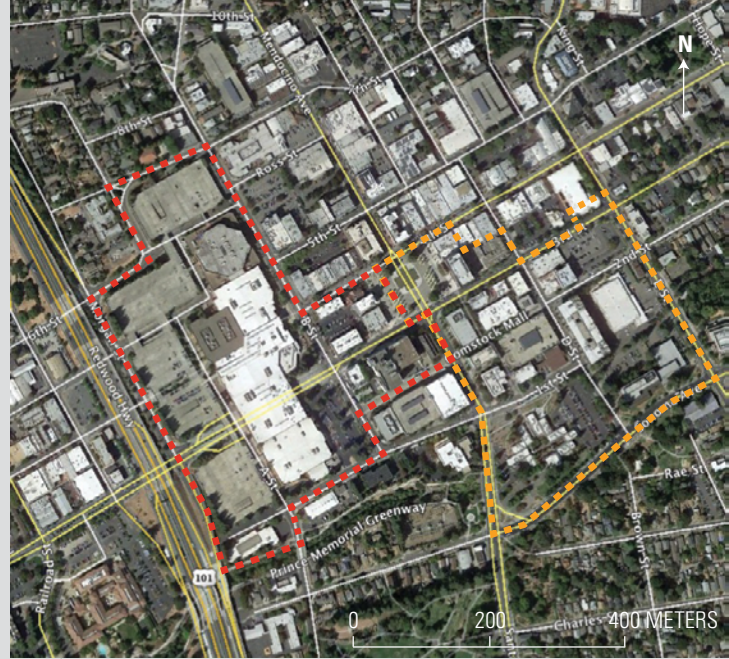
Google Earth satellite image of downtown Santa Rosa (dated October 19, 2018) showing approximate boundaries of the urban renewal project. Area outlined in orange was included in the original project, which began in 1961; area outlined in red was added following the 1969 earthquakes. The shopping center (large white-roofed complex within the red line) was the cornerstone of the project's second phase.

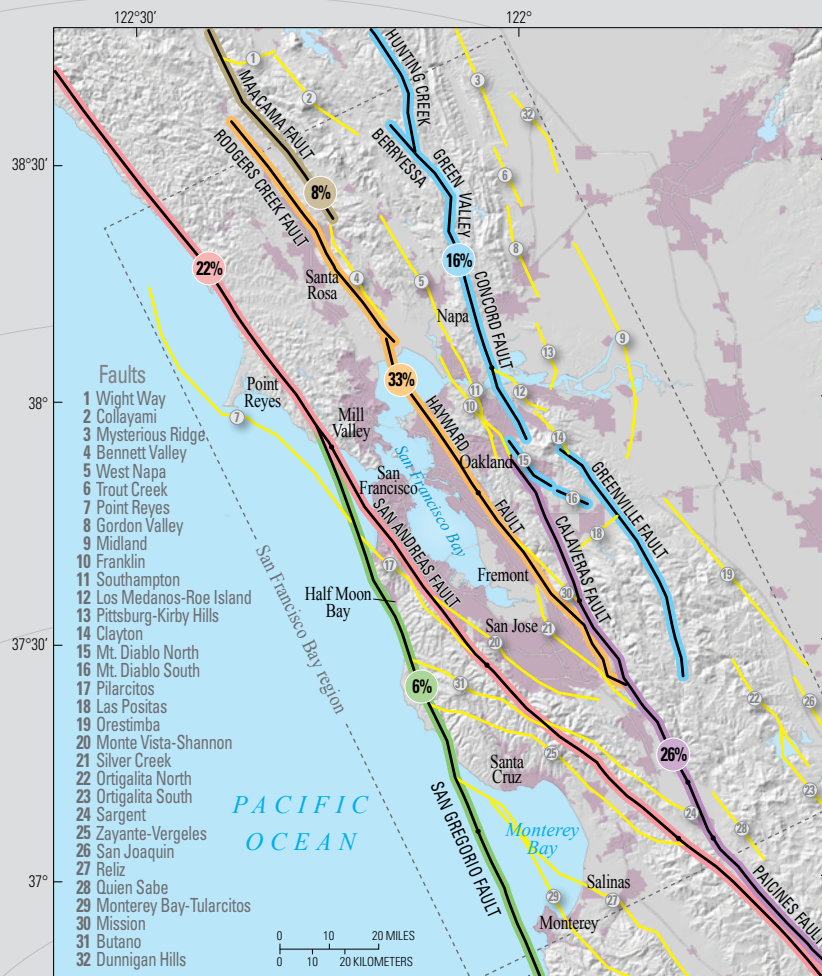
Map showing probability of a magnitude 6.7 or greater earthquake between 2014 and 2043 on major active faults in the San Francisco Bay region. Lesser-known faults are shown in yellow.

Regardless of the potential for simultaneous rupture of both faults, the latest 30-year rupture forecast for the San Francisco Bay region gives a 33 percent probability of one or more large earthquakes (magnitude 6.7 or greater) occurring somewhere on the Rodgers Creek or Hayward Faults by the year 2043.
