National Historical Park, Arizona A t Tumacácori National Historical Park A t Tumacácori National Historical Park A t Tumacácori National Historical Park

A t Tumacácori National Historical Park in southern Arizona, resource managers are concerned about microbial pathogens in the Santa Cruz River that could pose a serious health risk to employees and visitors. The U.S. Geological Survey recently completed a comprehensive 3-year study of water quality in the Santa Cruz River watershed that investigated the possible sources of microbial contamination and how it relates to the amount of water and suspended sediment in the river. The results of this study help water managers and park administration better address this contamination and issue warnings to the public when the water is unsafe.

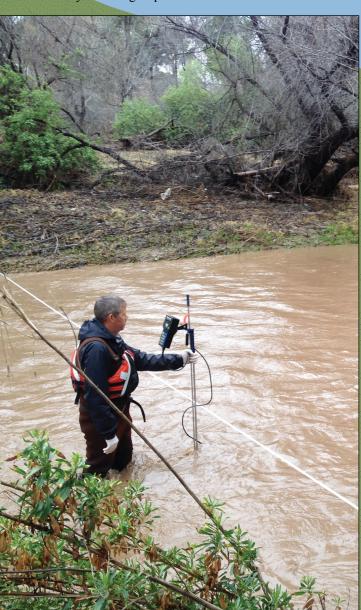
A U.S. Geological Survey scientist measures streamflow during flooding in the Santa Cruz River in Tumacácori National Historical Park. USGS photograph from January 30, 2015.
