Prepared in cooperation with the National Park Service, Utah State University, Sul Ross State University, World Wildlife Fund, Alpine Test Services, Rio Grande Scientific Support Services, and RiversEdge West

# A River of Change—The Rio Grande in the Big Bend Region

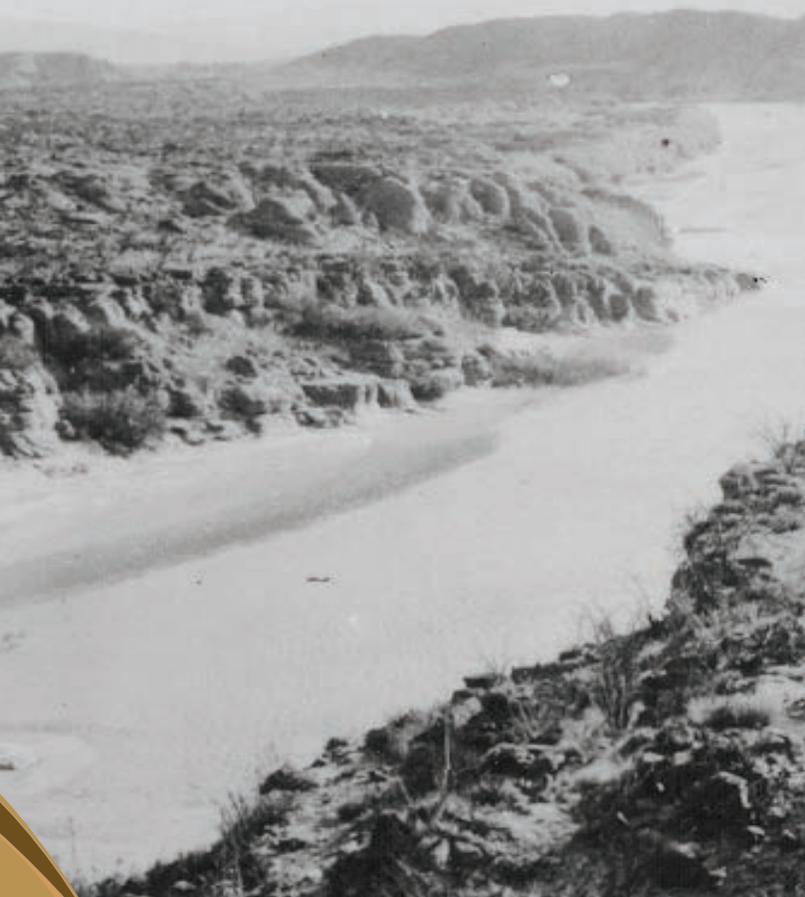
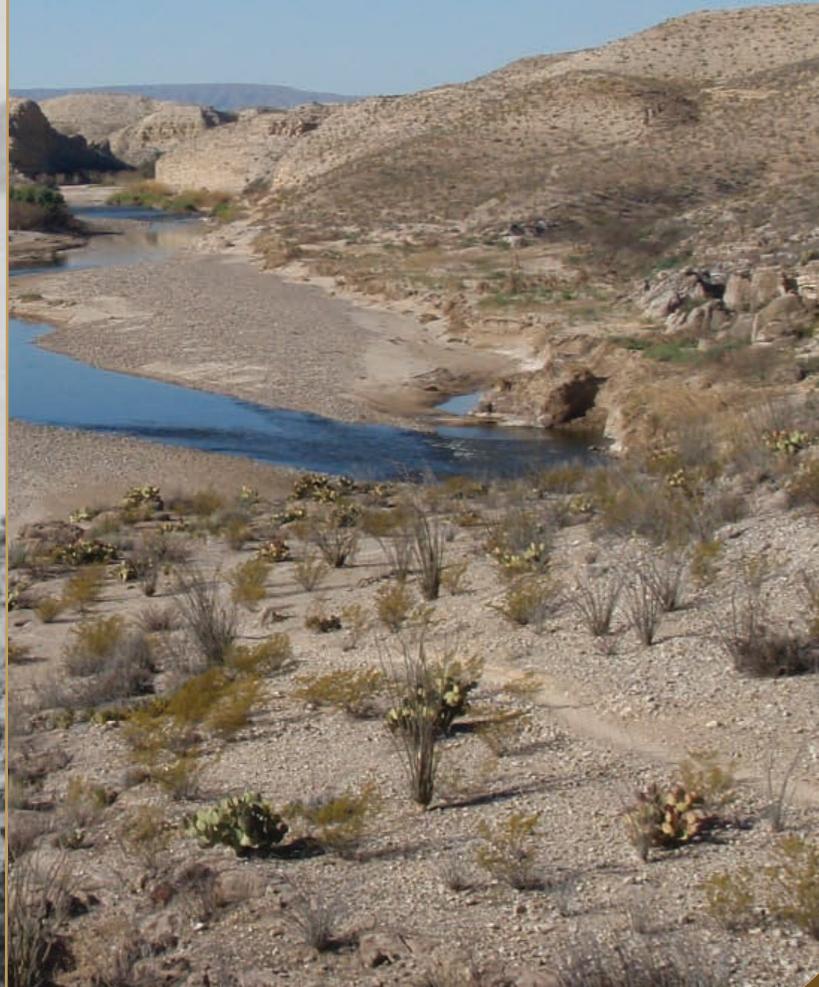
The Rio Grande in Hot Springs Canyon, Texas, Big Bend National Park. Left side image taken in 1901 by H.C. Oberholser, right side image taken in 2008 by David J. Dean, U.S. Geological Survey.

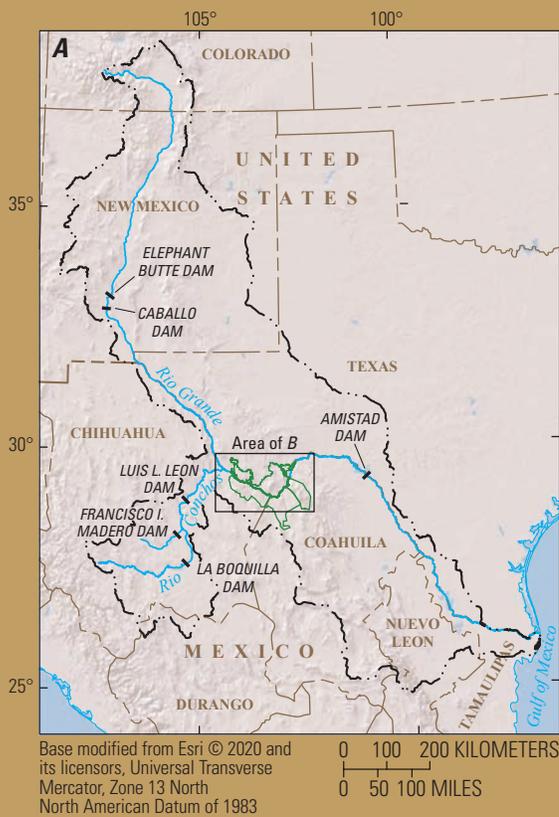
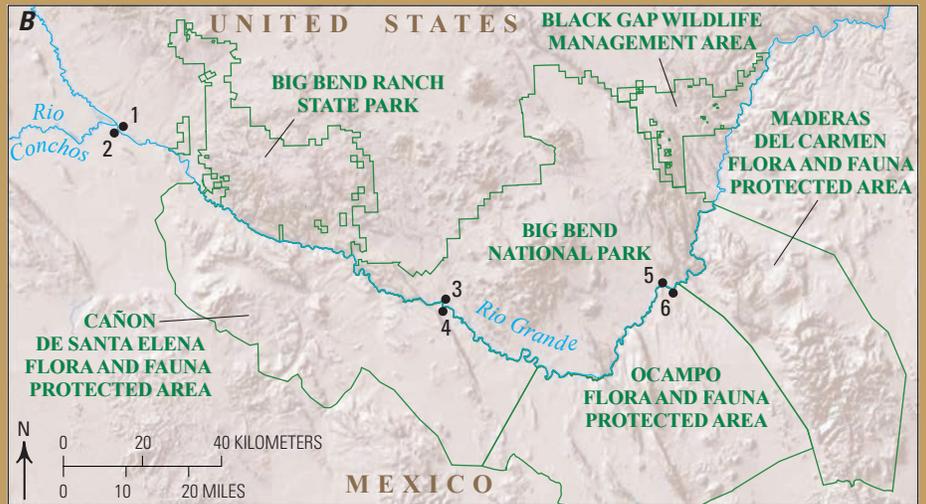
Regional map of the Rio Grande Basin (A) and map of the Big Bend Region (B). In A, the Rio Grande basin is shown by the dash-dot black line. In B, places numbered 1–6 refer to (1) Presidio, Texas; (2) Ojinaga, Chihuahua; (3) Castolon, Texas; (4) Santa Elena, Chihuahua; (5) Rio Grande Village, Texas; and (6) Boquillas, Coahuila.

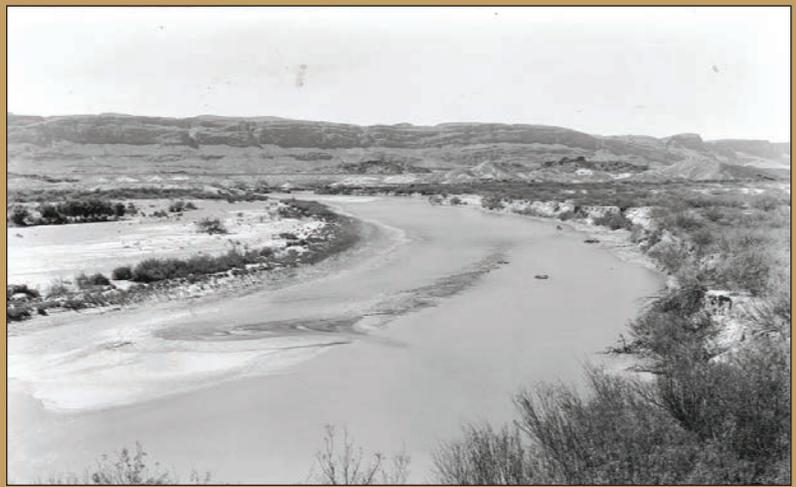
Photograph of the Rio Grande, looking upstream, approximately 20 kilometers downstream from Castolon, Texas, and Santa Elena, Chihuahua. Photograph by George Grant, National Park Service, 1936.

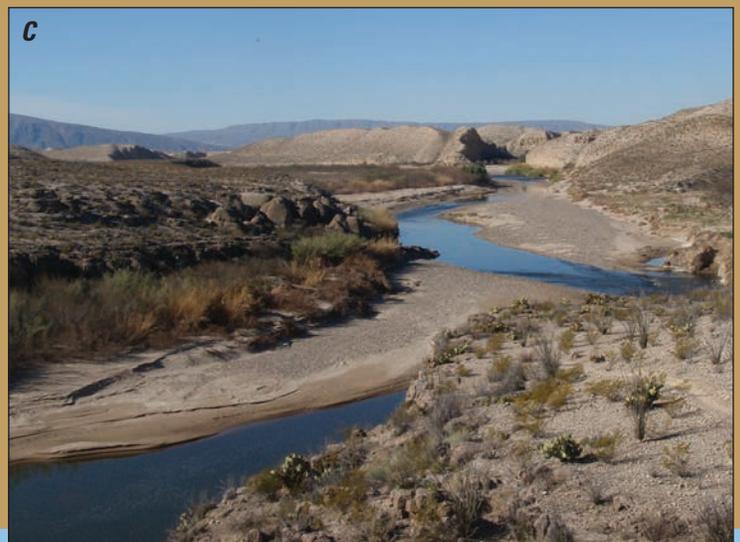
Photographs of the Rio Grande taken from the same location in Hot Springs Canyon, Texas, in Big Bend National Park. Photograph A was taken in 1901 by H.C. Oberholser. Photographs B and C were taken before and after the 2008 channel-reset flood, respectively. Note the much narrower width of the channel between A and B, the stands of nonnative vegetation (saltcedar and giant cane) in B, and the extensive widening caused by the 2008 channel reset flood in C. Photographs B and C by David J. Dean, U.S. Geological Survey.

Occasional large floods, called channel-reset floods, can cause widespread erosion, thereby temporarily reversing the narrowing that occurs during years with small floods. Channel-reset floods are usually driven by large amounts of rainfall caused by tropical storms and hurricanes in the Rio Conchos Basin. These rainfall events can fill upstream reservoirs, requiring large dam releases that cause flooding downstream. A channel-reset flood in 2008 resulted in 26–52 percent channel enlargement in the wide valleys of the Rio Grande; however, rapid channel narrowing resumed shortly thereafter. In the early 1900s, floods of similar magnitude to channel-reset floods occurred approximately once every four years, which maintained a much wider channel during that period. Today, floods of this magnitude occur once every decade or two.

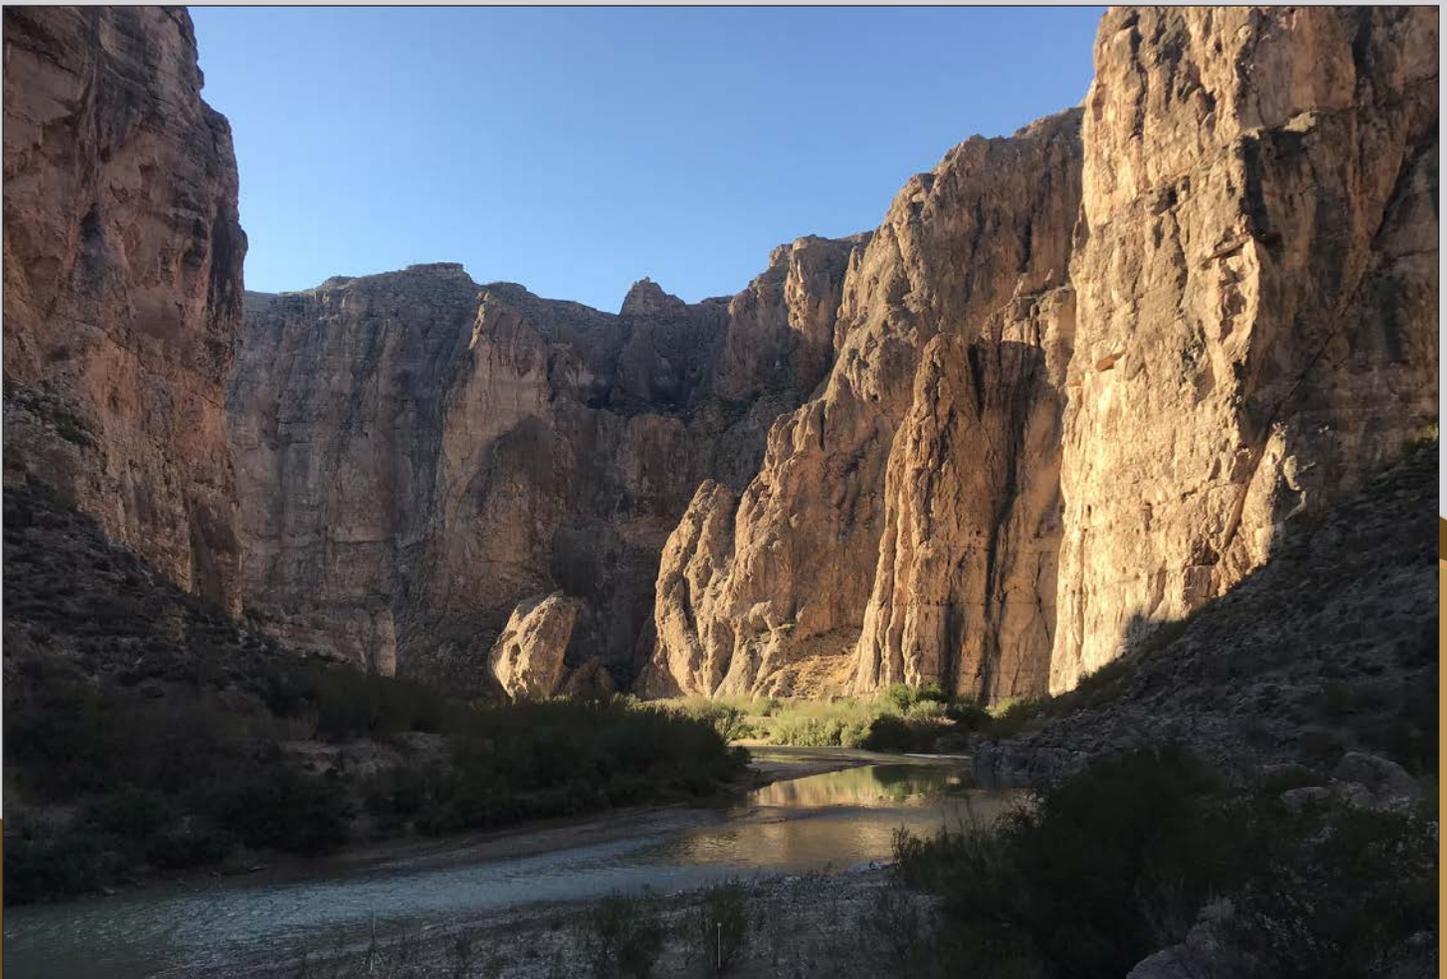
Upstream view of the Rio Grande within Boquillas Canyon, taken by David J. Dean, U.S. Geological Survey.
