Occurrence and Transport of Aerially Applied Herbicides to Control Invasive Buffelgrass in Rincon Mountain District, Saguaro National Park, Arizona

Introduction

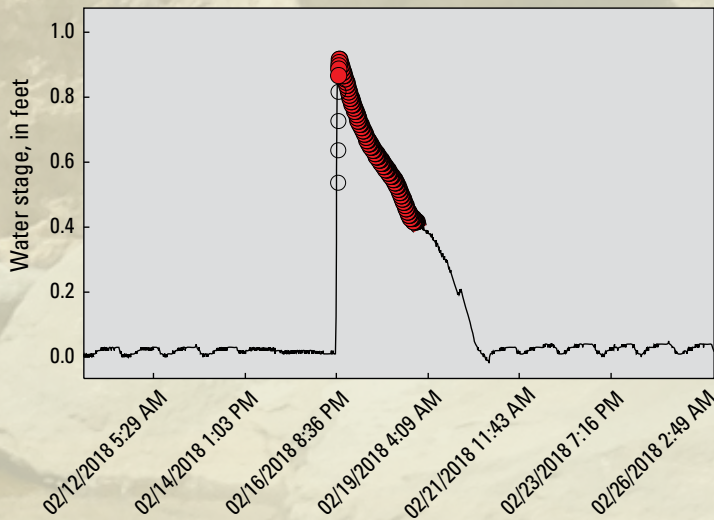
Water stage hydrographs for the Madrona Canyon (top) and Box Canyon (composite sample; middle left) watersheds showing the timing of detections and graph (right) showing half-lives of glyphosate and aminomethylphosphonic acid at about 75 and 125 days, respectively.

although these compounds are persistent, they dissipate over time, such as through microbial degradation. Two Box Canyon areas that received consistent yearly treatments were sampled multiple times during the study. The concentration information yielded estimates of the time it takes for half of the concentration of glyphosate and AMPA to disappear. These estimates were about 75 and 125 days for glyphosate and AMPA, respectively. Findings from the soil sampling suggested the areal extent and amount of herbicide sprayed was proportional to the likelihood of detecting one or both compounds downstream, especially after a stormwater runoff event.

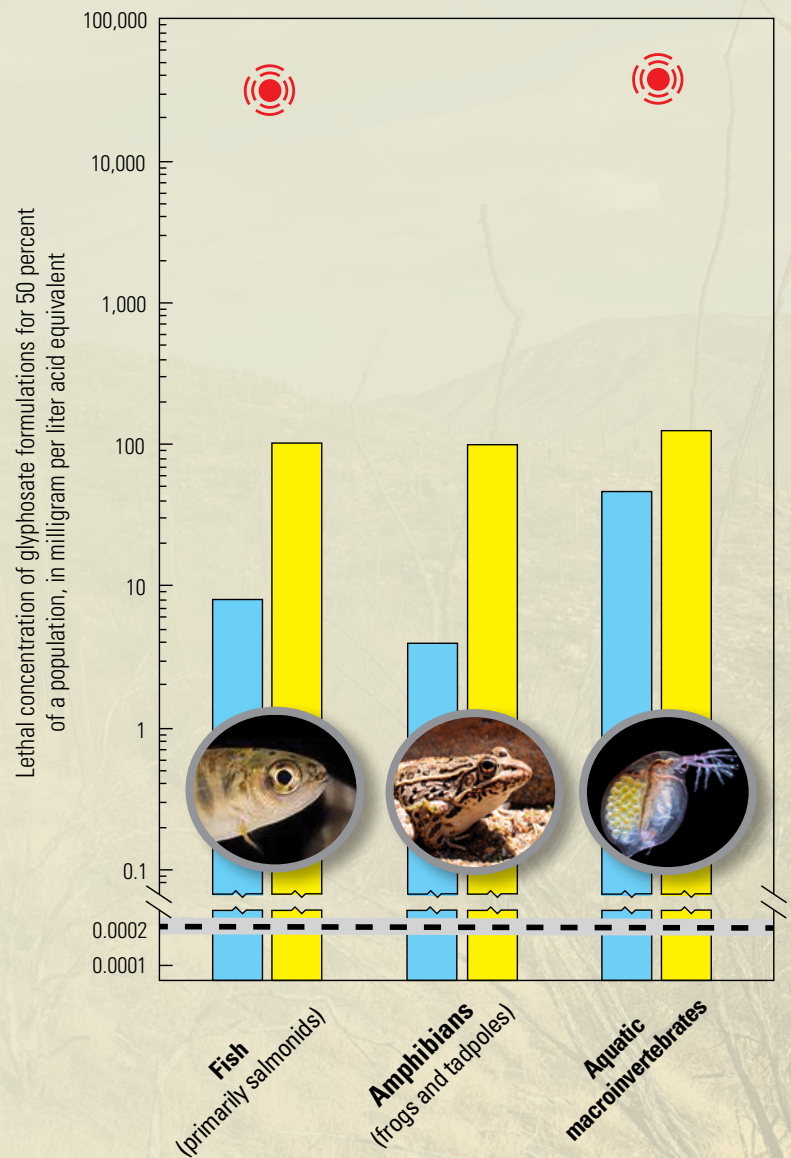
Comparison of lethal concentrations of glyphosate with and without surfactants and additives for three general groups of aquatic organisms. Formulation values detailed in Durkin (2011). Photograph of Salmonid from <https://home.nps.gov>. Photograph of Daphnia from [shutterstock.com](https://www.shutterstock.com).

level is 700 $\mu\text{g/L}$ for glyphosate) or aquatic-life benchmarks (chronic levels of glyphosate for fish and invertebrates are 25,700 and 49,900 $\mu\text{g/L}$, respectively) established for surface water and freshwater organisms. The highest concentration recorded in this study was 0.2 $\mu\text{g/L}$, and about 90 percent of the water samples collected were below the analytical detection limit of 0.02 $\mu\text{g/L}$. Little is known however about the ecological effects of low-level concentrations, inconsistent exposure to glyphosate and AMPA, or multiple sources (water and sediment) of exposure within a semiarid aquatic ecosystem.
