Flood Damage Costs Beyond Buildings—A Lake Champlain Case Study

Lake Champlain Case Study Context and Approach

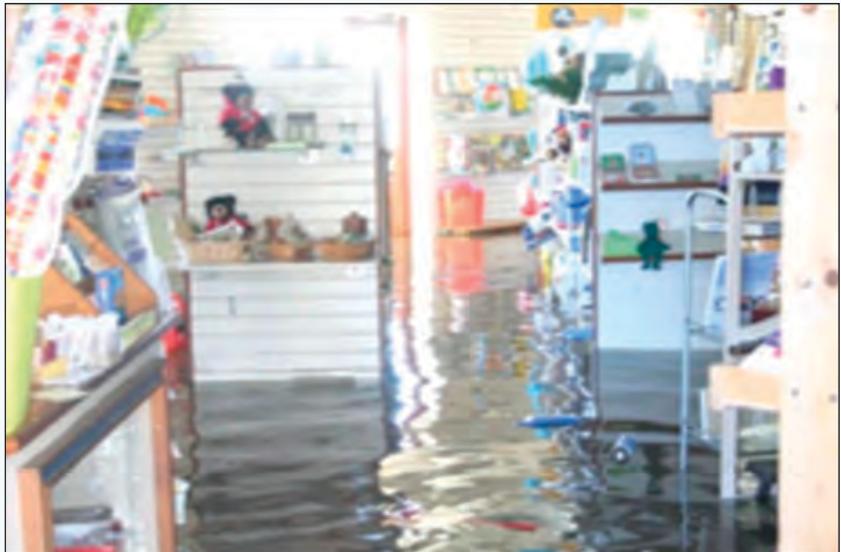
A Lake Champlain marina store flooded in 2011. Photograph used with permission.

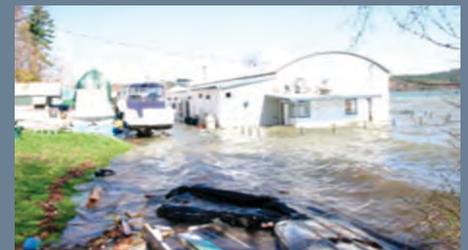
A Lake Champlain marina flooded in 2011. Photograph used with permission.

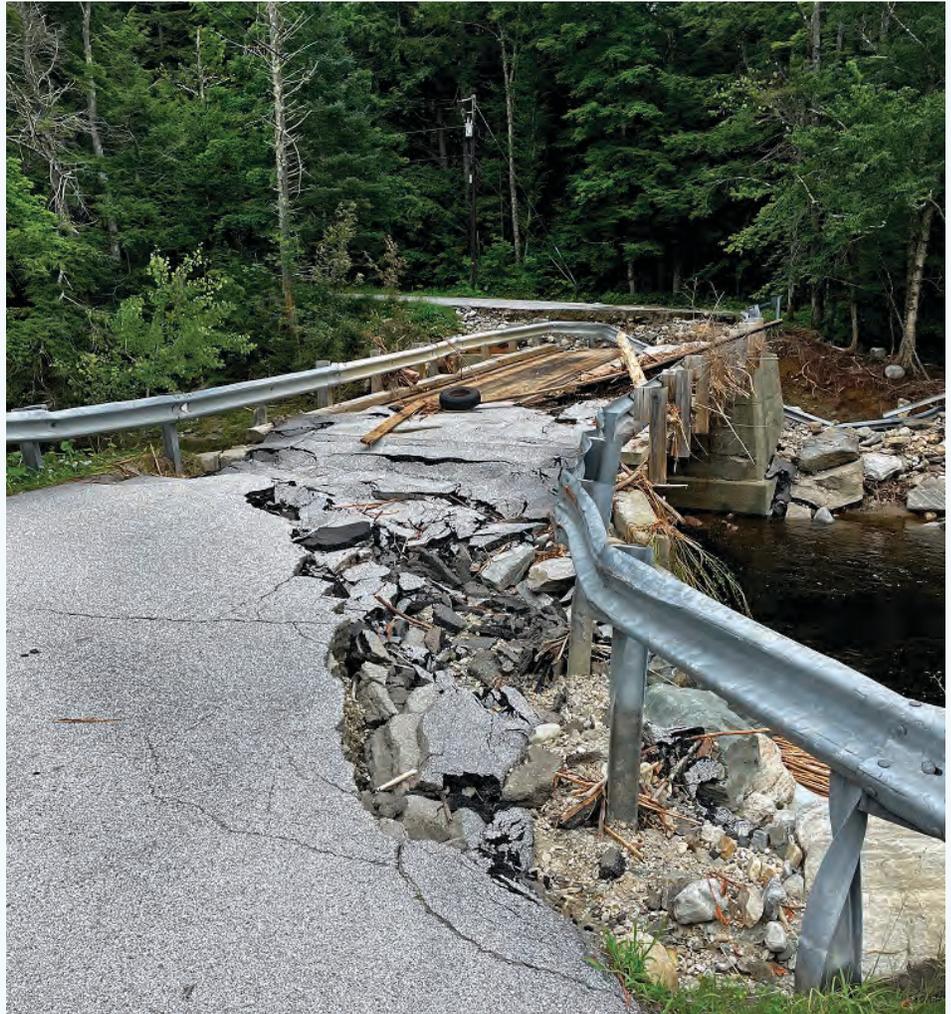
Right: Flood damage to the Cobble Ridge Road Bridge after a heavy rainfall event in Londonderry, Vermont. Photograph by the U.S. Geological Survey.

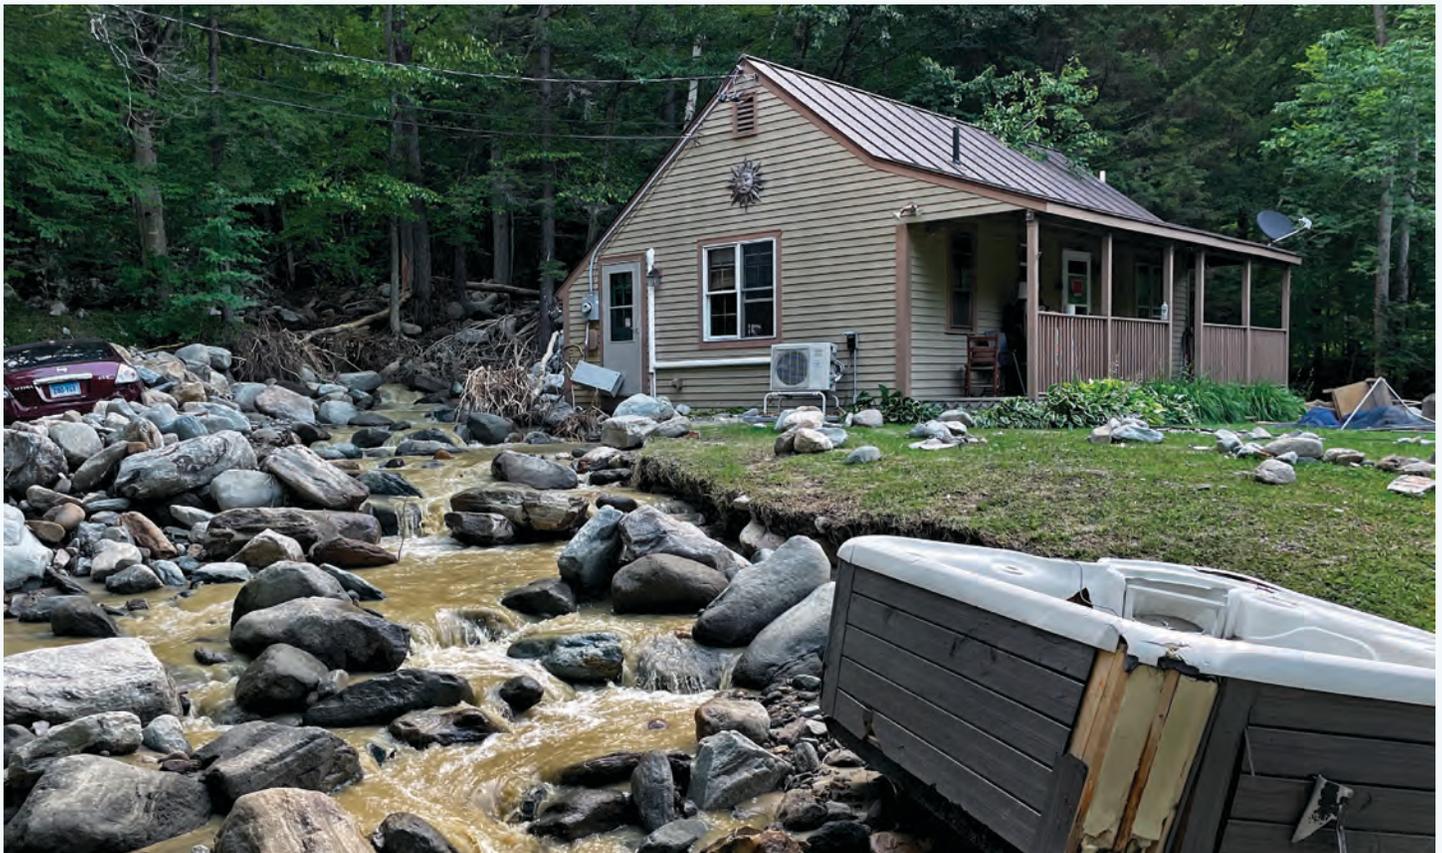
Below: Heavy flooding in Plymouth, Vermont, caused by a two-day rainstorm in July 2023, transported boulders down a hillside to cover a resident's car and move their hot tub. Photograph by the U.S. Geological Survey.
