# Puerto Rico

## Hurricane Georges

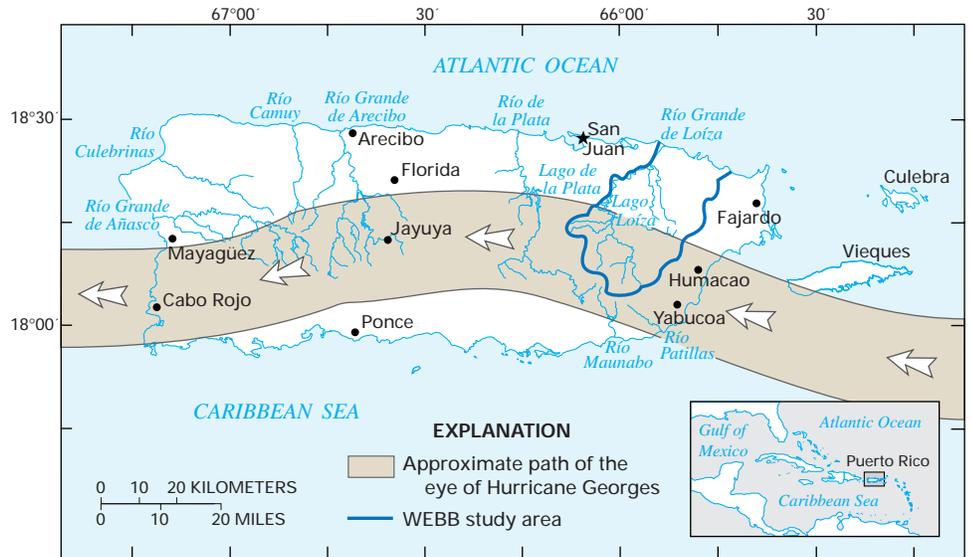
Figure 1. Path of Hurricane Georges in relation to Puerto Rico and USGS study sites.

At 7 p.m. on Monday, Sept. 21, 1998, the eye of Hurricane Georges made landfall near Yabucoa and Humacao on the east coast of Puerto Rico (fig. 1). Hurricane Georges traversed the island from east to west, lashing furiously at urban and rural areas indiscriminately with estimated sustained winds of 115 miles per hour and gusts of 150 miles per hour. The storm had a minimum central pressure of 957 millibars and was classified as a Category 3 Hurricane on the Saffir-Simpson Scale. By 1 a.m. the next day, Hurricane Georges had left the island severely damaged and flooded. Hurricane Georges produced heavy rains over Puerto Rico, especially in the central interior mountains. The U.S. Geological Survey (USGS) rain gage network reported totals that ranged from less than 4 inches to about 26 inches near the center of the island (fig. 2).

The USGS Water, Energy, and Biogeochemical Budget Program (WEBB) began in 1991 at five locations in the United States, including one in Puerto Rico (fig. 1). The Puerto Rico research site consists of the U.S. Forest Service-administered Luquillo Experimental Forest and the Río Grande de Loíza drainage basin, an agriculturally developed watershed. This combined region serves as a terrestrial laboratory for the study of issues related to the global loss of tropical forest and the associated changes in land-use practices. The research focuses on geomorphic and biogeochemical processes that control the movement and transformation of water, energy, bedrock weathering products, and nutrients. The study examines erosion processes, soil development, nutrient cycling, and hillslope and fluvial transport of sediment and dissolved chemicals. One important finding to date is that intense agricultural practices of the 19th and early 20th century have resulted in high sus-

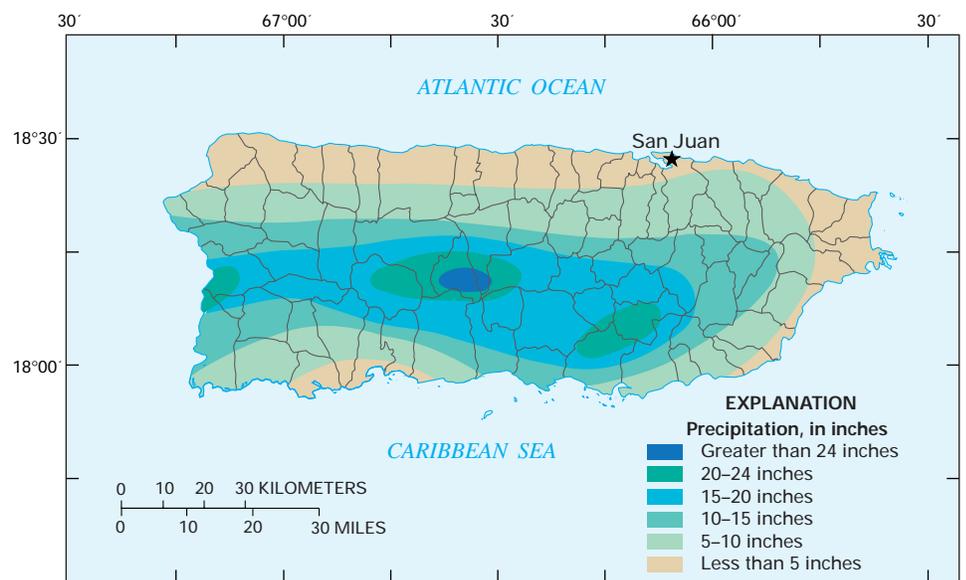
Figure 2. Precipitation totals from Hurricane Georges.

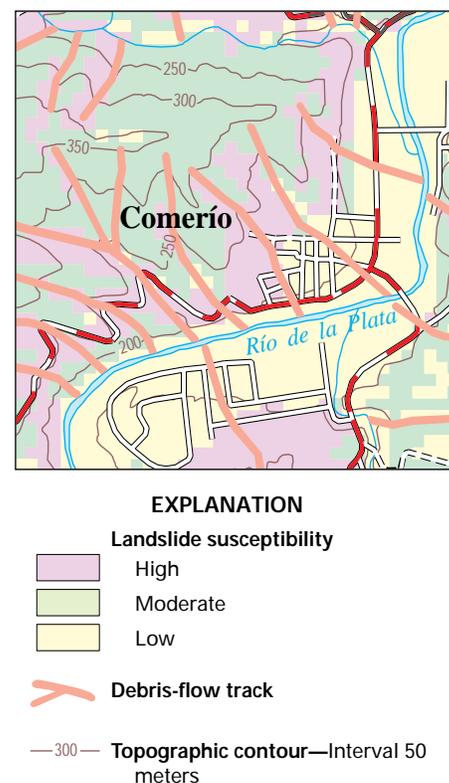
Figure 4. Excerpt from map showing susceptibility to landslides in the municipality of Comerío, Puerto Rico.

of landslides in the mountainous areas of the island where hillslopes are steep and mean annual rainfall is high. Each year, landslides cause extensive damage to property, and they occasionally result in loss of life. Population density in Puerto Rico is high, and it is increasing. This increase is accompanied by the use of less desirable construction sites, and, as a result, human populations are becoming more vulnerable to landslide hazards. To address this problem, a map showing landslide susceptibility in Comerío was published in 1998 (fig. 4). The map was compiled using a methodology developed by the USGS in an earlier study in the mountains of eastern Puerto Rico; the method uses topographic, geologic, and land-use information to categorize all hillslopes into zones of low, moderate, or high landslide susceptibility.

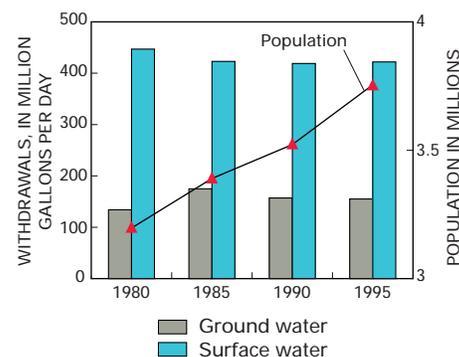
Figure 7. Population and water-use trends in Puerto Rico.

The population of Puerto Rico has increased 15 percent from 1980 to 1995 (fig. 7); however, the total freshwater per capita withdrawals decreased. Total freshwater per capita withdrawals in 1995 were 154 gallons per day per person compared to 176 gallons per day per person in 1985—

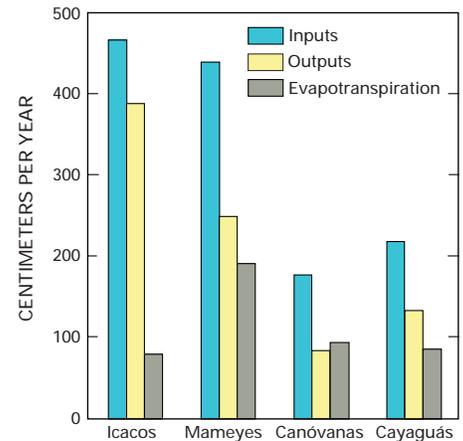
Figure 8. Average water budgets of four watersheds in eastern Puerto Rico, water years 1991 to 1997. Inputs include rainfall, cloud drip, and infiltration from septic tanks. Outputs include runoff, ground-water flow, and extraction for public consumption. Evapotranspiration is estimated as the difference between inputs and outputs.
