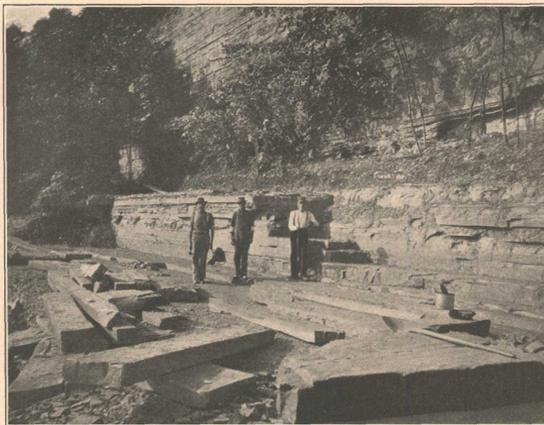
FIGURE 15.—FLAGSTONES IN THE PORTAGE FORMATION; QUARRY SOUTH OF WATKINS.  
The quarried blocks are delimited by joint planes.

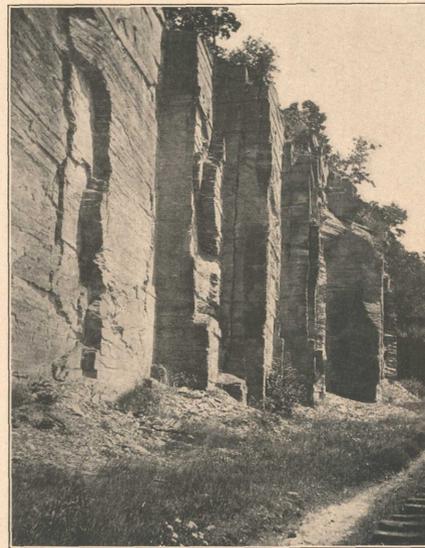
FIGURE 16.—JOINT STRUCTURE IN SHERBURNE FLAGSTONE MEMBER OF THE PORTAGE FORMATION EAST SHORE OF LAKE CAYUGA.

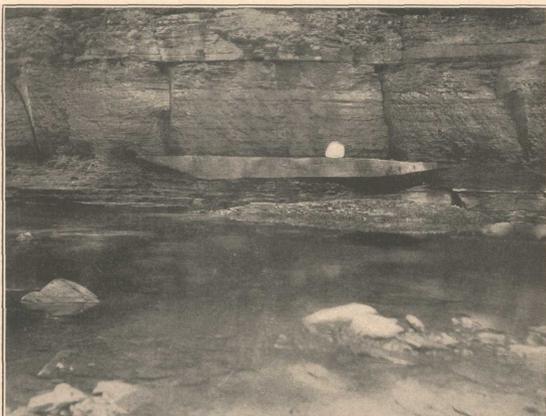
FIGURE 18.—SANDSTONE LENS IN ITHACA SHALE MEMBER, NEAR MESSENGERSVILLE.

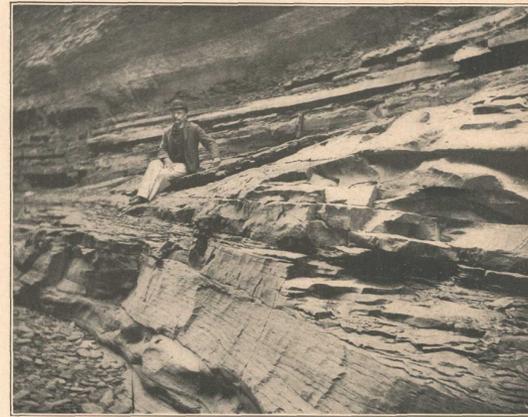
FIGURE 19.—SUBMARINE UNCONFORMITY IN SHERBURNE FLAGSTONE MEMBER, CATHEDRAL HALL, WATKINS GLEN.

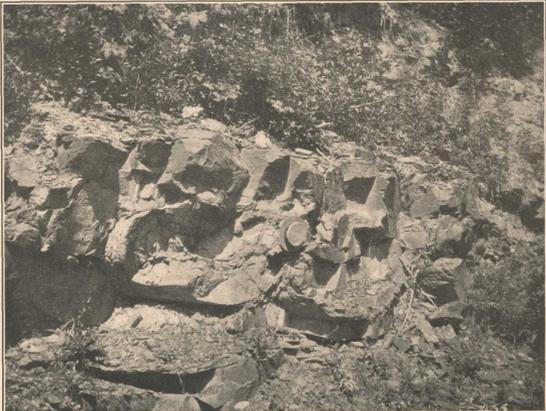
FIGURE 21.—LARGE CONCRETIONS WITH FOSSIL BAND ON PERIPHERY, IN CHEMUNG FORMATION, ROSSTOWN.

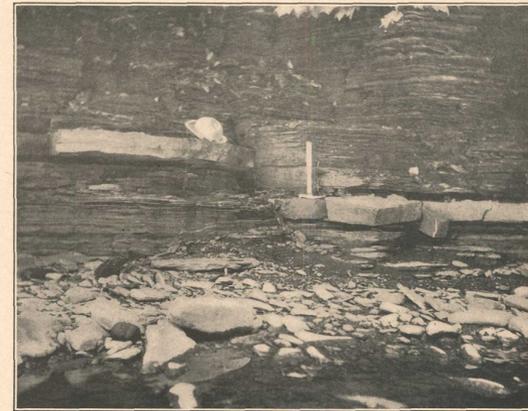
FIGURE 22.—SMALL FAULT OFFSETTING SANDSTONE BED IN ENFIELD SHALE MEMBER, GLEN CREEK.

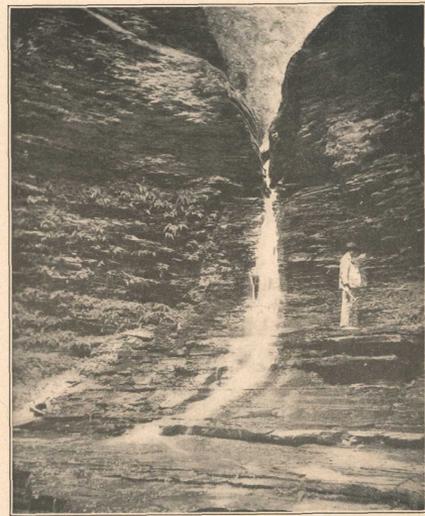
FIGURE 26.—MOUTH OF EXCELSIOR GLEN, SHOWING V-SHAPED CHANNEL IN ITHACA SHALE MEMBER.

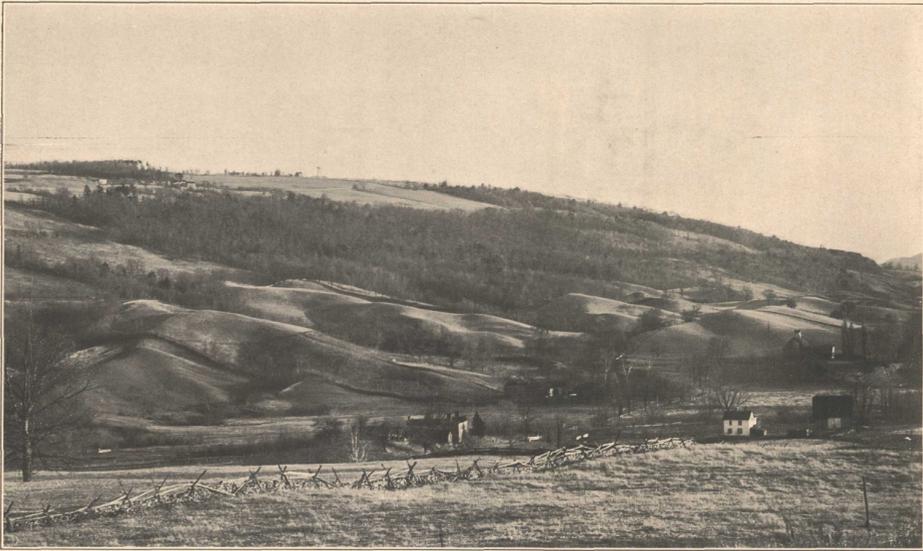
FIGURE 27.—MORaine ON EAST SIDE OF CAYUGA INLET VALLEY, JUST SOUTH OF THE MOUTH OF BUTTERNUT CREEK.  
Shows characteristic hummocky surface of morainal deposits.

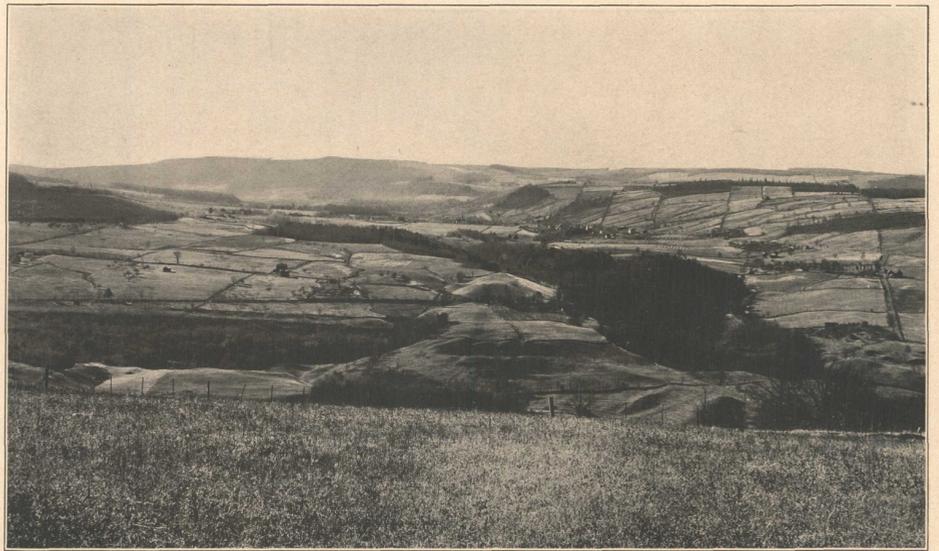
FIGURE 28.—VIEW UP WEST BRANCH FROM THE TOP OF THE STEEP SLOPE OF CAYUGA INLET VALLEY EAST OF NINA, 1400 FEET ELEVATION.  
Shows the plateau upland in the background, in which is sunk the flat-bottomed hanging valley of West Branch, and the morainal topography on the west side of the deeper Cayuga Inlet valley.

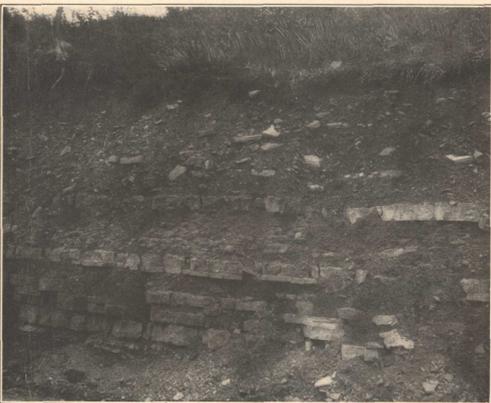
FIGURE 29.—DISINTEGRATED SANDSTONE AND SHALE NOT REMOVED BY THE GLACIERS, 1 MILE EAST OF BERKSHIRE.  
The sandstones are cracked and stained by iron. The shale has weathered to spheroidal forms and residual clay.

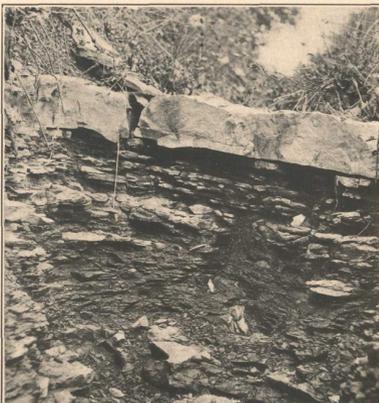
FIGURE 30.—GLACIATED SANDSTONE CAP WHICH PROTECTED THE UNDERLYING DECOMPOSED SHALE FROM EROSION BY THE GLACIERS; WATKINS GLEN QUADRANGLE.

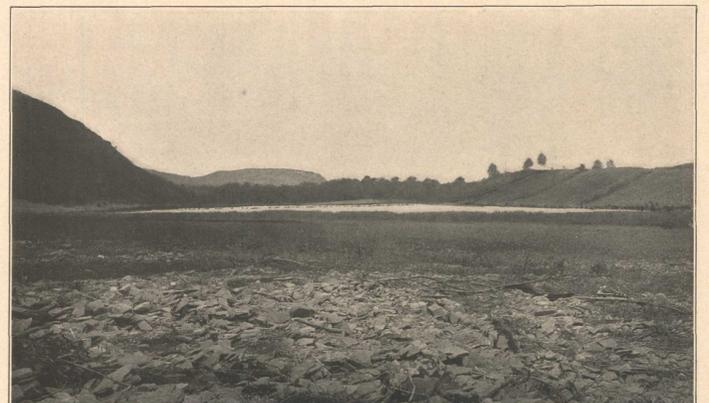
FIGURE 31.—JOHNSON HOLLOW OUTFLOW CHANNEL, 2 MILES WEST OF MILLPORT.  
Large valley, formerly the outlet of glacial Lake Newberry, now occupied by ponded waters.

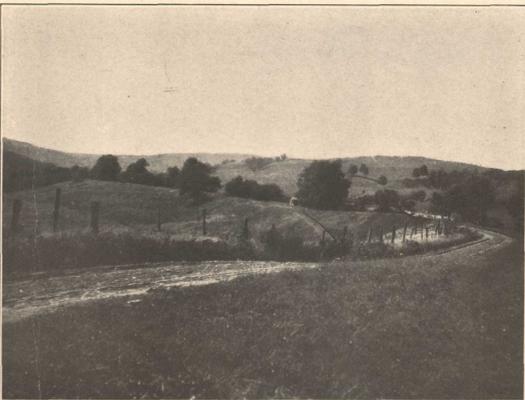
FIGURE 32.—ESKER RIDGE BETWEEN CENTER LISLE AND EAST RICHFORD.  
The turnpike follows its crest.

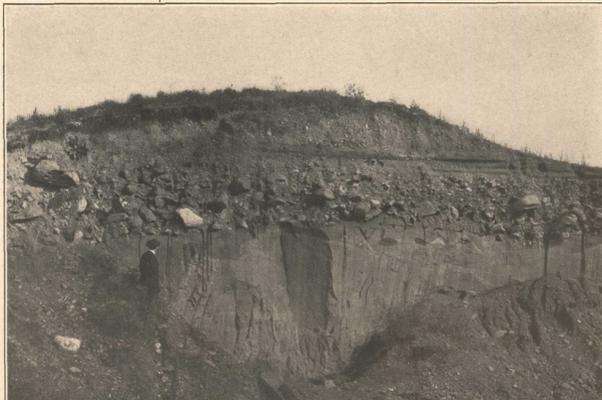
FIGURE 33.—OLDER, SLIGHTLY FAULTED SAND, ICE ERODED AT THE TOP, COVERED BY A SANDY AND GRAVELLY TILL, ABOVE WHICH ARE STRATIFIED DEPOSITS; FOREST HOME, JUST EAST OF CORNELL UNIVERSITY CAMPUS.  
The ice-eroded sand may represent an earlier ice invasion than that of the overlying till.

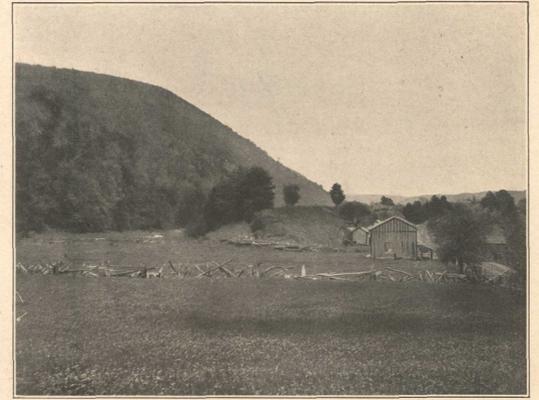
FIGURE 34.—OUTLET CHANNEL OF GLACIAL WEST DANBY LAKE, 4 1/2-2 MILES SOUTH OF DANBY, LOOKING TOWARD THE SOUTH.  
The channel lies between the narrow rock ridge to the left of the barn and the high wooded ridge in the background.

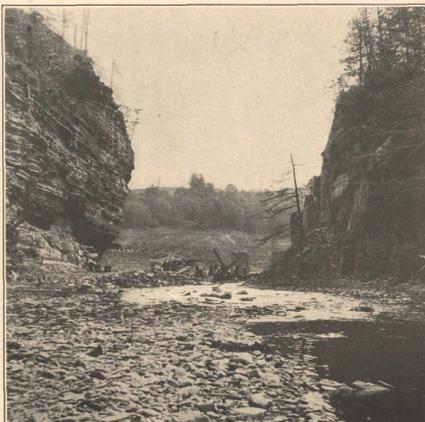
FIGURE 36.—POSTGLACIAL GORGE OF SIXMILE CREEK ABOVE ITHACA.  
The stream flows through the gap from one section of the old buried valley to another. Site for dam and reservoir under construction.

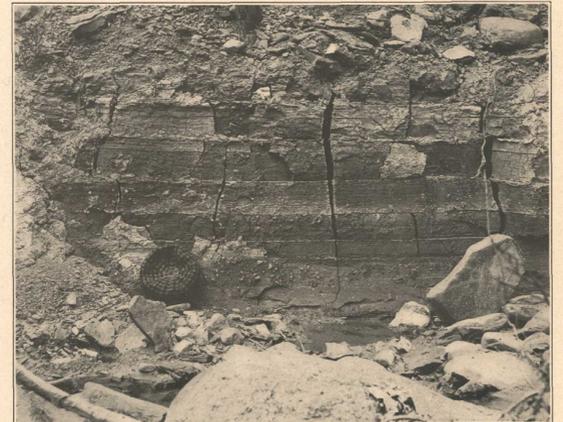
FIGURE 37.—GLACIAL-LAKE CLAY IN THE MORAINIC AREA OF SIXMILE CREEK.  
Jointed by shrinkage from drying. Contains small scratched pebbles.
