Tracking Change Over Time—River Flooding

Background

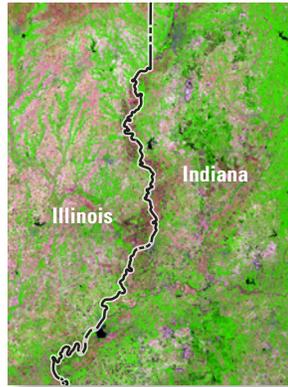
June 9, 2007—Landsat 5

These three Landsat 5 images show a flood in southern Indiana and Illinois. Peak flooding was observed in this area on June 10 and 11, 2008. The clear Landsat scene from June 11, 2008, and the clear image of “normal” conditions from June 9, 2007, allow us to compare the scenes and see exactly what damage a flood of this magnitude can cause.

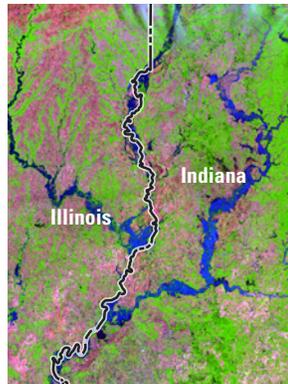
June 11, 2008—Landsat 5

Rainfall amounts ranging from about 2 inches (in.) to more than 10 in. fell in this area on June 6–7, 2008. Because of a wetter than normal spring, this heavy rain fell on already saturated ground. The rivers quickly rose to exceed flood stage.

5. In the 2008 flood image, what could account for the large, nearly square-shaped area of floodwater at lat/long 39.31, -87.23? How many acres does it encompass?
6. In the 2008 flood image, at about lat/long 39.31, -87.58, there seem to be rectangular islands in the middle of the water. What could be causing these areas to appear unflooded?
7. In the 2007 image, a large area at about lat/long 38.76, -87.59, band combination 5,4,3, contains some green fields, but some fields are maroon and others pink. Why are these fields different colors?
