1976 Big Thompson Flood, Colorado

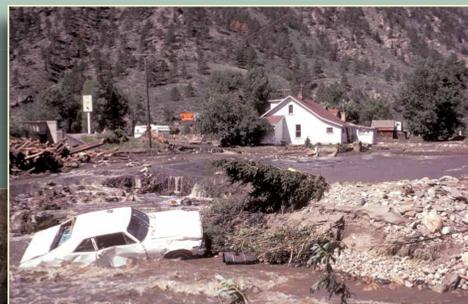
Damaged and destroyed homes along the Big Thompson River. This photograph was taken from the hillside looking downstream at Drake. The river flow is from bottom right to top center.

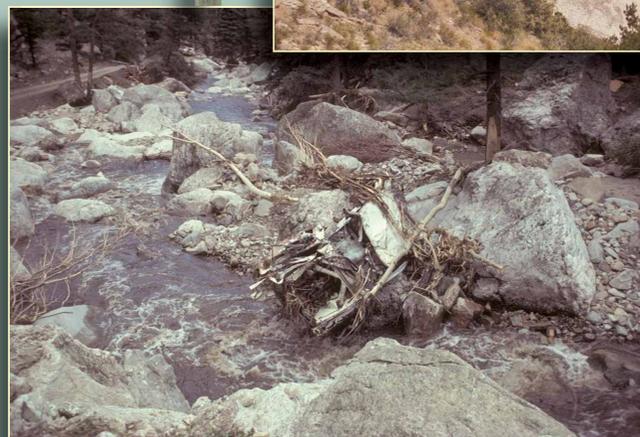
Damaged car and house at the confluence of the North Fork Big Thompson and Big Thompson Rivers in Drake.

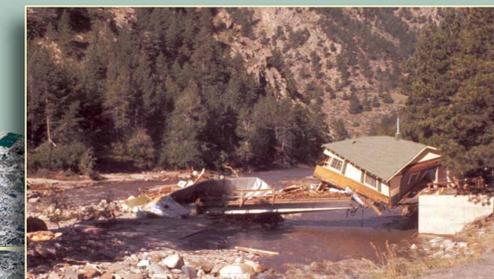
Upstream view of flood-displaced house that is lodged on a bridge. About 0.5 mile downstream from Drake. Peak flood discharge was estimated to be 26,100 cubic feet per second in this area.

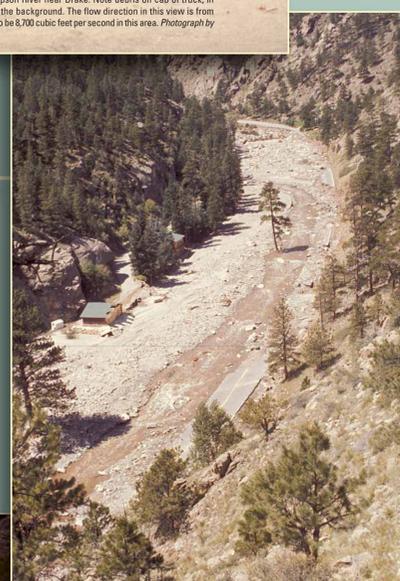
Downstream view of damaged Nihart Motel on the Big Thompson River near Glen Comfort.
