KOKOSING RIVER FLOOD AREA

FLOODS ON THE KOKOSING RIVER, DRY CREEK, AND CENTER RUN, AT MOUNT VERNON, OHIO, IN 1959

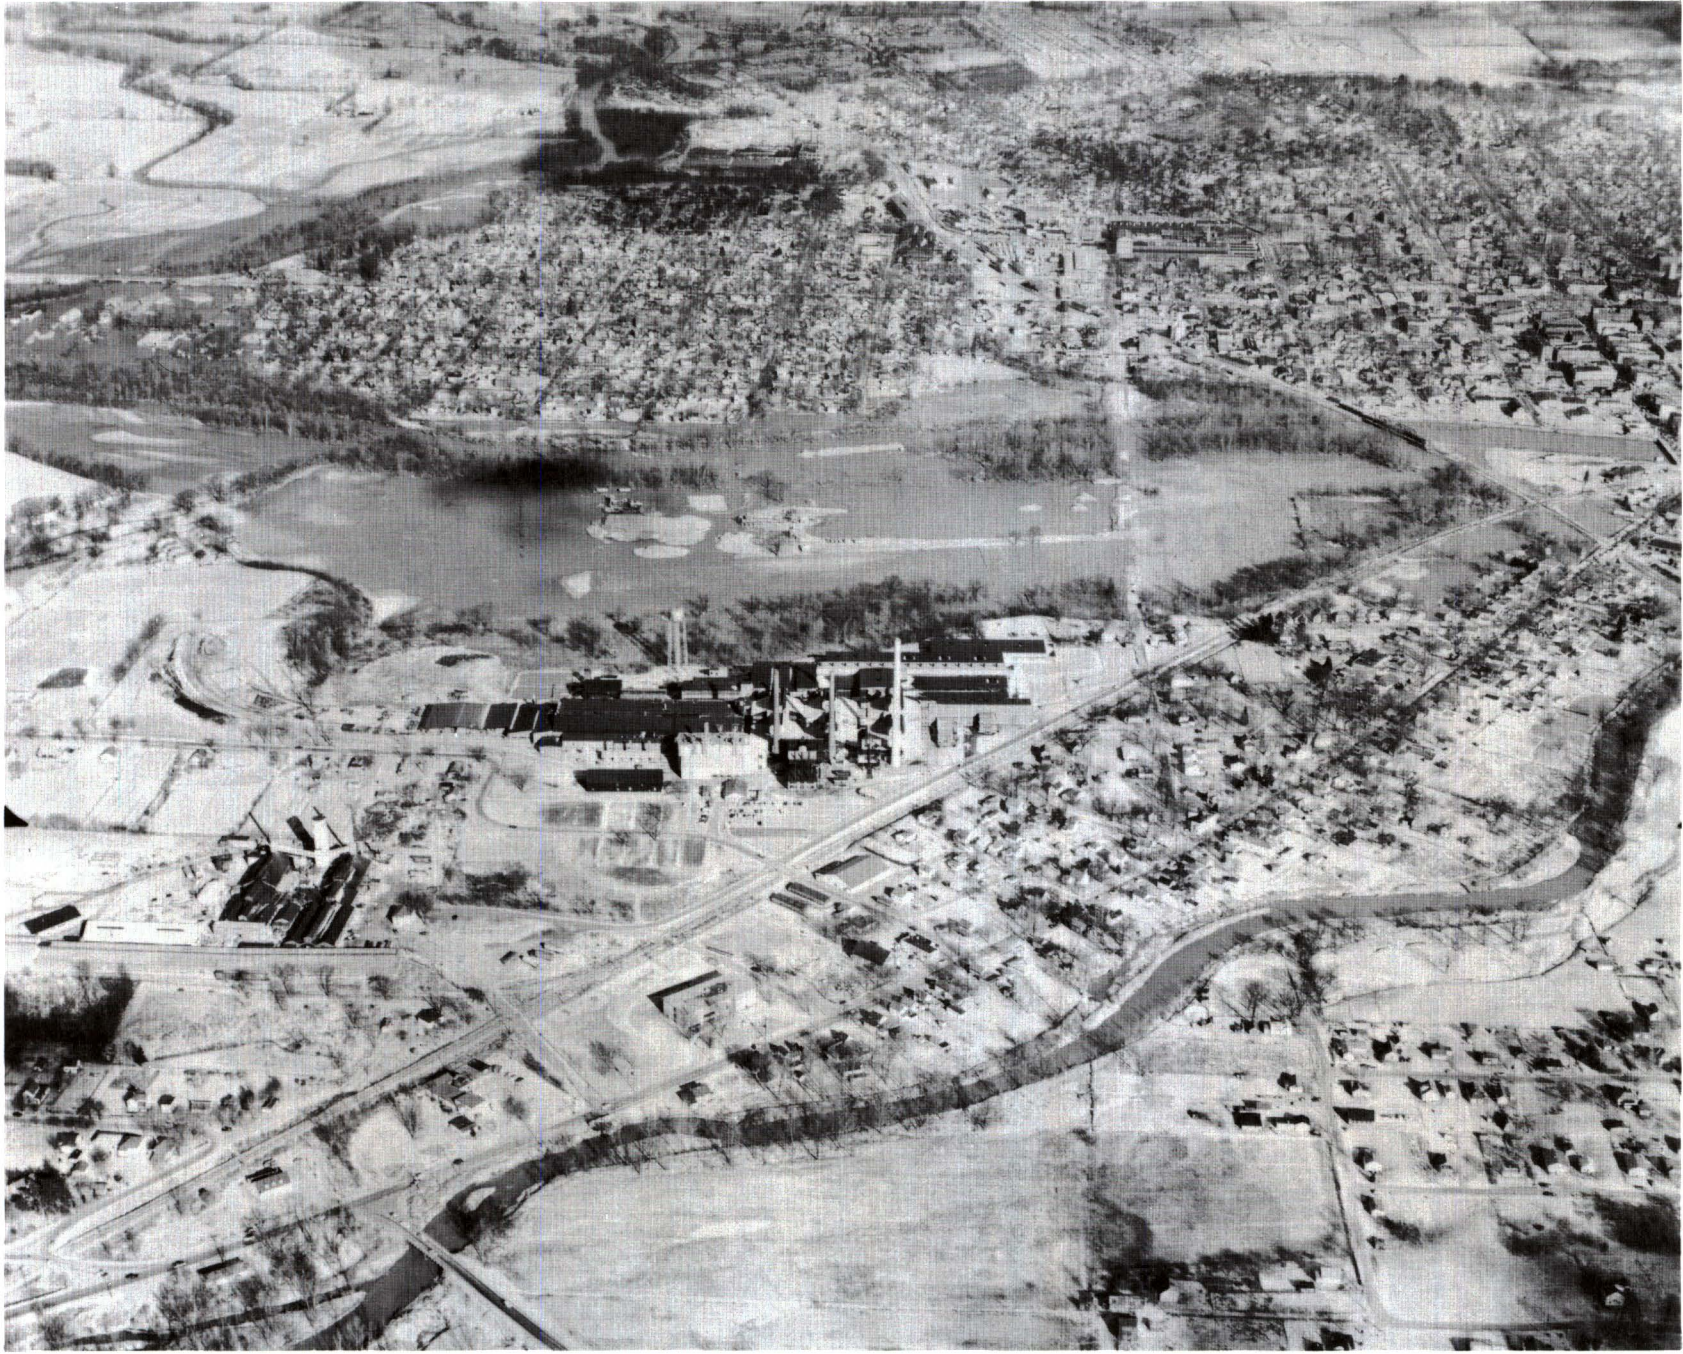
AERIAL VIEW OF FLOODED MOUNT VERNON, OHIO, JANUARY 22, 1959

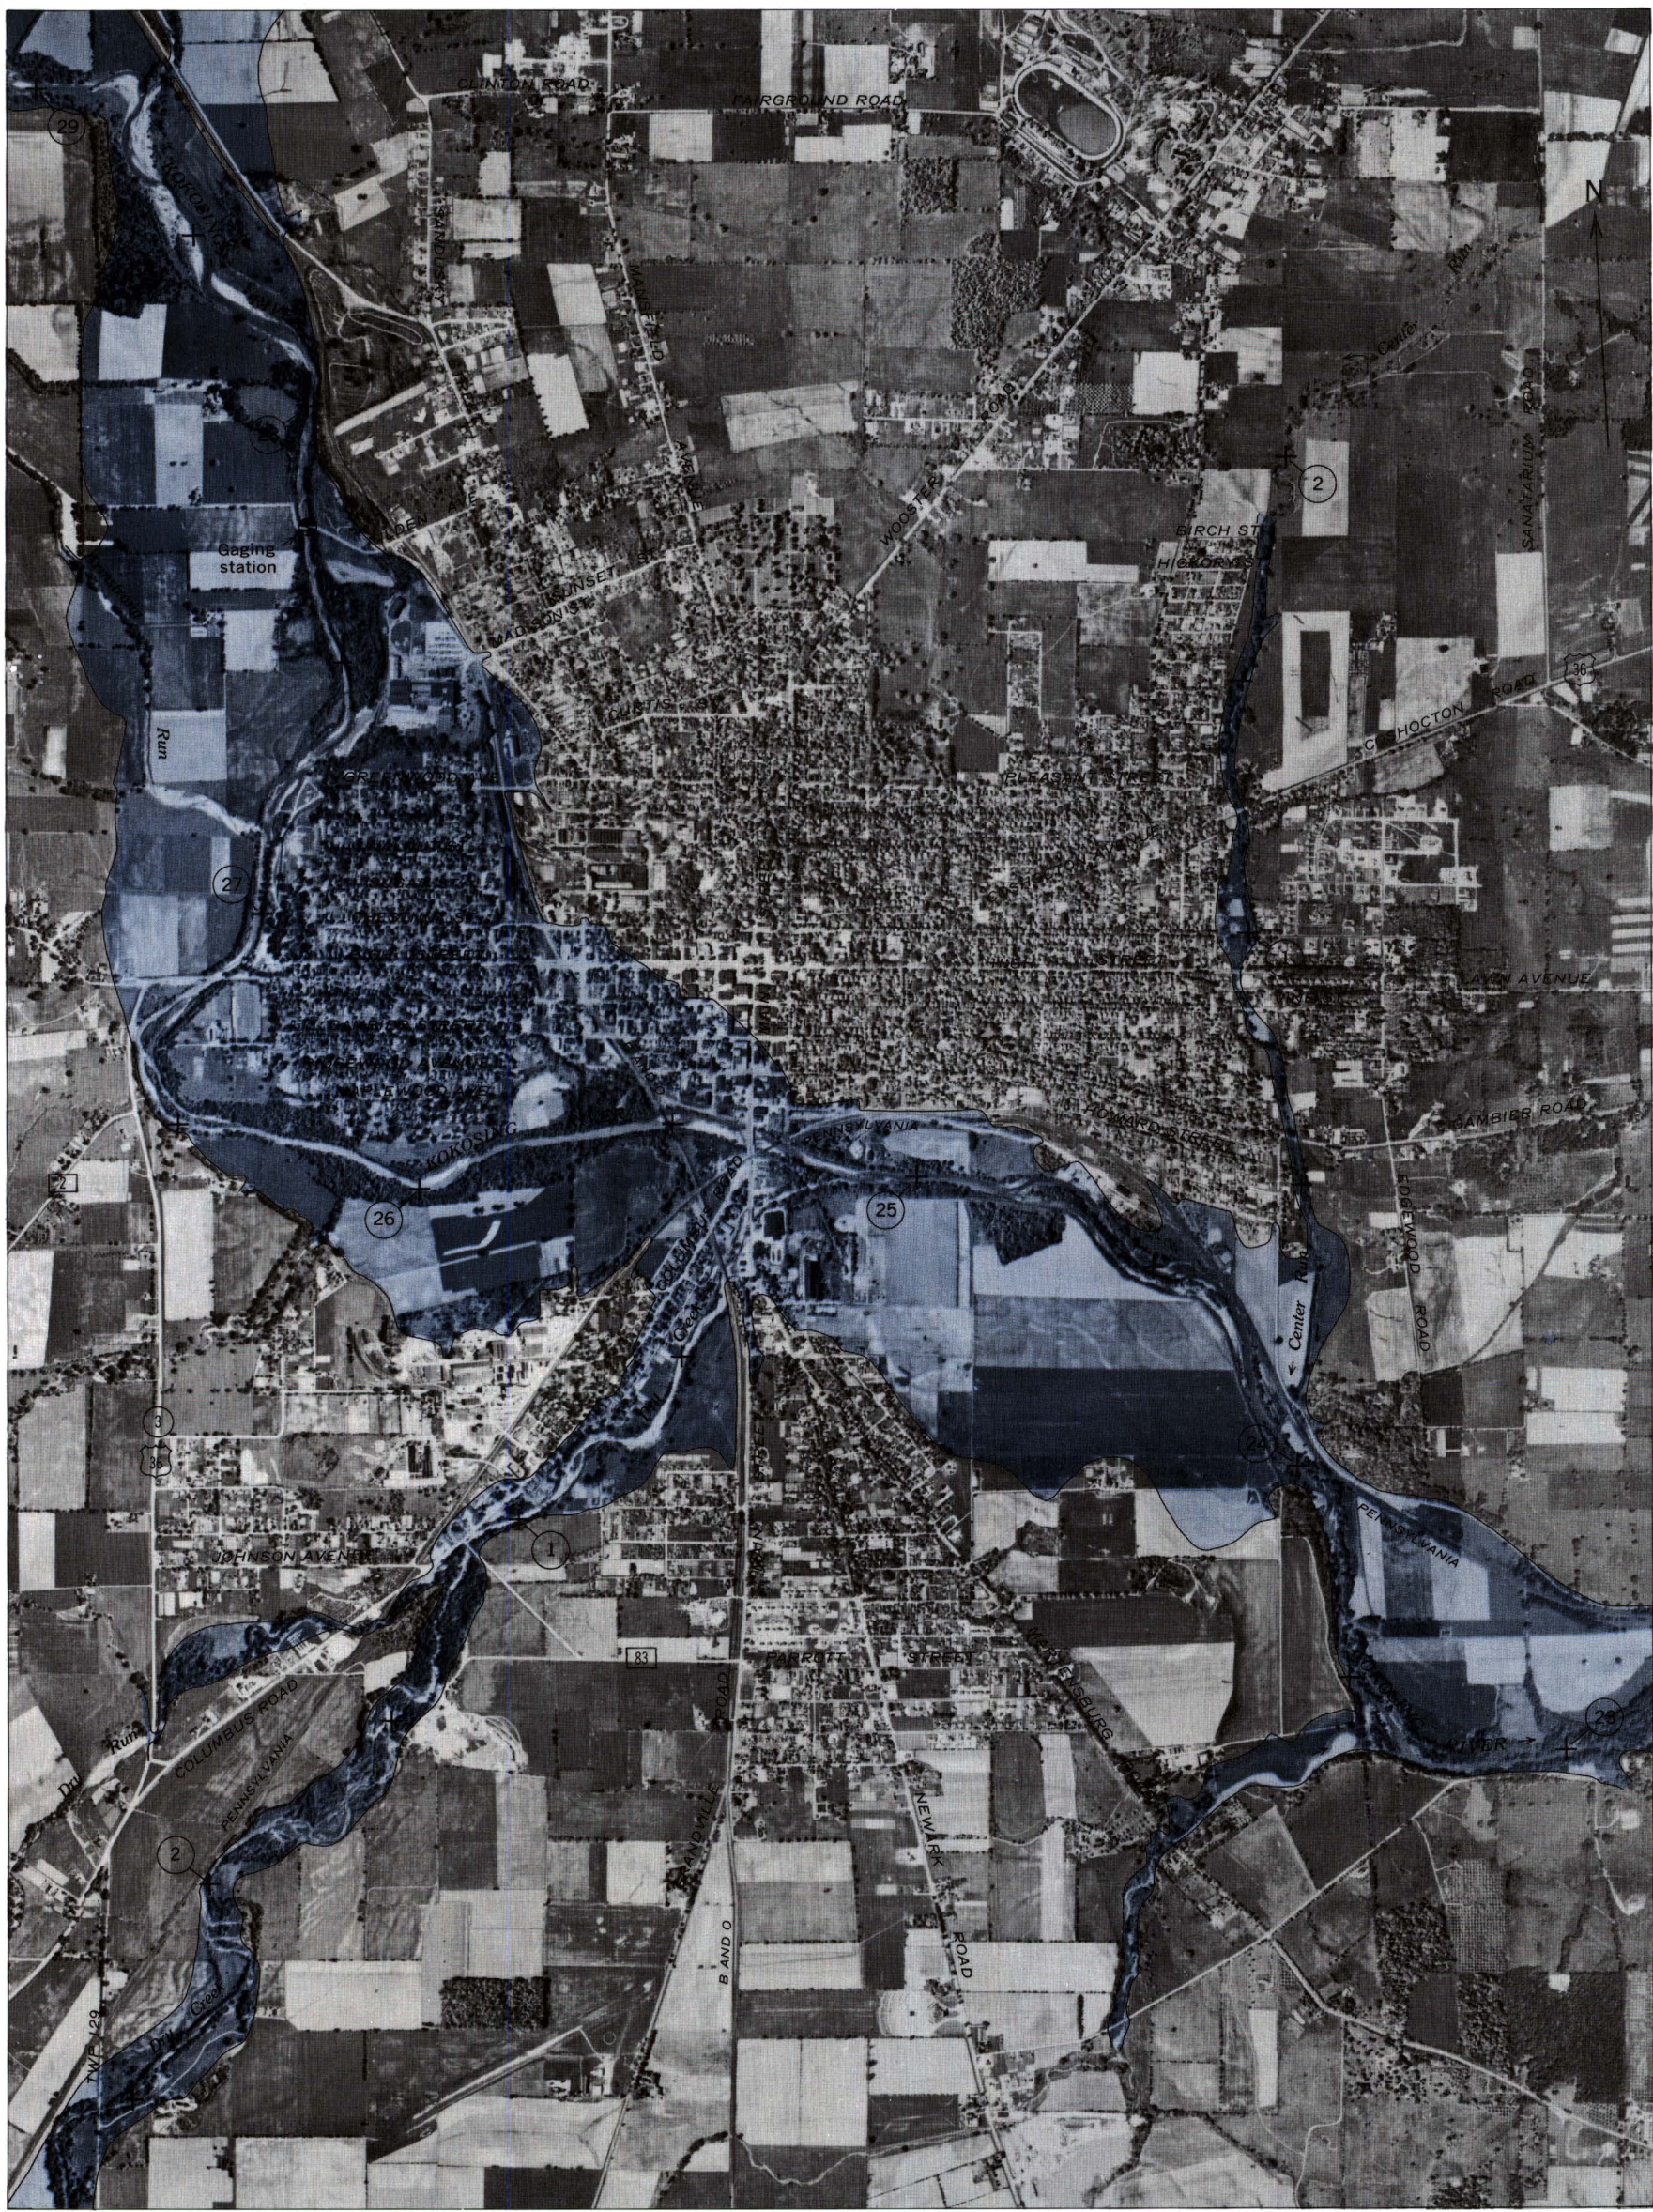
This photomosaic shows the area covered by the 1959 flood on Kokosing River, Dry Creek, and Center Run. Blue represents approximate area flooded Jan. 21, 1959. Indicated flood height is for the Tilden Avenue Bridge gaging station on Kokosing River.

STAGE (FEET)	ELEVATION ABOVE MEAN SEA LEVEL (FEET)	DATE OF FLOOD
18.19	1002.35	Jan. 21, 1959

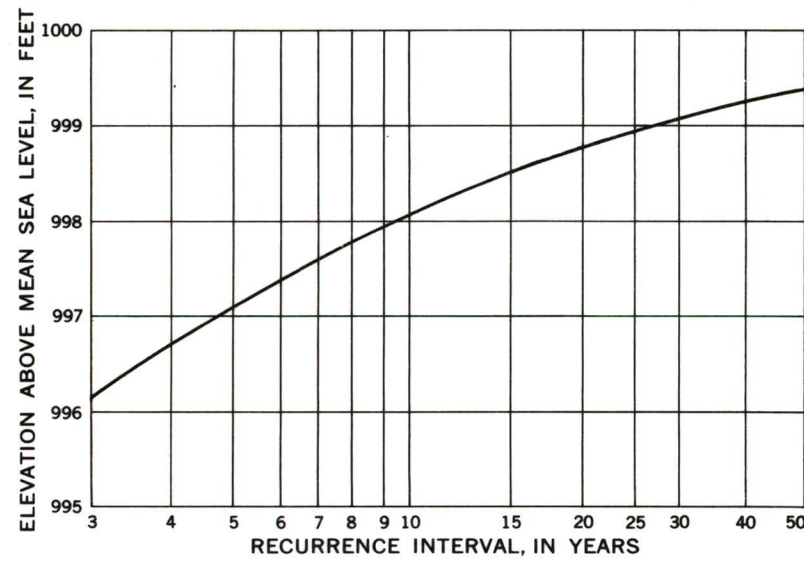
FIGURE 2.—FREQUENCY OF FLOODS ABOVE ELEVATION 996 FEET ON KOKOSING RIVER AT MOUNT VERNON, OHIO

The general relationship between recurrence interval and flood height for the Kokosing River at the Tilden Avenue gaging station (fig. 2) is tabulated below.

Recurrence interval (years)	Elevation above mean sea level (feet)
50	999.4
30	999.1
20	998.8
10	998.1
5	997.1
3	996.1

Flood frequency.—Frequency of flooding on Kokosing River has been derived from the short term record (since 1954) at the U. S. Geological Survey gaging station at the Tilden Avenue Bridge, combined with the regional flood-frequency relation for all streams in Ohio outside the Maumee River basin. Large errors may result if the flood-frequency curve is extrapolated beyond the limit shown. Frequency of flooding on Dry Creek and Center Run has not been determined.

It is emphasized that recurrence intervals are average figures—the average number of years that will elapse between occurrences of floods that equal or exceed a certain flood height. Thus, at Mount Vernon, a flood that reaches a 999.1-foot elevation at the Tilden Avenue Bridge is said to have a 30-year recurrence interval. However, because of the erratic nature of flood occurrence, the 999.1-foot elevation may not be reached in any one 30-year period, or it may be reached more than once.

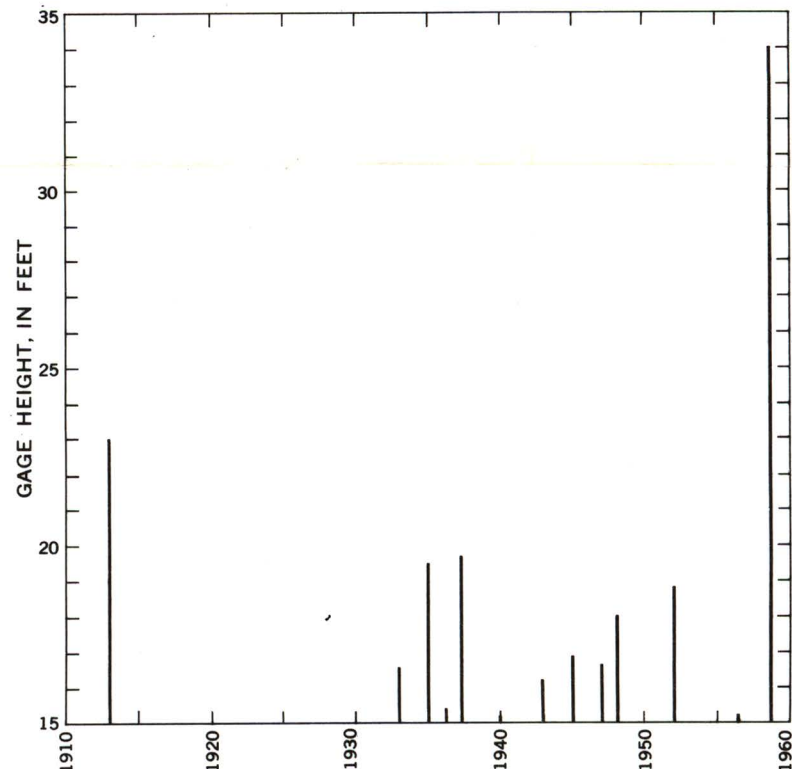
FIGURE 1.—ANNUAL FLOODS ABOVE 15-FOOT STAGE ON KOKOSING RIVER AT MILLWOOD, OHIO, 1913-1959

Gage height and year of occurrence of each annual flood (highest peak discharge each year) above the 15-foot stage at the gaging station on the Kokosing River at Millwood, about 19 miles downstream from the Tilden Avenue gaging station at Mount Vernon, are shown in figure 1. The Millwood gaging station record is used here because it is much longer than that at Mount Vernon. The 15-foot stage was exceeded 13 times in 39 years of record (fig. 1) and the erratic occurrence of floods is evident. Although floods above a 15-foot stage occurred on the average of about three per decade on the Kokosing River, only one was experienced in some decades, whereas five occurred during the period 1932-41 and also during the period 1940-49.

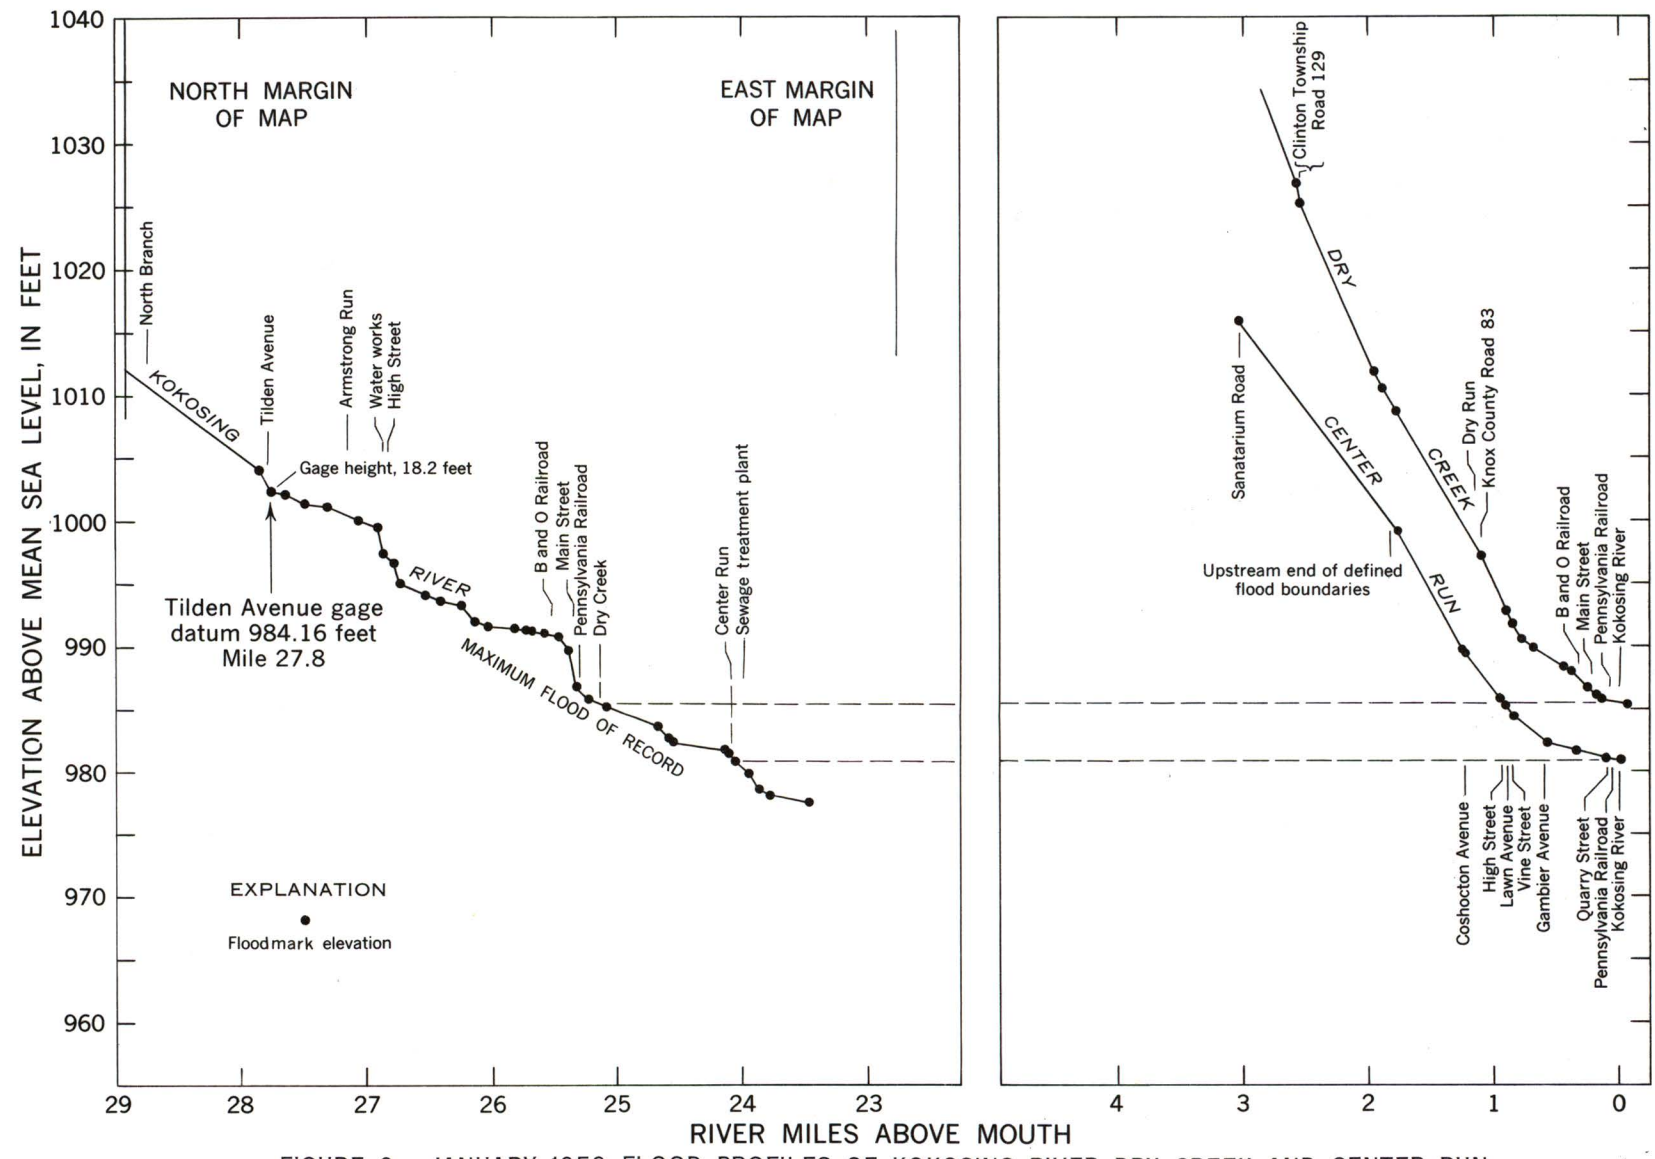
FIGURE 3.—JANUARY 1959 FLOOD PROFILES OF KOKOSING RIVER, DRY CREEK, AND CENTER RUN

Flood profiles.—Profiles of the water surface, constructed from marks left by the flood of January 1959, are shown in figure 3. The abrupt changes in the profiles shown at some street locations indicate the difference in water surface elevations at the upstream and downstream sides of bridges. Profiles of floods corresponding to other flood heights can be plotted on this diagram, generally parallel to those shown. River miles above the mouth, used for the profiles in figure 3, are also marked along the streams on the flood inundation map.
