FLOODS ON LICKING RIVER, NORTH FORK AND SOUTH FORK OF LICKING RIVER AND RACCOON CREEK, AT NEWARK, OHIO IN 1959

The approximate area inundated at Newark, Ohio, by the Licking River, by the North Fork and South Fork of Licking River, and by Raccoon Creek, during the flood of January 21, 1959, is shown on a photomosaic base in order to record the flood hazard in graphical form. This flood is a historic fact. Greater floods are possible, but no attempt has been made to show their probable overflow limits. The 1959 flood was the greatest on the Licking River since at least 1884. Protective works built after the flood of January 1959 can reduce the frequency of flooding in the area but will not necessarily eliminate future flooding. New highways and other cultural changes made after the flood of 1959 may influence the inundation pattern of future floods.

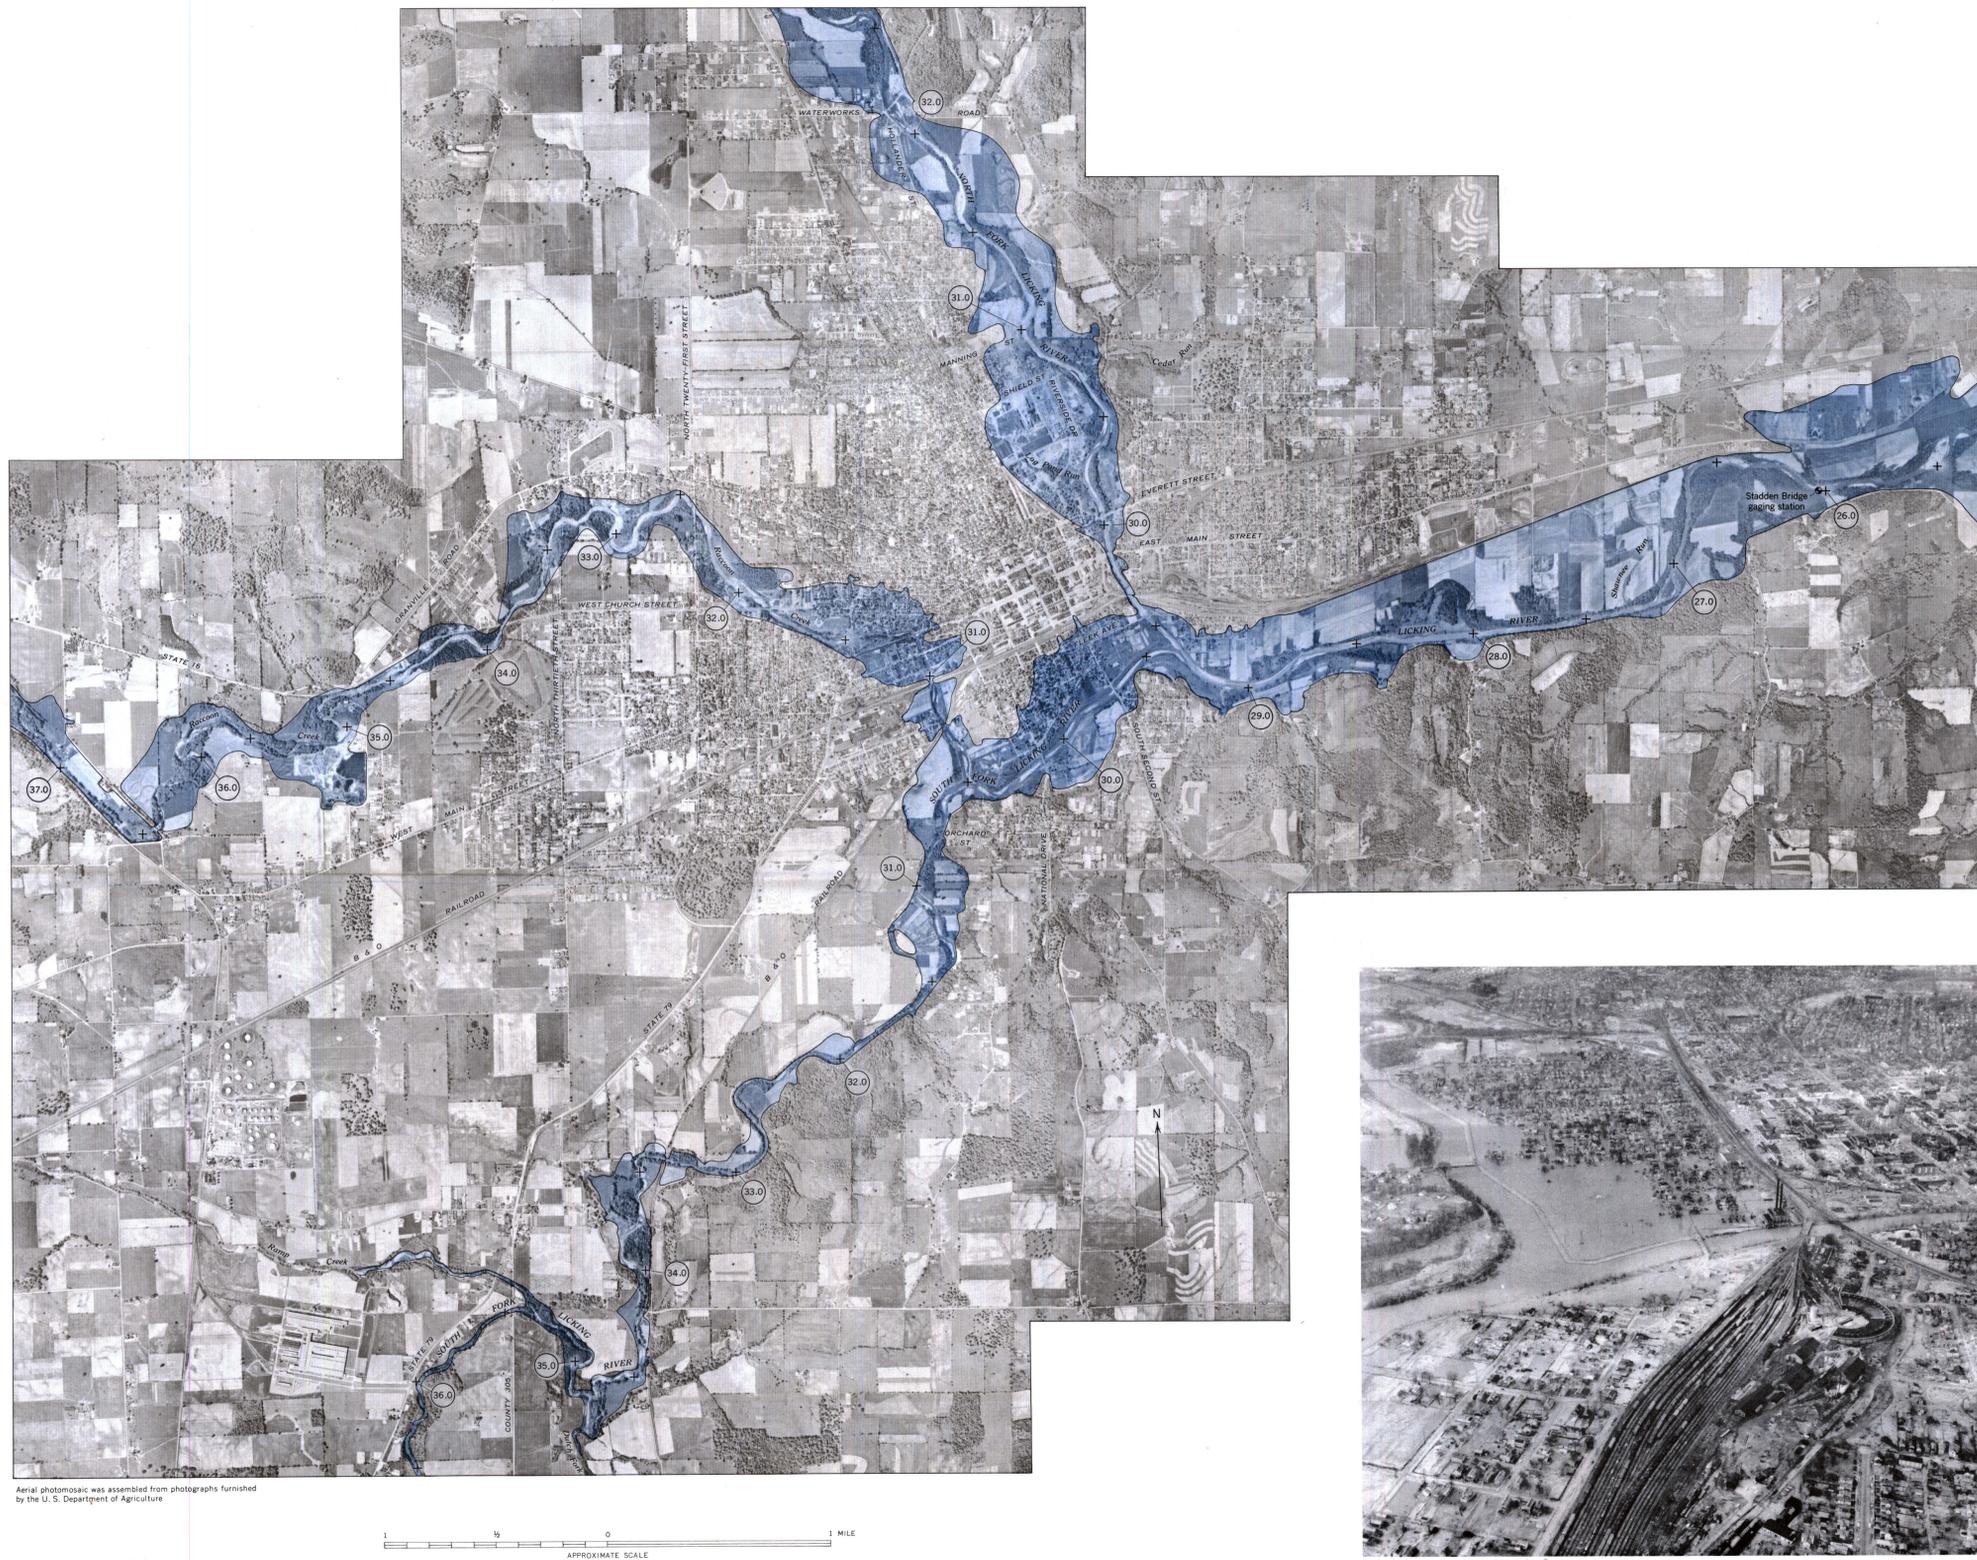
LICKING RIVER FLOOD AREA
Heavy, solid, black lines represent approximate limit of the flood of January 21, 1959. Indicated gauge height is for the gaging station on Licking River near Newark, located at Stadden Bridge.

DATE OF FLOOD	ELEVATION ABOVE MEAN SEA LEVEL (FEET)	GAGE HEIGHT (FEET)
Jan. 21, 1959	799.3	20.3

EXPLANATION

— Flood limit 1959

○ 33.0
+ River miles above mouth of Licking River

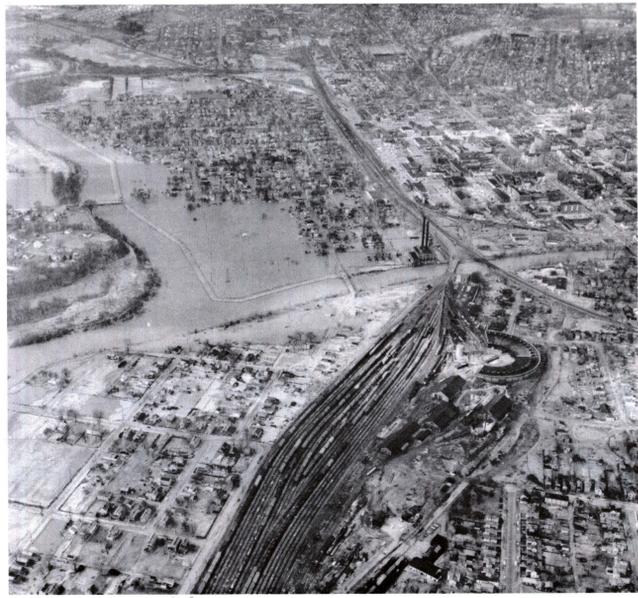
Photograph by the Ohio Department of Highways
AERIAL VIEW OF FLOODED NEWARK, OHIO, JANUARY 22, 1959

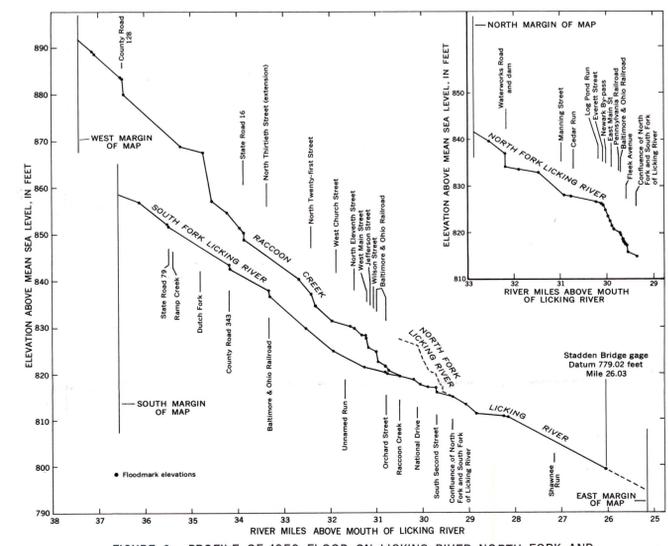
FIGURE 3.—PROFILE OF 1959 FLOOD ON LICKING RIVER, NORTH FORK AND SOUTH FORK OF LICKING RIVER, AND RACCOON CREEK

Flood profiles.—Profiles of the water surface along Licking River, North Fork and South Fork of Licking River, and Raccoon Creek, constructed from marks left by the flood of January 21, 1959, are shown in figure 3. Profiles of floods corresponding to other flood heights can be plotted on this diagram generally parallel to those shown.
