#### FLOODS ON SCIOTO RIVER AND PAINT CREEK AT CHILLICOTHE, OHIO, IN 1959

#### FLOODS AT CHILLICOTHE, OHIO

By  
George W. Edelen, Jr., Frederick H. Ruggles, Jr.,  
and William P. Cross

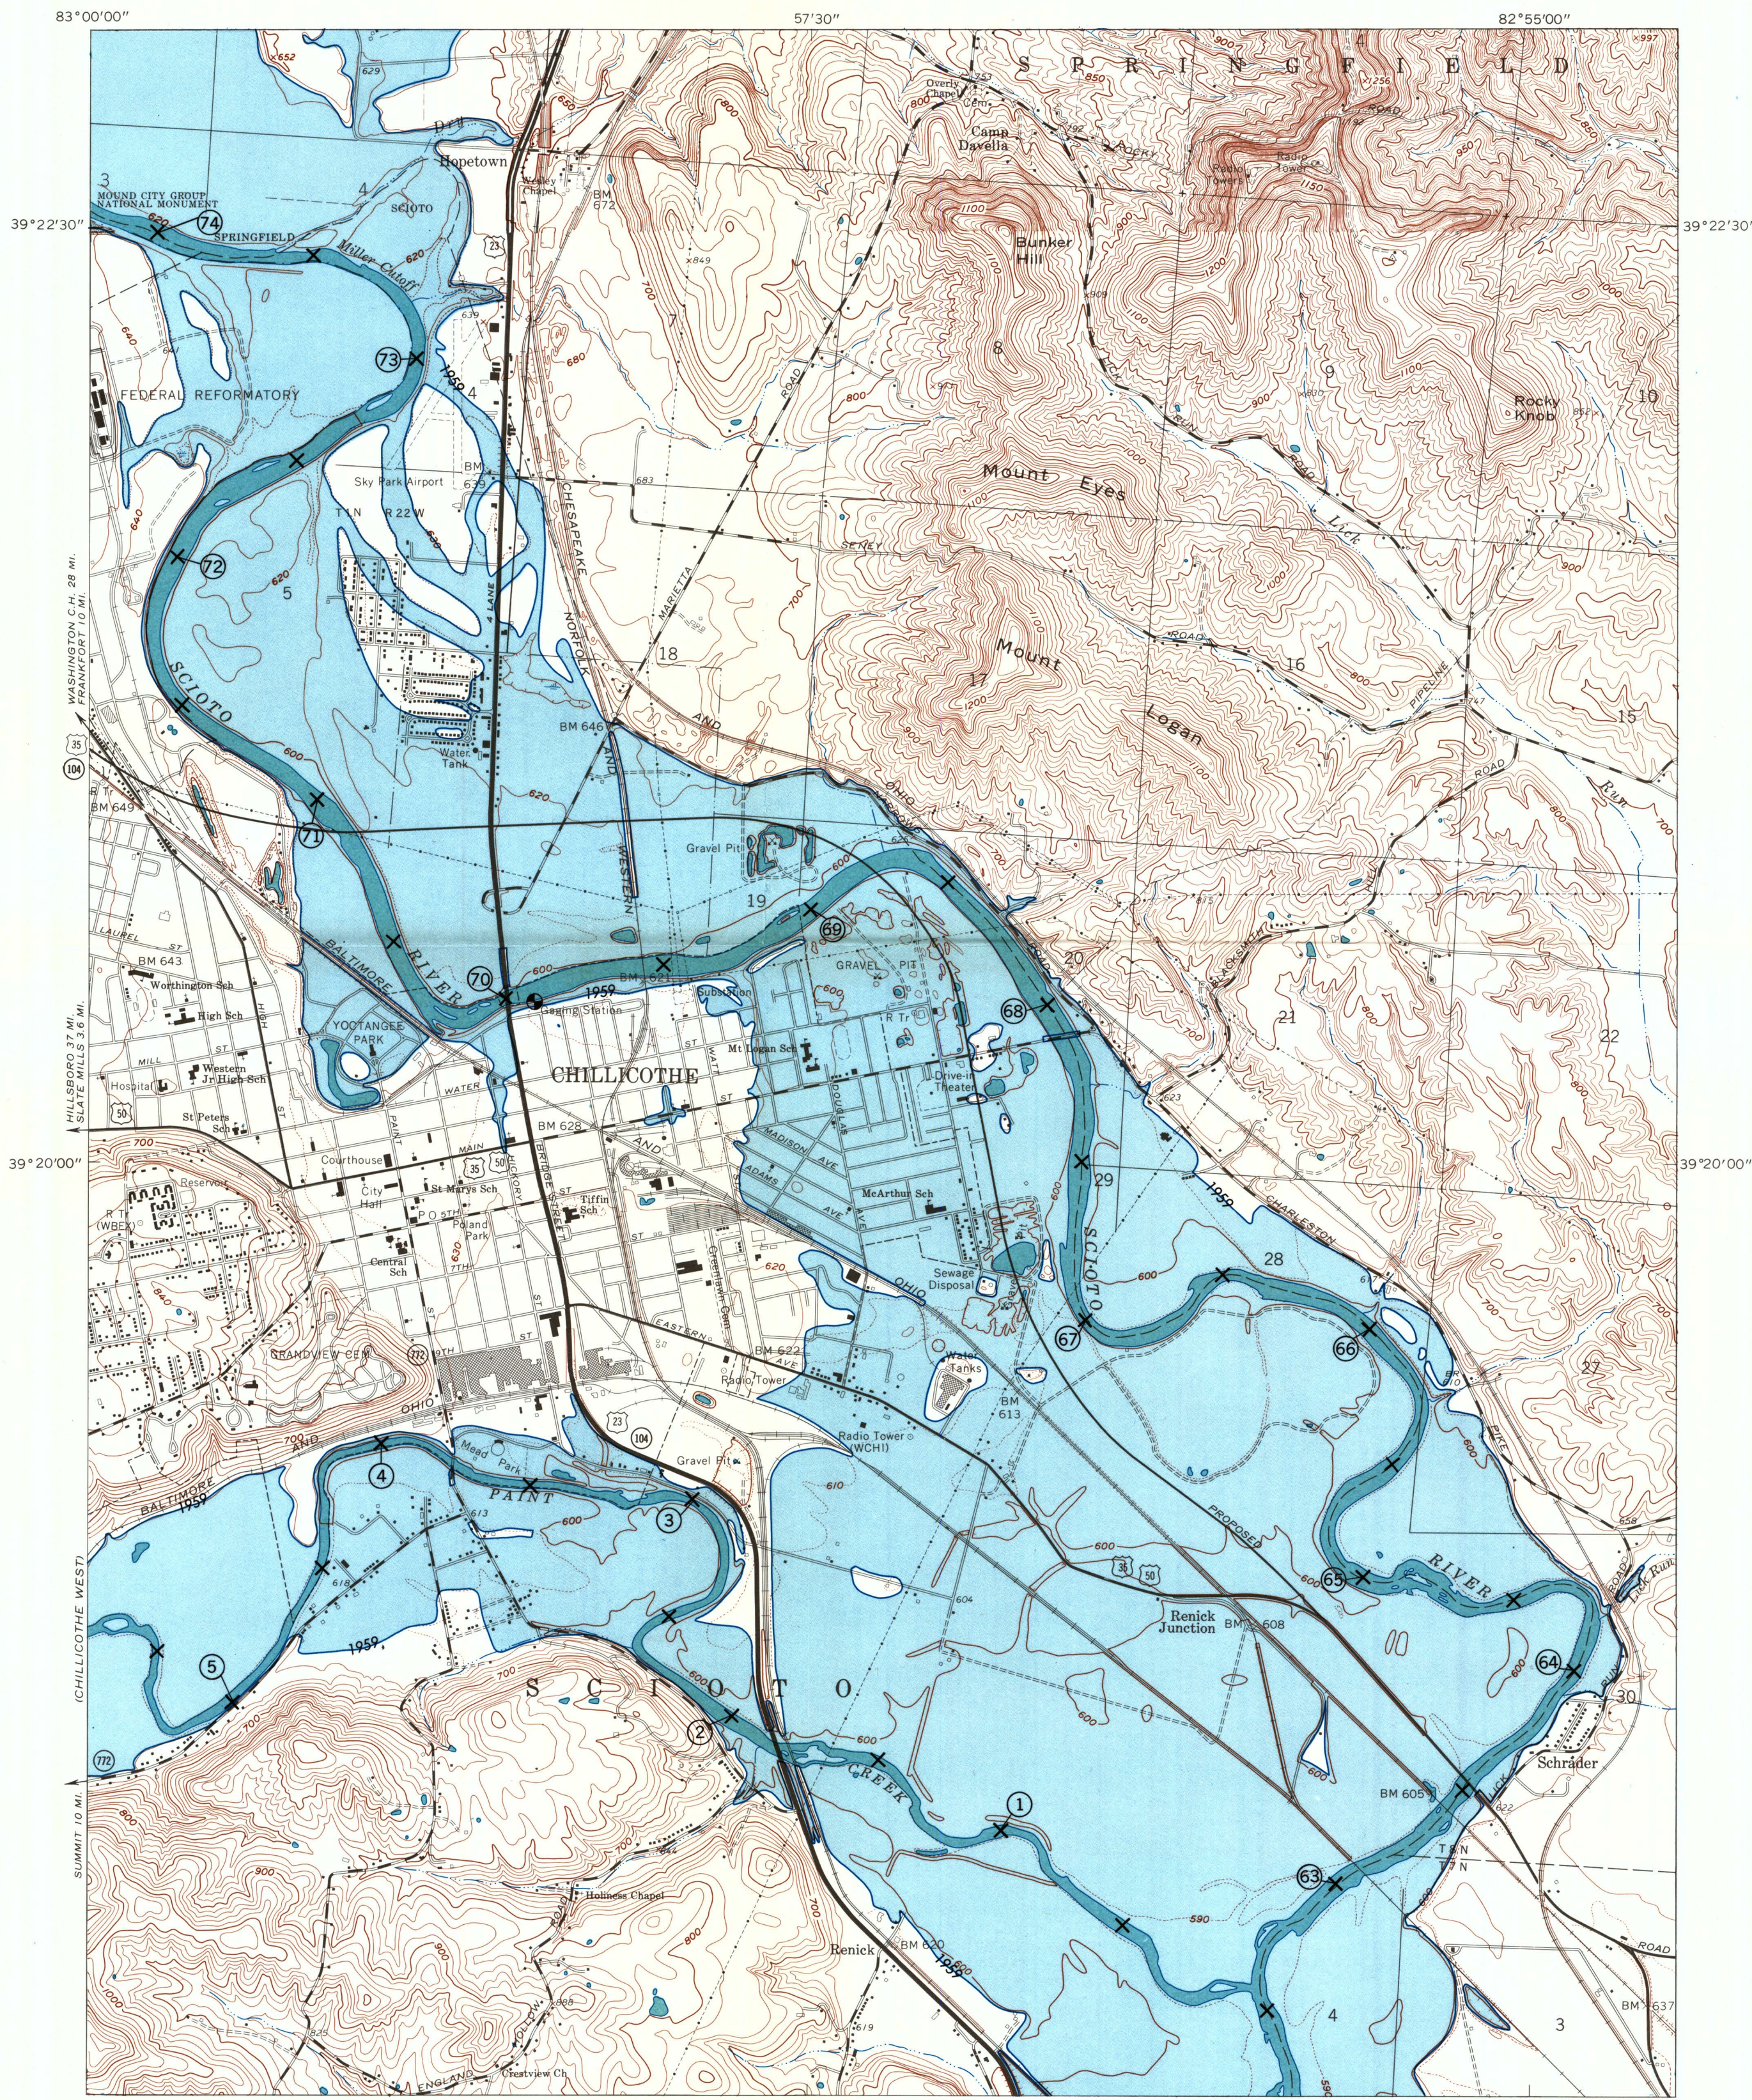
- Area flooded January 22, 23, 1959
- Boundary of 1959 flood
- River mile measured upstream from mouth

The approximate area inundated by the flood of January 22, 23, 1959, is shown on a topographic map to record the flood hazard in graphical form. Greater floods are possible but no attempt has been made to define their probable overflow limits. The flood of January 1959, although reduced somewhat by storage in reservoirs upstream, was the highest on the Scioto River since the flood of March 26, 1913. The 1913 flood was the greatest since at least 1800. Future protective works may reduce the frequency of flooding in the area but will not necessarily eliminate flooding. The inundation pattern of future floods may be affected by new highways, bridges, different levee conditions, and other cultural changes.

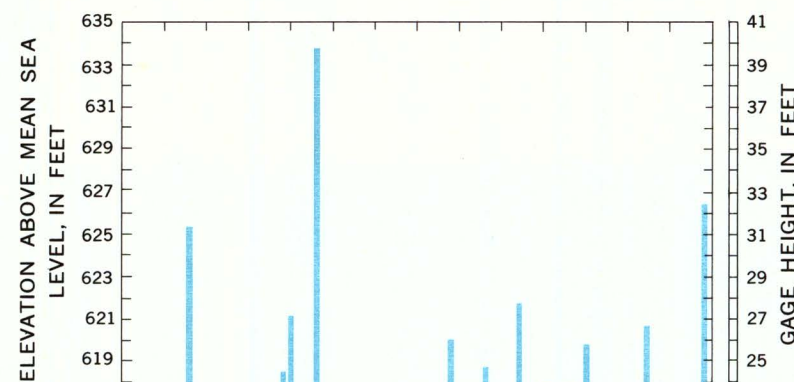
FIGURE 1.—Annual floods above 617-foot elevation, 1898, 1908-60, on Scioto River at Chillicothe (downstream from Bridge Street).

Gage height and year of each annual flood (highest momentary peak discharge in each calendar year) that exceeded elevation 617 feet at the Bridge Street gaging station on Scioto River at Chillicothe during the period 1898, 1908-60, are shown in figure 1. The irregular

occurrence of floods is evident. Floods above 617-foot elevation occurred 13 times in the 54 years of record, an average of about one flood each 4 years. Although no flood of this magnitude occurred in 41 of the years, 4 floods were greater than elevation 617 feet during the 8-year period 1909-16.

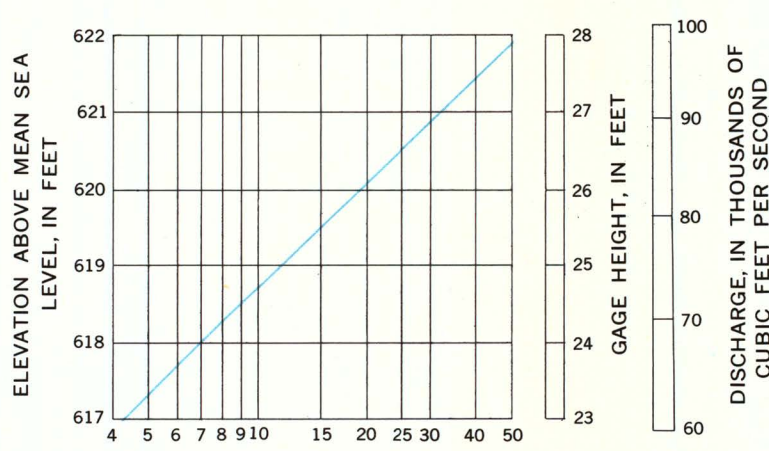
FIGURE 2.—Frequency of floods above 617-foot elevation on Scioto River at Chillicothe (downstream from Bridge Street)

**Flood frequency**—Frequency of flooding on the Scioto River at Chillicothe has been derived for conditions of natural flow without the effect of reservoir storage. The frequency derivation is based on records from the U.S. Geological Survey gaging station located downstream from Bridge Street, combined with a regional flood-frequency relation for all streams in Ohio except those in the Maumee River basin. The relation between stage and frequency is dependent on the relation of stage to discharge, in which the stage-to-discharge relation is affected by changes in physical conditions of channels and constrictions. The frequency curve shown in figure 2 is based on channel conditions existing in 1959. Large errors may result if the flood-frequency curve is extrapolated beyond the limits shown. Frequency of flooding on Paint Creek has not been derived.

**Recurrence intervals**—As applied to flood events, recurrence interval is the number of years, on the average, within which a given flood height will be equaled or exceeded once. It is inversely related to the probability of a specific flood being equaled or exceeded in any one year. Thus a 20-year flood would have 1 chance in 20, or a 5-percent chance, of being equaled or exceeded in any one year.

The general relation between recurrence interval and both flood height and flood discharge at the Bridge Street gaging station on Scioto River at Chillicothe (fig. 2) is tabulated below:

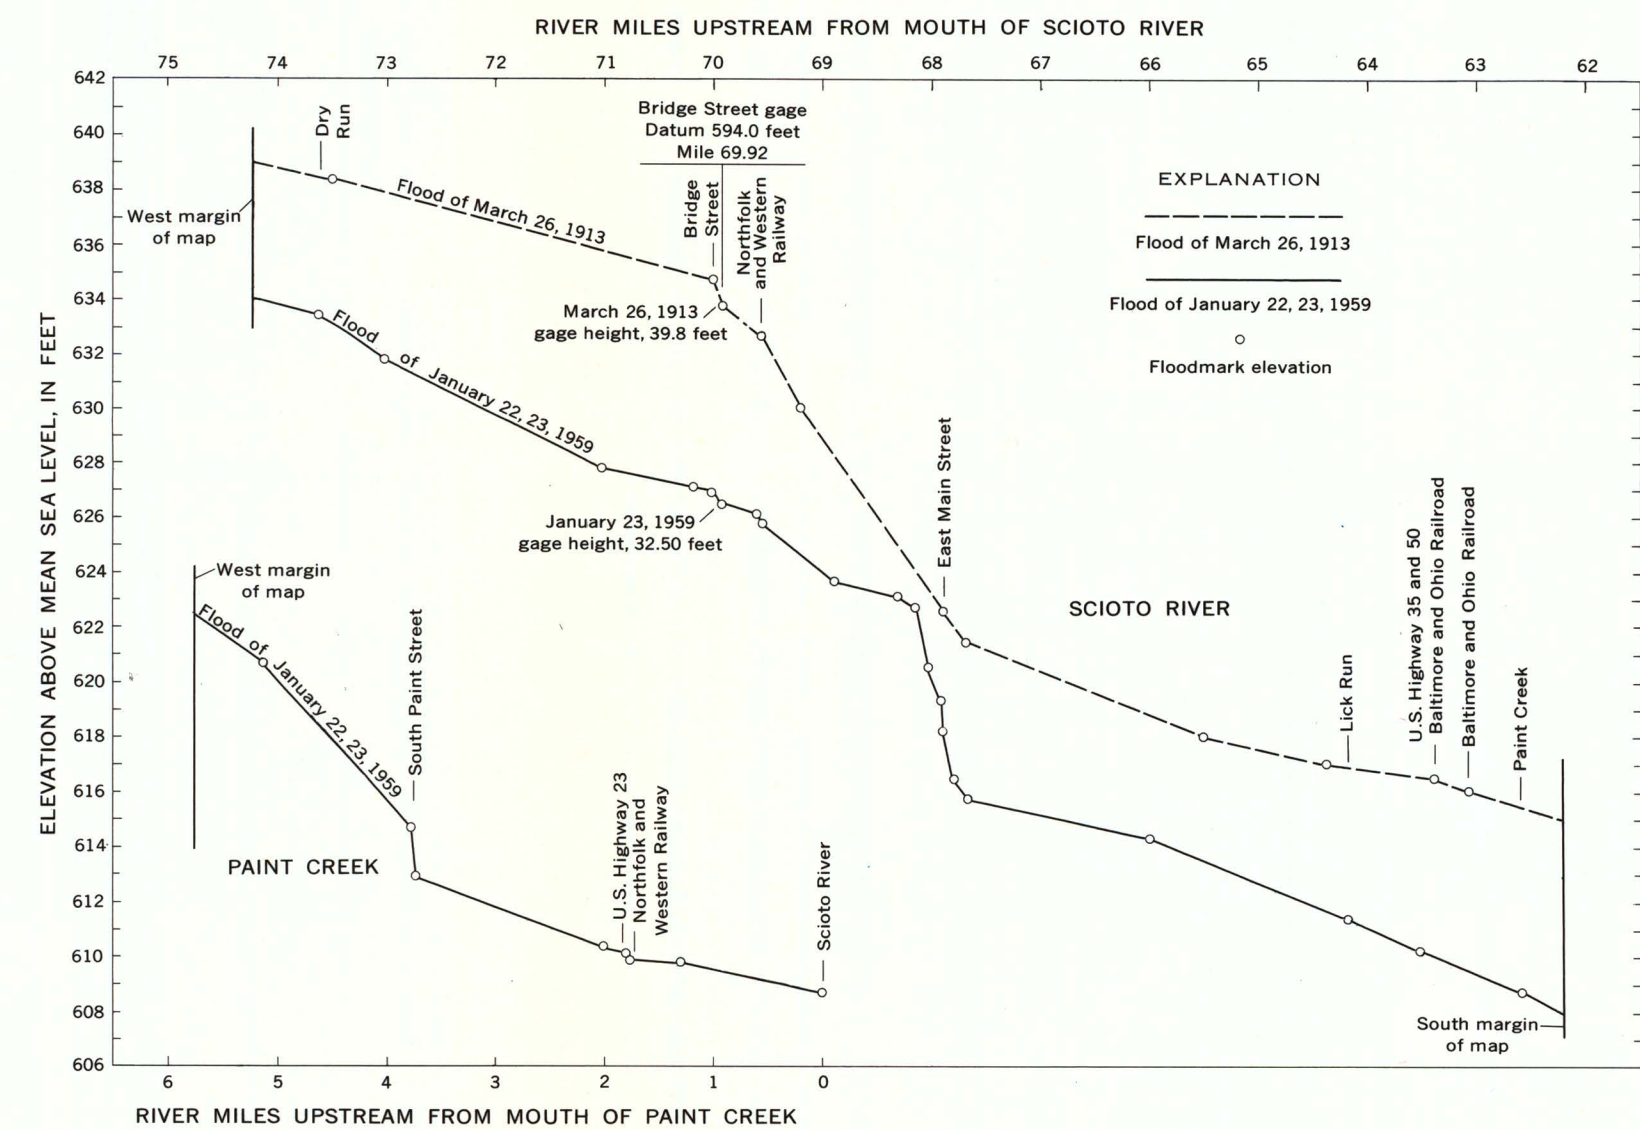
FIGURE 3.—Profiles of floods on Scioto River and Paint Creek

Data for the 1959 flood profile were furnished by the Ohio Department of Natural Resources, by the Corps of Engineers, U.S. Army, and by the City of Chillicothe.

The 1913 flood profile of the Scioto River was obtained from the 1916 report, "Flood Relief for Scioto Valley" to the Franklin County Conservation District, and used with the permission of Alvord, Burdick, and Howson, Consulting Engineers, Chillicothe, Ohio.
