FLOODS ON LICKING RIVER AT ZANESVILLE, OHIO, IN 1959

Hydrologic data relating to the depth and frequency of flooding along the Licking River in the vicinity of Zanesville, Ohio, are presented in this atlas. The Licking River flows into the Muskingum River at Zanesville. In January 1959, prior to the completion of the Dillon Reservoir, the western part of Zanesville was inundated extensively by the Licking River. Very little flooding was caused by the Muskingum River, which is regulated by storage in several reservoirs. The map and flood data provide a technical basis for making land-use decisions designed to minimize flood damages. No recommendations or suggestions for land-use regulations are made, and no solutions of existing flood problems are proposed.

**FLOODS AT ZANESVILLE, OHIO**  
By  
George W. Edelen, Jr., Frederick H. Ruggles, Jr.  
and William P. Cross  
1964

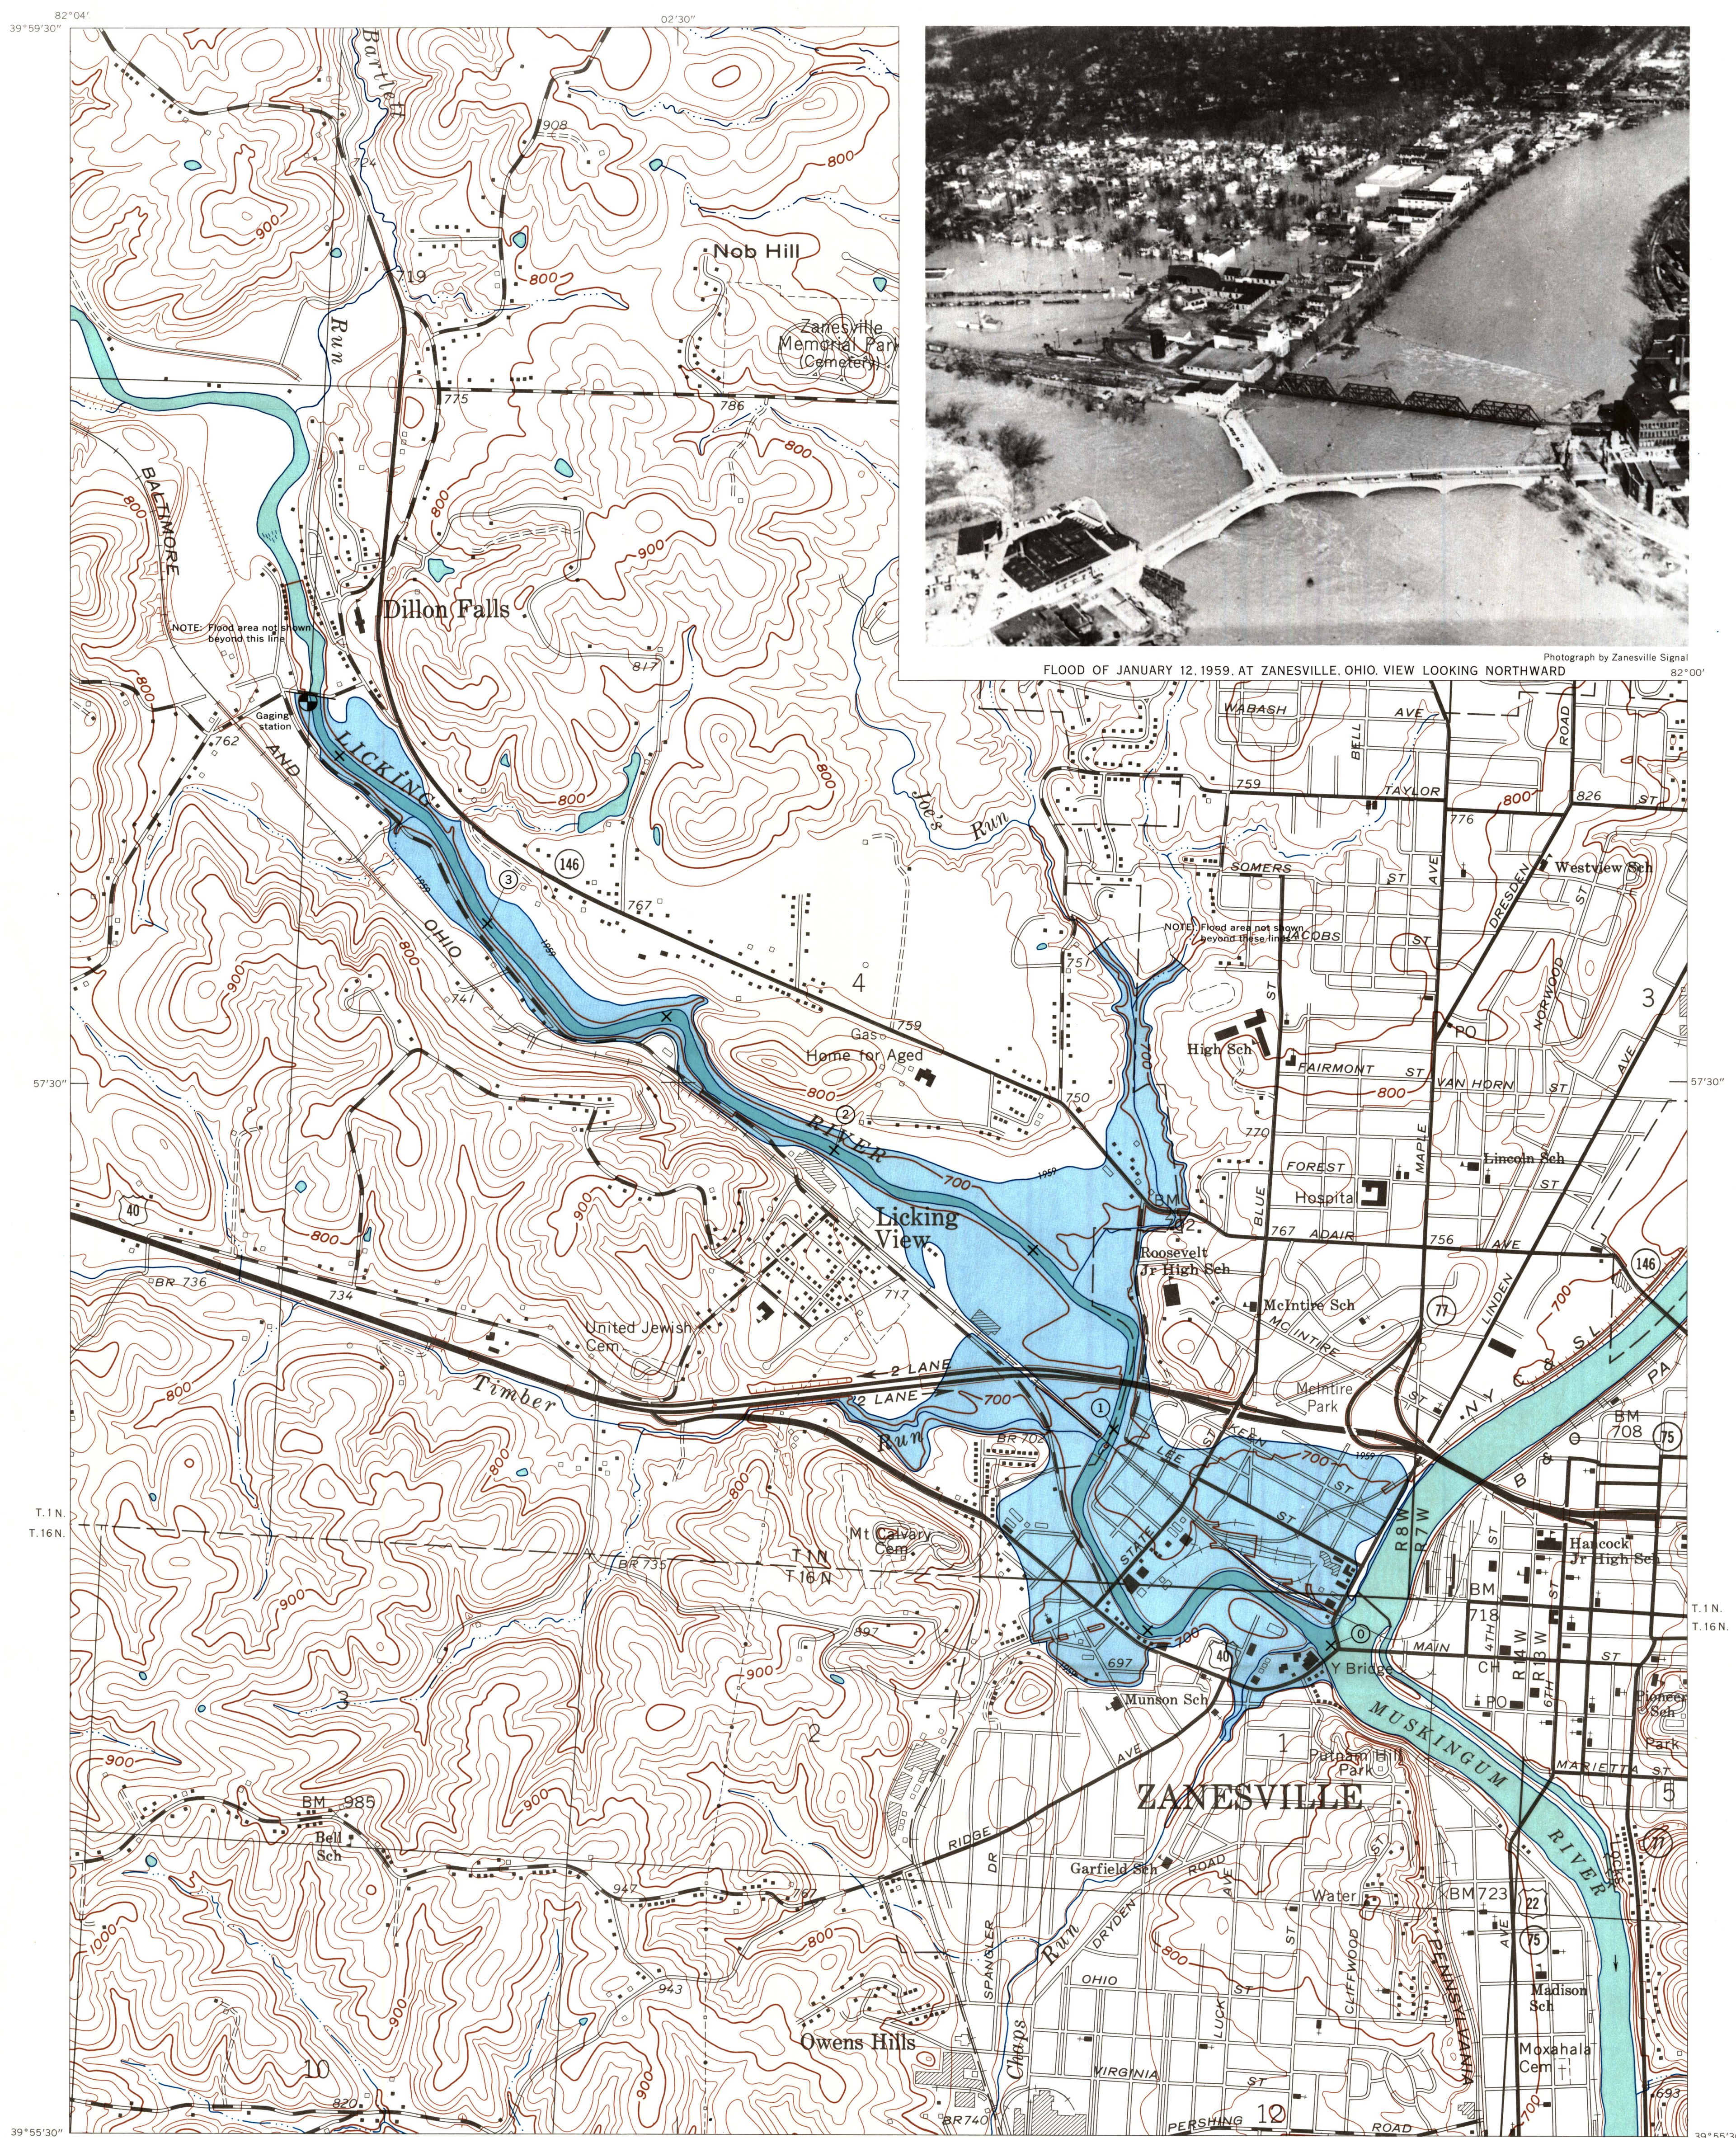
The approximate area flooded on January 22, 1959, is shown on a topographic map to record the flood hazard in graphic form. Greater floods are possible but no attempt has been made to define their probable overflow limits. The flood of January 22, 1959, was the second highest on the Licking River at Zanesville since 1884, having been exceeded only by the flood of March 1913. However, 10 miles upstream from Zanesville, beyond the effects of backwater from the Muskingum River, the 1959 flood was greater than that of 1913. In 1913 great floods occurred simultaneously on the Licking and Muskingum Rivers at Zanesville, but during the January 1959 flood the Muskingum River was several feet lower than in 1913.

**EXPLANATION**  
Area flooded January 22, 1959  
Boundary of 1959 flood  
River mile measured upstream from mouth of Licking River

Tabulated below are flood data recorded at the U.S. Geological Survey gaging station on Licking River at Dillon, located 3.65 miles upstream from the mouth. Overflow limits for only the flood of January 22, 1959, are shown on the map.

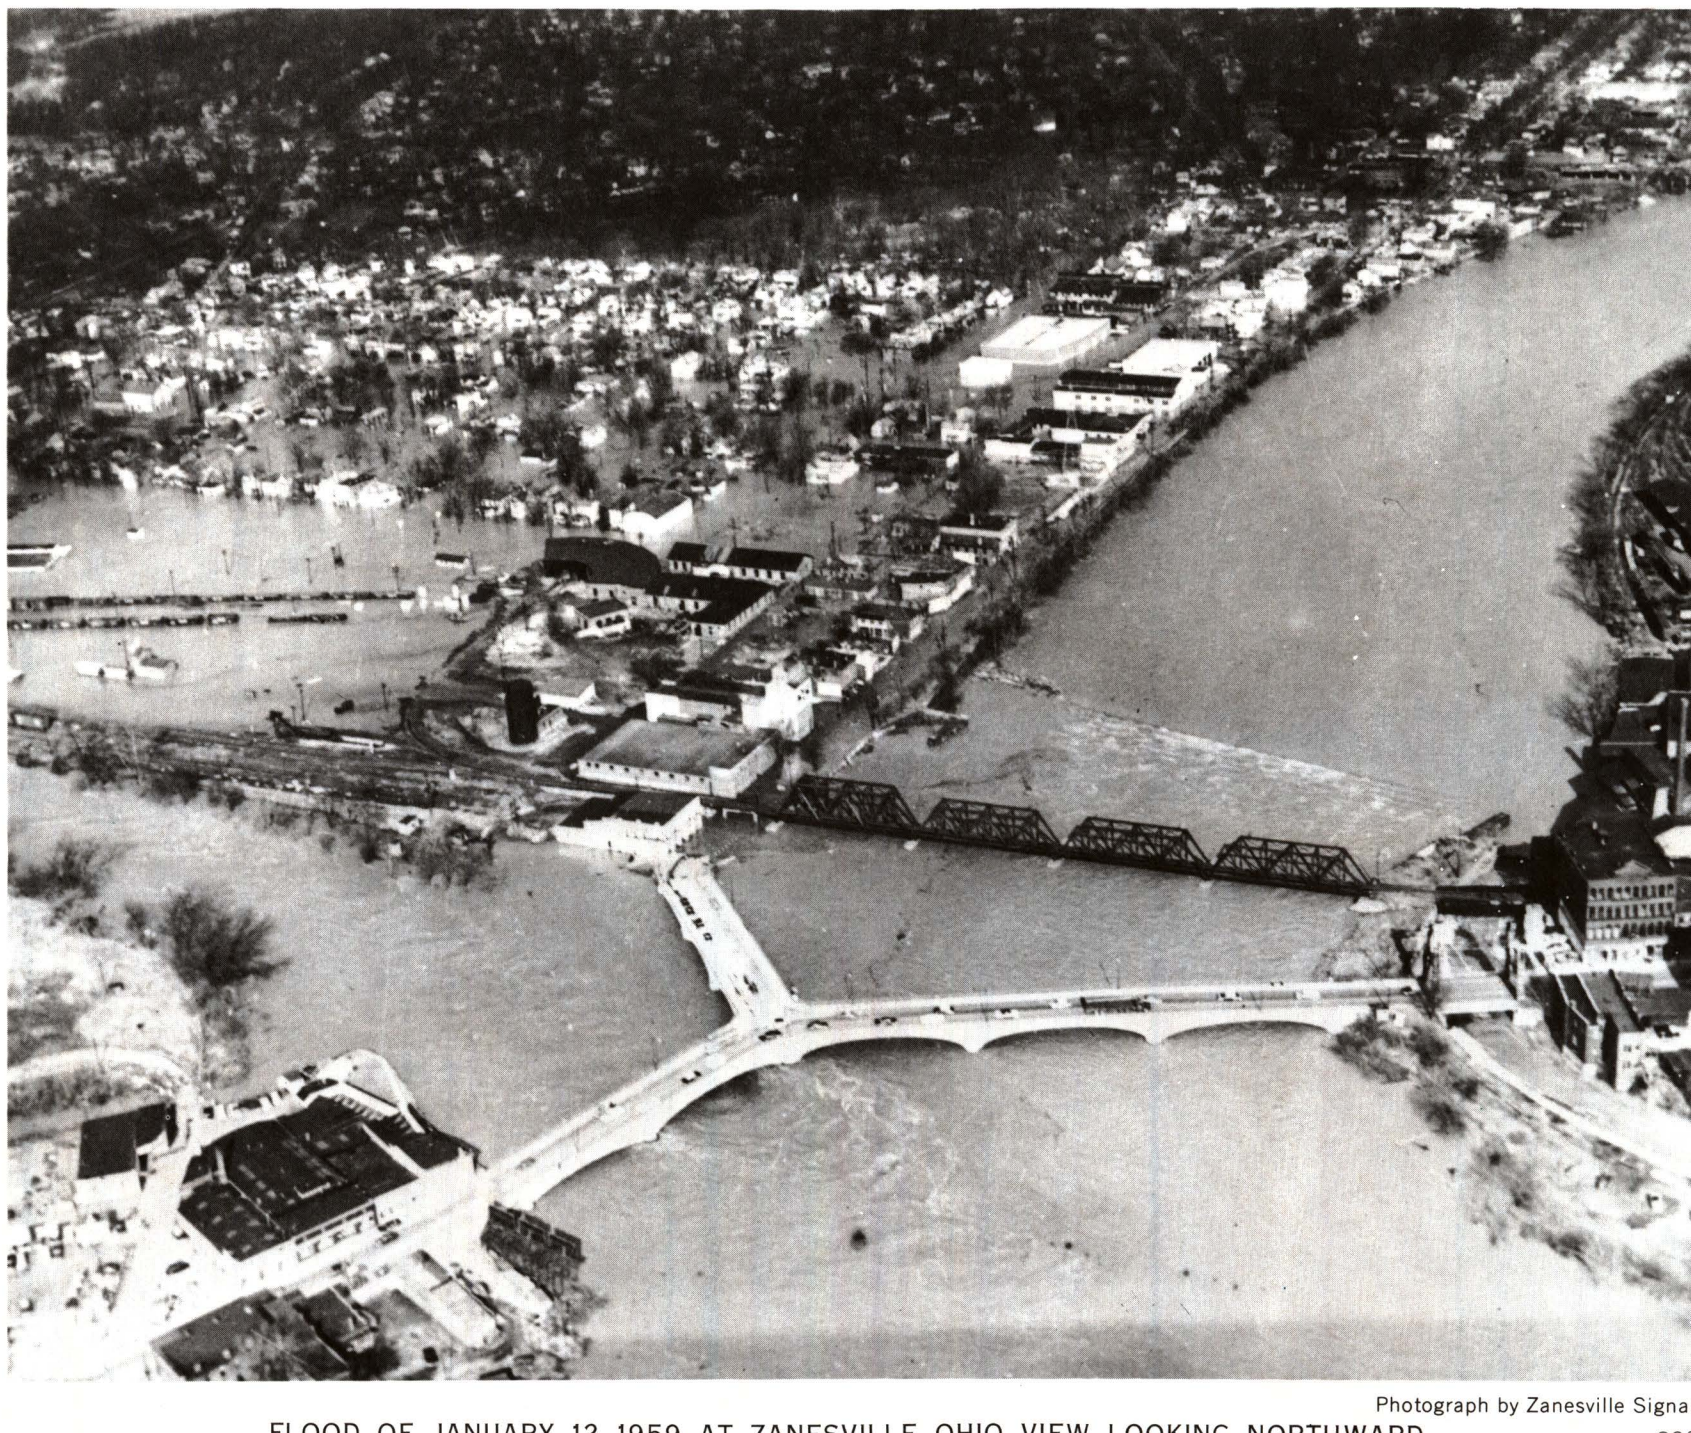
The aerial photograph was furnished by the Zanesville Signal.

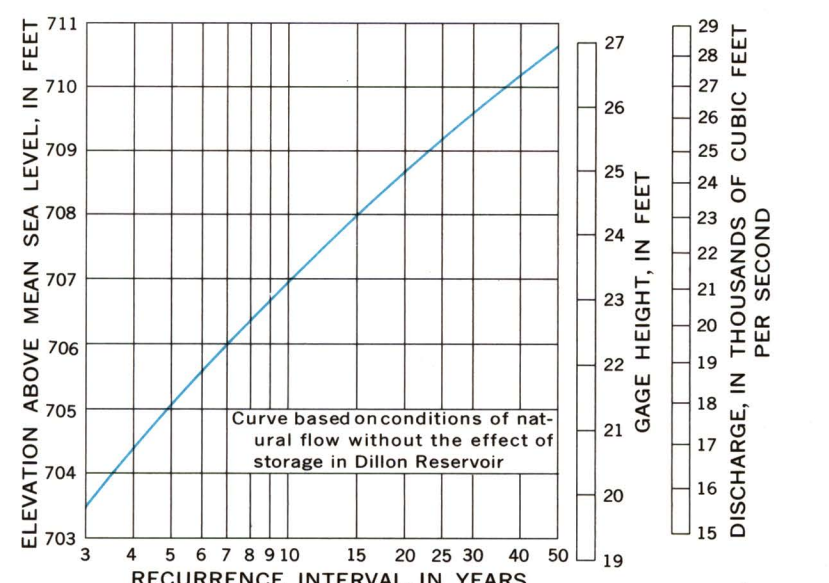
The general relation between recurrence interval and both flood height and flood discharge at the U.S. Geological Survey gaging station on the Licking River at Dillon is shown in figure 2 and is tabulated below. The curve represents conditions of natural flow without the effects of storage in Dillon Reservoir and backwater from Muskingum River.

FIGURE 2.—Frequency of floods above 703-foot elevation on Licking River at Dillon, Ohio.

Recurrence interval (years)	Elevation above mean sea level at gaging station at Dillon, (feet)	Discharge (cubic feet per second)
50	710.7	28,400
40	710.2	26,100
30	709.6	24,300
20	708.7	21,100
10	707.0	18,000
5	705.1	15,000

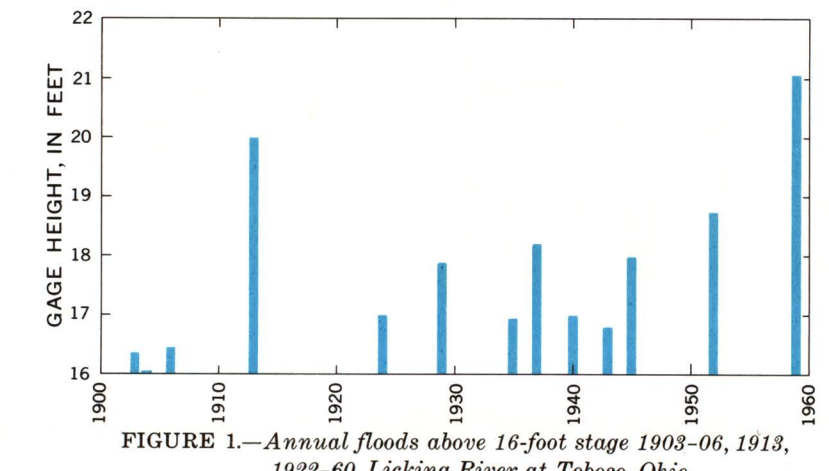
**Gage height and year of each annual flood** (highest momentary peak discharge each year) which exceeded the 16-foot stage at the gaging station on Licking River at Toboso, Ohio, are shown in figure 1. The record for the Toboso gaging station, located about 19 miles upstream from Zanesville, is used because it covers a much longer period than the record for the gaging station at Dillon. The irregular occurrence of floods is evident. Annual floods at Toboso exceeded the 16-foot stage 13 times in the 44 years of record (fig. 1), an average of about one flood each 3 1/2 years. Although no flood of this magnitude occurred in 31 of the years, there were 5 floods that exceeded this stage during the 11-year period 1935-45.

FIGURE 1.—Annual floods above 16-foot stage 1903-06, 1912, 1922-60, Licking River at Toboso, Ohio.
